AIRCRAFT ACCIDENT REPORT**ADOPTED:** February 2, 1962**RELEASED:** February 6, 1962

IMPERIAL AIRLINES, INC., LOCKHEED CONSTELLATION L-049,
N 2737A, BYRD FIELD, RICHMOND, VIRGINIA,
NOVEMBER 8, 1961

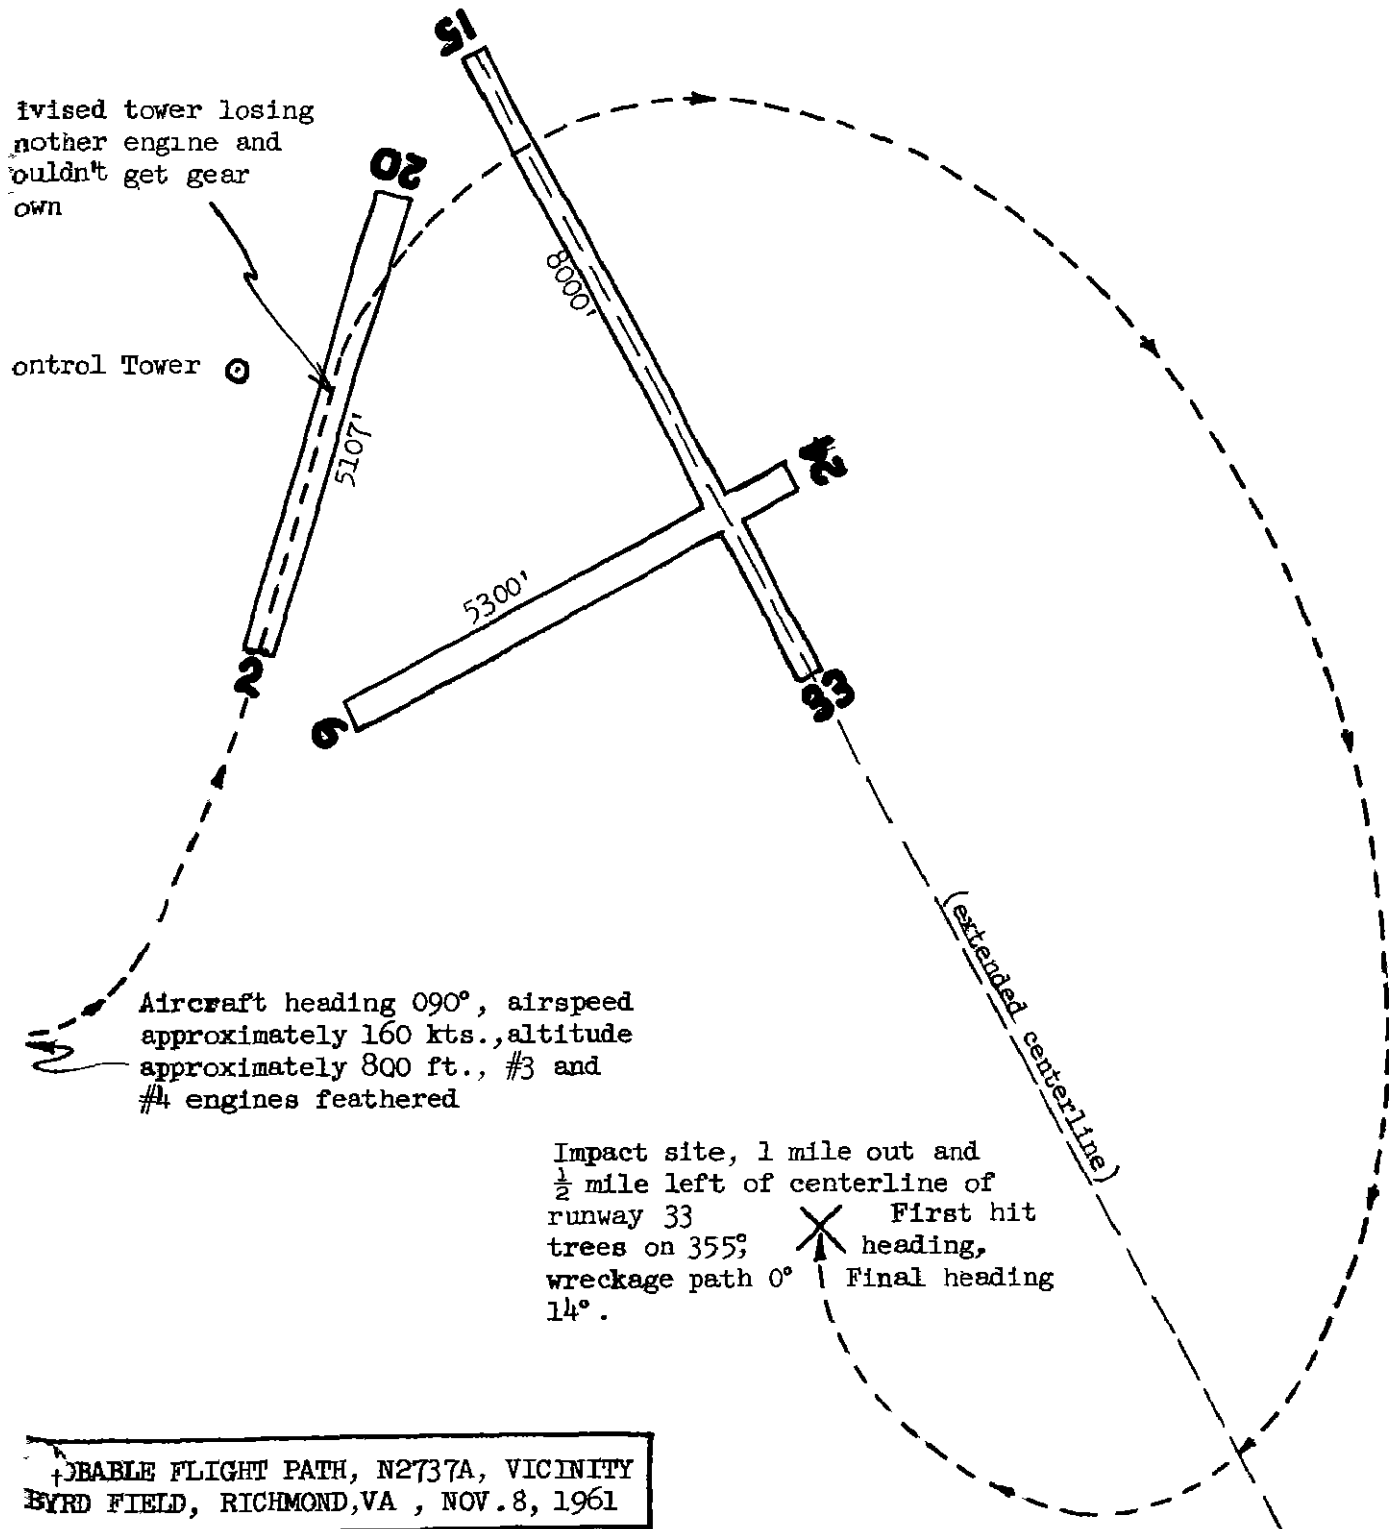
RECOVERABLE FLIGHT PATH, N2737A, VICINITY
BYRD FIELD, RICHMOND, VA , NOV. 8, 1961

From the location of the wreckage it is apparent that the landing pattern was poorly executed. It is believed that when the airplane was on its base leg the bank angle was steepened in an attempt to avoid overshooting the extended centerline of the runway. This increased angle of bank and increased rate of turn bled off airspeed and the aircraft began to sink. To try to arrest the sink rate Greenlee called for "...all the power you got." By this time the No. 1 engine was destroying itself as a result of the over boosting during the emergency. It failed completely. With only one engine delivering power it was impossible to maintain flight and the aircraft stalled into the trees.
