C I V I L A E R O N A U T I C S B O A R D  
A I R C R A F T A C C I D E N T R E P O R T

Adopted: April 16, 1963

KODIAK AIRWAYS, INC., GRUMMAN G-21A, N 1503V,  
OLD HARBOR, KODIAK ISLAND, ALASKA,  
DECEMBER 24, 1961

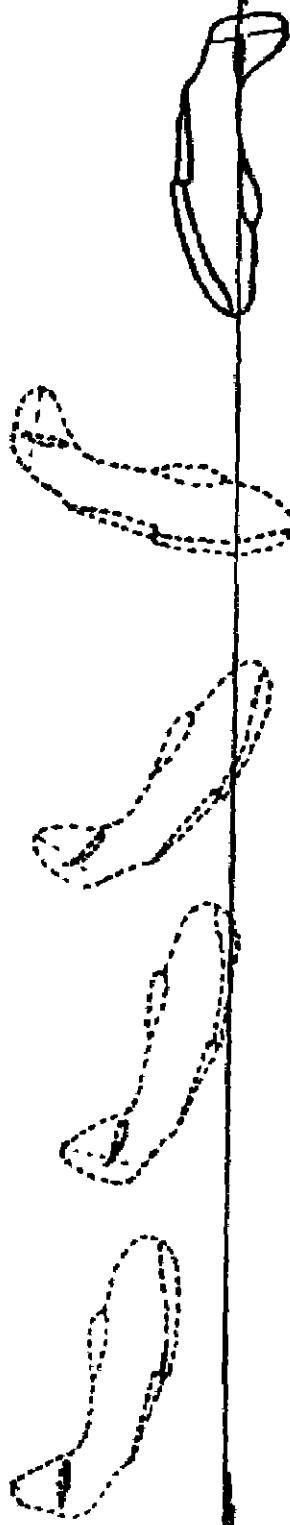
**SEQUENCE OF EVENTS DURING DIVING**

Report Number 1025 further states, "There were three incidents involving diving in smooth water, one of which followed the first cycle of high-speed low-angle porpoising. The fourth case of diving occurred in moderately rough water. In all these accidents the aircraft were completely demolished. In one instance the diving started at about 85 knots, which is some 25 knots above the stalling speed " This section referred specifically to the JRF-4 and 5, which is the U. S. Navy designation for the Grumman G-21A The report also included a drawing to differentiate between diving and high-speed low-limit porpoising. The sketch is included in this report as Attachment A.

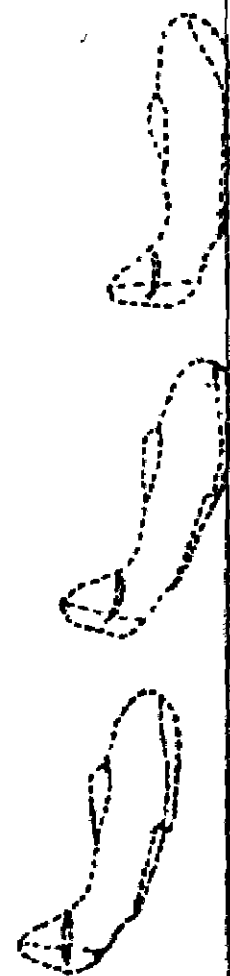
**DURING HIGH SPEED LOWER LIMIT PORPOISING**

The sequence of events described by the witnesses and passengers, and which, with the exception of the first high speed touchdown in the water, is consistent with the pilot's testimony, corresponds precisely to the sequence of events

associated with high-speed low-angle porpoising. While this accident occurred on takeoff, the pilot's failure to recognize the subsequent loss of altitude, resulted in the aircraft striking the water under conditions nearly identical to those of an improperly executed high-speed low-trim landing. In this instance structural failure occurred at impact after the first cycle.
