CIVIL AERONAUTICS BOARD

AIRCRAFT ACCIDENT REPORT

AMERICAN AIRLINES, INC., BOEING 707-123B
N 7506A, JAMAICA BAY, LONG ISLAND, NEW YORK,
MARCH 1, 1962

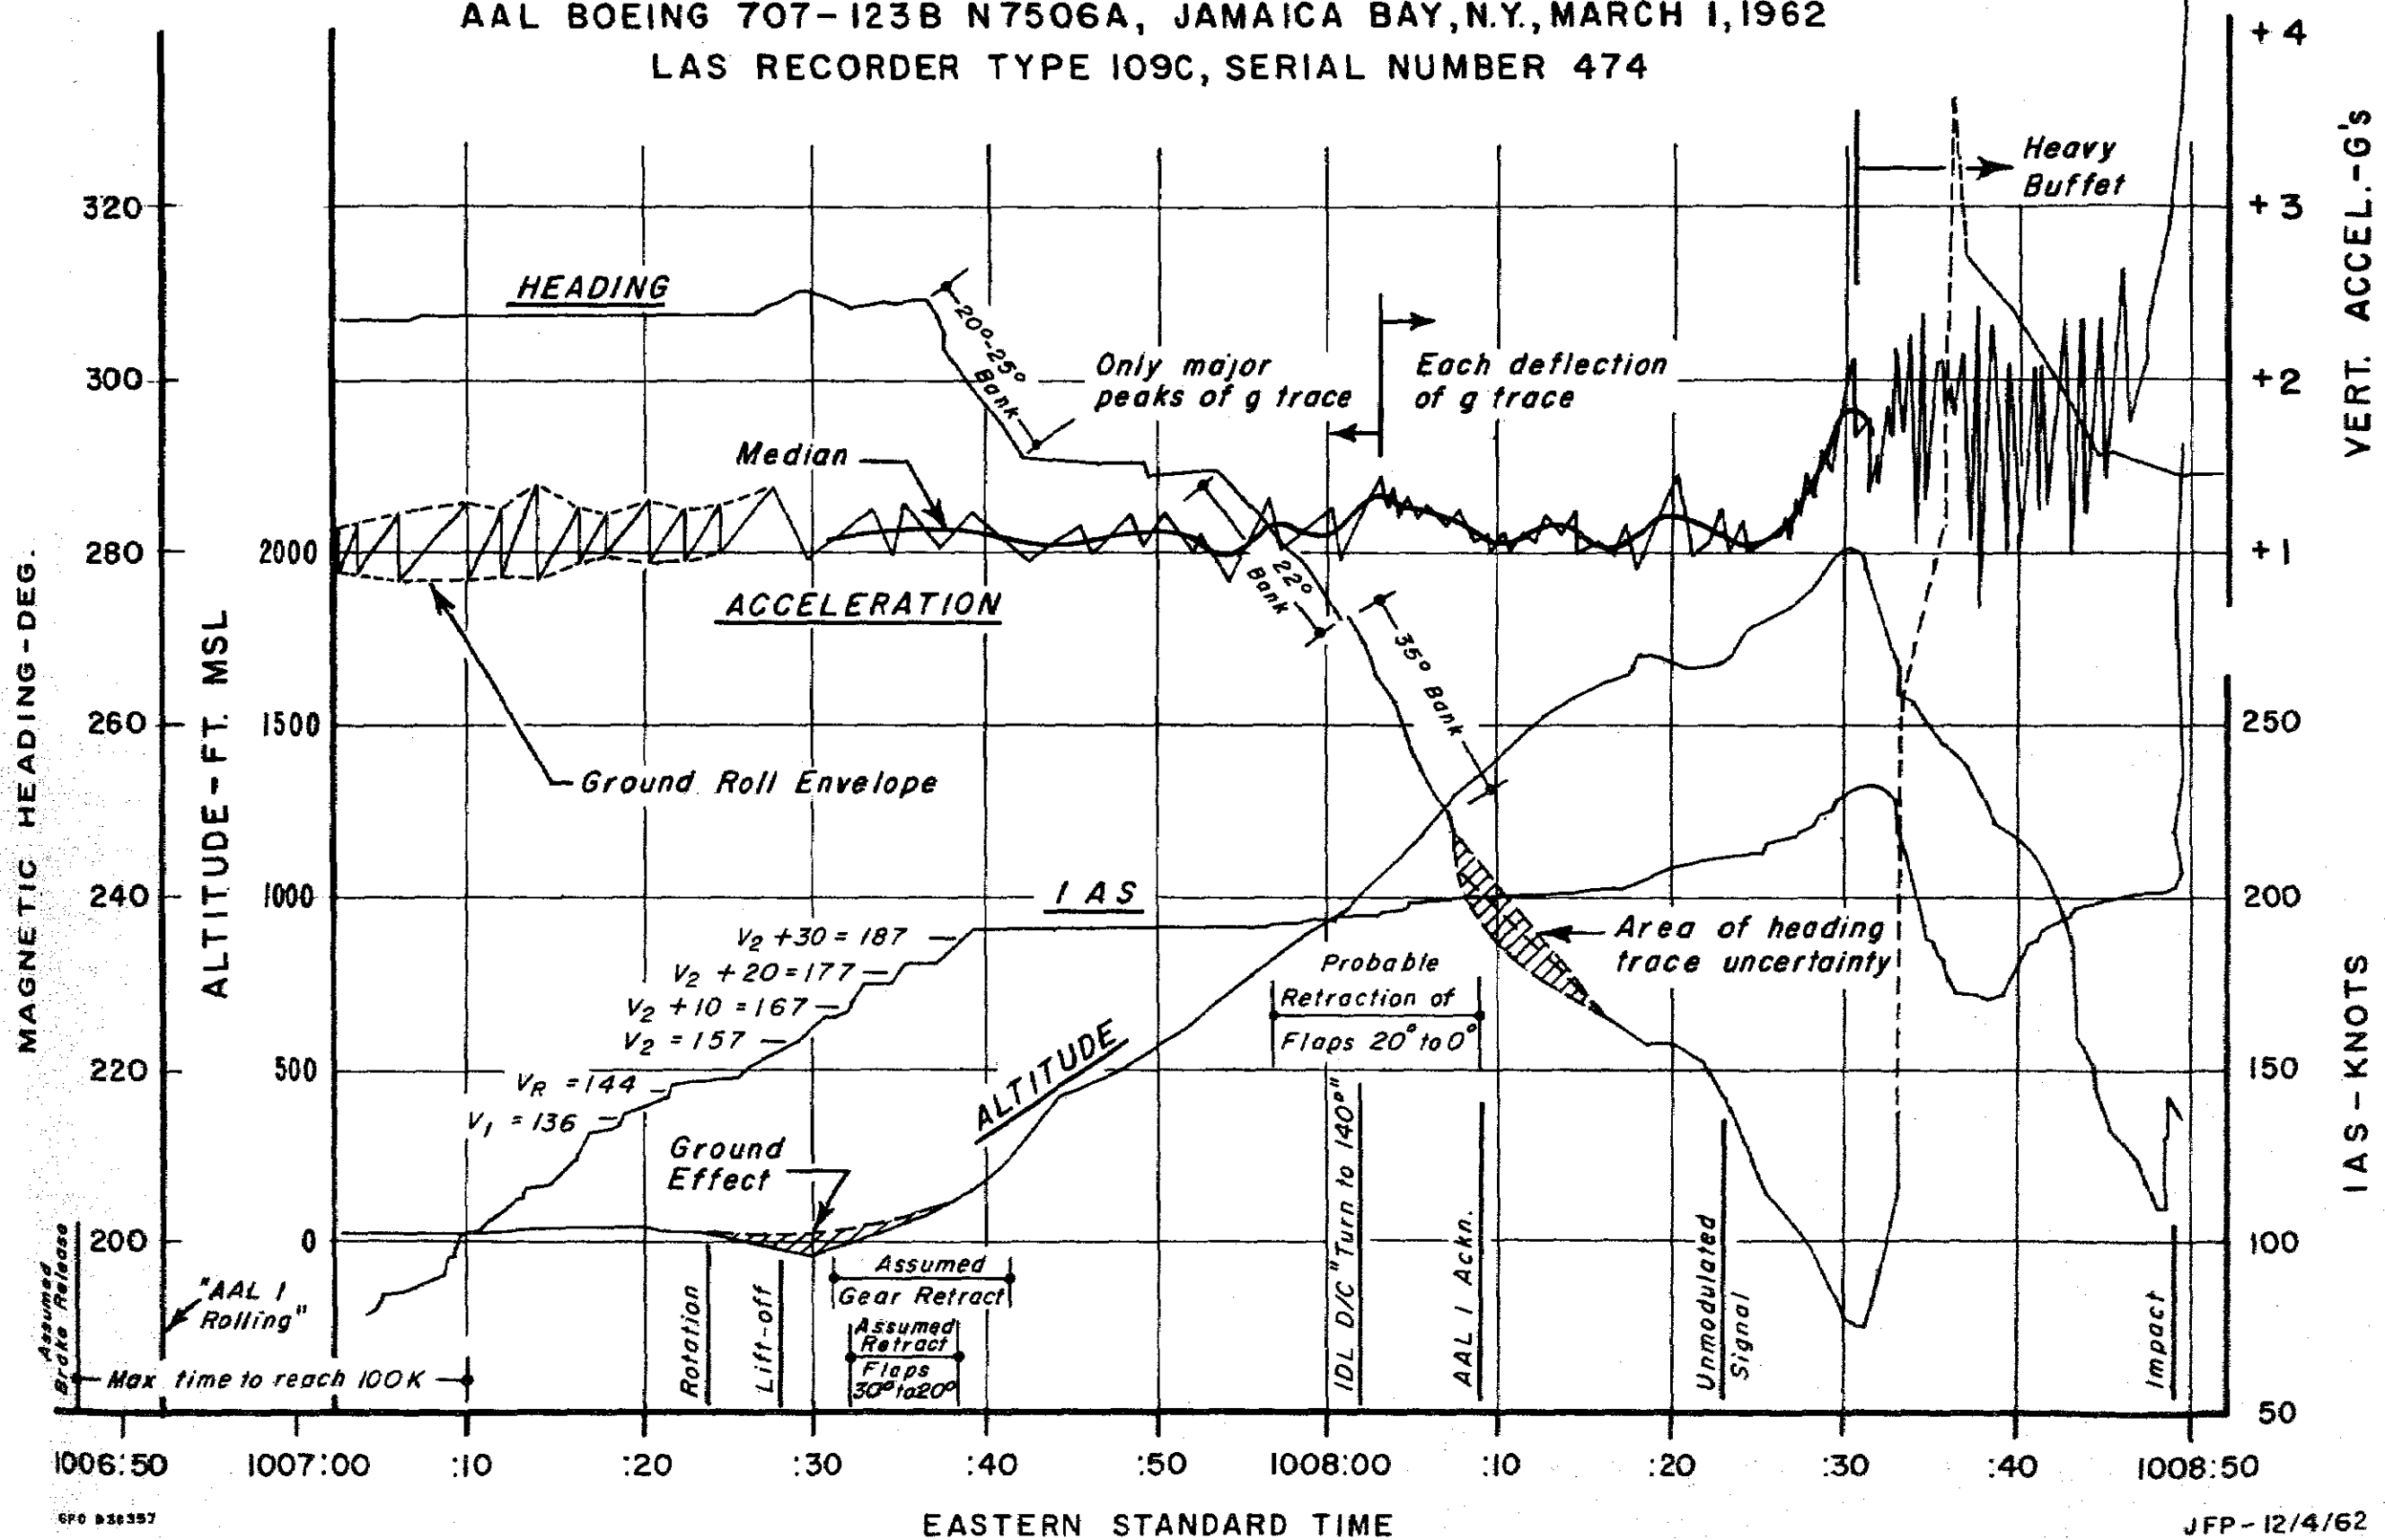
CIVIL AERONAUTICS BOARD FLIGHT RECORDER DATA

At 1008:07, within six-tenths of a second, a heading change from 250 to 243 degrees is recorded; a change rate of 12 degrees/second, amounting to an instantaneous tripling of the 3.83 degrees/second change rate recorded just prior to this time. From 1008:08 to 1008:16 the heading trace passes through the badly wrinkled, abraded and torn portion of the foil, during which time the heading changed from 245 to 225 degrees. At time 1008:16, the heading trace emerges from the badly damaged portion of the foil and for the next one and one-half seconds indicates a much lower rate of heading change than that immediately preceding entry into the damaged area. The heading trace shows a momentary cessation of turn at 1008:19 followed by a higher turn rate continuing until 1008:31, when a sharp reversal in the recorded heading is noted. Such an abrupt change from a left turn to a right turn is beyond the aircraft's capability and is an indication of gimbals error in the directional gyro of the airplane as the angle of left bank approached 90 degrees. From this time to about 1008:42 the recorded headings are similarly in error due to the high roll and pitch angles of the airplane as it inverted and dove to the ground.

At time 1008:18, 1008:25 and 1008:29 the airspeed and altitude traces indicate sharp simultaneous increases which were beyond the aircraft's performance capability, and the highest peaks recorded indicate an airspeed of 230 knots and 2,000 feet of altitude at 1008:30. The precise significance of these recordings cannot be completely defined. However, a single static port low on the left side of the forward fuselage is connected to the airspeed and altitude sensors of the flight recorder. As a result, nose left sideslip (relative wind from the right) and high angles of attack cause appreciable plus errors in the recorded airspeed and altitude.
