CIVIL AERONAUTICS BOARD  
AIRCRAFT ACCIDENT REPORT

Adopted: July 15, 1963

ALLEGHENY AIRLINES, INC., CONVAIR 340/440, N 8415H,  
NEAR BRADLEY FIELD, WINDSOR LOCKS, CONNECTICUT  
OCTOBER 19, 1962

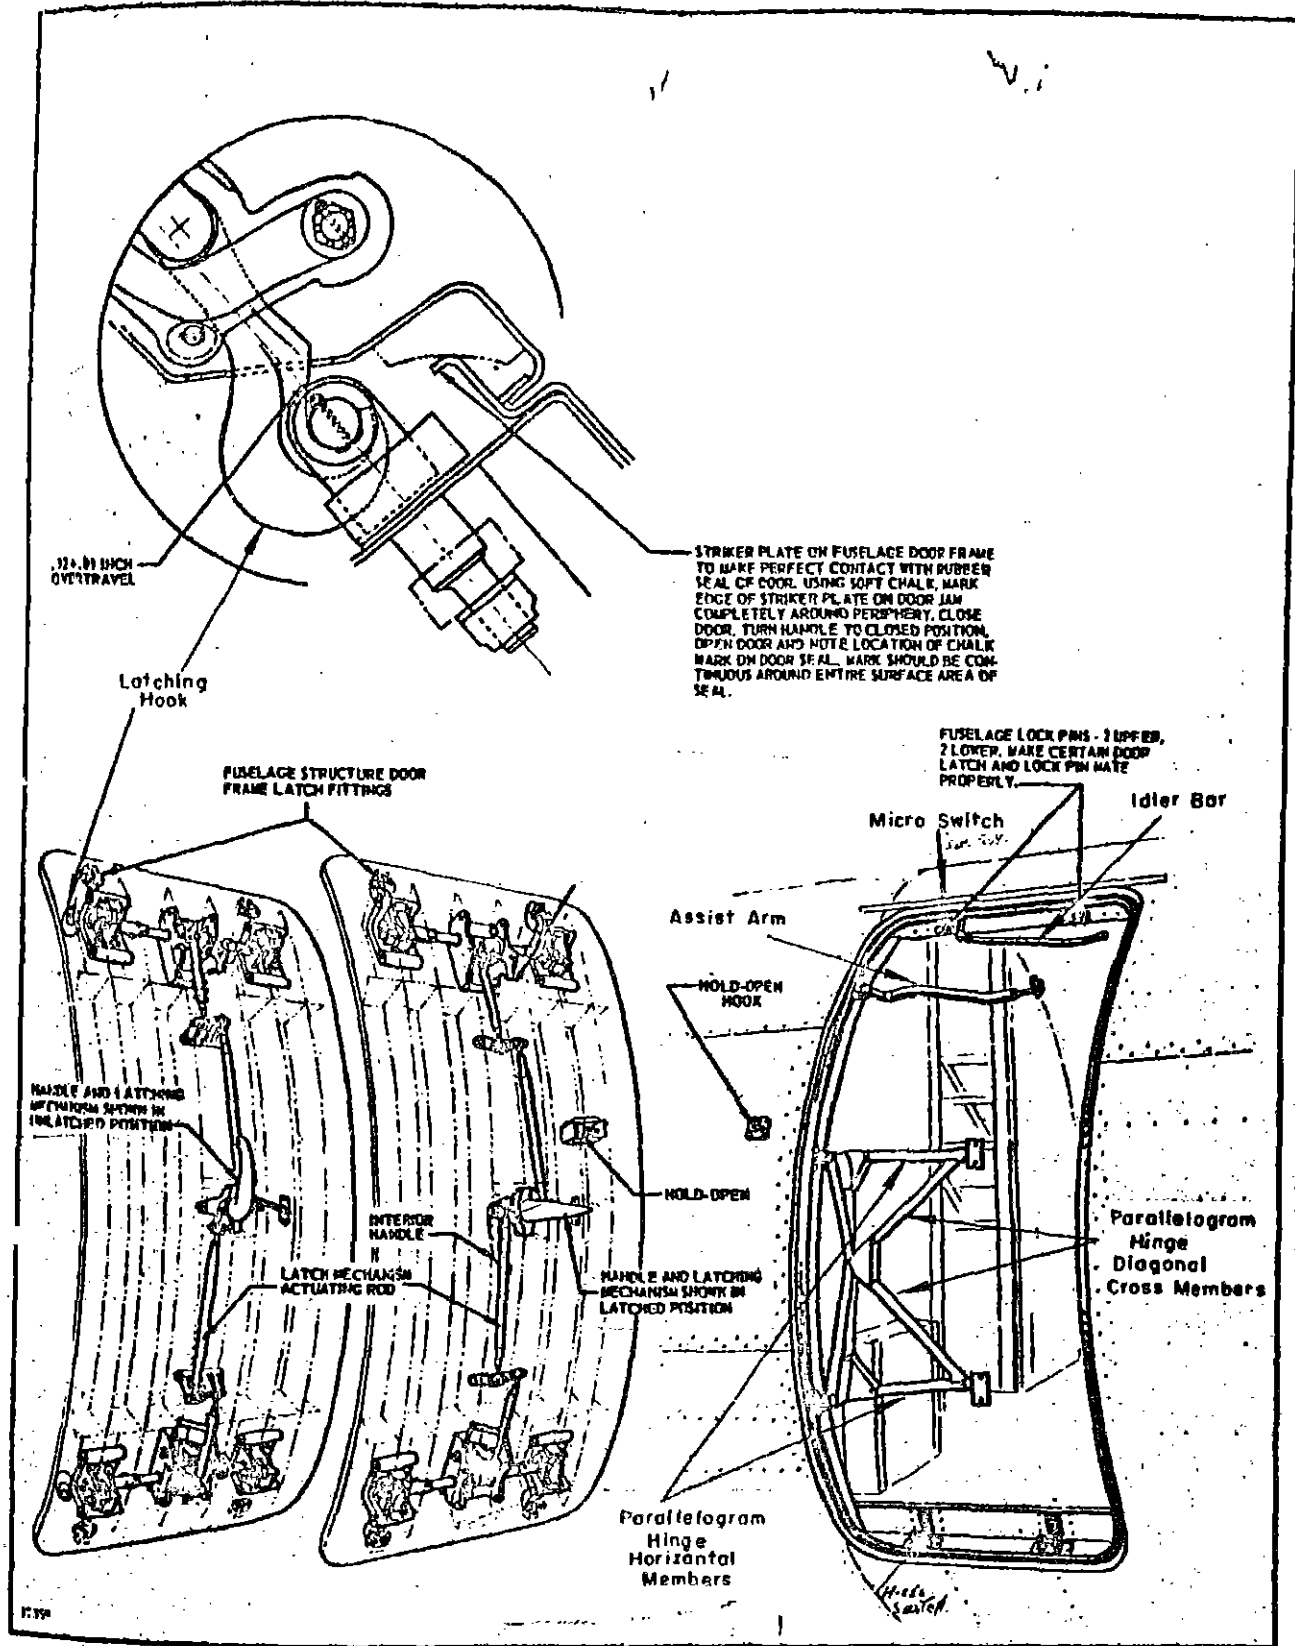
Figure 3.2.104 Rear Service Door

Investigation by the Civil Aeronautics Board at Bradley Field disclosed that the lower edge of the rear service door was one foot away from the lower lock pins and twisted rearward. The upper latching hooks were over the upper lock pins; however, the hooks were twisted and bent outward. The door handle was in the open position, aligned with the "open" reference arrow painted on the door fabric.

The parallelogram door hinge had separated at the horizontal and diagonal tubular cross members (see attachment). The vertical portion remained attached to the fuselage and the horizontal portion separated at the attachment to the interior of the door. The upper idler bar and the assist arm were separated. The attachment of the assist arm to the interior surface of the door was intact, allowing the arm to become wedged between the door and jamb at the aft side.
