AIRCRAFT ACCIDENT REPORT

DOUGLAS DC-7B, N815D
EASTERN AIR LINES, INC.
New York International Airport
Jamaica, New York
November 30, 1962

CIVIL AERONAUTICS BOARD
WASHINGTON, D.C. 20428

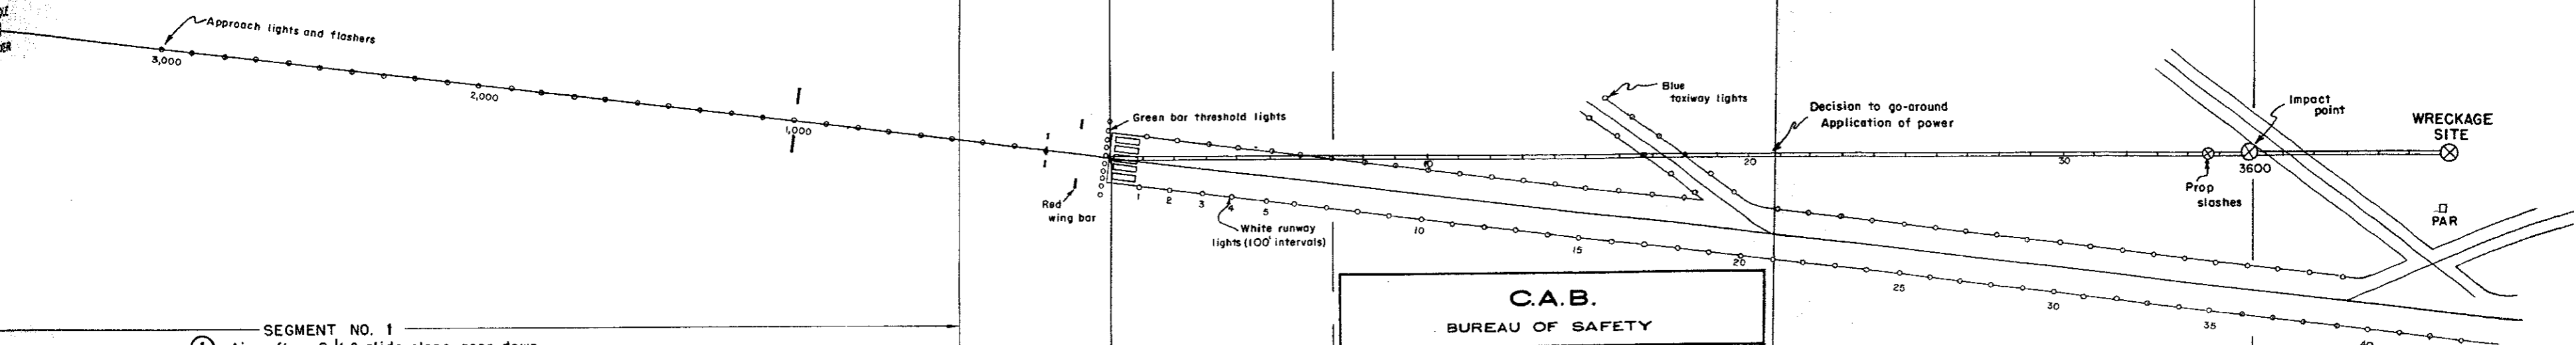
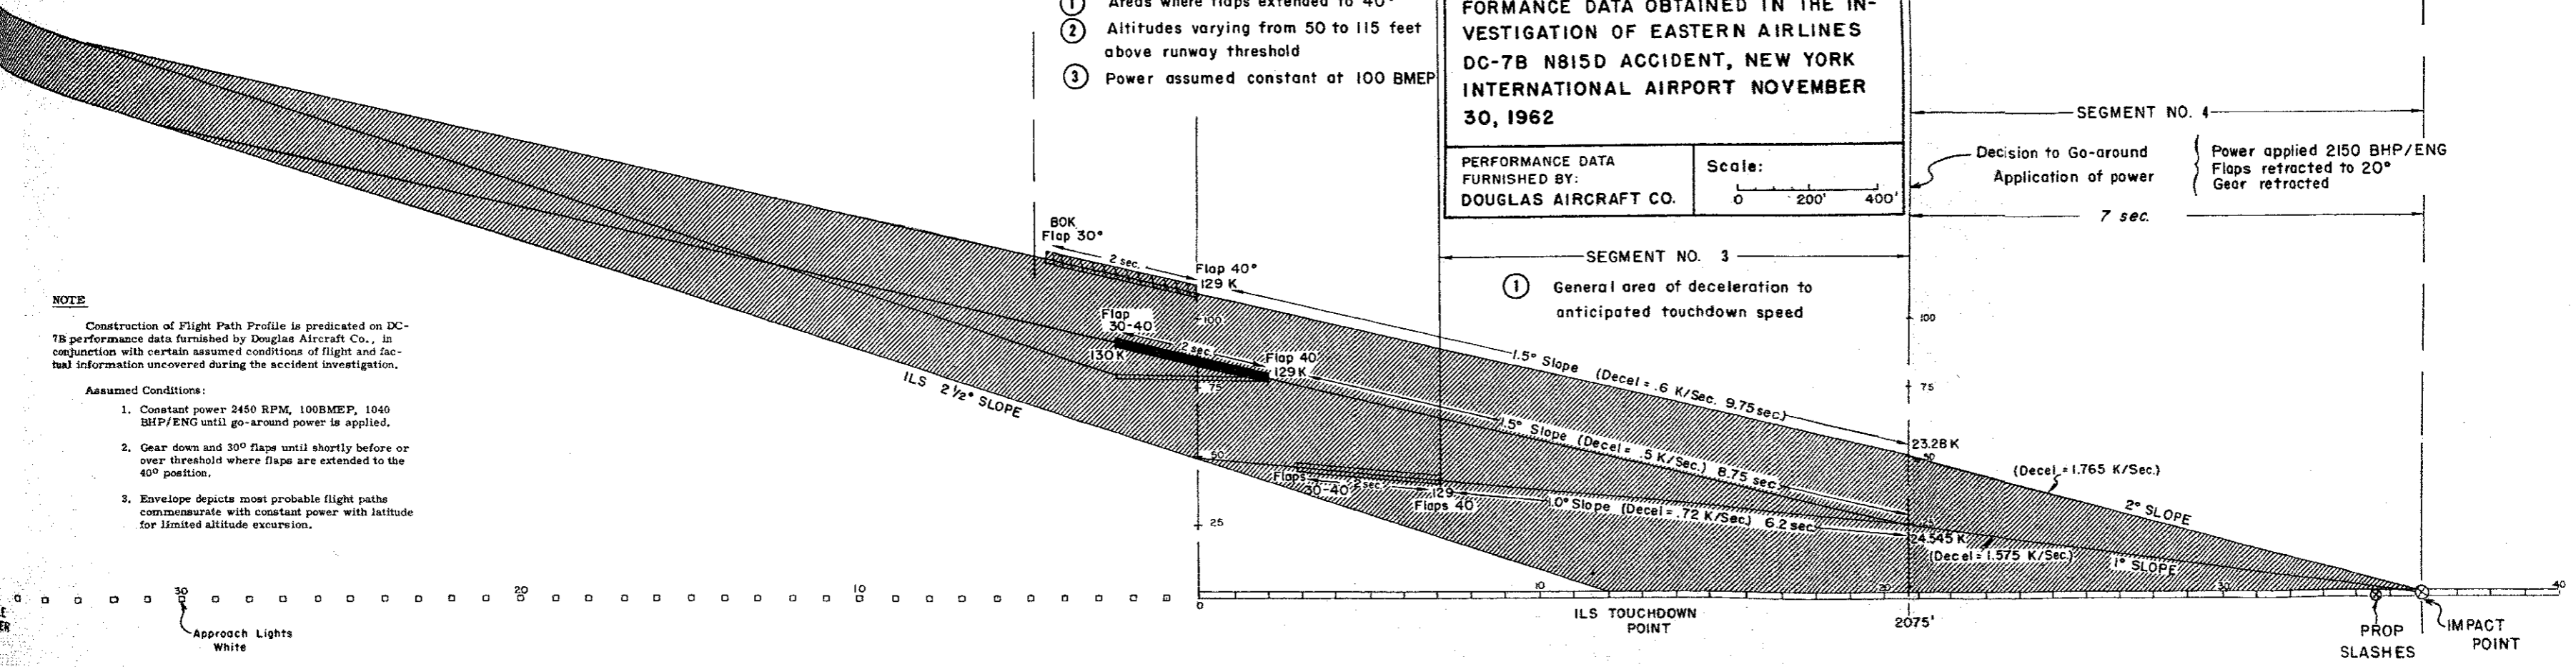
COMPUTED ENVELOPE OF PROBABLE FLIGHT PATH OF A DC-7 AIRCRAFT UTILIZING GROUND OBJECT DAMAGE, WITNESS INFORMATION, AND DC-7 PERFORMANCE DATA OBTAINED IN THE INVESTIGATION OF EASTERN AIRLINES DC-7B N815D ACCIDENT, NEW YORK INTERNATIONAL AIRPORT NOVEMBER 30, 1962

Attached to this report is a drawing depicting the probable flight profile of EAL 512 which indicates that:

1. The aircraft was on the glide path at the middle marker with its gear down, flaps at 30 degrees, airspeed at 130 knots, descending at 574 feet per minute and a constant power of 100 BMEP at 2,450 r p.m., or 1,040 brake horsepower per engine.

2. As the runway threshold was approached, flap extension from 30 degrees to 40 degrees was initiated at an altitude of approximately 75 to 80 feet. The extension of flaps from 30 degrees to 40 degrees required 2 seconds, during which time the aircraft decelerated approximately 1 knot to 129 knots. A slight deviation above the glide slope occurred when the crew, seeing the threshold and some of the runway lights, began to execute a visual approach

3. After crossing the threshold, the aircraft continued along a flightpath of 1-1/2 degrees slope downward and about 6 degrees to the left of the runway heading for 8-3/4 seconds. During this period, there was a rapid deterioration of visual reference when thick ground fog was encountered. At the end of this period, the aircraft had decelerated to a speed of 124-1/2 knots and had descended to an altitude of approximately 25 feet above the ground. After perceiving the fog and evaluating the situation, the crew of EAL 512 elected to abandon the approach. Without increasing the r.p.m., slightly more than climb power was applied, and the landing gear was retracted coincident with retraction of the flaps to 20

degrees. The nose of the aircraft was rotated upwards to between 3 to 5 degrees above the level position. The missed approach procedure was initiated about 1,000 feet beyond the ILS touchdown point, to the left of the runway, altitude about 25 feet.

- SEGMENT NO. 1
- ① Aircraft on $2\frac{1}{2}^\circ$ glide slope, gear down, flaps 30° 130 KTS, descending 574 FPM (2450 RPM, 100 BMEP, 1040 BHP/ENG)
 - ② Envelope depicts flight path on and slightly above glide slope.

- SEGMENT NO. 2
- ① Areas where flaps extended to 40°
 - ② Altitudes varying from 50 to 115 feet above runway threshold
 - ③ Power assumed constant at 100 BMEP
