AIRCRAFT ACCIDENT REPORT

ADOPTED: December 26, 1963

THE FLYING TIGER LINE INC.,
LOCKHEED 1049H, N 6913C, NORTH HOLLYWOOD, CALIFORNIA
DECEMBER 14, 1962

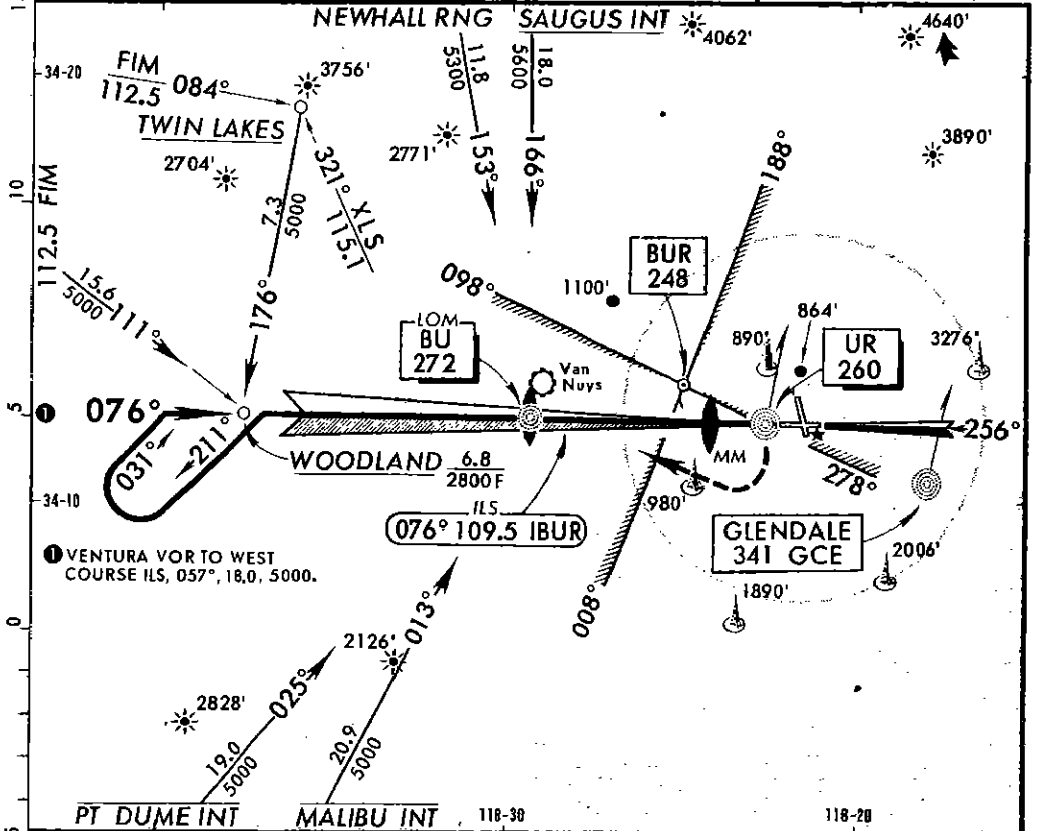
Attachment A

in that the localizer antenna is located at the approach end of the runway. The outer marker, middle marker, and inner-compass locator are 6.0, 1.7, and .4 nautical miles, respectively, from the threshold. (See Attachment A). Electrical power to operate this facility is supplied by a public utility company. Additionally, an auxiliary generator is available to supply power to the localizer, glide slope, and inner-compass locator in the event of a general power failure. All of the ILS components are continually monitored for proper operation by individual automatic monitoring devices. These monitors are designed to detect any change in signal characteristics beyond established limits and to alert tower personnel through an alarm system in the event of a failure.

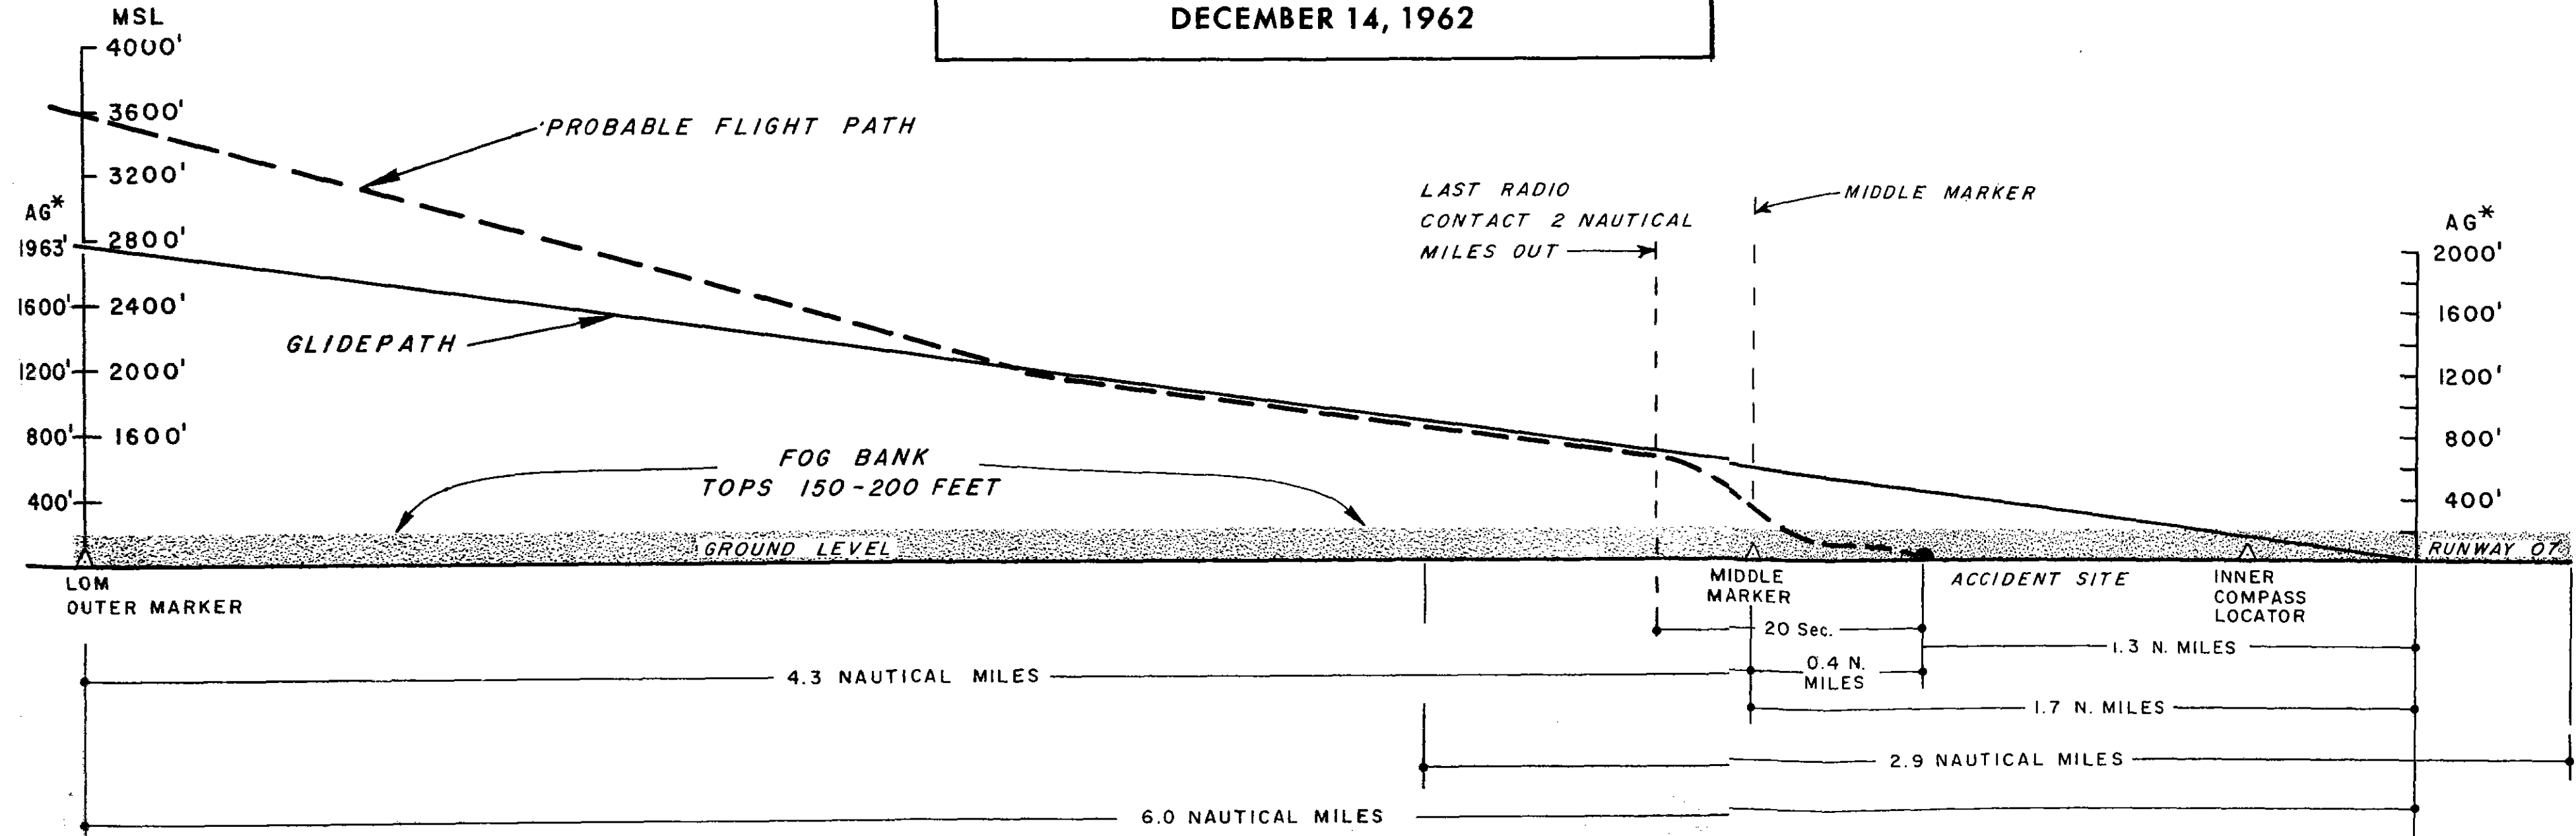
C.A.B.
 Bureau of Safety
PROBABLE FLIGHT PROFILE
FLYING TIGER LINE
 L1049H, N6913C
 NORTH HOLLYWOOD, CALIFORNIA
 DECEMBER 14, 1962

Based on the test flight data and witness observations, a flight profile of N 6913C was developed. (See Attachment B). It indicates that Flight 183 passed over the outer marker at an altitude of between 3,500 and 3,700 feet m.s.l. (800 to

1,000 feet above glide slope) and that glide slope interception occurred between the outer and middle markers. The landing gear is believed to have been extended prior to glide slope interception. The last radio contact with the flight occurred at 2211:55 at a point two miles from the end of the runway. This contact, "OK understand," was identified as having been made by the captain in reply to a "two miles out," radar position given by Approach Control. Therefore, it is believed that at this point the aircraft was within glide slope parameters at a height of about 650 feet. If the aircraft had descended on through the glide slope at the point of interception and a constant rate of descent were maintained to the point of ground impact, the aircraft would have been approximately 290 feet below the glide slope at or near the last radio contact point. A deviation from glide slope to this extent should have caused a full scale "fly-up" reading on a normal IIS indicator. It is inconceivable that this condition would have been allowed to remain uncorrected to this degree if all was normal on the flight deck. Additionally, the only witness located who observed the aircraft appreciably west of the middle marker stated that the aircraft appeared to be at normal approach altitude.

Approximately 20 seconds elapsed from the two miles out position to the point of initial impact. It is believed that the flightpath changed radically within this short period of time especially considering that at the time of power application the aircraft was at an extremely low altitude.
