# AIRCRAFT ACCIDENT REPORT

ADOPTED: September 4, 1963

WEST COAST AIRLINES, INC., FAIRCHILD F-27, N 2703  
GREAT SALT LAKE, UTAH, JANUARY 17, 1963

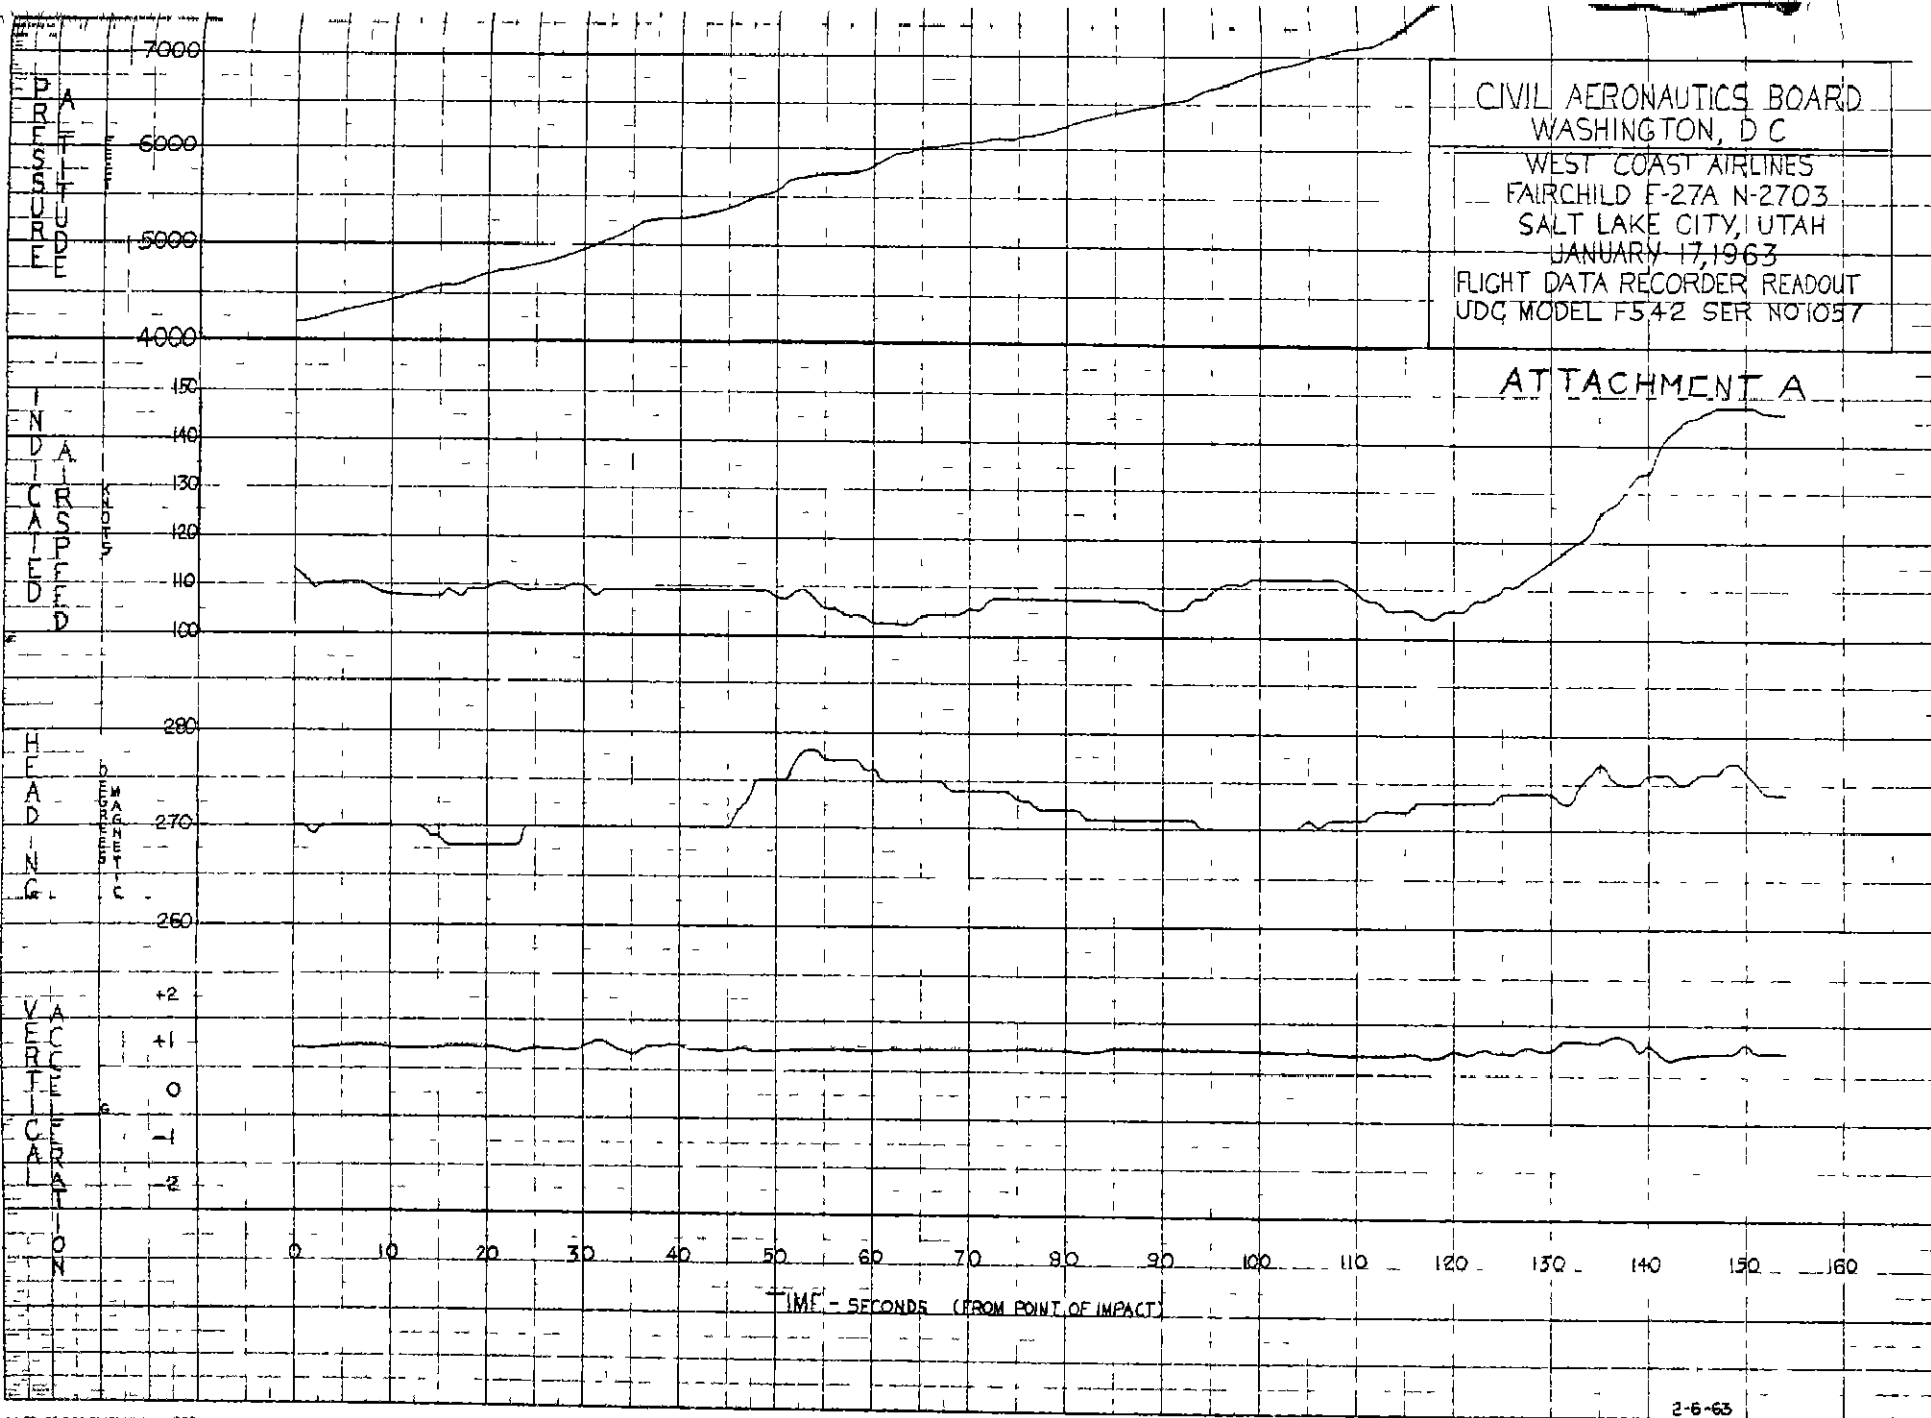
CIVIL AERONAUTICS BOARD  
 WASHINGTON, D C  
 WEST COAST AIRLINES  
 FAIRCHILD F-27A N-2703  
 SALT LAKE CITY, UTAH  
 JANUARY 17, 1963  
 FLIGHT DATA RECORDER READOUT  
 JDC, MODEL F542 SER NO 1057

Examination of the tape traces during the final 127 seconds prior to impact established the following: Flight 703 started a descent from 7,498 feet m.s.l., 127 seconds prior to impact, and continued this descent to the lake's surface which is 4,180 feet m.s.l. The average rate of descent was 1,566 feet per minute. The airspeed varied between 102 and 113 knots, with an average of 107.8 knots. The magnetic heading varied between 268 degrees and 278 degrees. The vertical acceleration was almost constant at .95 g.,<sup>2/</sup> with some variations between 1.1 g. and .8 g. The flight recorder tape revealed no evidence of an attempted flareout just prior to impact. (See Attachment A.)
