AIRCRAFT ACCIDENT REPORT

CONTINENTAL AIR LINES, INC.
VICKERS VISCOUNT 812, N242V
MUNICIPAL AIRPORT, KANSAS CITY, MISSOURI
JANUARY 29, 1963

SYNOPSIS

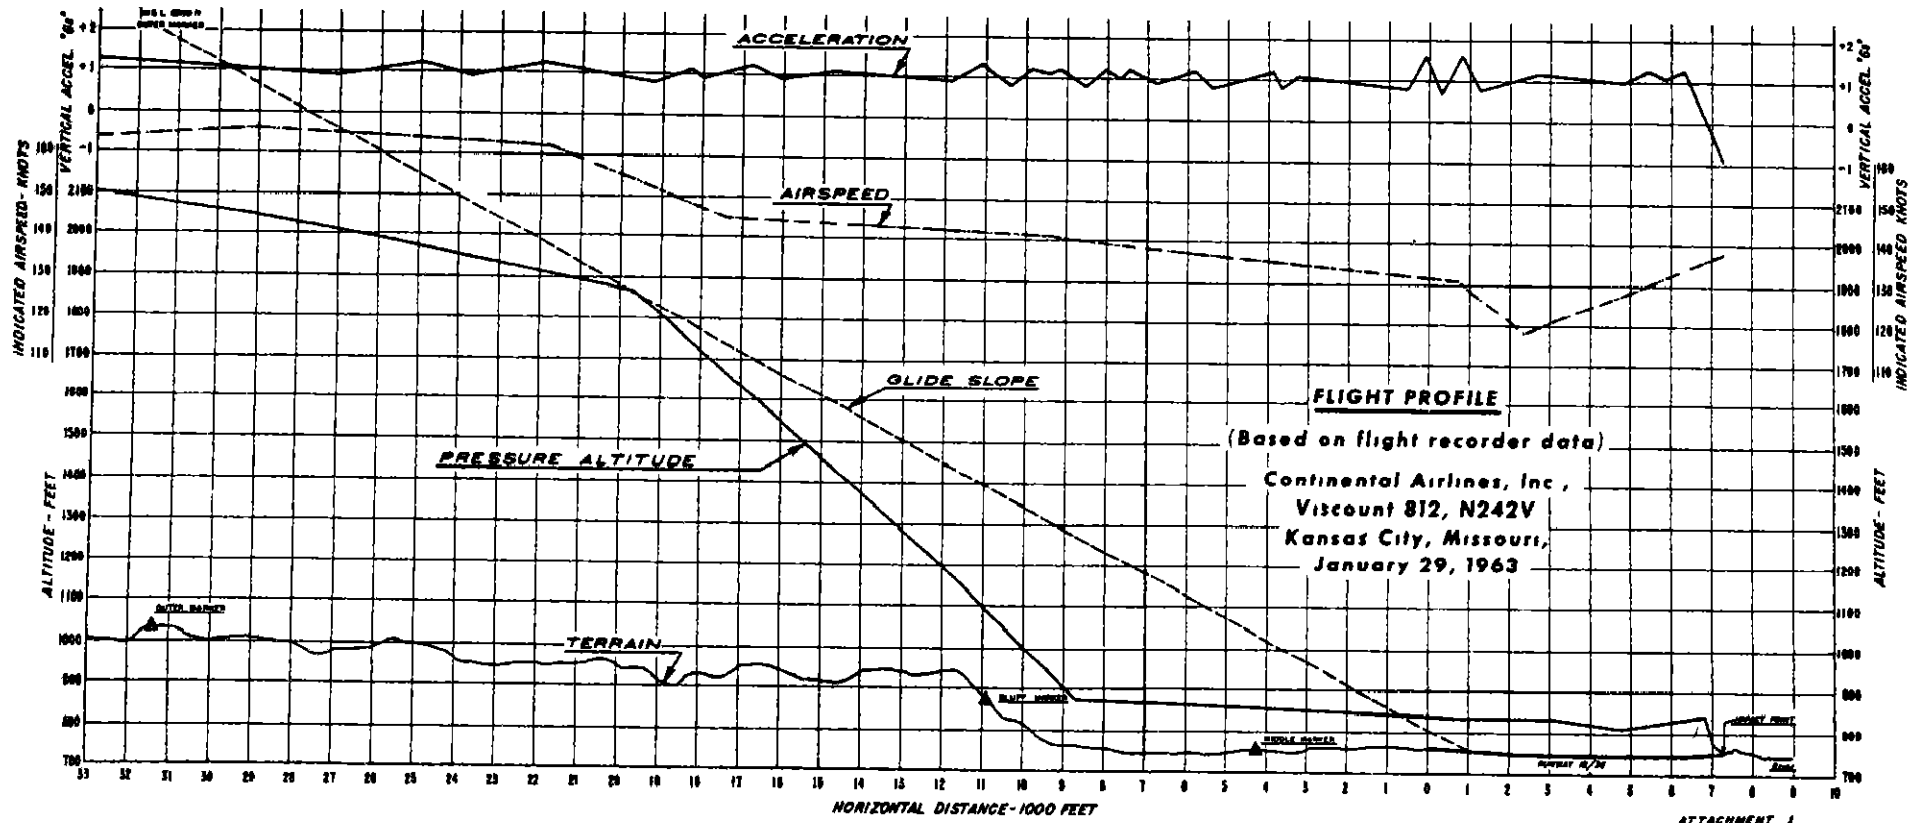
FLIGHT PROFILE
 (Based on flight recorder data)
 Continental Airlines, Inc.,
 Viscount 812, N242V
 Kansas City, Missouri,
 January 29, 1963

Flight 290 was observed executing an approach from the ILS outer marker to runway 18. After passing the runway threshold, approximately 80 feet above the ground, the aircraft flew over the 7,000-foot long runway in what appeared to be a go-around. A climbing attitude was observed accompanied by engine sounds similar to those normally associated with a Viscount go-around or takeoff. The main landing gears were noted, by a number of witnesses, to be in the down position. According to the flight recorder the airspeed was approximately 132 knots as the aircraft crossed the runway threshold and was relatively constant until about 700 feet past the threshold when there was a deceleration to 118 knots with no loss of altitude.

The altitude remained nearly constant until about 3,000 feet down the runway, at which point the aircraft descended to about 50 feet. It then ascended to an altitude of 90 feet from which it nosed over into the ground.

The airspeed reached its minimum value of 118 knots about 2,200 feet south of the approach end of runway 18 and then increased steadily until it reached 138 knots at the time of the nose-over.

From a position approximately 750 feet south of the approach end of runway 18 to the point at which the aircraft nosed over, there is little variation of the acceleration (G) trace.^{2/} However, at the time the nose-over occurred the trace shows a negative excursion which was terminated at -0.9G by the impact.

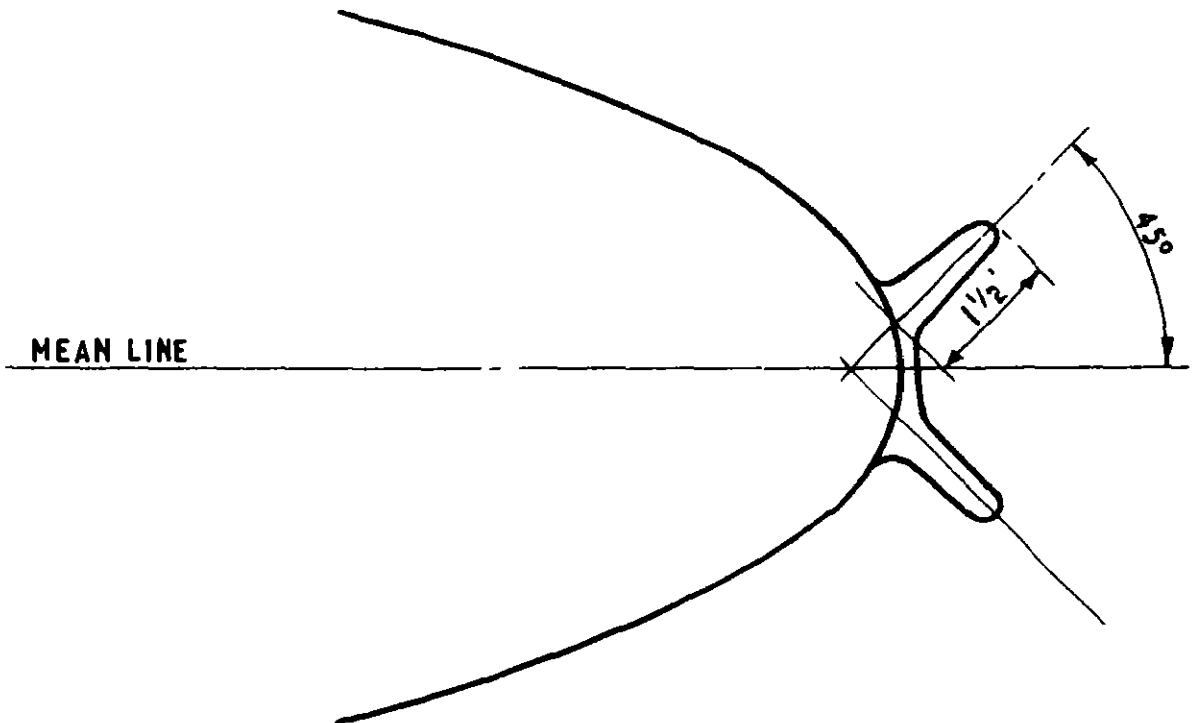
A TYPICAL PILOT SKETCH OF
HORN TYPE ICING

After landing, the aircraft was examined and light rime ice was found on the wings and radome, the propellers were clean and dry, and the horizontal stabilizer and vertical stabilizer had a concave, cup-shaped buildup of rough rime ice, approximately one-inch thick with horns extending diagonally upward and downward approximately one and one-half inches into the airstream. (See attachment #2.)
