AIRCRAFT ACCIDENT REPORT

AAXICO AIRLINES, INC.
C-46-F, N 67941, NEAR GREAT FALLS,
MONTANA, AUGUST 14, 1963

SYNOPSIS

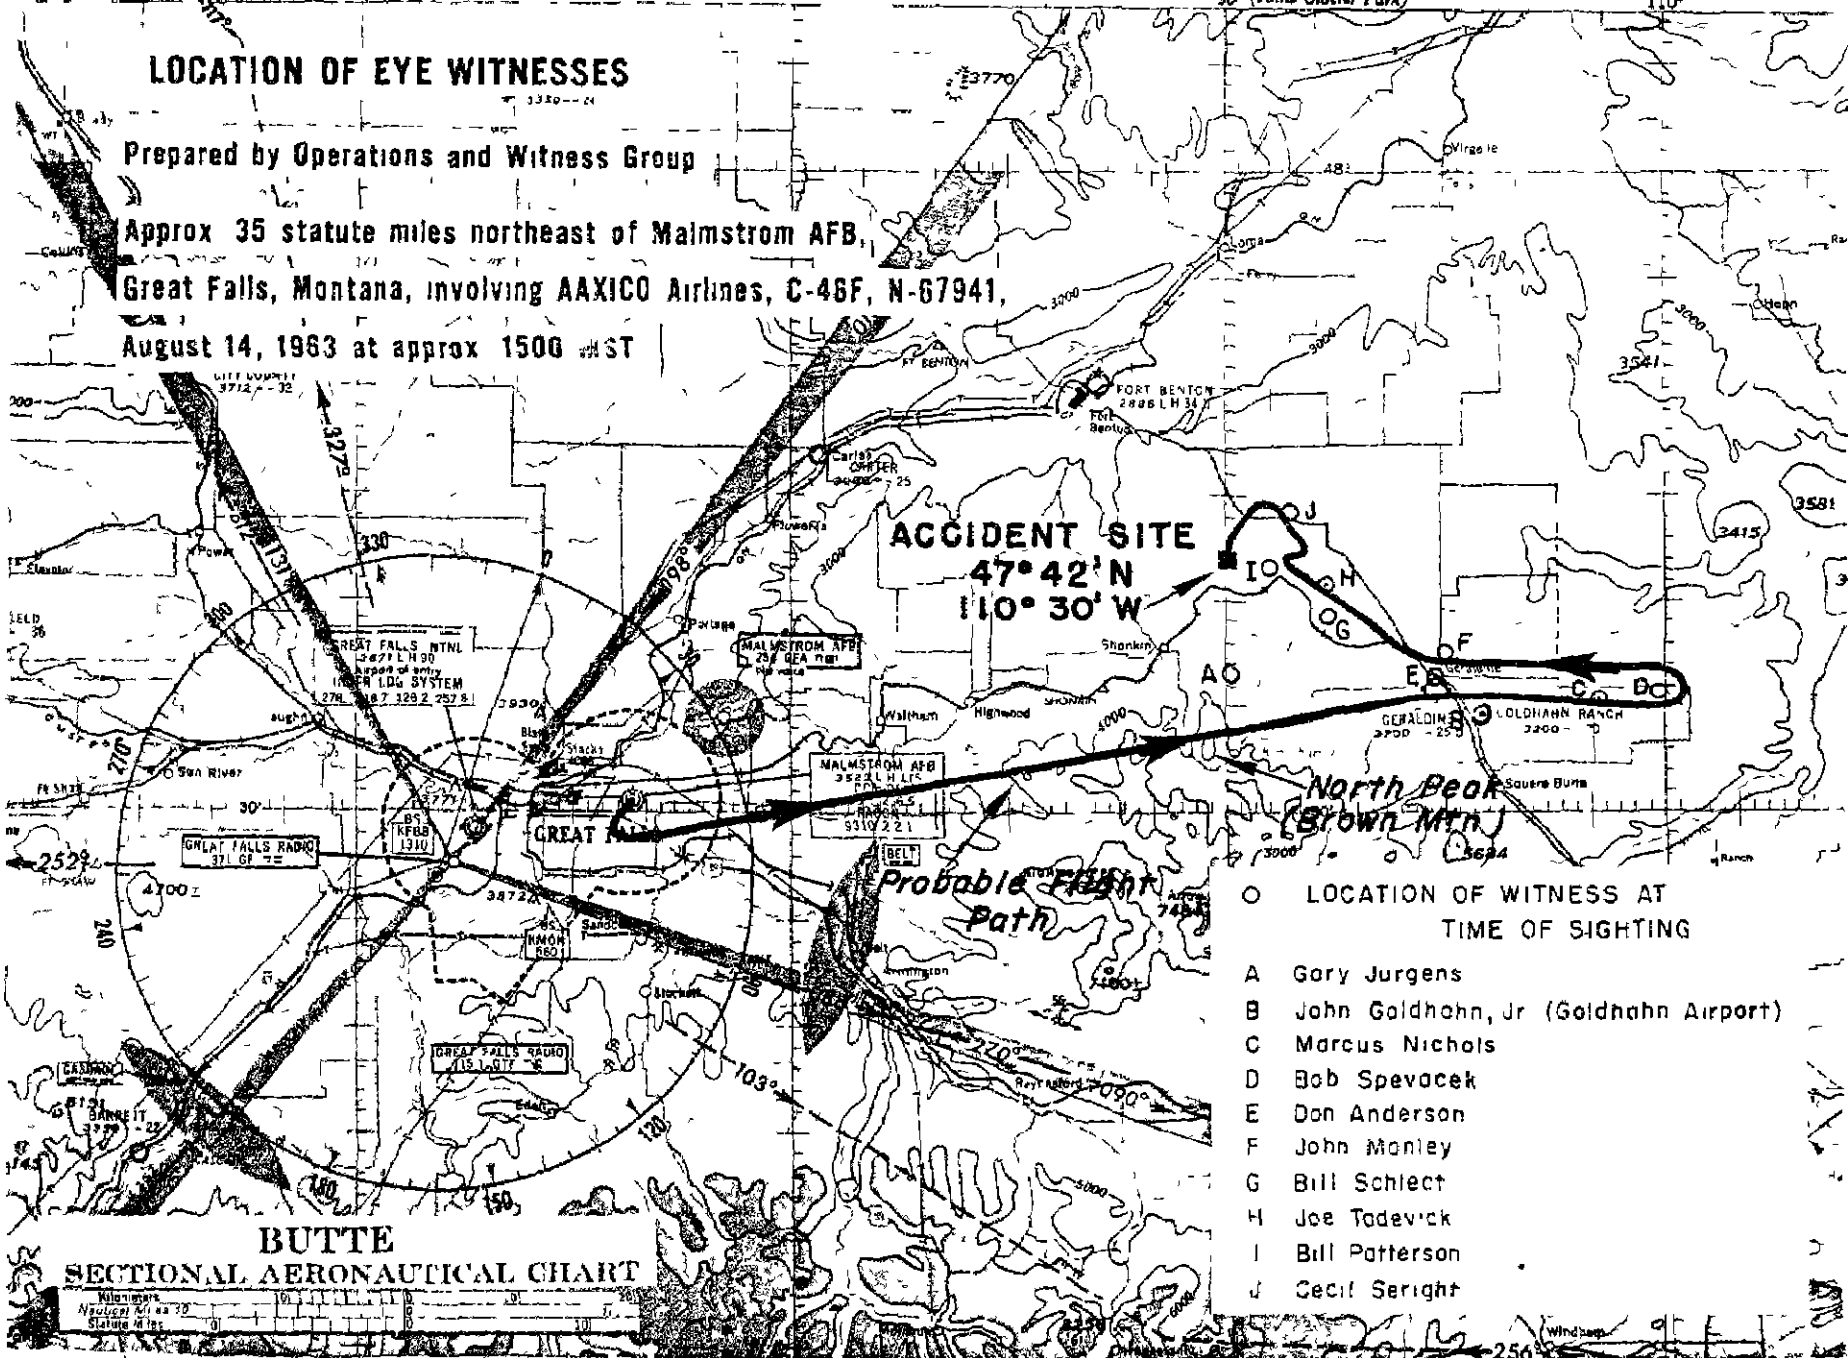
LOCATION OF EYE WITNESSES

A witness approximately 29 miles east-northeast of Malmstrom AFB and just north of the aircraft's flightpath situated on terrain of approximately 3,500-foot elevation described his observations. "It (the airplane) caught my attention because it was so low. I thought it was going to hit one of the mountains when it came up real slow and just missed it and then dropped quite a bit." (See Attachment I.)

As the aircraft continued eastward, it flew near the Goldhahn Ranch which is at an elevation of 3,200 feet, and is located 41 nautical miles from Malmstrom AFB, where another witness observed the aircraft. "I saw smoke coming from the right engine. The airplane passed directly over me at about 500 feet altitude. Both engines were working, the gear was retracted and flaps up. . . . As the airplane proceeded east the smoke became more dense and seemed darker, and the airplane seemed to be gaining a little altitude. When it was about five or six miles east of me the smoke disappeared and the plane started to circle to the north. It made a 180-degree turn and proceeded westbound. When it passed to the north of me there wasn't any smoke visible and I couldn't see if the prop was feathered at that time." (See Attachment I.)

Another witness who held a private pilot's license stated he observed the aircraft fly over his ranch still in an eastbound direction. "It was at low altitude, approximately 50 feet above the ground. Its flight attitude was unsteady and the motors were laboring. I observed smoke of black color and major intensity pouring from the right . . . motor." Subsequently, he observed the aircraft make a turn to the left and fly west back toward the Geraldine Airport. (See Attachment I.)

As the aircraft approached Geraldine westbound, two witnesses in the area observed it. (See Attachment I.) One witness stated his attention was drawn to a low flying aircraft about 300 feet above the ground 1/4 to 1/2 mile away flying in a west-northwest direction. He observed the right propeller turning slowly. The second witness observed the aircraft with a feathered right propeller flying at less than 500 feet above the ground headed ". . . a little north of west."

Several witnesses observed the aircraft following its course change to a northwest direction after passing Geraldine. (See Attachment I.) One witness, located approximately four miles northwest of Geraldine, observed the aircraft pass above him. It was approximately 250 feet above the ground with a feathered right propeller. Thinking the aircraft was about to crash, the witness climbed from the rock crusher he was operating and followed the aircraft for about three miles in his pickup truck before losing sight of it. Another witness observed the aircraft with the right propeller feathered flying north-northwest at an estimated altitude of 50 to 100 feet. These and other witnesses describe the aircraft as making turns, some as steep as 45 degrees.
