AIRCRAFT ACCIDENT REPORT

NEW YORK AIRWAYS, INC.
BOEING-VERTOL 107-II, N 6673D
NEW YORK INTERNATIONAL AIRPORT
JAMAICA, NEW YORK
OCTOBER 14, 1963

SYNOPSIS

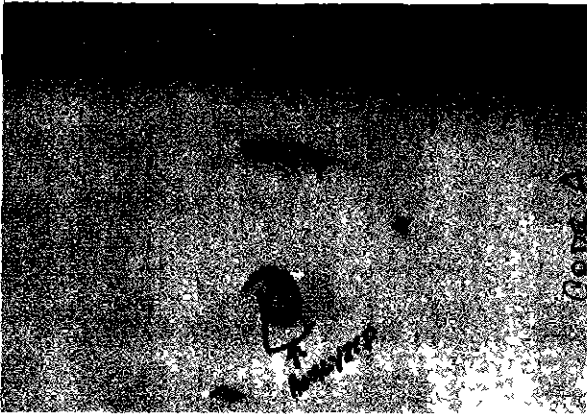
Following the accident, the entire drive system^{3/} of N 6673D was taken to the Vertol Division of the Boeing Company at Morton, Pennsylvania. Teardown and detailed examination, supervised by Board personnel, revealed that quill shaft P/N 107D2067-1,^{4/} S/N TA-102,^{5/} which transmits the drive force from the mix box to the aft transmission, had failed in fatigue. Three of the six stepped studs P/N AN150832 which hold the mix box collector gear bearing retainer in place had also failed in fatigue. In addition, it was discovered that the two jets^{6/} designed to lubricate the quill shaft were plugged with metal shavings. These

Chips from .040 inch hole at bottom of lube nozzle, P/N 107D2268, in aft transmission.

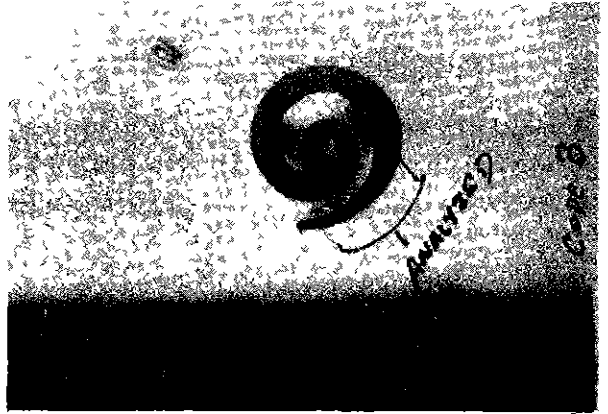
Since the first shavings in mix box S/N A 11-102 were found during the initial load run, but prior to mating it with aft transmission S/N TA 9-10, it follows that shavings were introduced into the lubrication system as a result of the initial boring operation by the manufacturer. It is possible that additional shavings may have been introduced during subsequent boring operations on either the aft transmission or mix box. It is significant that following discovery of the plugged lubrication jets two changes were incorporated in the manufacture and overhaul of transmission assemblies. Plastic plugs were inserted in the oil passages during the boring operation on the liners, and all plug type lubrication jets were removed prior to the flushing of cases during overhaul. These changes were accomplished to reduce the possibility of metal shavings becoming lodged in the narrow passages of the case, or in the orifices of the jets during the boring or flushing procedure.

Chips from mix box following initial load run 0 hours TSO

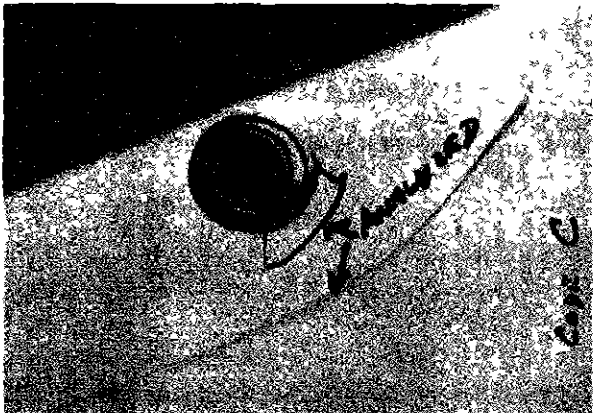
The metal shavings found in aft transmission S/N TA 9-10 during the initial load run, and at TSO 94:55 were removed from the transmission overhaul log sheets where they were taped, and submitted for metallurgical tests. It was determined that they were both AISI 4130 steel. Additional tests were made on a metal machining curl taken from aft transmission S/N TA 9-9 on November 3, 1963. This was identified as AISI 4340 steel, a substitute grade for AISI 4130.

Chips found in mix box on February 18, 1963, at 94:55 TSO

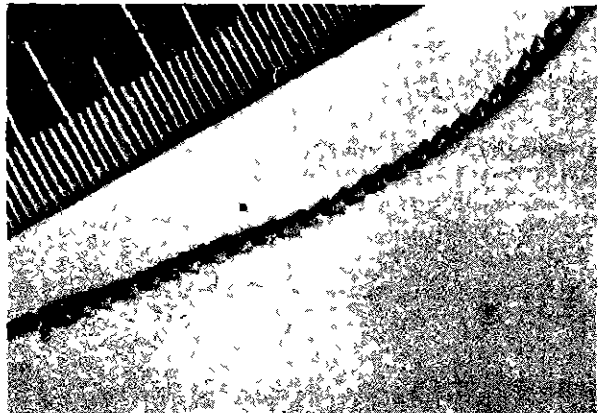
Chips removed from oil jet, P/N 107D2214, in aft transmission

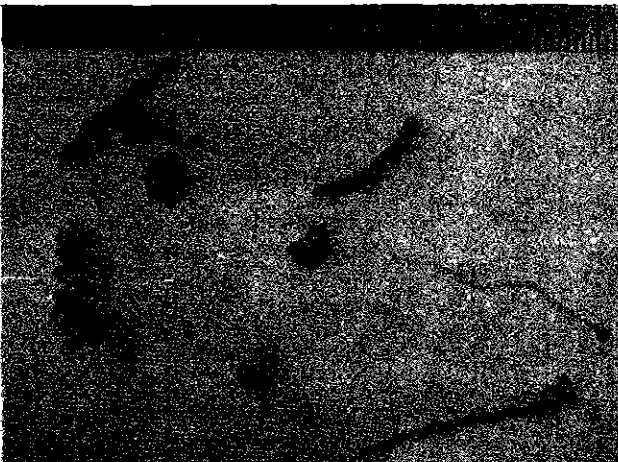
metal shavings were identified as AISI^{7/} 4130 steel. The only parts in the mix box and aft transmission containing this grade of steel are the bearing liners.

Random sampling of chips from Liner Boring Operation.
