# AIRCRAFT ACCIDENT REPORT

ADOPTED. February 25, 1965

PAN AMERICAN WORLD AIRWAYS, INC  
BOEING 707-121, N709PA  
NEAR ELKTON, MARYLAND  
DECEMBER 8, 1963

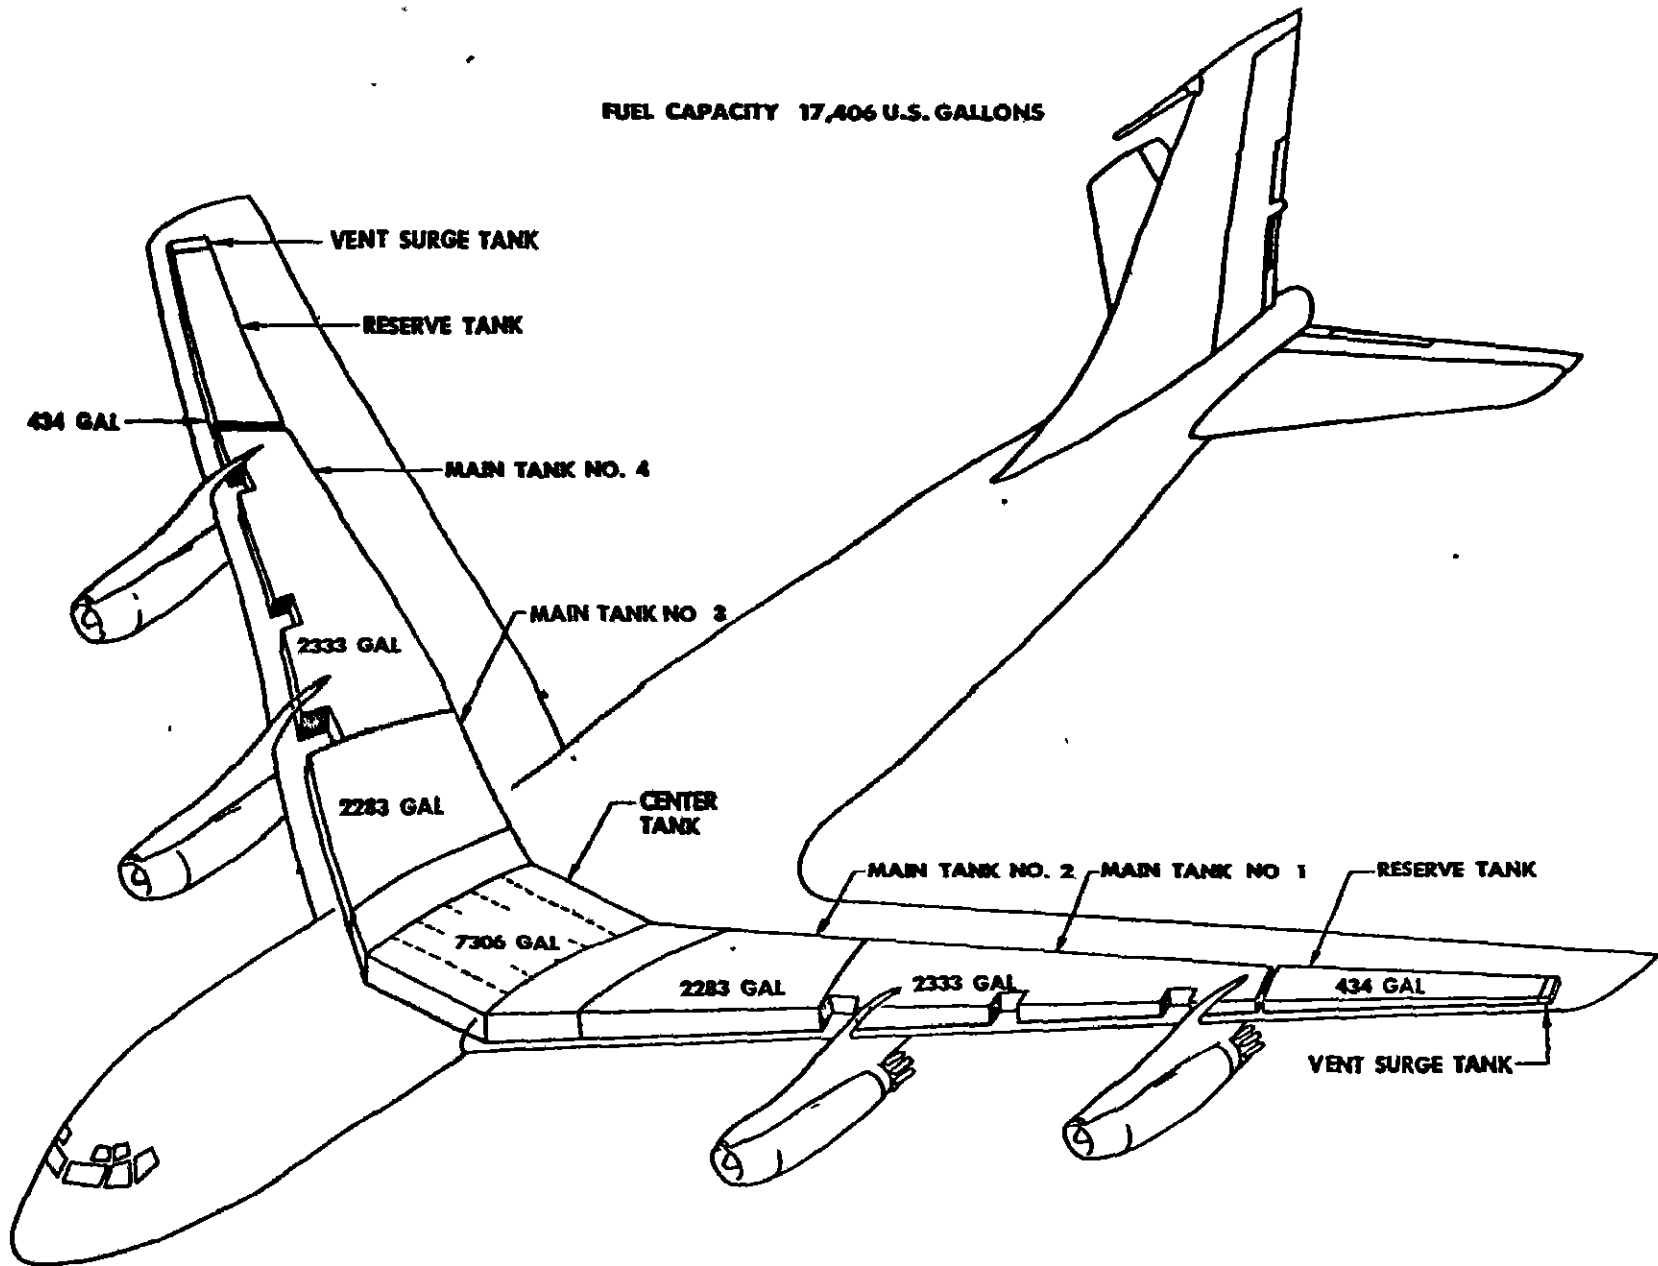
FUEL TANK ARRANGEMENT

The surge tank box<sup>7/</sup> was intact except for a 2.2 inch opening along the top extending from spar to spar. This opening encompassed the surge tank end of the vent passages from the fuel tanks. The ends of the fracture curled up and were moderately sooted. The bottom surge tank skin was curled downward at a fracture line along the tank end closure rib. Very slight outward bulging of the tank end rib was noted. The interior of the surge tank was heavily sooted on all sides and the sealant was burned inside.

A 27-inch section of the forward spar was bulged outward and the bottom spar cap was bulged downward. There was slight sooting or discoloration on the reserve tank side of the spar and slight charring of the sealant at the juncture of the spar and the closure rib.

The center tank <sup>8/</sup> bottom skin was separated in three pieces. Stiffeners and access doors were bowed outward. The largest section was bowed chordwise in an outward direction. There were no signs of fire damage
