CIVIL AERONAUTICS BOARD

AIRCRAFT ACCIDENT REPORT

PARADISE AIRLINES, INC.
LOCKHEED CONSTELLATION L-049, N 86504
NEAR ZEPHYR COVE, NEVADA
MARCH 1, 1964

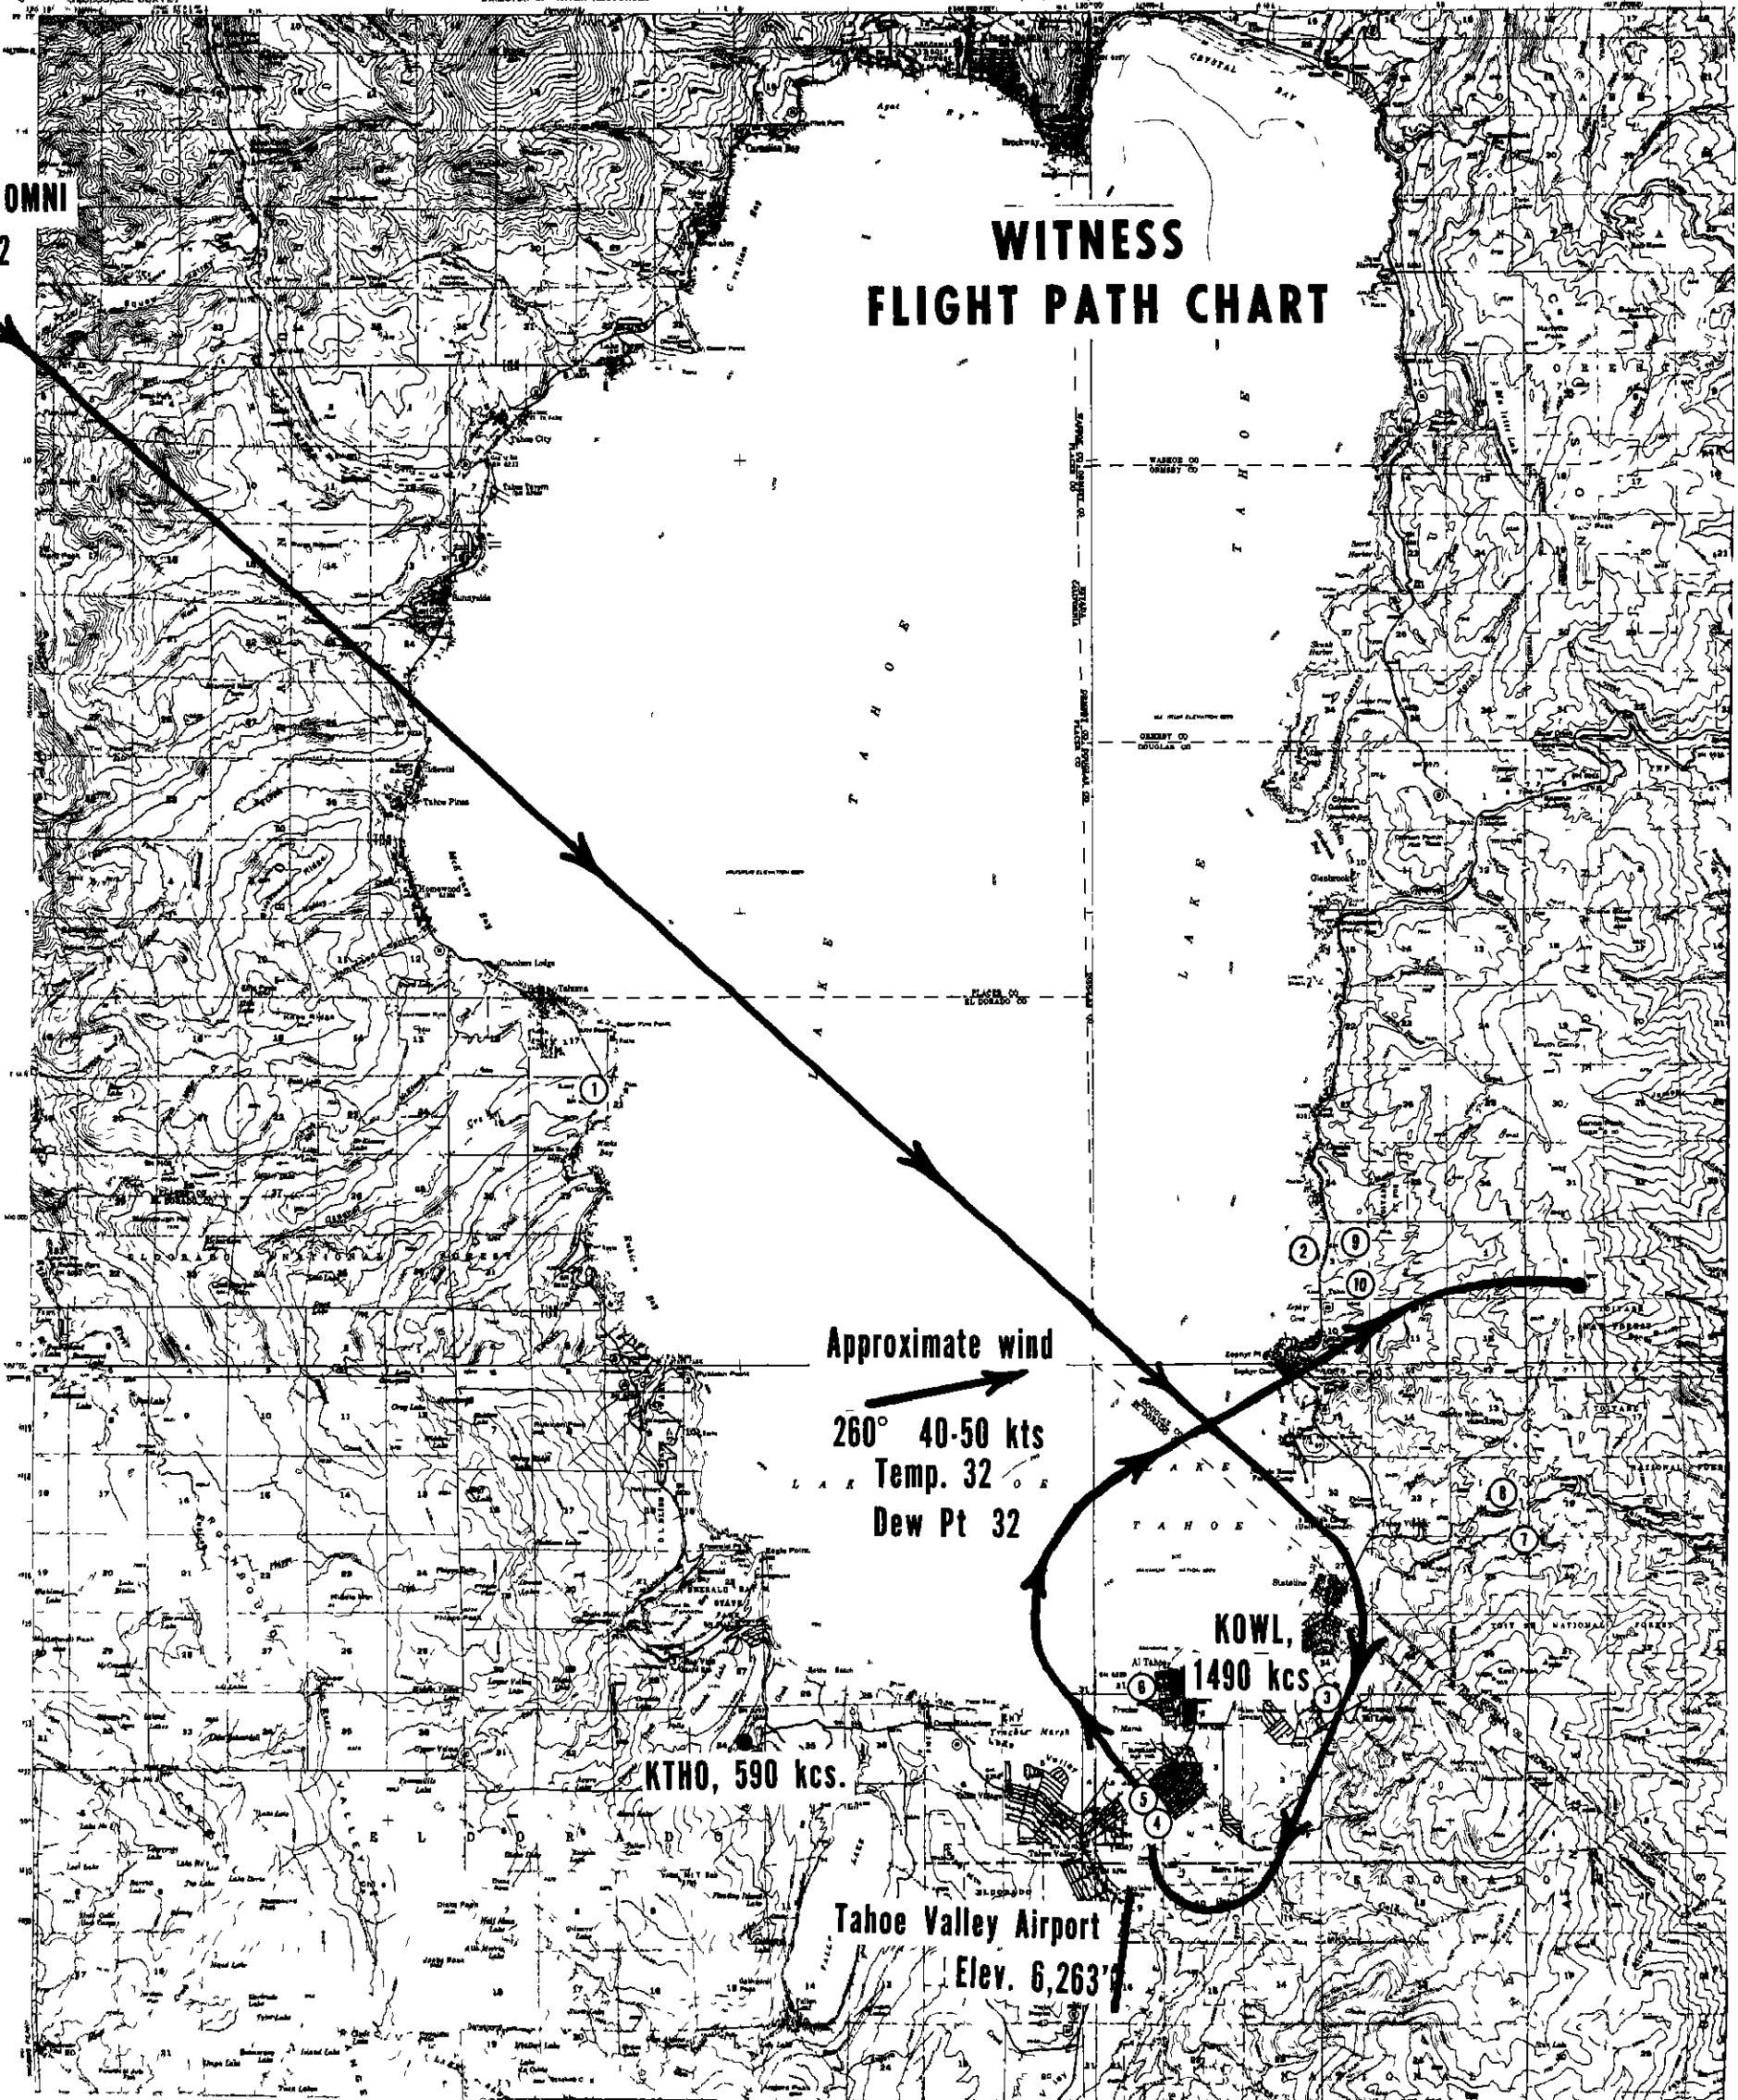
WITNESS FLIGHT PATH CHART

A witness on the west shore of Lake Tahoe (See Attachment No. 1) heard, but did not see, an aircraft proceeding over the lake between 1100 and 1130. The weather in his vicinity was inclement with visibility ranging from zero to one-fourth mile in blowing snow. A witness on the east shore also heard, but did not see, an aircraft southbound over the lake at about the same time.

When the crew decided to abandon the approach, they took up a heading which they must have known would take them towards the high terrain east of the lake. (See Attachment No. 1.) It is very likely that from their position over the Tahoe VOR they were able to observe the VFR conditions that existed east of Lake Tahoe on the leeward side of the mountains. Additionally, it is assumed that the first officer was aware of the existence of Daggett Pass and considered it an access to VFR conditions beyond the pass. It is further assumed that he knew an altitude of 9,000 feet would provide about 1,500 feet terrain clearance through the center of the pass. Further, an easterly heading from the south end of the lake would take the aircraft through the pass which is several miles wide.
