CIVIL AERONAUTICS BOARD

AIRCRAFT ACCIDENT REPORT

SLICK AIRWAYS DIVISION
THE SLICK CORPORATION
DOUGLAS C-54B-DC, N384
CASTLE ISLAND
BOSTON, MASSACHUSETTS
MARCH 10, 1964

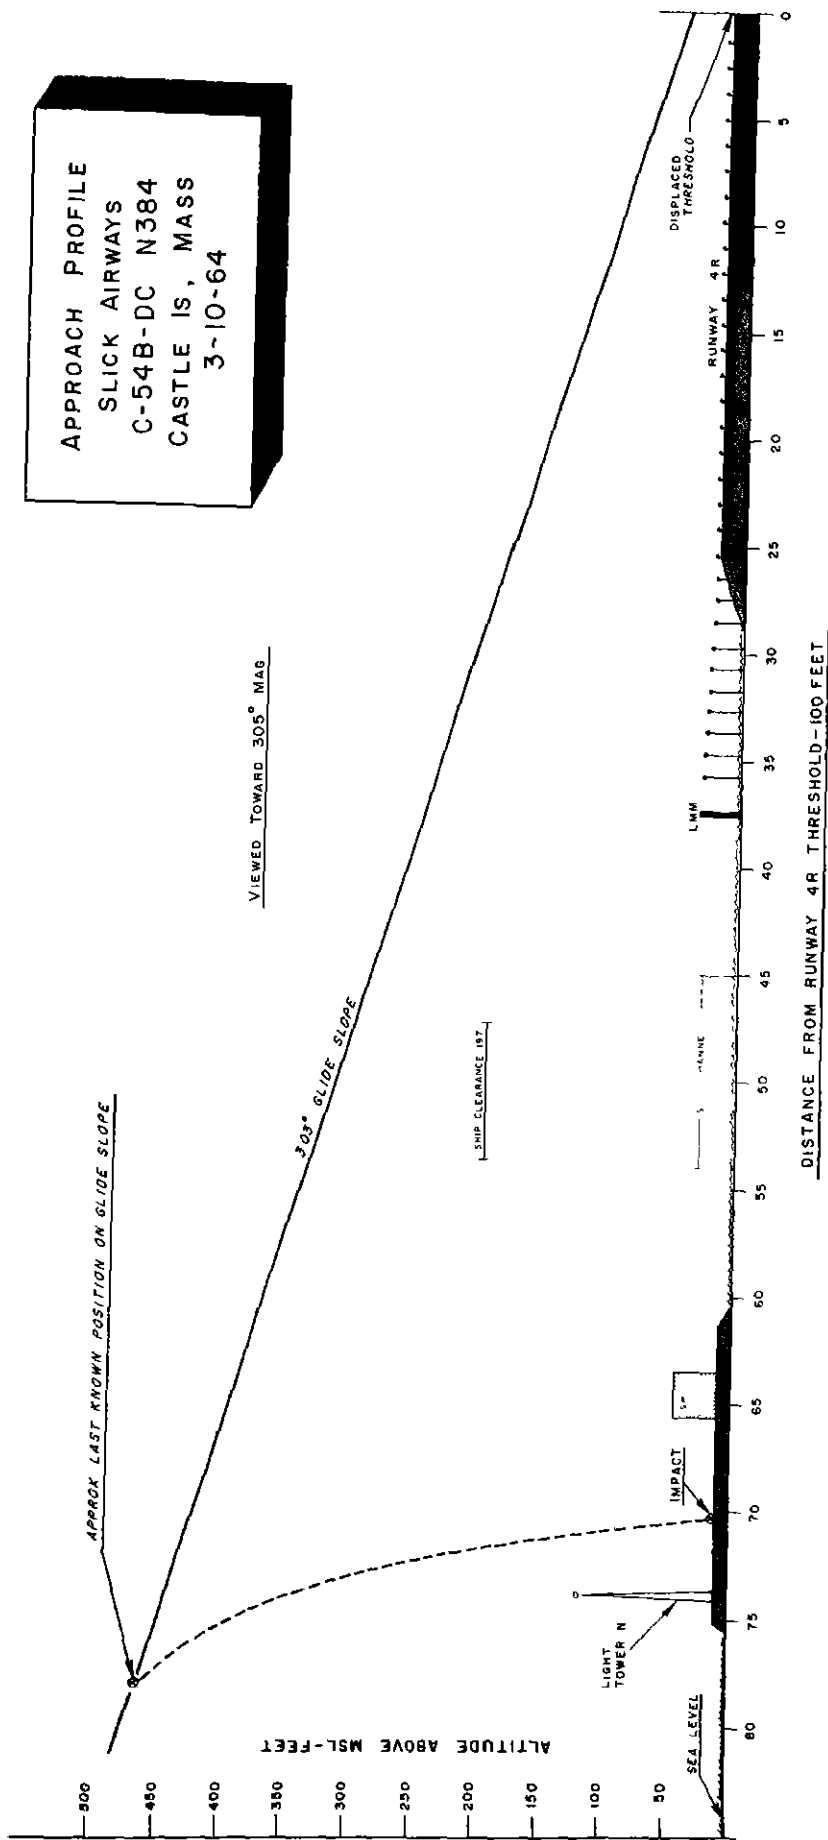
APPROACH PROFILE
SLICK AIRWAYS
C-54B-DC N384
CASTLE IS, MASS
3-10-64

hold^{5/} of Runway 4R in a lumberyard on Castle Island. (See Attachment 1.) The lumberyard is located on the extended centerline of Runway 4R. All the witnesses who saw the aircraft (and they only saw it for a few seconds) were persons who were in the lumberyard. The lumberyard has a number of floodlight towers which are 116 feet high. The consensus of these witnesses was that the aircraft was flying toward the airport and that it passed to the right of one of the light towers. It then suddenly pitched nosedown steeply and struck the ground. Witnesses differed as to engine noise.

Based on the testimony of the PAR controller, the communications transcript and the geometry of the ILS, the position of the aircraft with respect to altitude and linear distance when last seen by the PAR controller on the glide-slope was 480 feet m.s.l. and 780 feet out from the impact point or approximately 7,800 feet from the displaced threshold.

It is known from a propeller slash mark in the lumber stack that the aircraft struck the ground at a nosedown pitch angle of approximately 60° with the horizontal: also, that the aircraft was approximately 480 feet m.s.l. when the pitchover began and that the horizontal distance from this point in space to the point of impact was approximately 780 feet. Timing of certain known investigative data produced a groundspeed of about 108 knots from the outer marker inbound. Applying the wind, the true airspeed was about 130 knots and with the existing temperature, calibrated airspeed would also be about 130 knots.
