CIVIL AERONAUTICS BOARD

AIRCRAFT ACCIDENT REPORT

PACIFIC AIR LINES, INC.
FAIRCHILD F-27, N277OR
NEAR SAN RAMON, CALIFORNIA
MAY 7, 1964

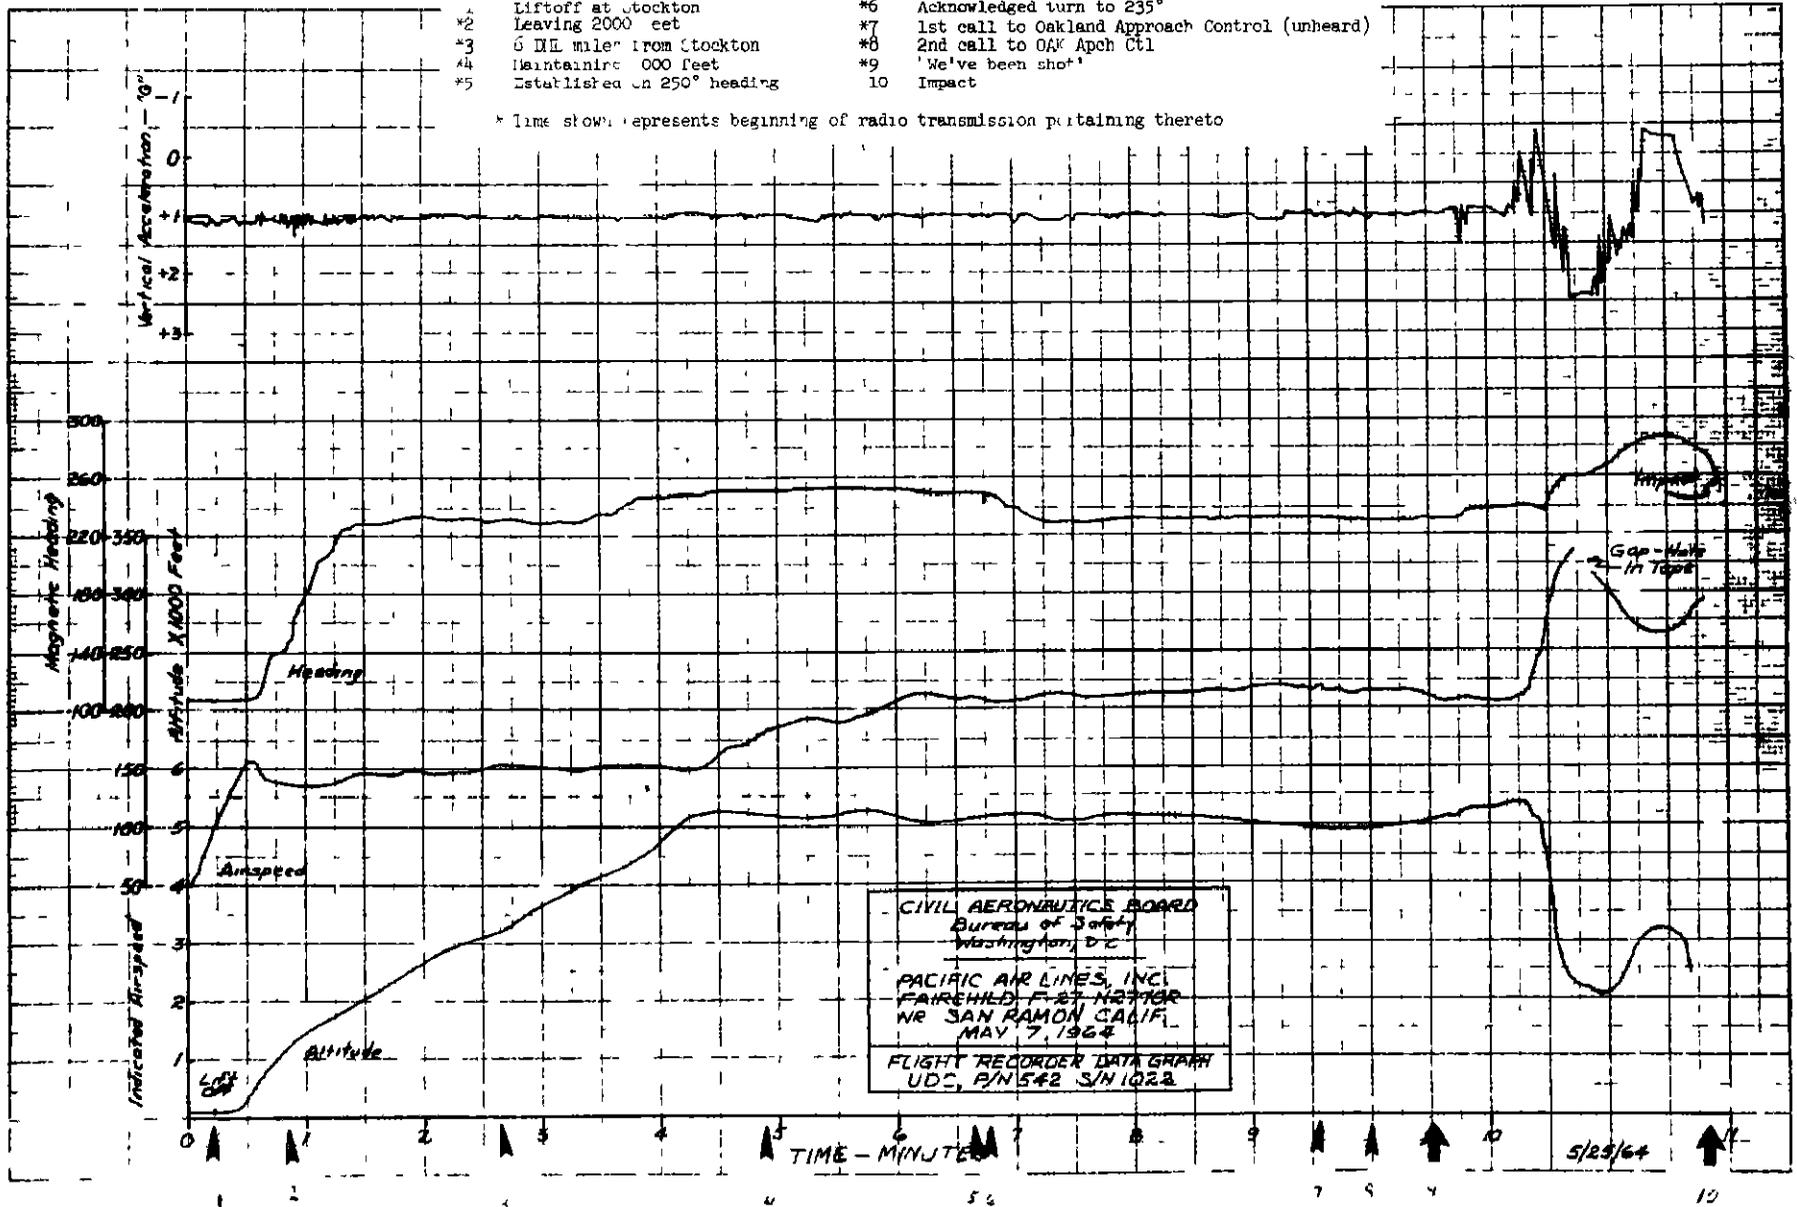
ATTACHMENT I

A readout of the flight recorder tape indicates that the flight was normal from takeoff at 0638 until approximately 10 minutes after departure

from Stockton. At this time, the recorder traces indicate the aircraft was cruising at 5,000 feet indicated altitude on a magnetic heading of approximately 230 degrees and at an airspeed of approximately 213 knots. The first erratic indications on the tape appear commensurate with the high-pitched transmission by the copilot which occurred at 0648:15. At this point on the flight recorder tape, the four traces for altitude, airspeed, heading, and acceleration begin to make sharp positive excursions. The altitude trace begins a sharp excursion indicating a descent from 5,300 to 2,100 feet within 22.5 seconds or at a descent rate of approximately 9,000 feet-per-minute. During the same time interval, the airspeed trace indicates an increase to 335 knots and the heading trace indicates a change to approximately 265 degrees occurred. The vertical acceleration trace indicates a decrease first to approximately minus 0.4 g, and then an increase to plus 2-1/2 g during this same period.

The altitude trace then indicates a climb to approximately 3,200 feet in 15 seconds or at a rate of 4,400 feet-per-minute, during which the airspeed trace indicates a decrease to approximately 265 knots. The heading trace continued a change to approximately 285 degrees. Vertical acceleration continued to vary from plus 2-1/2 g to minus 0.4 g. From this point to the end of the recorded tracings, all traces were abnormal.

The flight recorder tape indicated normal flight until 0648 when a steep descent began. Fifteen seconds later, the first officer broadcast his last high-pitched transmission. That transmission and the flight recorder record of a momentary interruption in the dive 22 seconds after it began, were the only indications of the flight crew's actions during the final minute of flight. This evidence does not furnish sufficient parameters to determine the specific time point at which both pilots became completely incapacitated. Such a measurement is not essential to the determination of the cause of this accident. This evidence does, however, indicate the improbability of pilot suicide.
