# AIRCRAFT ACCIDENT REPORT

NORTHEAST AIRLINES, INC.  
DOUGLAS DC-6B, N8221H,  
LAGUARDIA AIRPORT, NEW YORK  
JUNE 5, 1964

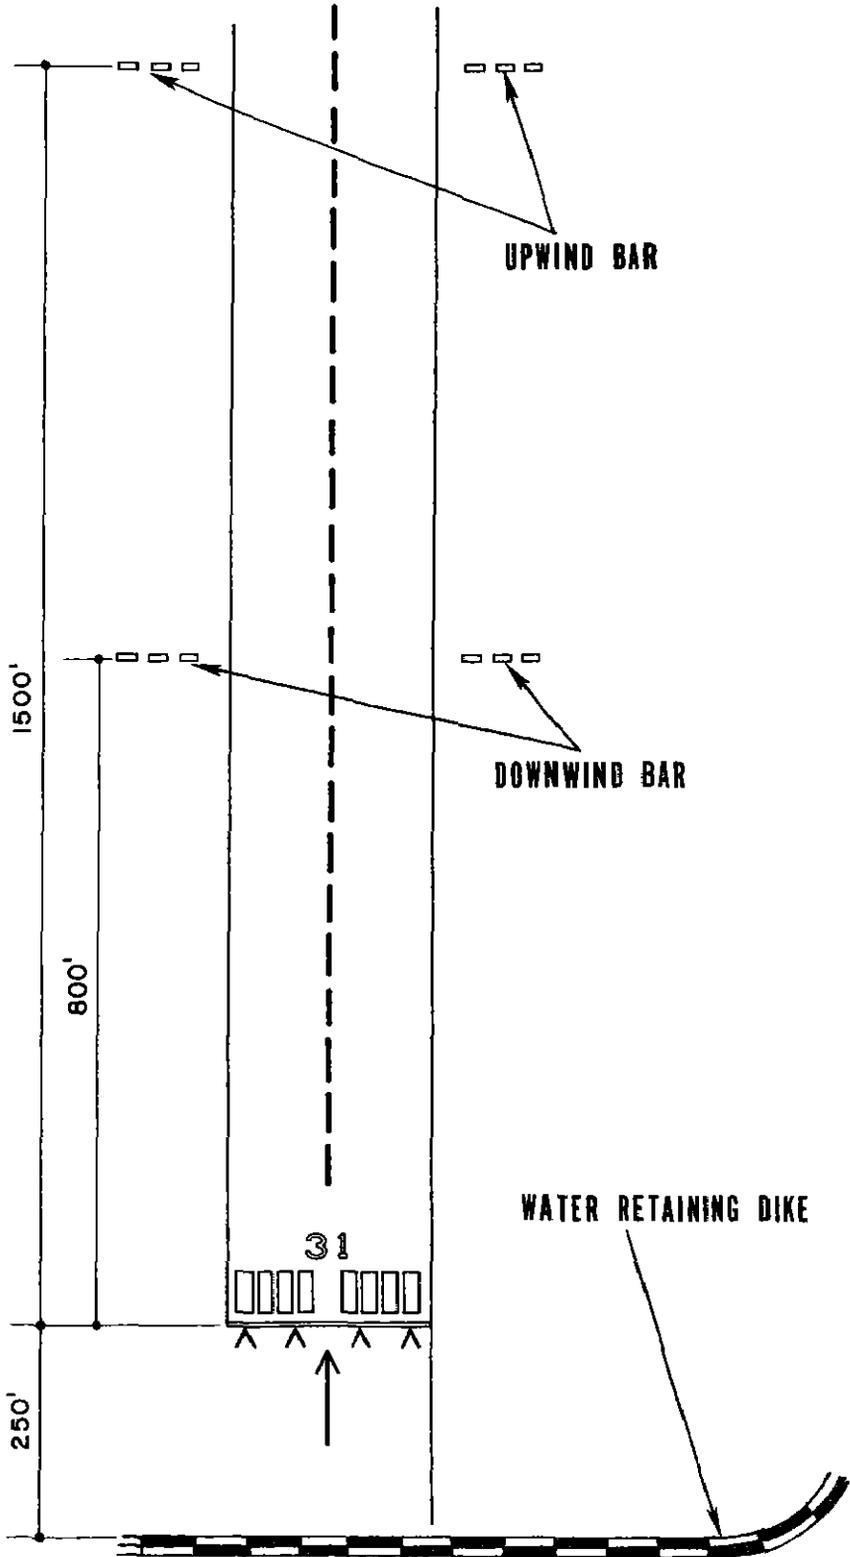
# VISUAL APPROACH SLOPE INDICATOR (VASI) RUNWAY 31 LAGUARDIA AIRPORT, NEW YORK

The installation on runway 31 at LaGuardia consists of twelve light source units arranged in light bars with three units placed on each side of the runway opposite the 800-foot mark and three on each side of the runway at the 1,500-foot mark. (See Attachment #1 ) These are the downwind and upwind bars, respectively. The visual glide slope reference point is midway between the upwind and downwind bars.

The on-glidepath corridor or wedge is 42 feet thick directly above the dike on the approach end of runway 31. The bottom of this wedge is 38 feet above the top of the dike.
