CIVIL AERONAUTICS BOARD

AIRCRAFT ACCIDENT REPORT

CONTINENTAL AIR LINES, INC.  
B-707-124, N70773  
KANSAS CITY MUNICIPAL AIRPORT  
KANSAS CITY, MISSOURI  
JULY 1, 1965

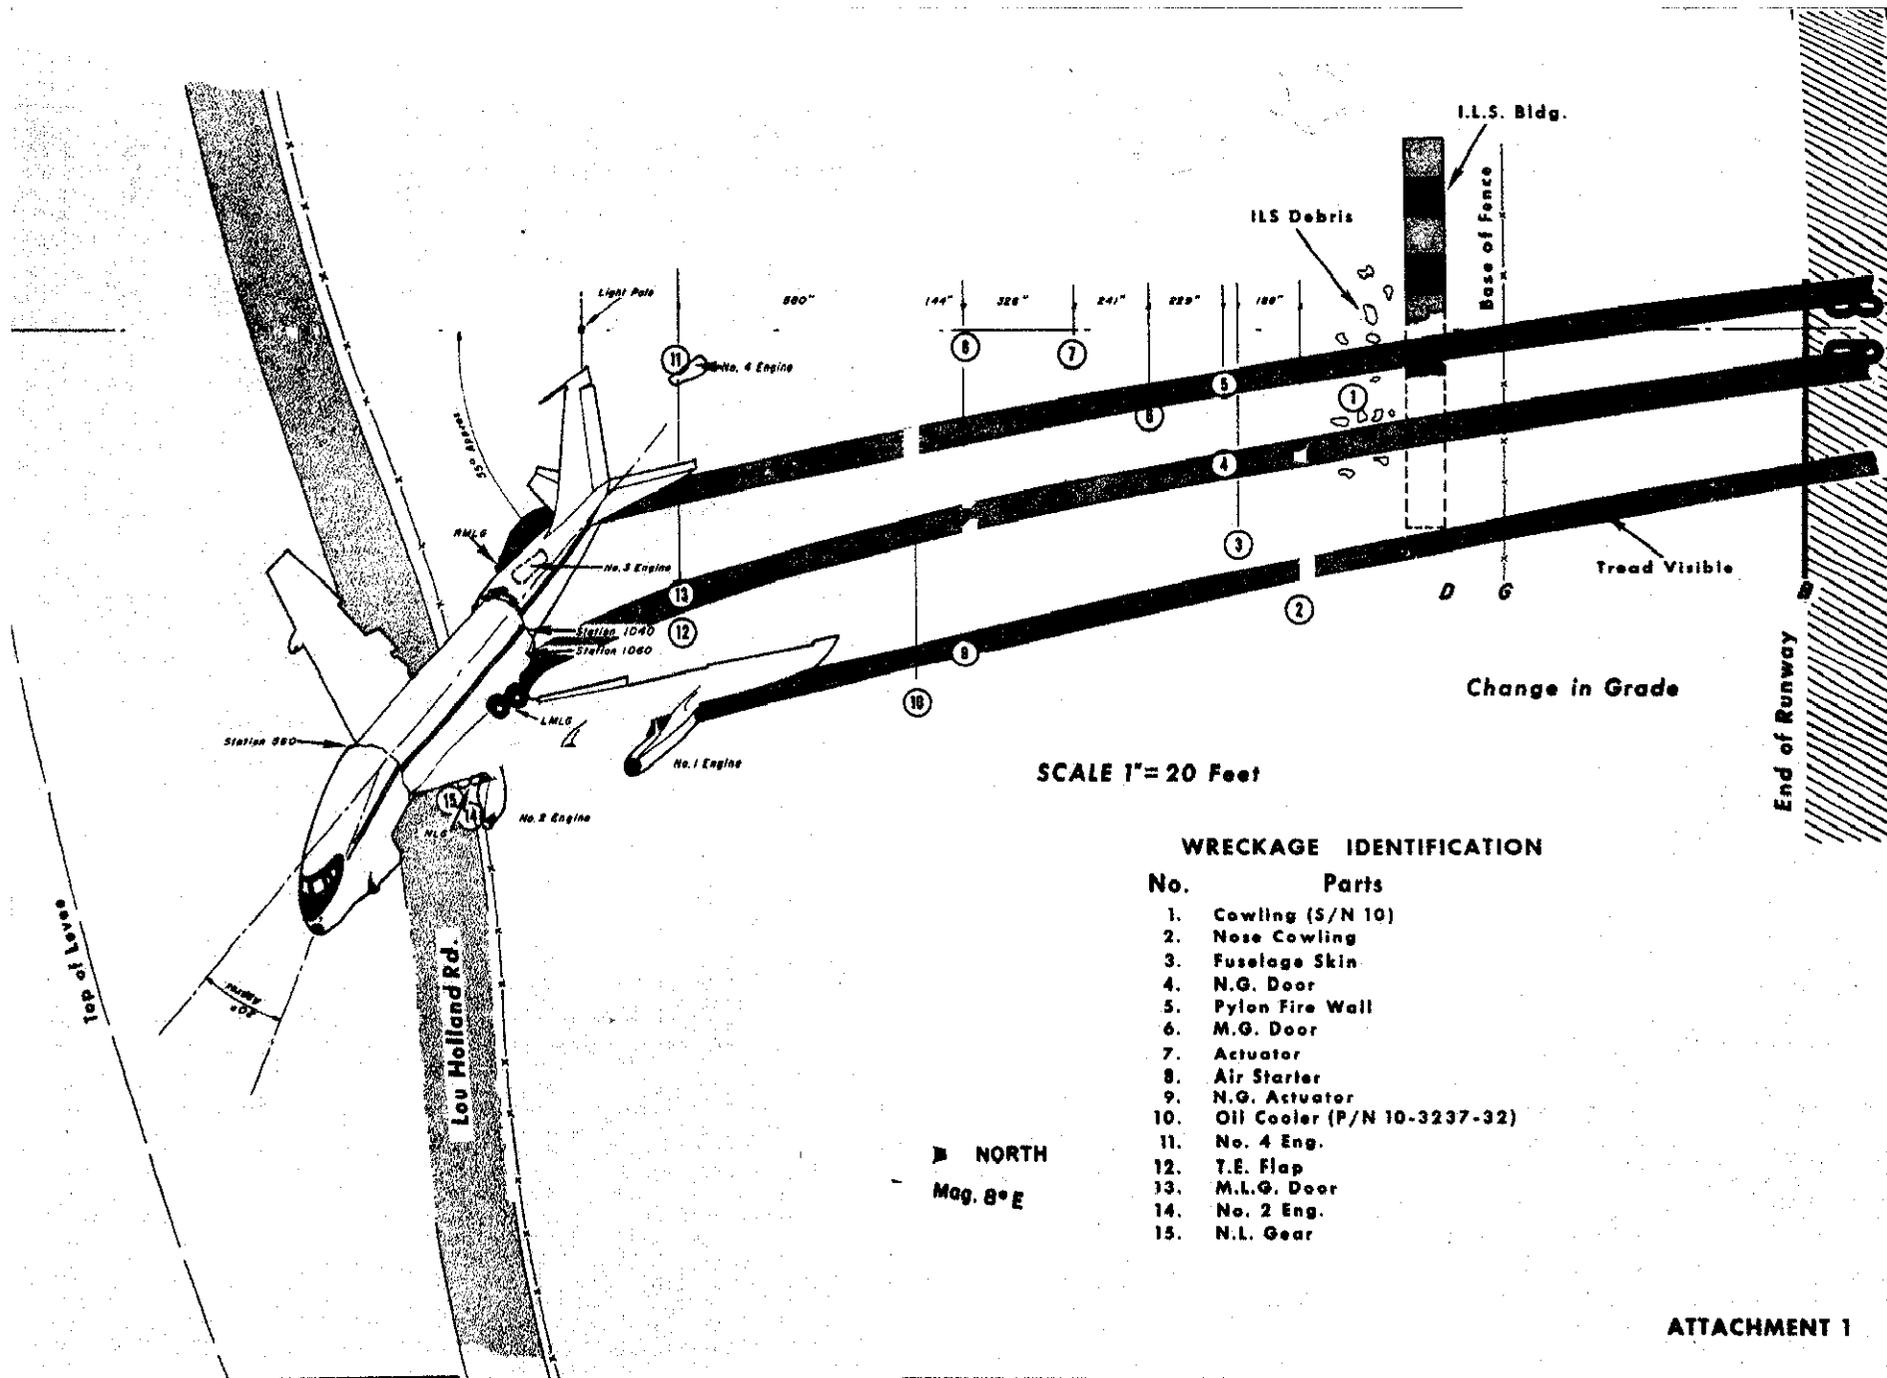
**WRECKAGE IDENTIFICATION**

All the major aircraft components were in the main wreckage area.

The main fuselage was broken into three sections which were still partially attached by portions of skin, cable, and portions of through structure. Major fractures occurred at fuselage stations (FS) 600 and 1060.<sup>7/</sup> Portions of the bottom fuselage were crushed and torn. The wings were intact and remained attached to the fuselage. The horizontal and vertical tail surfaces were generally undamaged. The elevators and rudder were attached and operational.

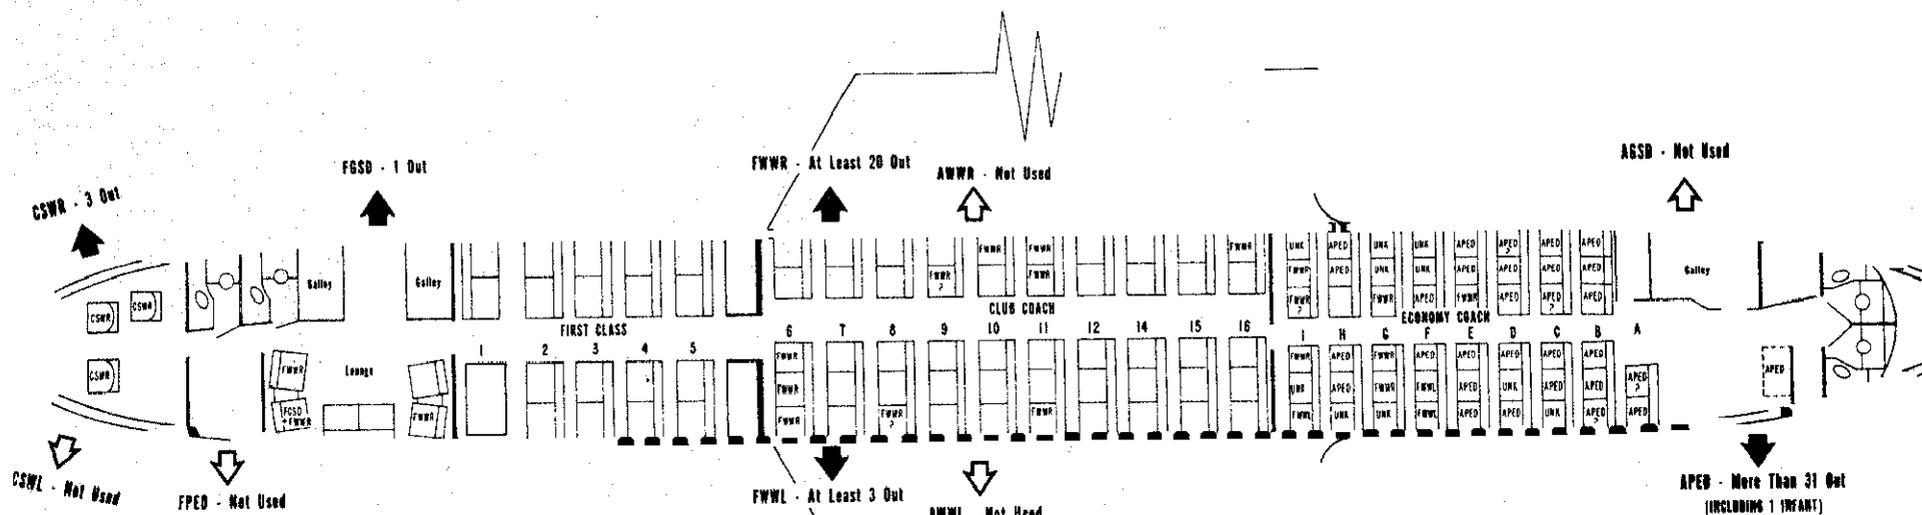
### EVACUATION FLOW CHART

passengers from the aft section of the aircraft as well as three from the lounge, forward of the wing, used the overwing exits to escape.
