# AIRCRAFT ACCIDENT REPORT

UNITED AIR LINES, INC

B-727, N7036U

August 16, 1965

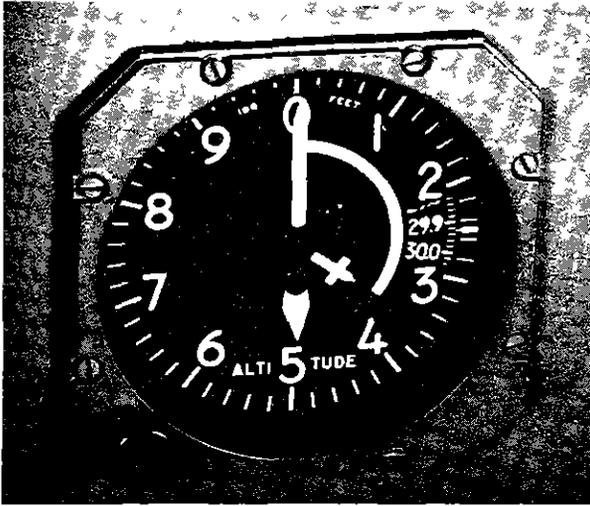
Setting (without parallax)

Baro	29 92
Alt	35,000

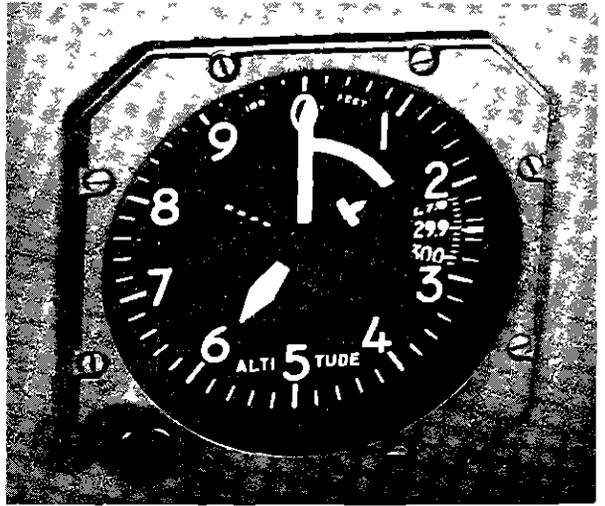
A review of Attachment No. 2 shows the position of the hands of the altimeter could be misinterpreted under certain operating conditions and the crew could have misread 6,000 feet to be 16,000 feet. It is believed the first officer was flying the aircraft. The captain's voice was identified on the air traffic control tapes and it is a normal custom in air carrier operations to have the pilot who is not flying the aircraft make the radio transmissions. If the captain were looking outside the aircraft for traffic or occupied with cockpit duties such as the completion of a checklist, and the first officer misread the altimeter, this error could escape undetected. To have such an error occur, however, it would be necessary for the pilot or pilots to fail to see the gradually increasing display of the cross-hatched warning section of the altimeter and the gradually decreasing display of the

Setting (without parallax)

Baro	29.915
Alt	16,000

Camera lens 34'' from dial 22° above and  
15° to left of altimeter axis

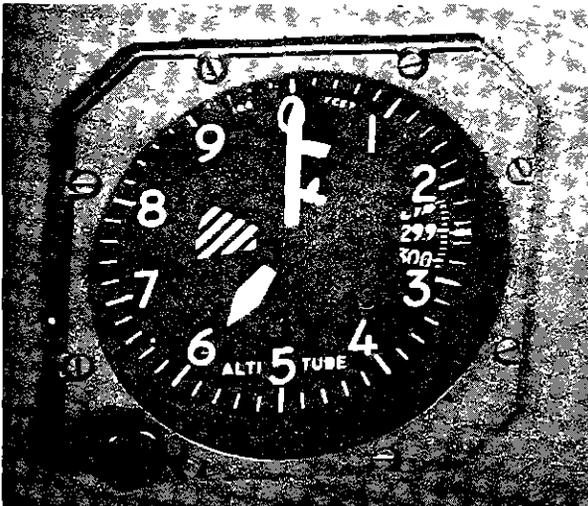
Setting (without parallax)

Baro	29 915
Alt	6,000

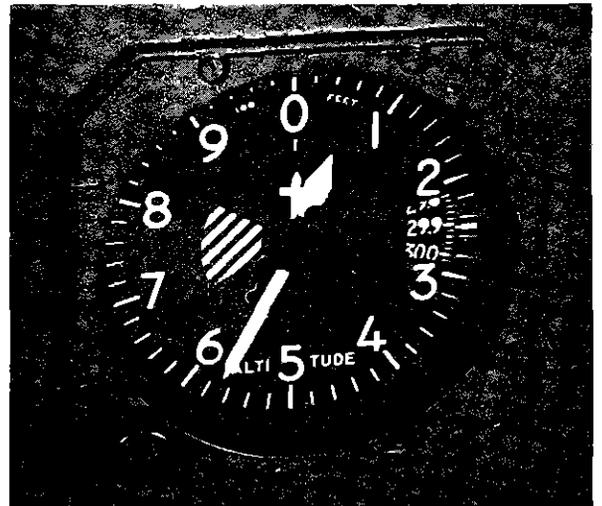
Setting (without parallax)

Baro	29 915
Alt	577
