AMERICAN AIRLINES, INC.
BOEING 727, N1996
NEAR THE GREATER CINCINNATI AIRPORT
CONSTANCE, KENTUCKY
NOVEMBER 8, 1965

CIVIL AERONAUTICS BOARD

AIRCRAFT ACCIDENT REPORT

ADOPTED: September 28, 1966

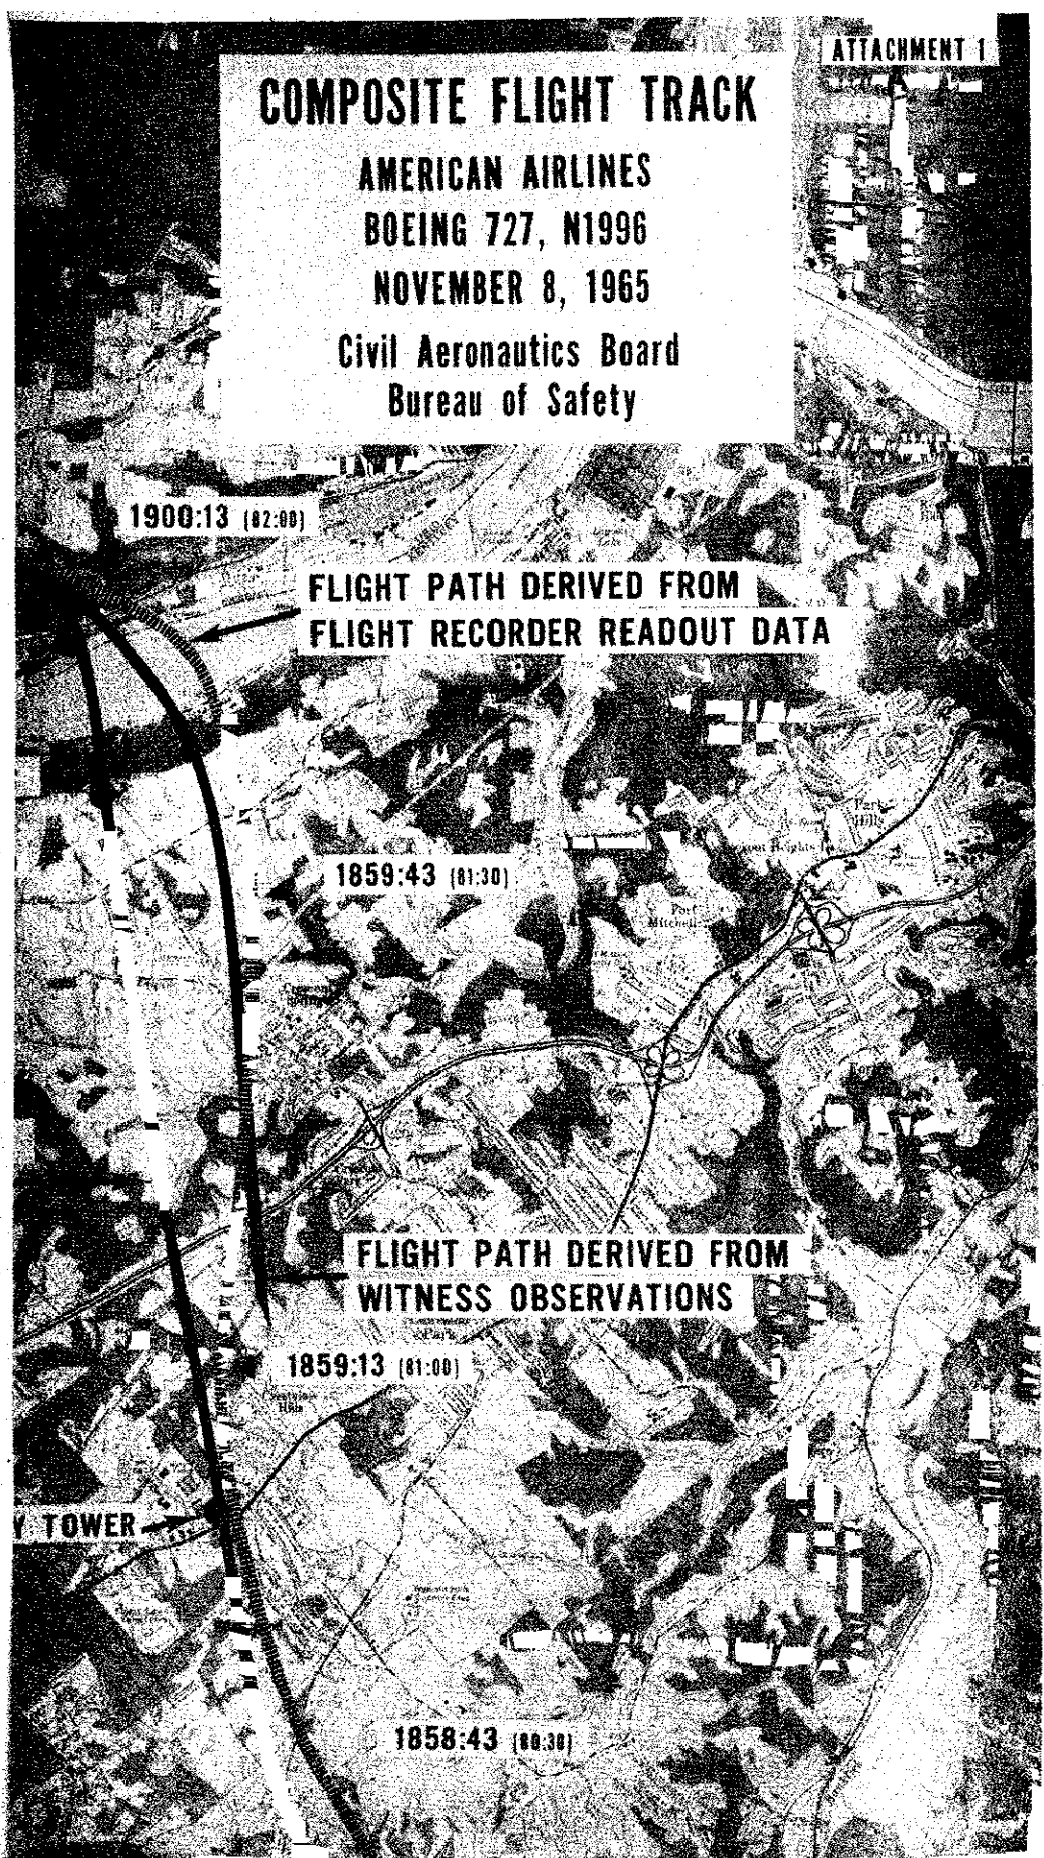
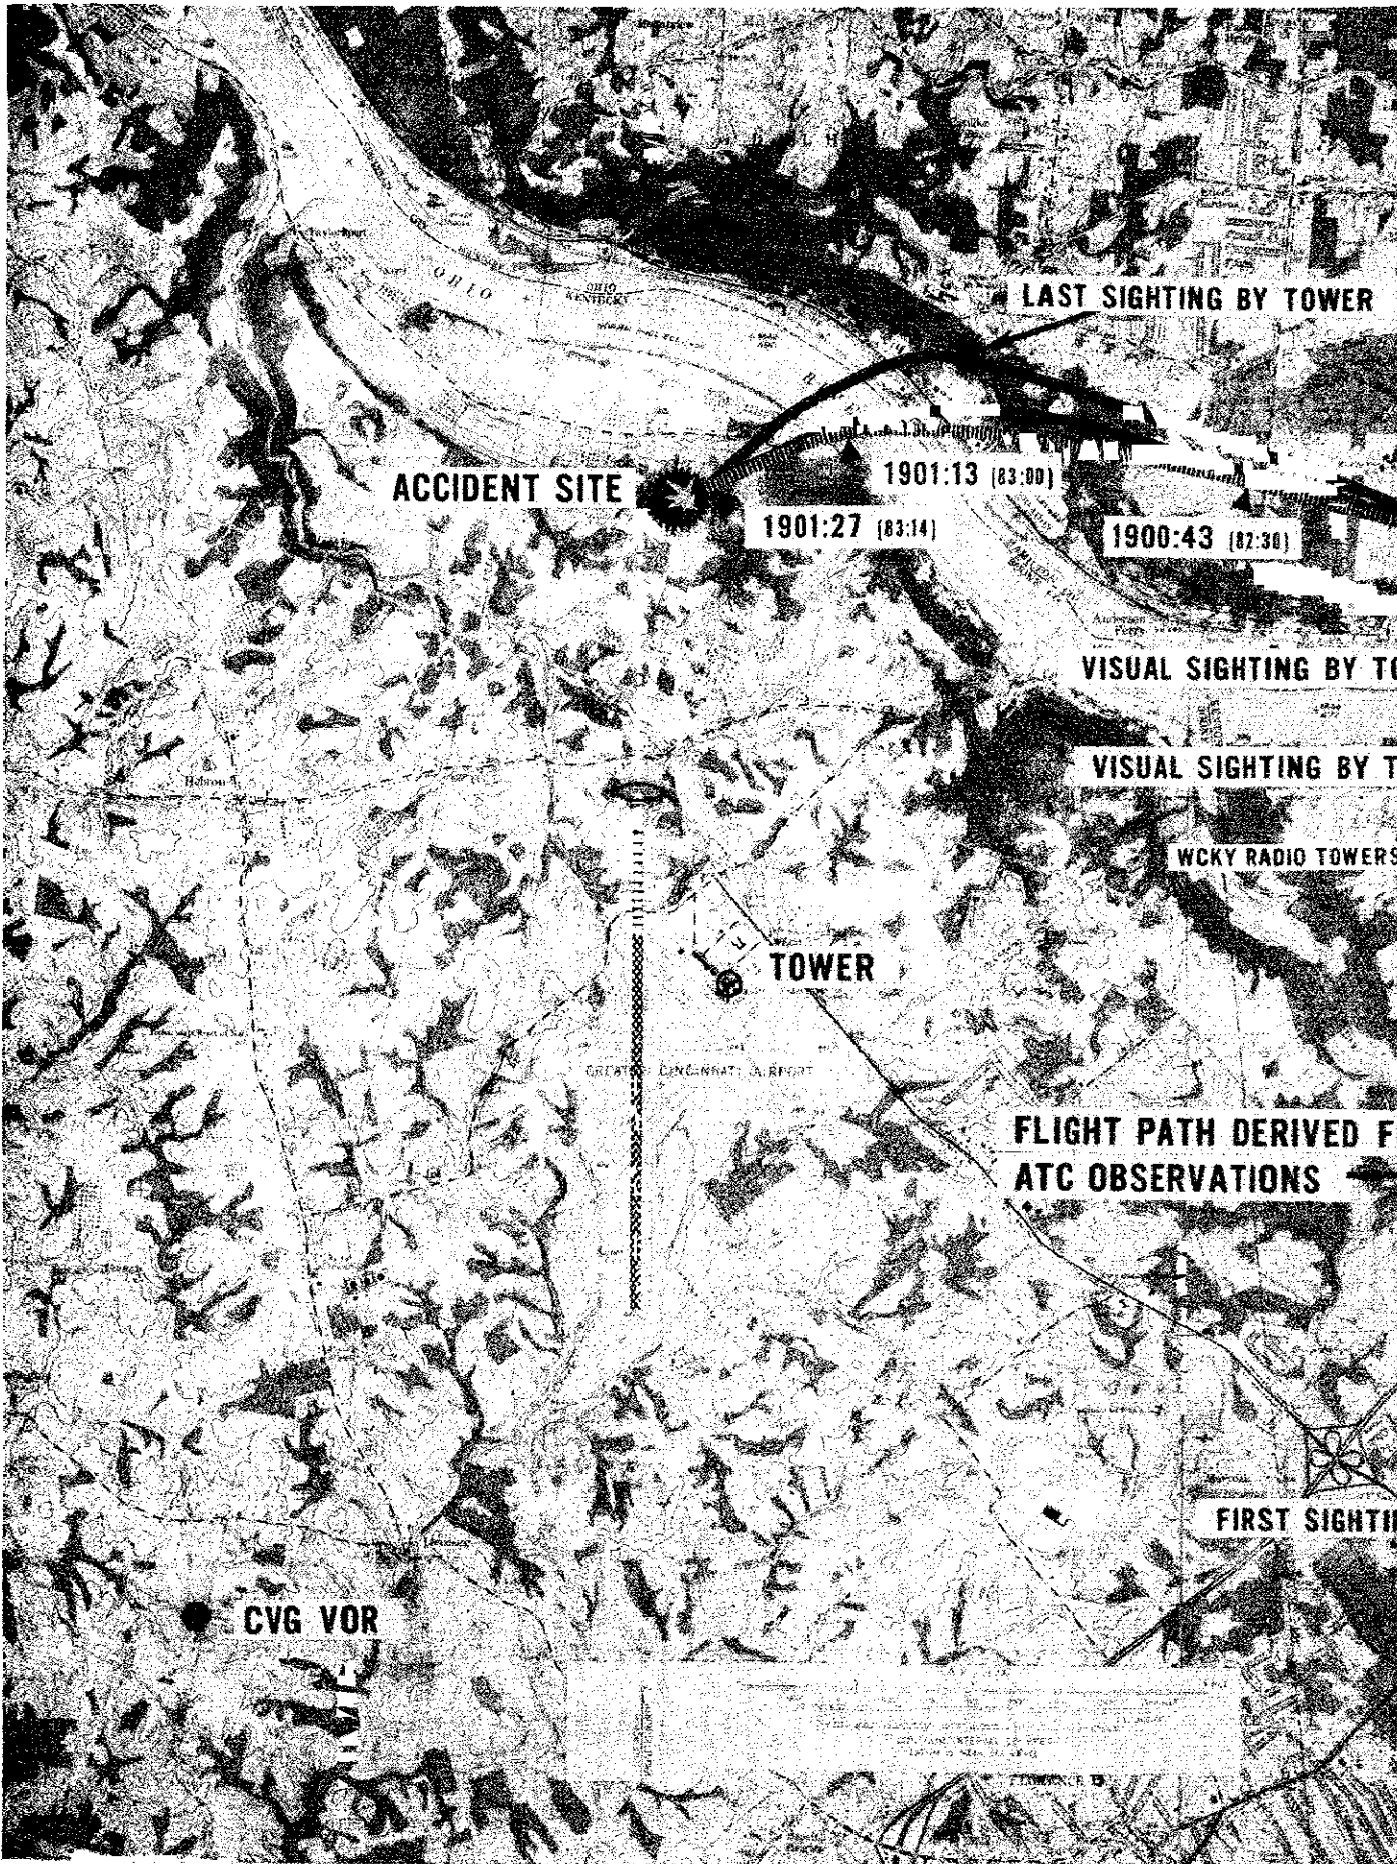
LAST SIGHTING BY TOWER

ACCIDENT SITE

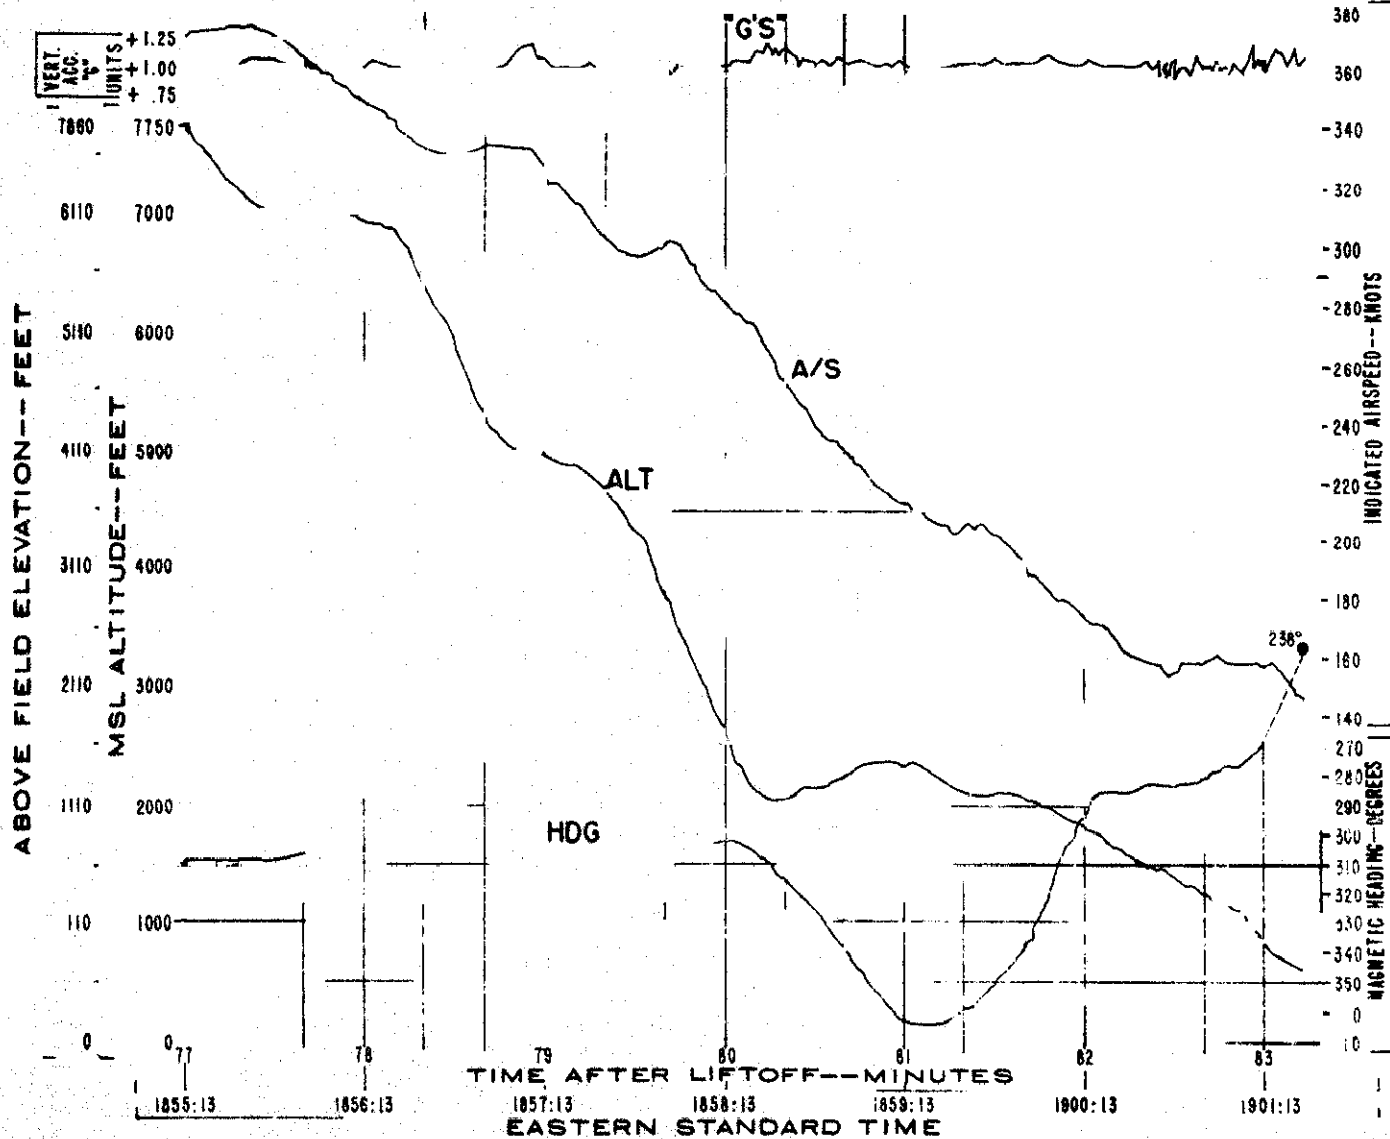
FLIGHT RECORDER DATA GRAPH
UDC MODEL F542 S/N 1395

The acceleration excursions noted throughout the readout were consistent with the maneuvers being performed and, except for the last 50 seconds of flight, no significant turbulence activity was noted. During the last 50 seconds of flight the G trace activity was suggestive of light turbulence computed to be less than 14 feet per second.

Note. Heading Parameter unreliable beyond 82.59 minutes due to aberrant area on tape except for data point at 83:14. Trace shown dotted between last readable points.

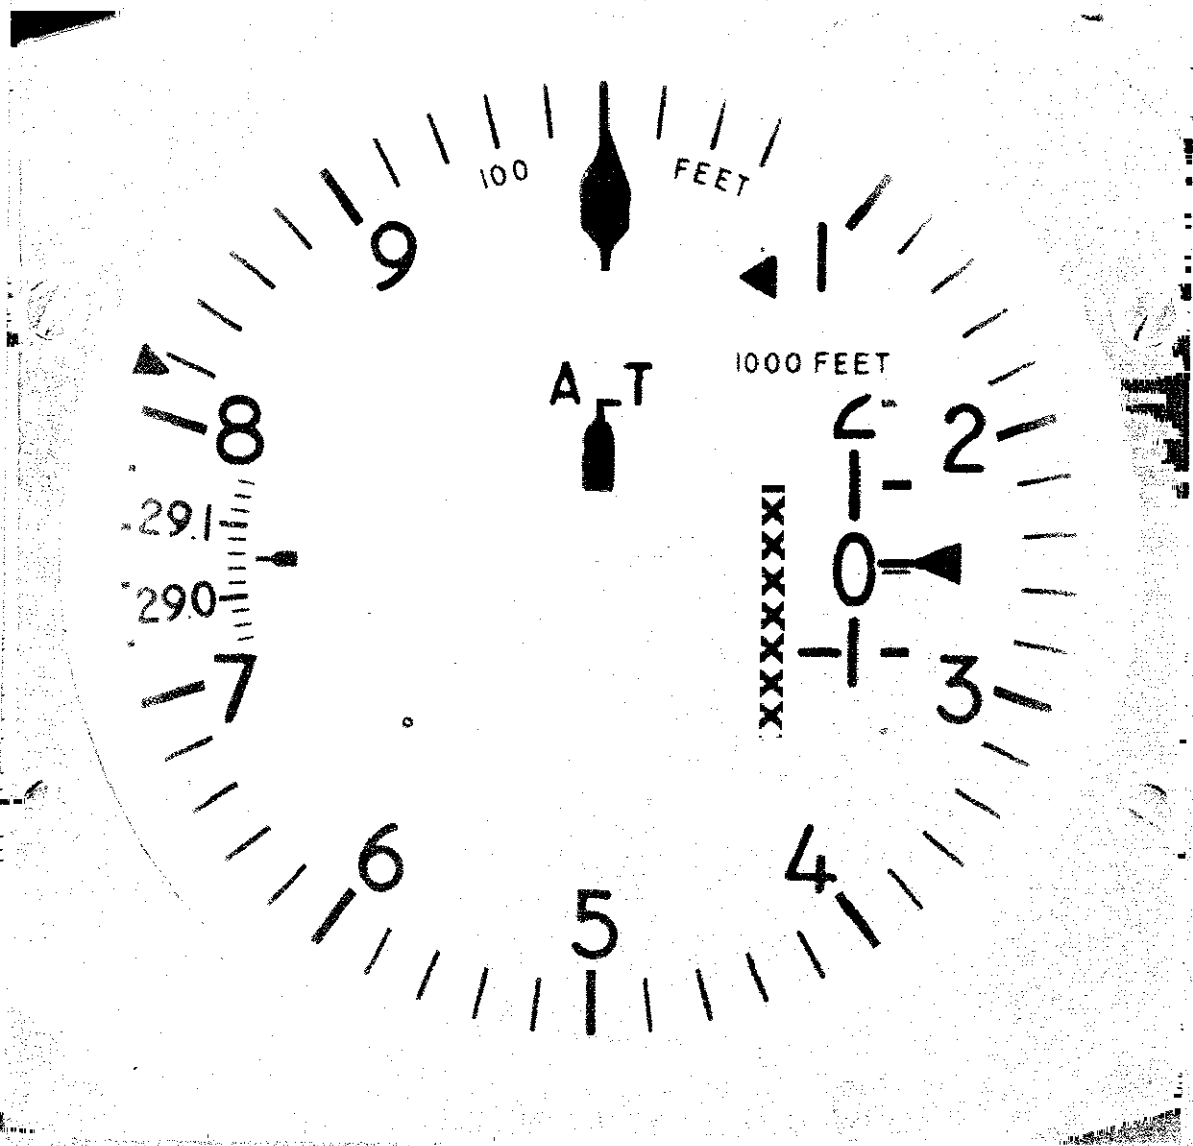
KOLLSMAN ALTIMETER

The three Kollsman altimeters^{9/} installed in the aircraft were recovered from the wreckage and were examined at the manufacturer's facility. The captain's (No. 1) altimeter was found at a barometric setting of 29.06 inches with the index marker set on 800 feet. A valid drum position could not be obtained because of internal mechanism disruption. The copilot's (No. 2) altimeter was found at a barometric scale setting of 29.03 inches with the index marker positioned at 815 feet. Only portions of the center instrument panel (No. 3) altimeter were recovered and no barometric, index marker, or drum position information could be obtained. A discussion of the American Airlines procedures for altimeter utilization and related procedures will be found in section 1.15 under the heading of AA altimeter procedures.

It is realized that in these cases or in any altitude presentation a pilot knowledgeable in the altimeter should have no problem whatsoever in quickly determining the correct altitude reading. However, it can also be seen that under certain conditions compounded by infrequent, fragmented, or distracted monitoring, a misreading/misinterpretation of altitude could occur.

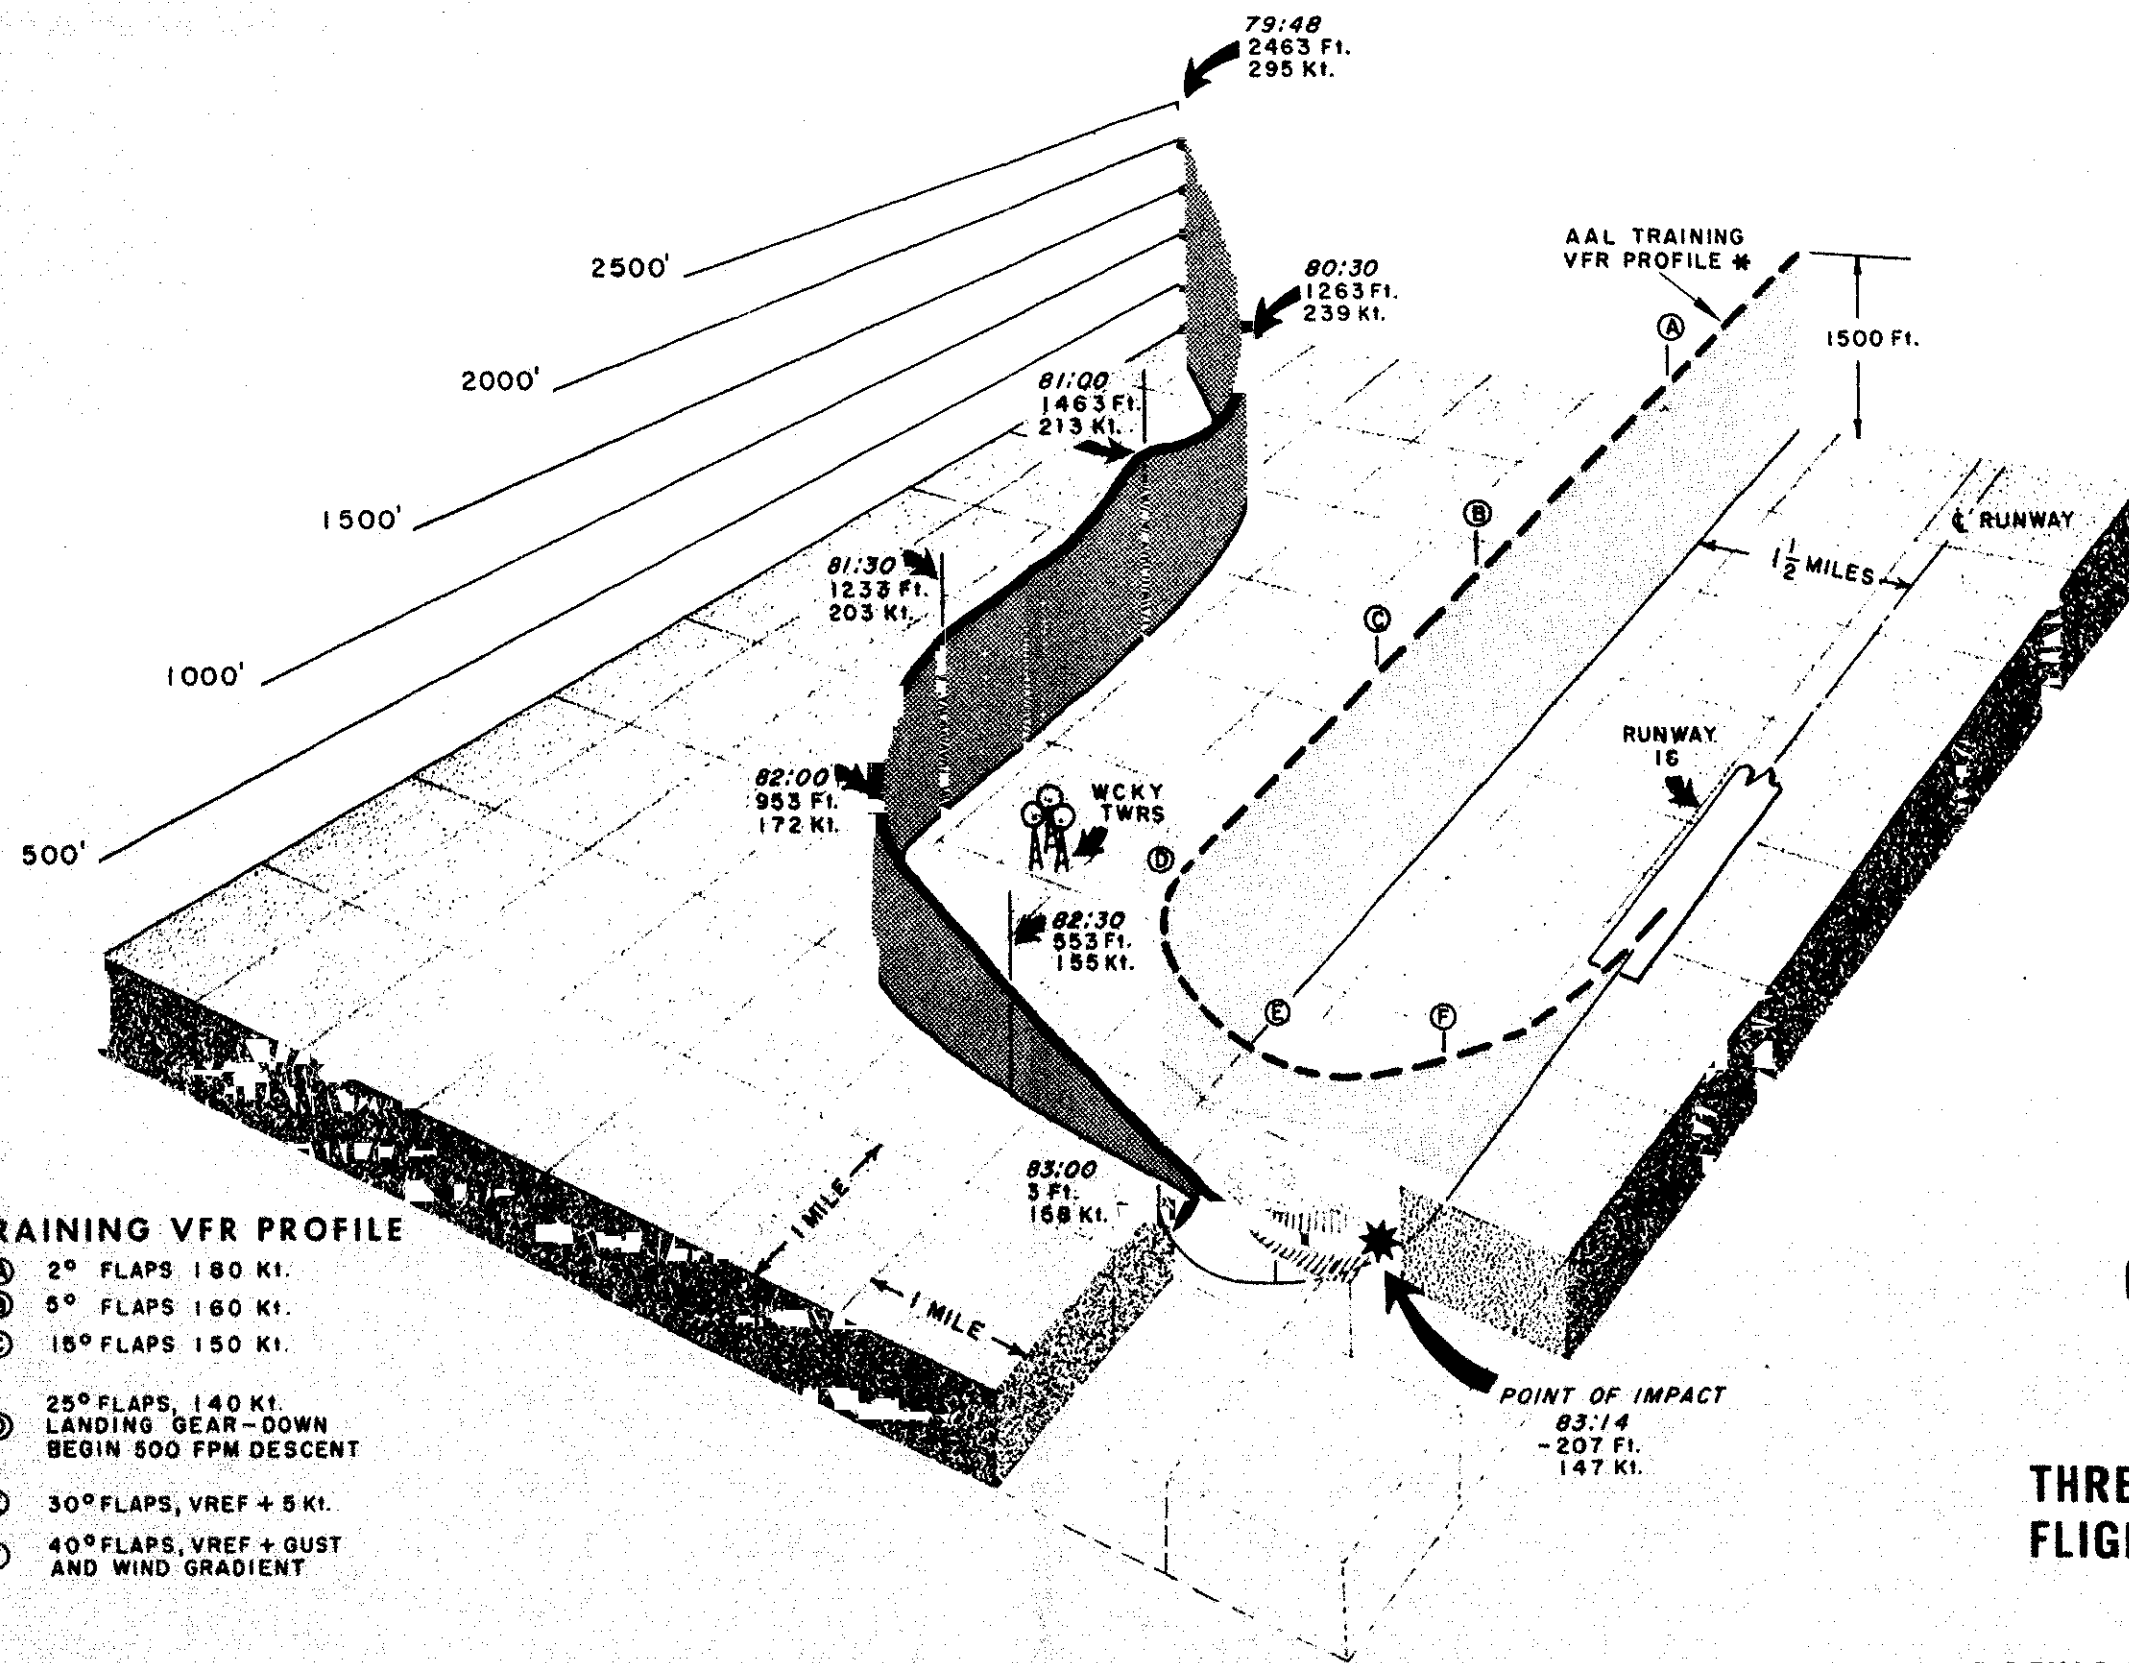
AAL TRAINING VFR PROFILE

Examination of the AA 727 flight training curriculum disclosed that the normal VFR (training) pattern for Boeing 727 type aircraft (see Attachment #3) calls for the downwind leg to be flown at a distance of 1-1/2 miles out from the runway. Since the flight recorder, ATC observations, and witness observed flightpaths all indicate that the downwind leg on this flight was flown at a distance of 4-1/2 miles from runway 18, this aspect of the approach was explored in detail. Testimony from AA training and operations representatives at the public hearing indicated that although the VFR training pattern taught to pilots in the training syllabus serves as the standard or desired VFR approach, many variances of this pattern can be, and are, utilized in actual line operations. It was stated that the variables in the VFR

The traffic pattern airspeeds and aircraft configuration sequences utilized by N1996 were compared to appropriate airspeeds and recommended configuration sequences outlined in the VFR training pattern. From this study it was indicated that the various flap extensions during the approach conformed with the AA normal operating extension speeds. However, because of the comparatively higher airspeeds maintained by the flight throughout the approach, these flap extensions were concentrated or "bunched-up" on the base leg.

- Ⓐ 2° FLAPS 180 KI.
- Ⓑ 5° FLAPS 160 KI.
- Ⓒ 15° FLAPS 150 KI.
- Ⓓ 25° FLAPS, 140 KI.
LANDING GEAR-DOWN
BEGIN 500 FPM DESCENT
- Ⓔ 30° FLAPS, VREF + 5 KI.
- Ⓕ 40° FLAPS, VREF + GUST
AND WIND GRADIENT
