# AIRCRAFT ACCIDENT REPORT

**TWA B-707, N748TW and  
EAL LOCKHEED CONSTELLATION N6218C  
Carmel, New York  
December 4, 1965**

MIDAIR COLLISION - TRANS WORLD AIRLINES, INC.,  
BOEING 707-131B, N748TW, AND EASTERN AIR LINES, INC.,  
LOCKHEED 1049C, N6218C, NEAR CARMEL, NEW YORK,  
DECEMBER 4, 1965

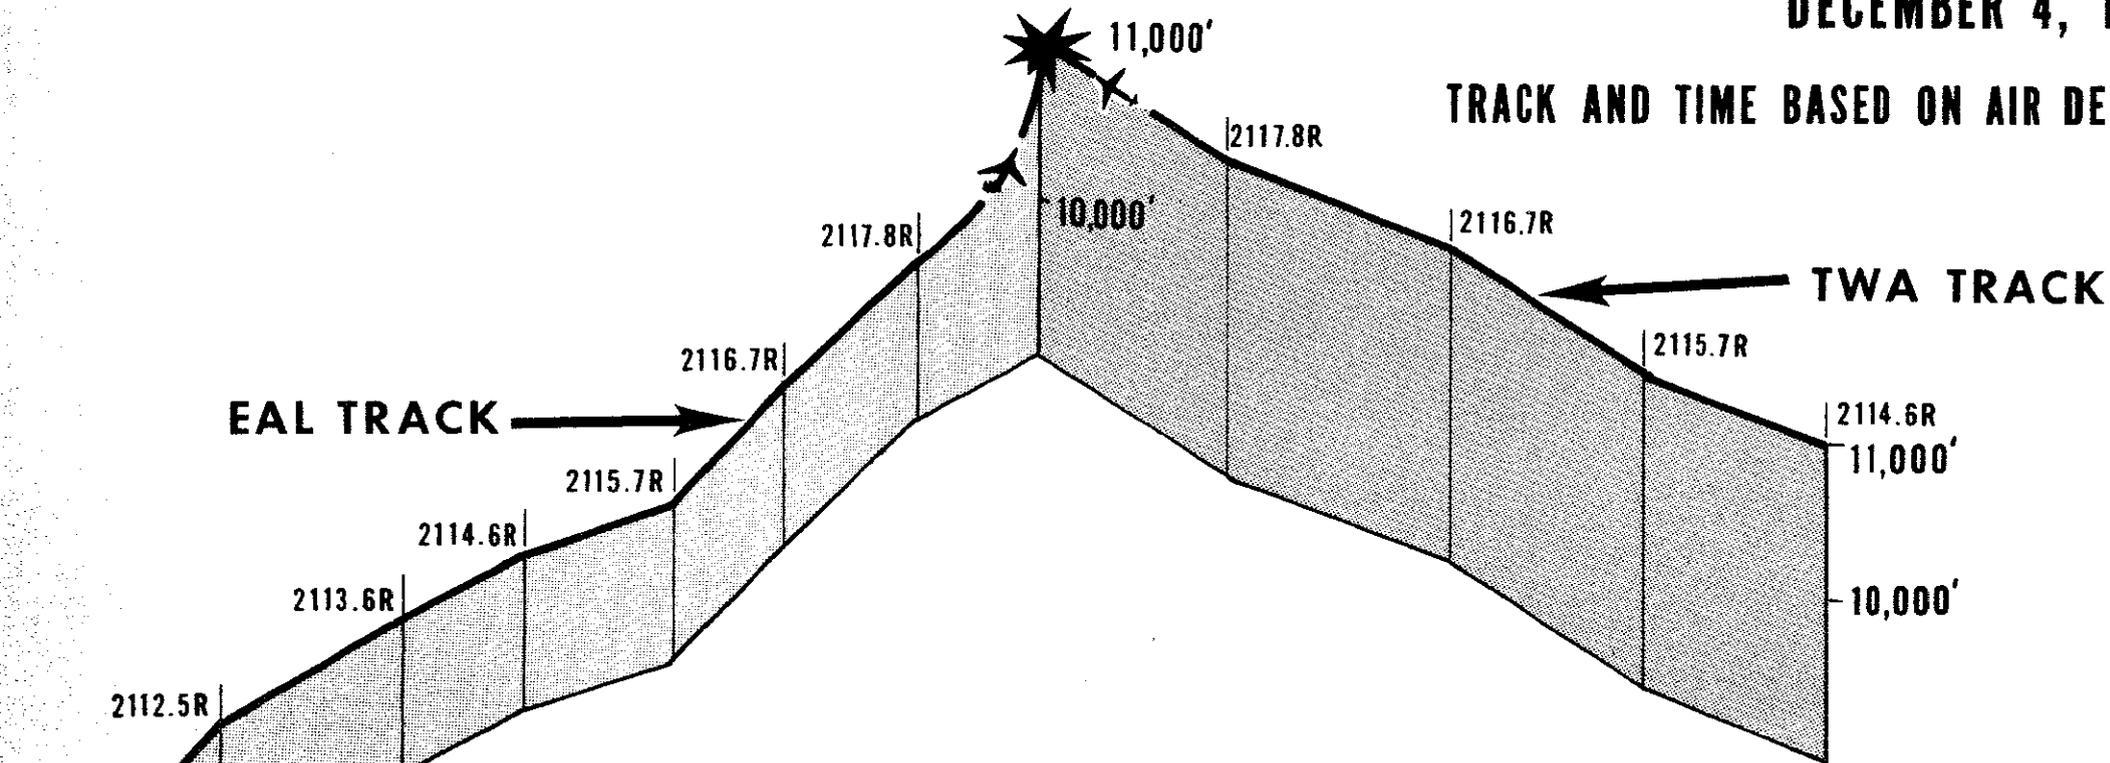
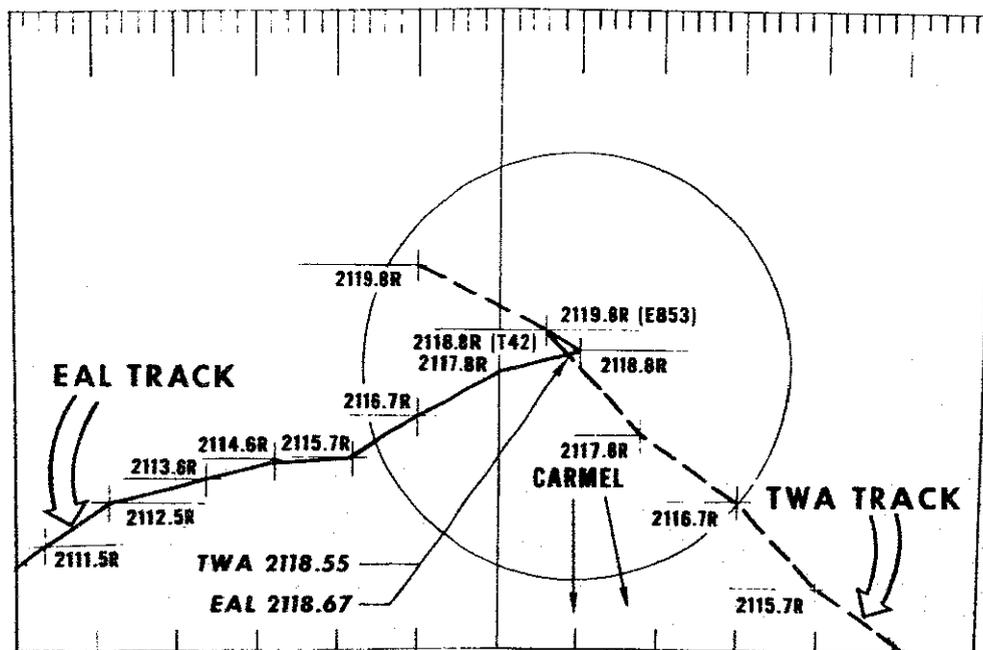
PLAN VIEW OF FLIGHT PATHS

TRACK AND TIME BASED ON AIR DEFENSE COMMAND DATA
