**RUNWAY DEPARTURE DURING ATTEMPTED TAKEOFF  
TOWER AIR FLIGHT 41  
BOEING 747-136, N605FF  
JFK INTERNATIONAL AIRPORT, NEW YORK  
DECEMBER 20, 1995**

**Adopted: December 2, 1996  
Notation 6671A**

**Abstract:** This report explains the runway departure during attempted takeoff of Tower Air flight 41, N605FF, a Boeing 747-136 at John F. Kennedy International Airport, New York, on December 20, 1995. The safety issues discussed in this report include the adequacy of Boeing and air carrier procedures for B-747 operations on slippery runways; adequacy of flight simulators for training B-747 pilots in slippery runway operations; security of galley equipment installed on transport category aircraft; role of communications among flight attendants and between the cabin crew and the flightcrew; adequacy of Tower Air galley security training; compliance of Tower Air's maintenance department with its established procedures; failure of the FDR system to function during the accident; adequacy of the Tower Air operational management structure; adequacy of FAA surveillance and workload imposed on POIs; adequacy of runway friction measurement requirements, including correlation of runway frictio

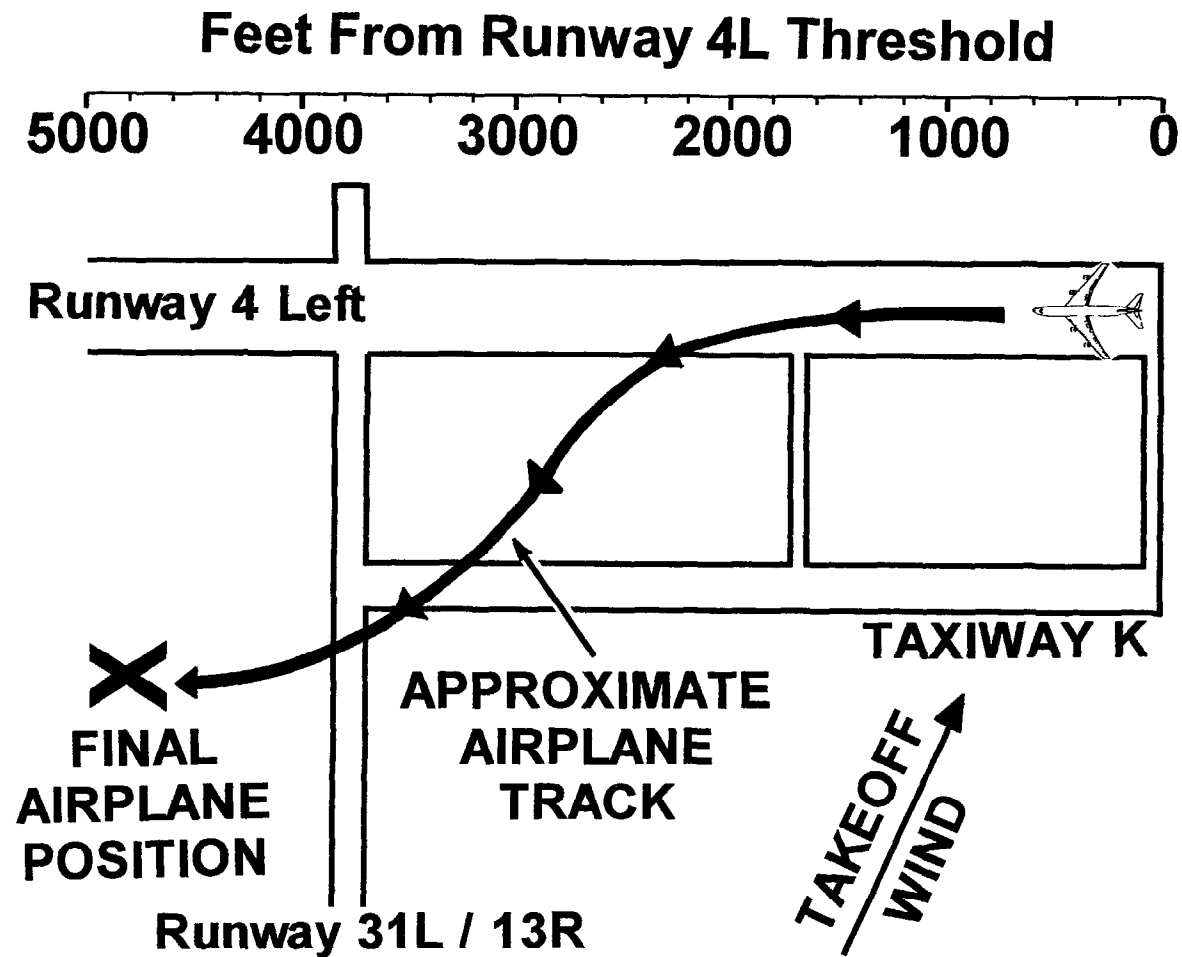
Figure 2—Airplane's Location After Skid

The first marks on the runway attributed to N605FF consisted of four pairs of black marks located approximately 2,000 feet from the threshold of runway 4L, and centered approximately 40 feet left of the runway centerline (see figure 2). The four pairs of tire marks were consistent with the tires of the airplane left main wing landing gear (LMWLG), left body landing gear (LBLG), right body landing gear (RBLG), and right main wing landing gear (RMWLG). The tire marks on the runway were continuous, and each mark was approximately 8 inches wide. No tire marks were found from the nose landing gear either on the runway or on the ground.

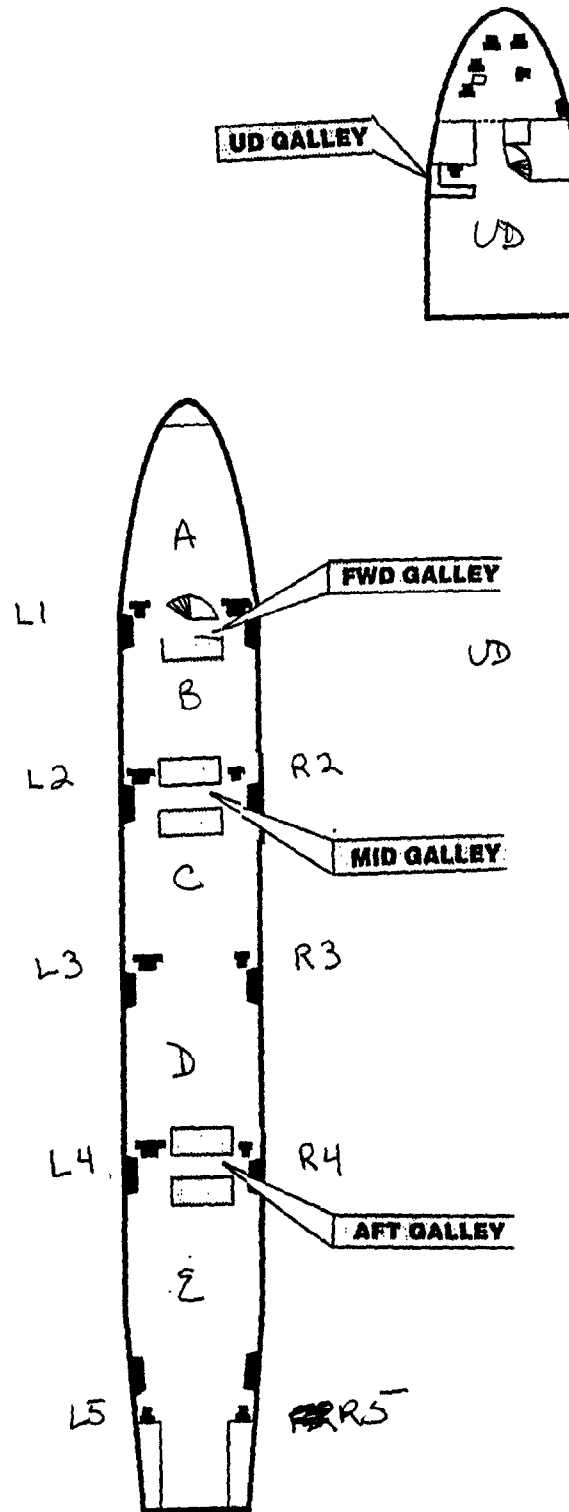
Figure 3—Cabin Layout

The cabin floor sustained substantial damage in Zone A. The floor was displaced upward approximately 2 feet in the center of the cabin at seat rows 6, 7, and 8. At least three of the four attach points for each of the seats in this area remained secured to the seat tracks, and no injuries were reported in this area.

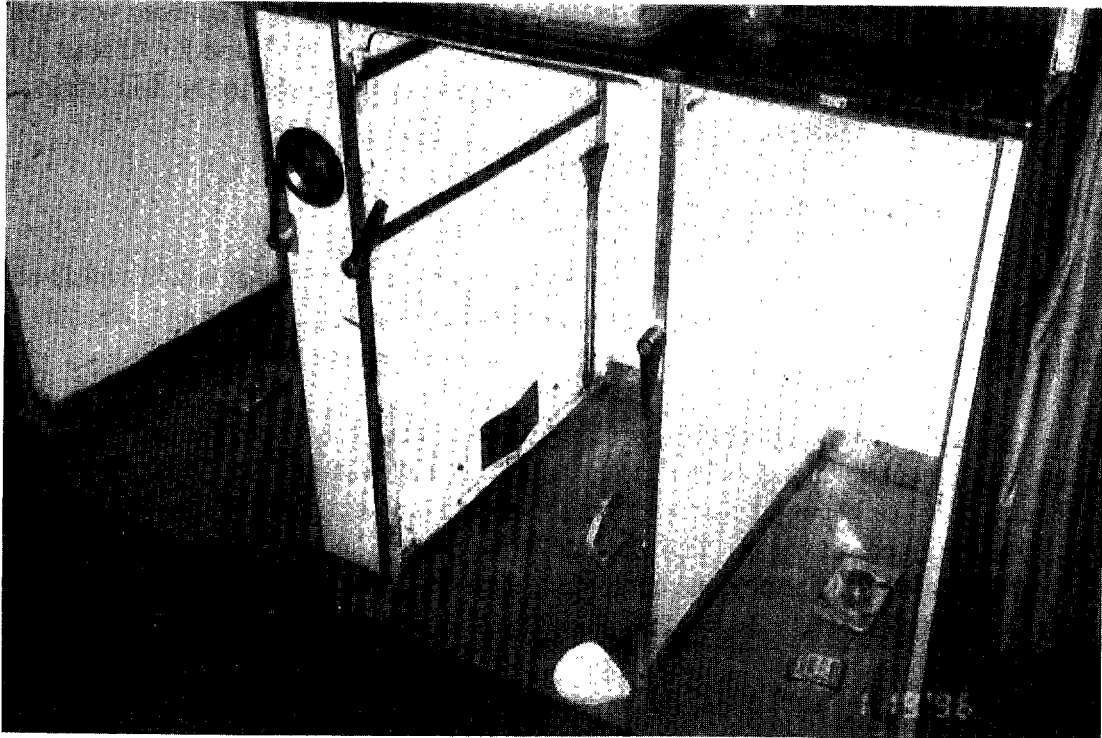
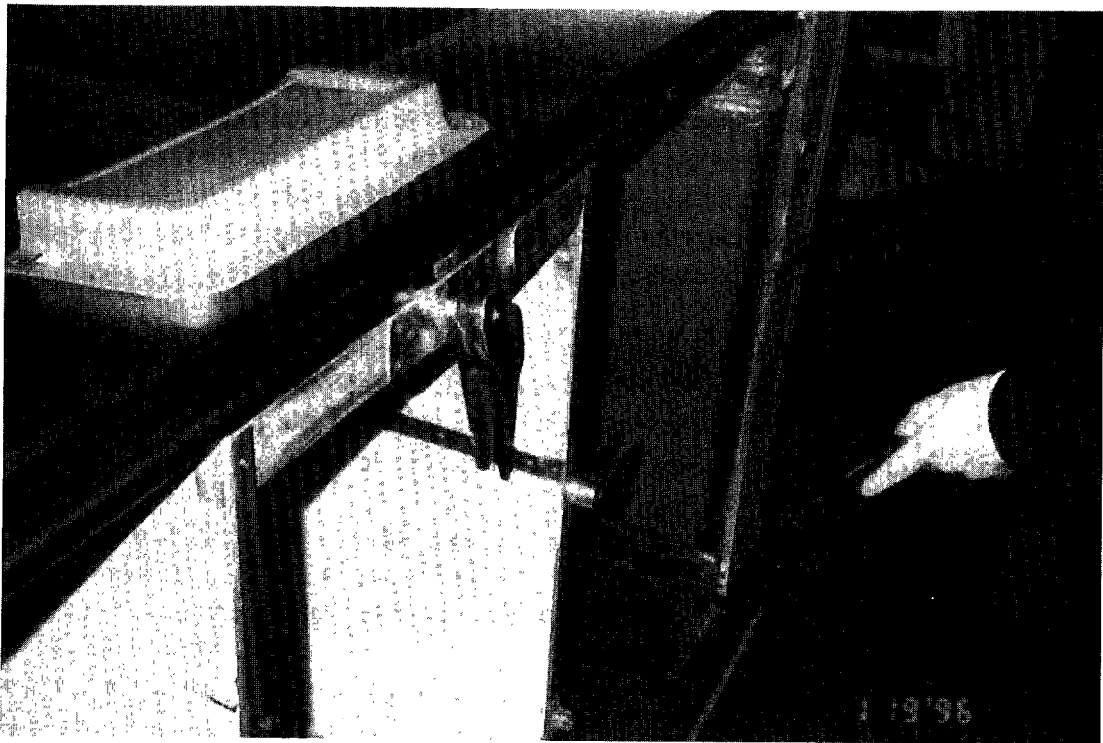
Figure 4—Galley Cart Primary and Secondary Securing Mechanisms

In contrast to the "mushroom" locking mechanism used to secure meal and beverage carts, the ice cart in each galley area of N605FF locked onto a retaining tongue mounted on the floor of the galley with a lever located on the bottom of the cart. The lever movement inserted a pin through a circular opening in the retaining tongue (see figure 4).
