EVALUATION OF SPRAYED-ON METALIZING FOR PRECAST PRESTRESSED CONCRETE I-BEAMS

**INNOVATIVE BRIDGE RESEARCH CONSTRUCTION
(IBRC) PROGRAM**

**PHYSICAL RESEARCH REPORT NO. 141
APRIL 2002**

Illinois Department of Transportation

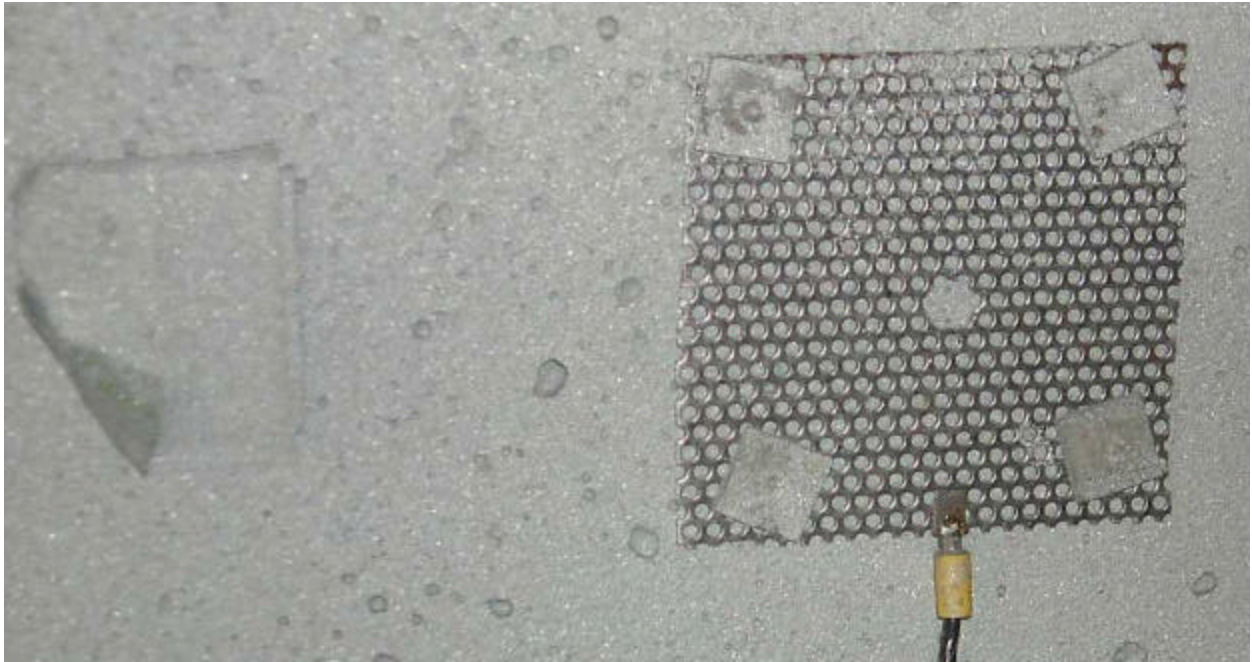
Photo 5. Expanded steel plate before second metallizing pass. Note loose tape on left.

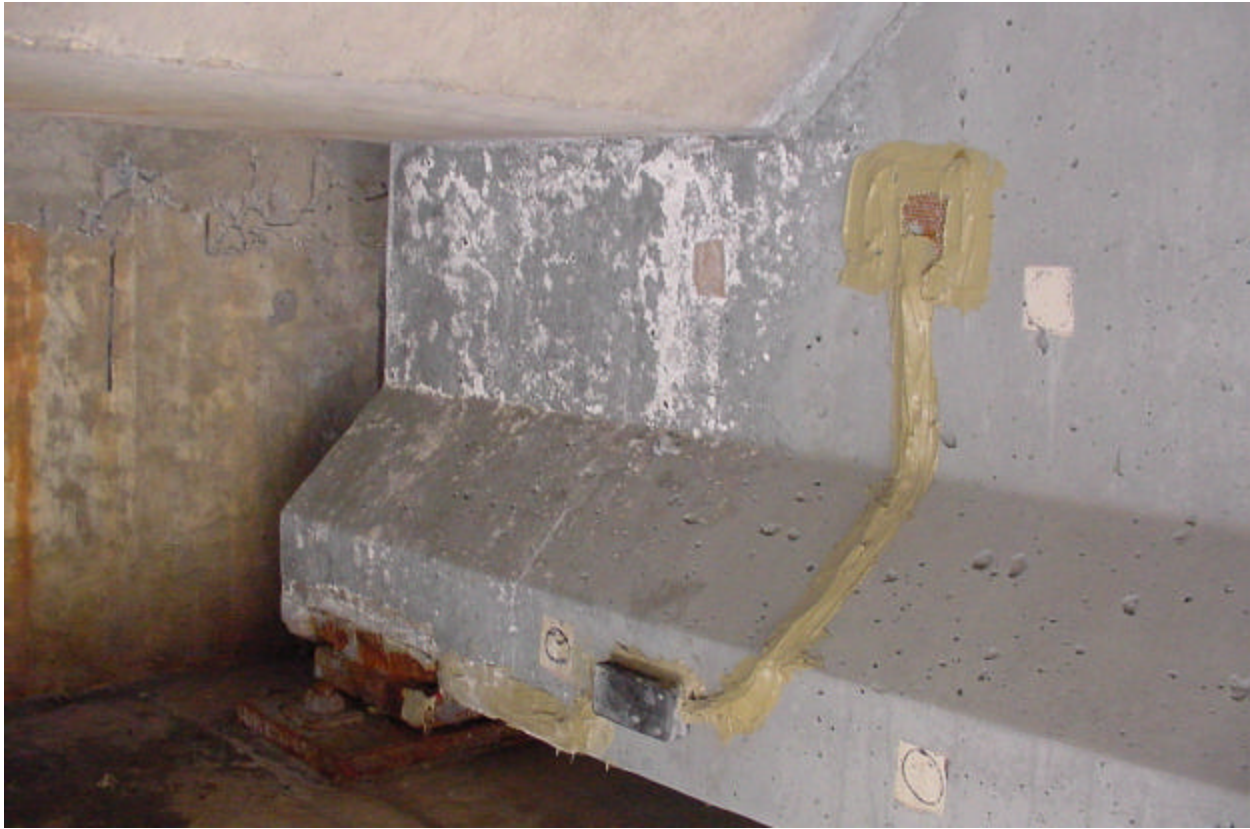
Values for Beams 2 and 3 show a higher rate of corrosion occurring at the bottom test locations as opposed to those on top, as well as at locations closer to the end of the beams than further in the beams. This is somewhat expected since water entering the beams from leaks in the joints would collect at the exposed ends of the pre-stressing strands. More would tend to collect at the bottom of the beam than at the top as it ran down the web and collected at the exposed ends of the pre-stressing strands. Photo 7 shows evidence of zinc oxide (a corrosion product) forming on the surface of the zinc anode where water has run down the surface of the beam.

Photo 7. Beam 2 west side Zn/Al anode corrosion products.

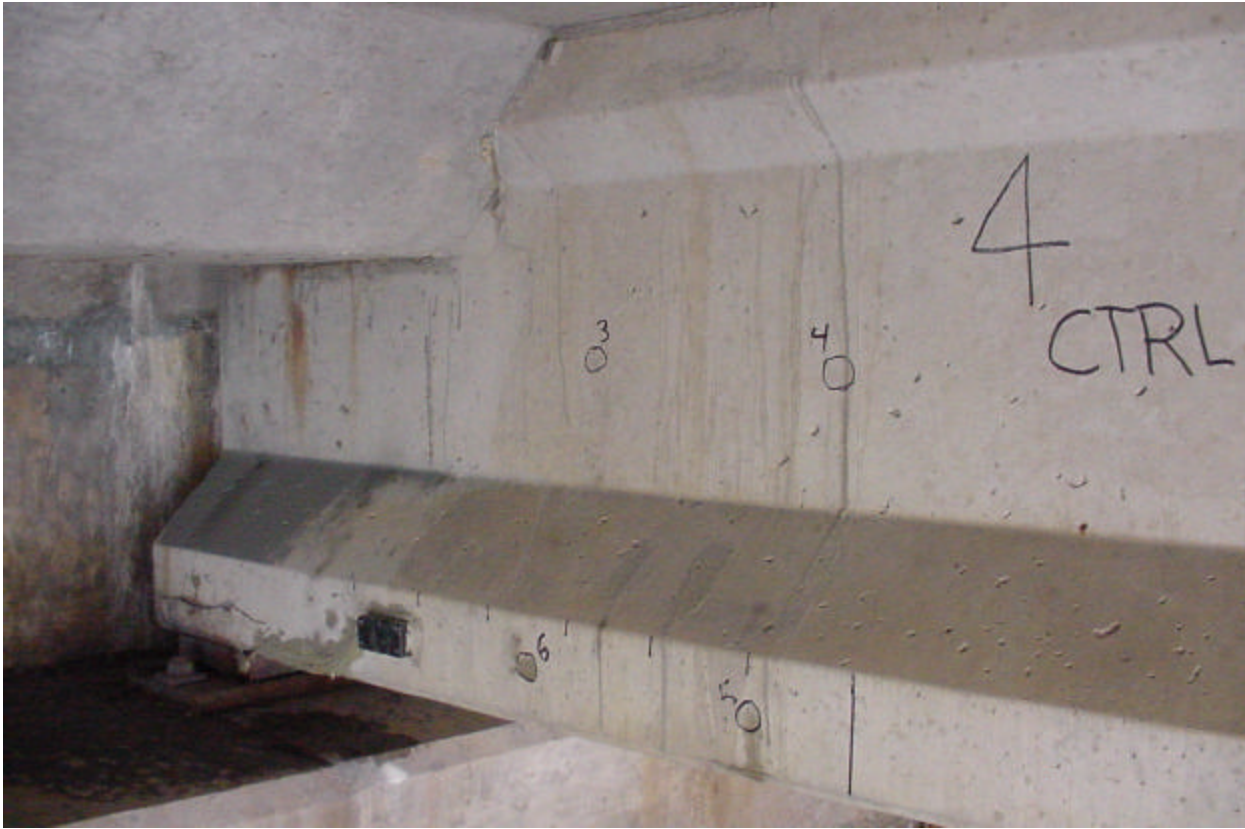
Beams 4 and 5 (control beams) show small changes in the corrosion potentials compared to the other beams, possibly due to the intact deck joint preventing water from migrating into the beams. The two beams show the least amount change in corrosion potentials compared to the treated beams. Photo 8 shows evidence of very little water running down the face of beam 4.

Photo 8. West side of Beam 4. Little evidence of water running down the face of the beam.

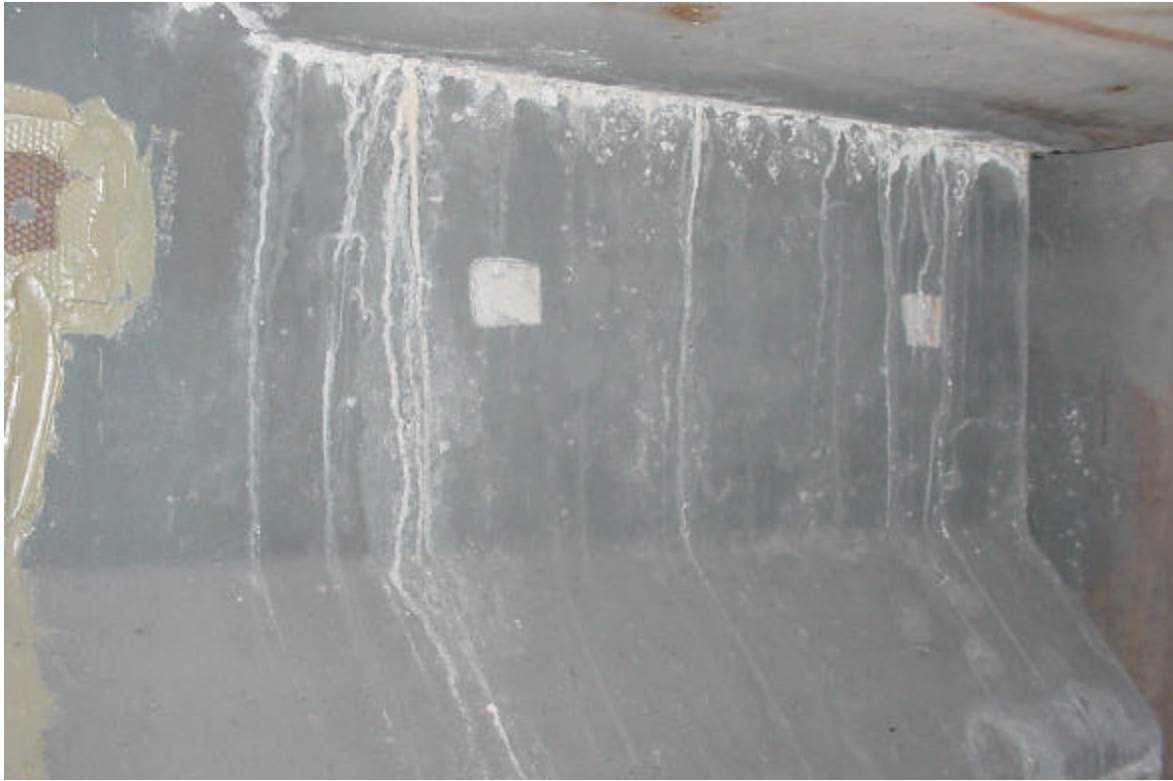
Beam 10 shows corrosion potentials which are somewhat higher than the control beams, possibly due to leaking joints. Photo 9 shows the corrosion products. Beam 12 shows corrosion potentials much lower than the control beams. These values, again are somewhat unrealistic for a fascia beam exposed to rain.

Photo 9. Beam 10, east side. Corrosion products forming from leaks in deck or at joint.

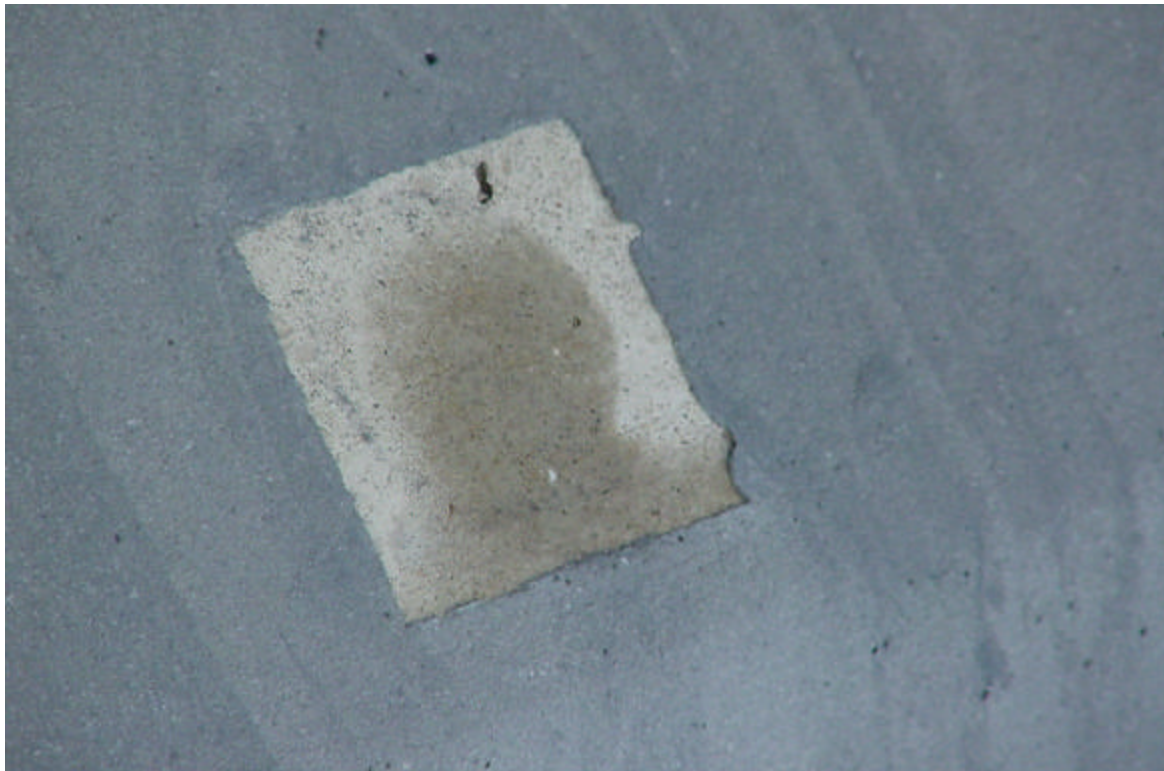
Beams 10, 11, and 12 were treated with an anode composed of 85% zinc and 15% aluminum. Beam 11 shows unrealistically high readings. This may be due to active corrosion occurring at the strands or may be in part due to an electrical short occurring between the zinc anode and the copper/copper sulfate half cell due to a small amount of water applied to the surface of the concrete per ASTM C-876. This is similar to what may have occurred at test site A on Beam 1.

Photo 10. Water short across concrete to anode.

Evaluation of the three different types of “spray on” anodes for galvanic cathodic protection indicate that the systems do not offer any improved amount of protection to the pre-stressing strands when compared to beams that were not treated. Results from the corrosion potential surveys indicate that the systems are not protecting the steel. It appears that the anodes do not develop enough current necessary to drive the ion exchange to arrest the corrosion process. An additional survey is proposed for spring of 2002 to evaluate the anode performance. Several environmental factors as well as equipment factors which may have affected the test results will be evaluated. A main concern is the effect of water, used to moisten the surface of the concrete, bridging across the anode to form a localized short in the system. This will be addressed by using a highly conductive multi-purpose electrolyte gel to ensure conductivity. Additionally, a smaller diameter copper-copper sulfate half-cell will be evaluated to reduce the chances of bridging across the anode.
