**Federal Railroad
Administration**

Passenger/Freight Train Collision

September 12, 2008, Chatsworth, CA:

Main Report

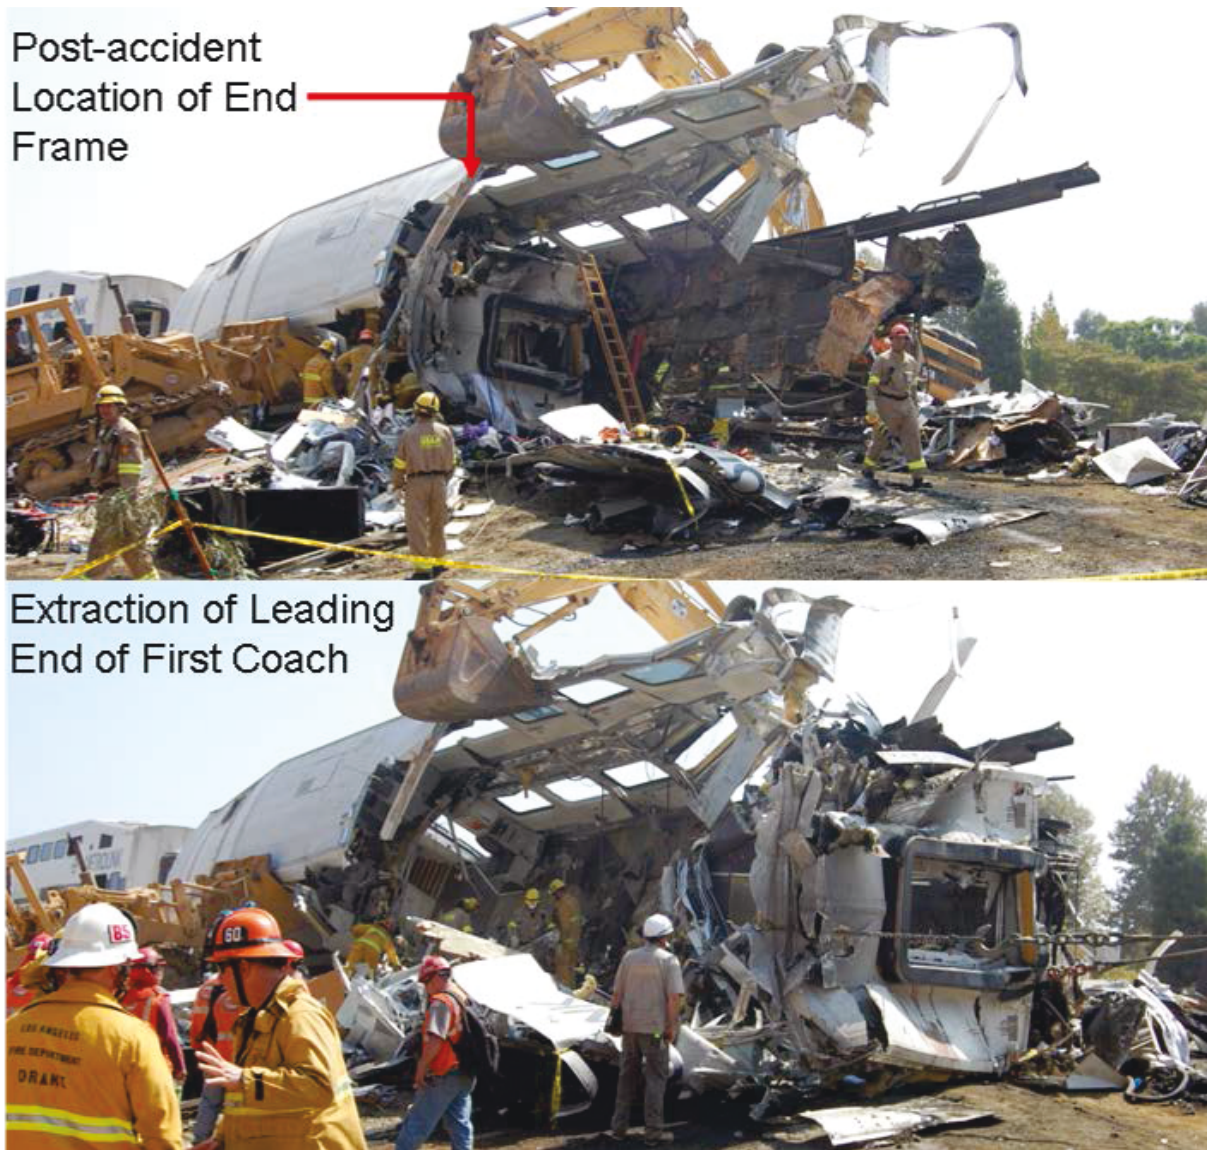
Figure 14. First Passenger Car Structural Damage

The top photograph in Figure 14 shows the lead passenger car after the passenger locomotive was cleared away. The bellows and end frame from the front of the car are visible, pushed into rear portion of the car, with the left side wall ahead of it held up by the backhoe. The side sill can be seen, pointing to the right. Close inspection shows the threshold for the left side door on the side sill. The lower photograph shows the end frame being pulled from the interior of the car. Though not visible in this figure, the underframe of the separated leading end of the car is essentially intact, with the lead truck still attached.

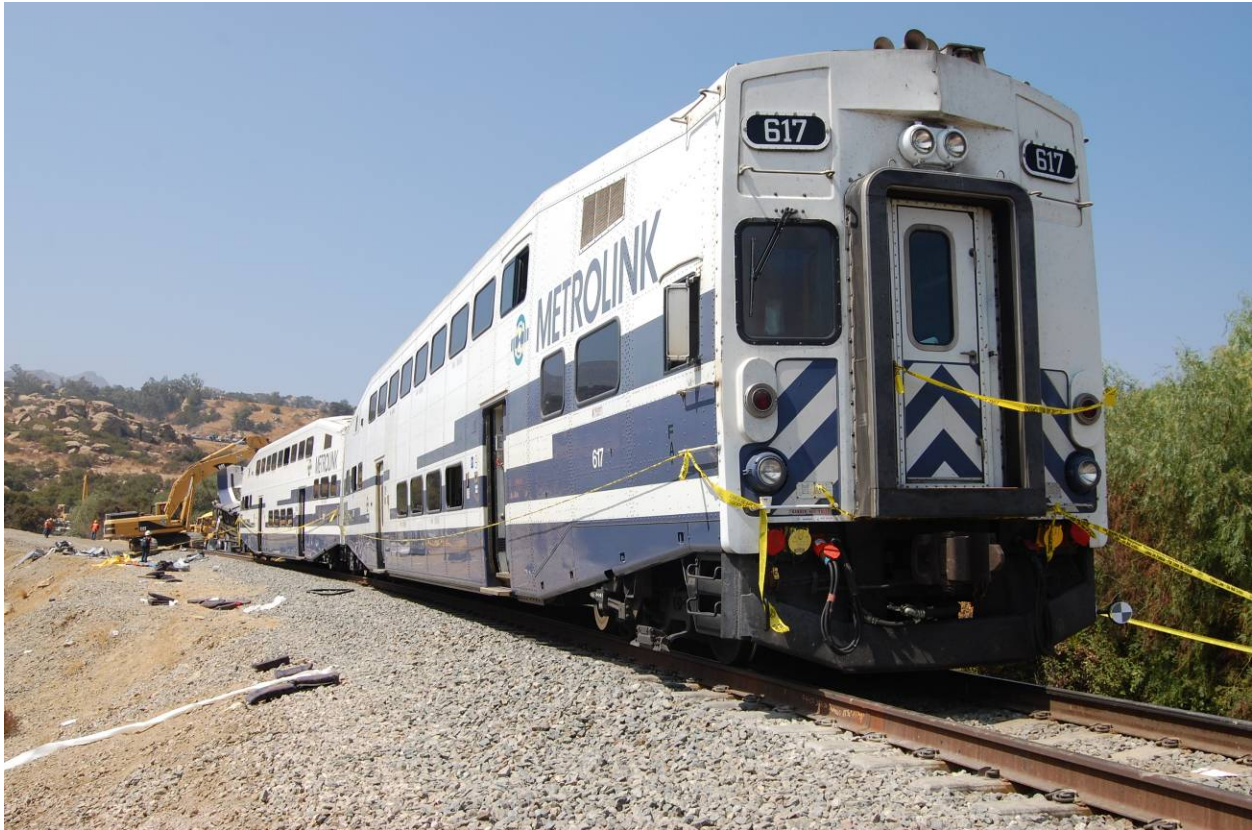
Figure 16. Second and Trailing Passenger Cars, (#207 and #617)

Figure 16 shows the second passenger car, Metrolink Trailing Passenger Car #207. Damage to this car was relatively minor. There was some damage to the leading end, which was coupled to the first passenger car. There was also some wrinkling of sidewall panels and damage to the lead truck attachment. There appeared to potentially be some distortion to the leading end draft sill, however, it was difficult to tell conclusively with only a visual inspection. Measurements were not possible with the truck in place. The leading bellows showed damage from contact with the car ahead. There were dents on the bellows frame, just above the spring loaded buffer beam. There was also damage to the fiberglass end cap above, just above the bellows. This damage was consistent with the leading car attempting to override this car.

Figure 16 also shows the third passenger car, Metrolink Trailing Passenger Car #617. There was very little structural damage to this car. The truck retention mechanism did fail, but the running gear remained intact and the truck remained in place beneath the car. Similar failures have been observed in an impact test of like equipment [1].

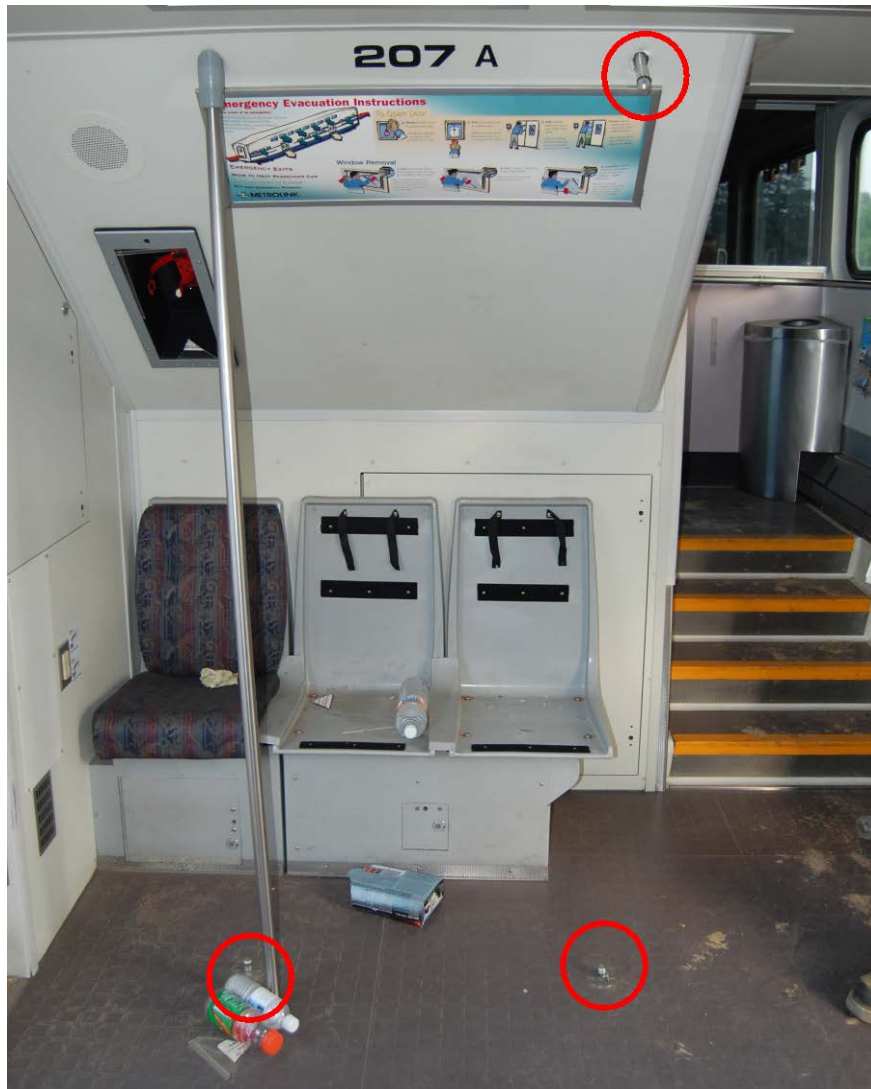
was observed on two seats. Numerous seat cushions were missing or displaced. A stanchion was completely separated from the floor and wall on the lower level, near the aft doors (see Figure 21).

Figure 21. Detached Stanchion Near Aft Doors, Lower Level, Car #207

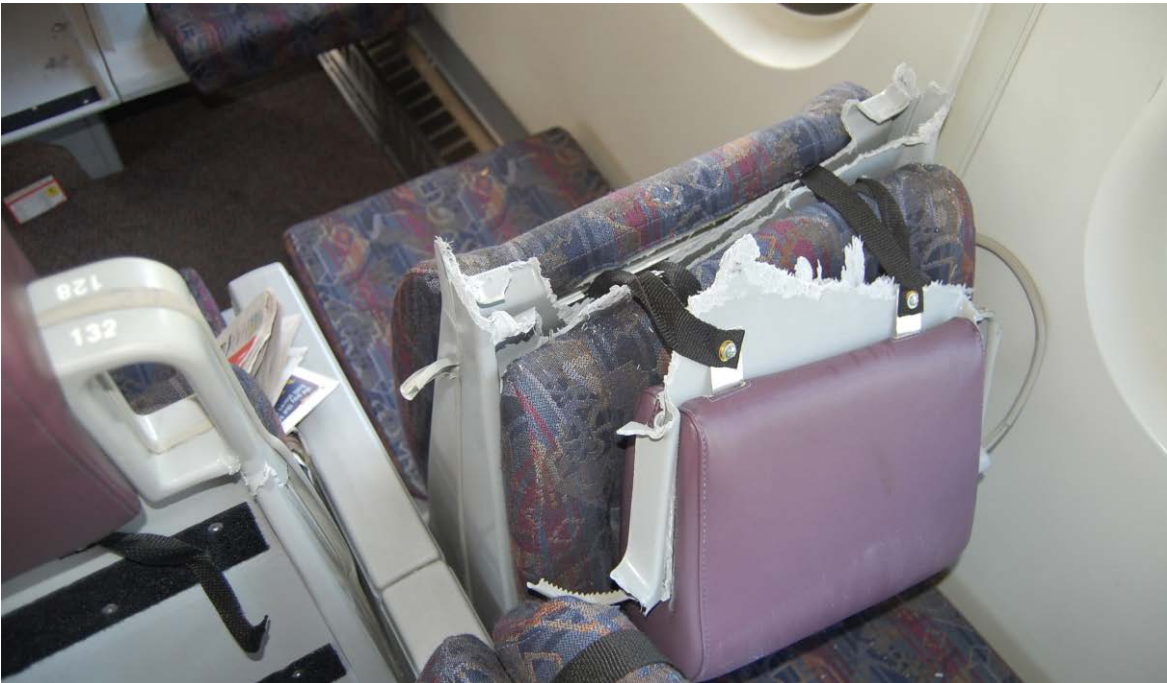
Figure 23. Broken Head Rests in Lower Level, Car #617

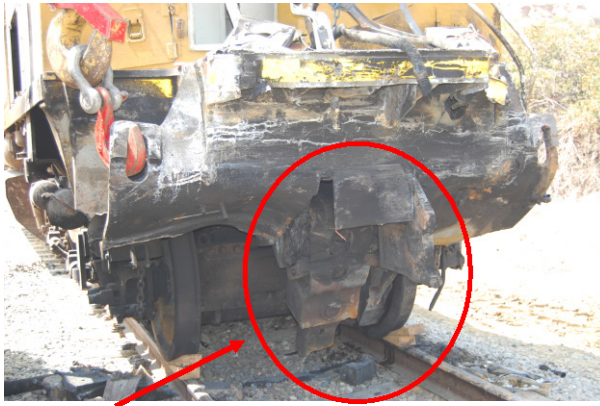
Lead Freight Locomotive

Broken coupler shank. Coupler draft pocket deformed and oriented downward.

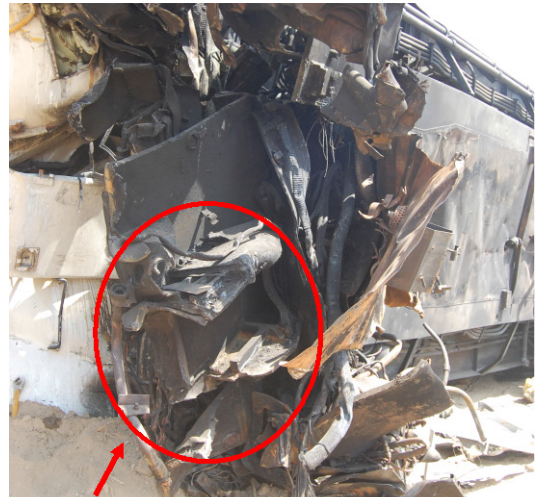
Lead Passenger Locomotive

Coupler and draft gear pocket fractured off of locomotive underframe.

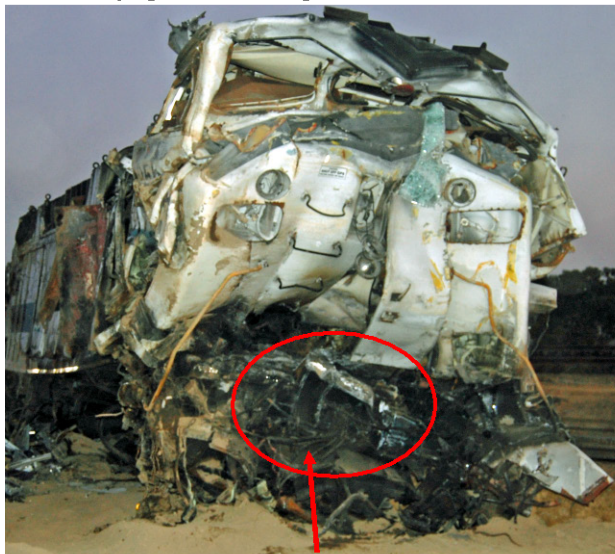
Uprighted Passenger Locomotive

Passenger Locomotive Anti-climber Engages Beneath Freight Locomotive Anti-climber.

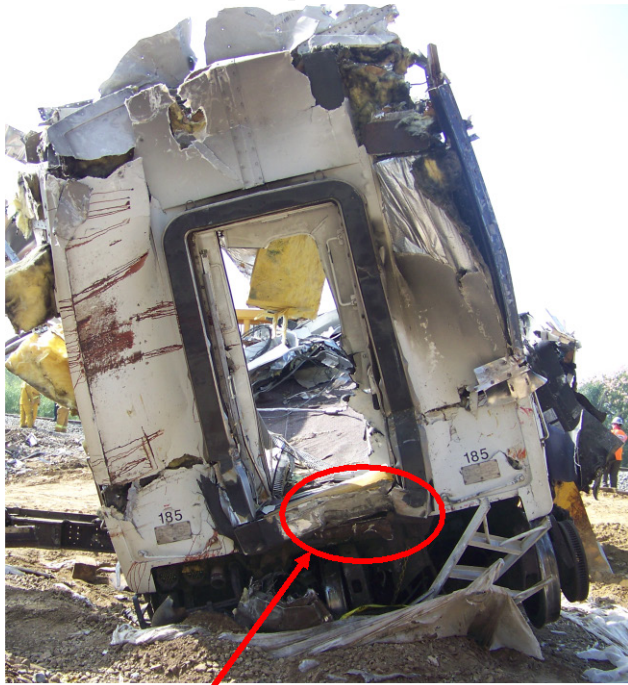
Extracted Leading End of First Coach

Indentation from
Locomotive Bellmouth

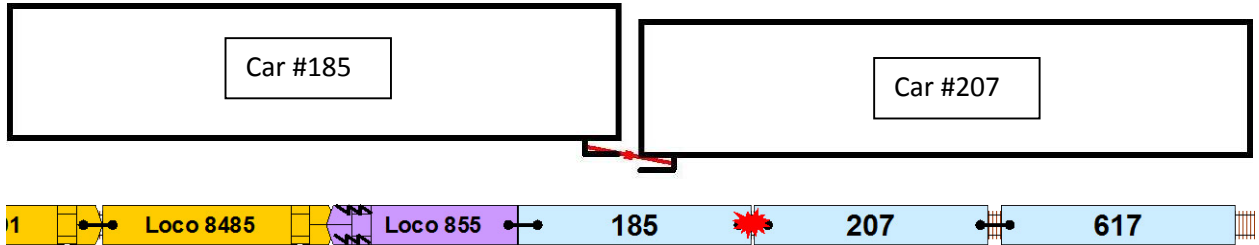
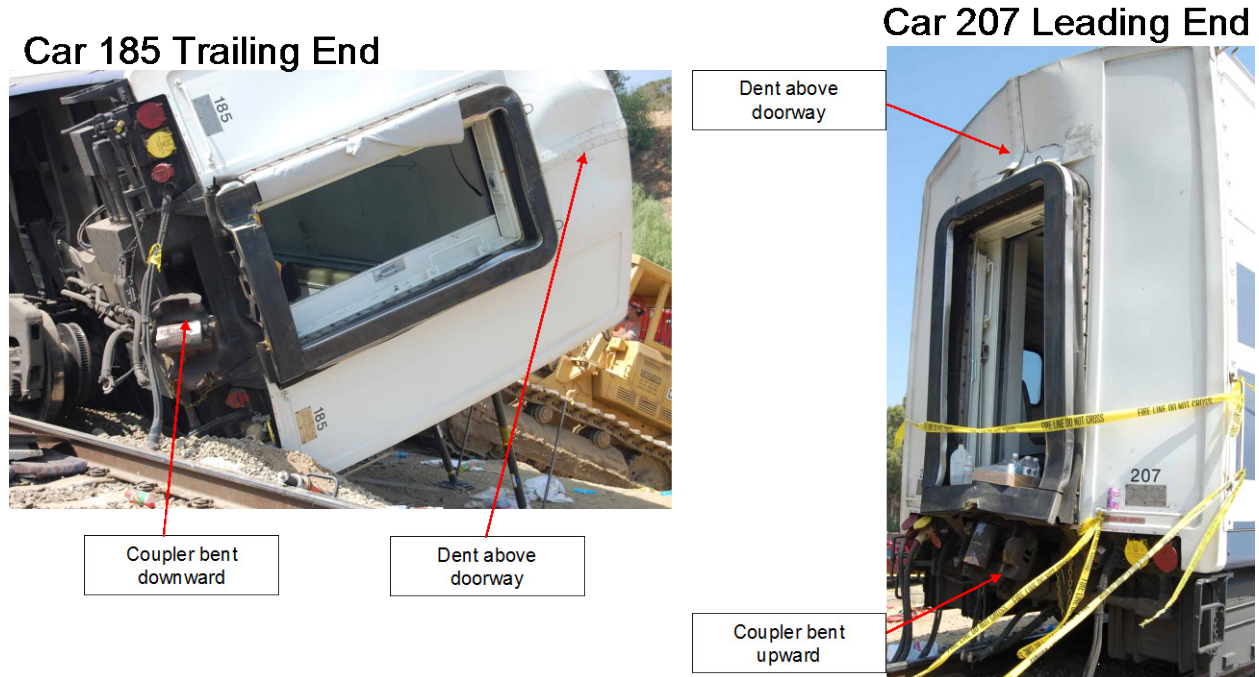
Figure A.1-6. Trailing End of First Passenger Car and Leading End of Second Passenger Car

The trailing end of Car #185 lifts upward relative to Car #207. The leading end of Car #207 pitches downward.

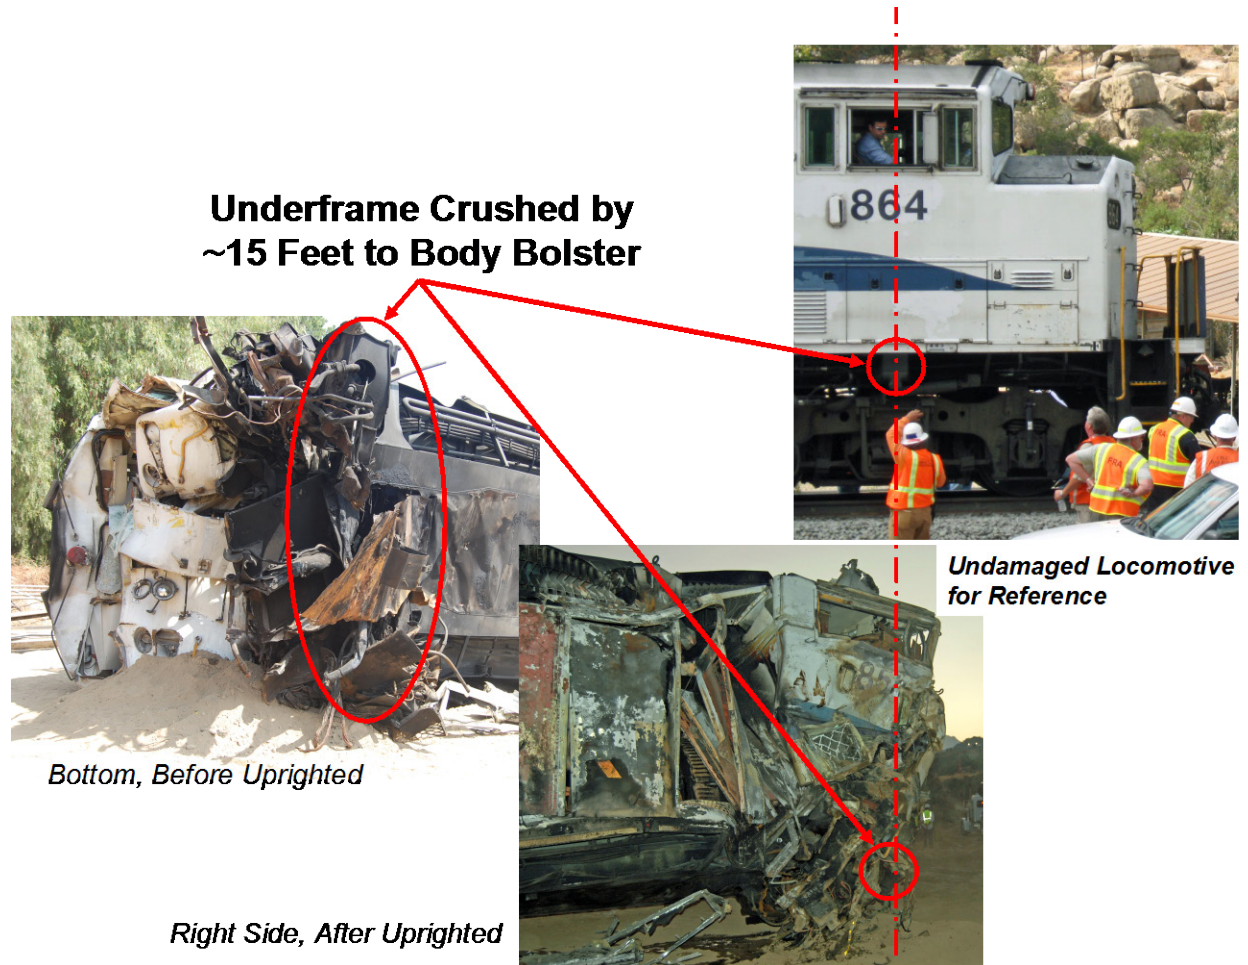
Figure A.2.1-2. Passenger Locomotive Lead End Crush

Figure A.2.1-2 shows the structural damage to the lead end of the passenger locomotive. A photograph of an undamaged locomotive is included for reference. While the side window frame is visible in the lower right photo, there is no interior cab space, as the cab has been pushed back over rotating equipment. The locomotive has been crushed approximately 15 feet, from the coupler back to the body bolster. The truck normally mounts to the frame at the body bolster; however, the attachments were destroyed in the collision. The lead truck separated from the equipment it supported, both the locomotive car and the fuel tank.

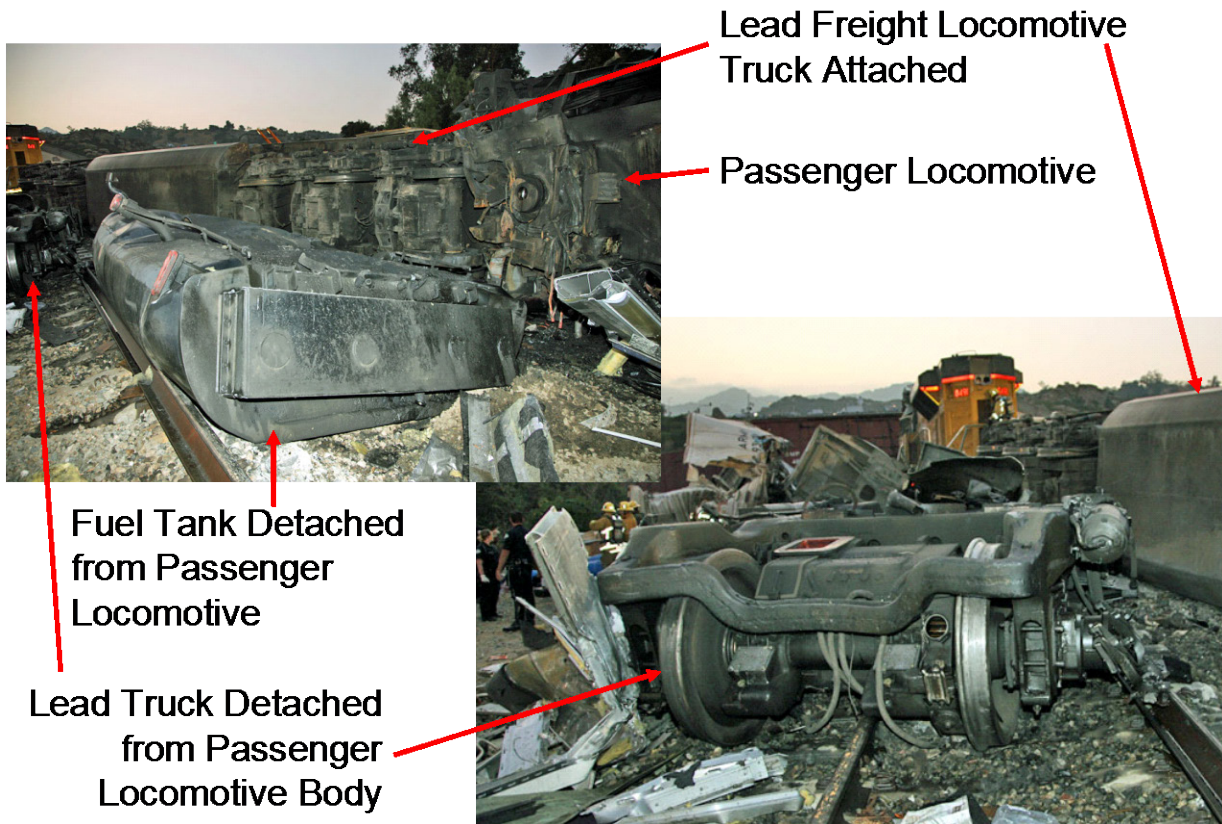
Figure A.2.1-3. Passenger Locomotive Fuel Tank and Lead Truck Separated from Locomotive

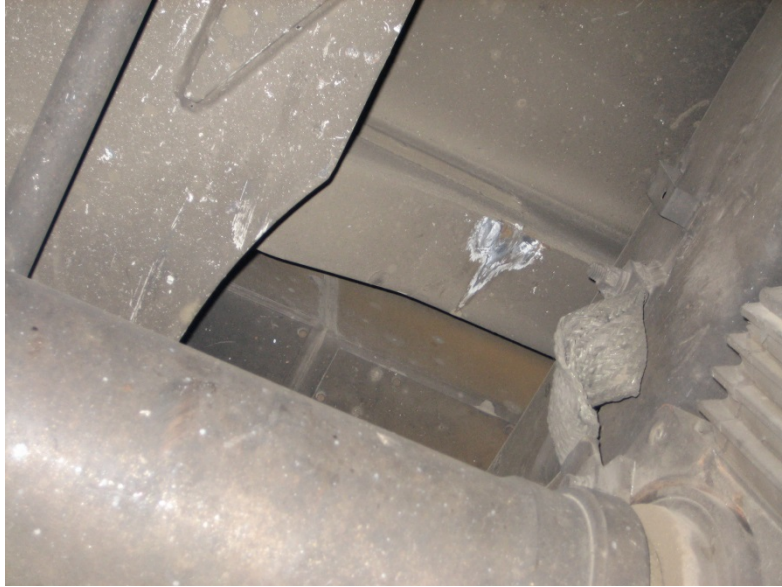
Figure A.2.1-11. Scar on Carbody Above B End Outboard Axle Bearing Housing

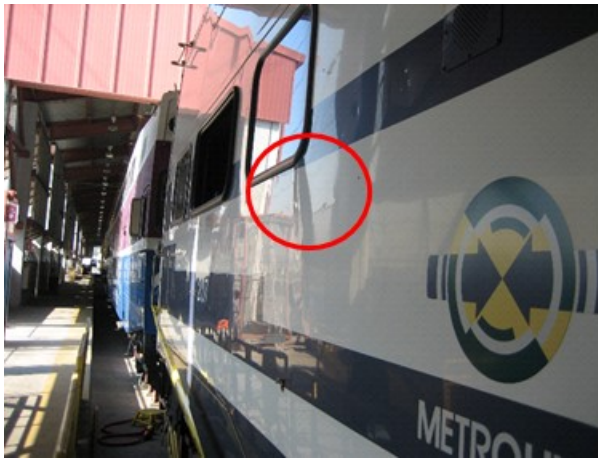
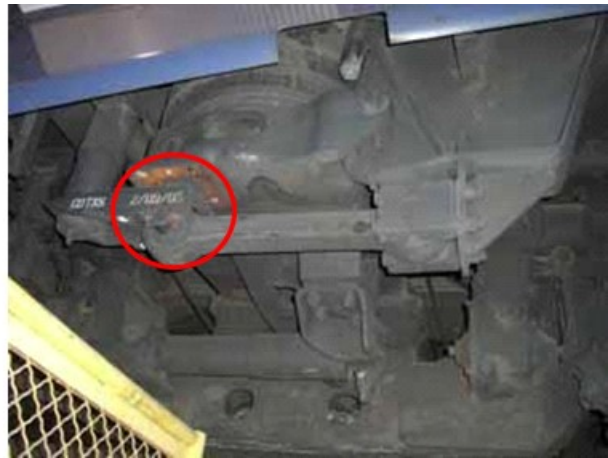
Figure A.2.1-12. Second Passenger Car Sidewall and Truck Attachment Damage

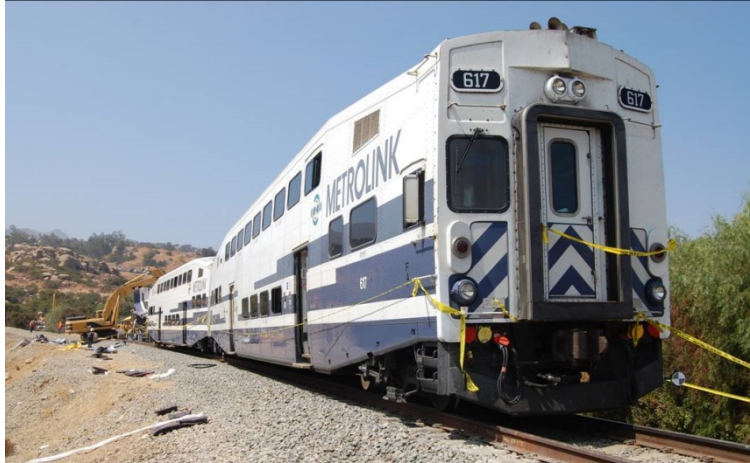
Figure A.2.1-13. Trailing Cab Car and Failed Truck Retention Mechanism

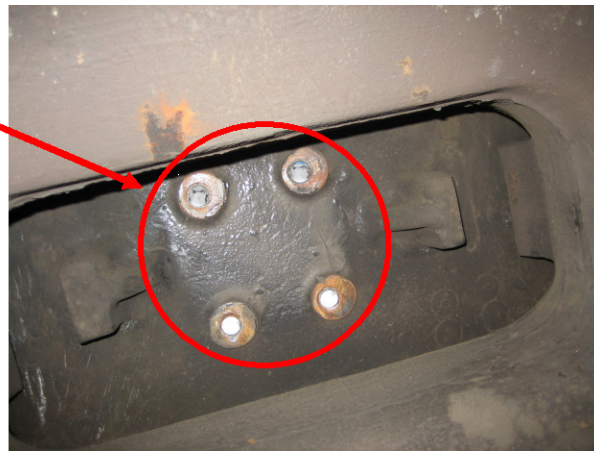
F-End Truck Failed Retention Mechanism

Figure A.2.1-14. Failed Truck Retention Mechanism on Trailing (F) End of Trailing Passenger Car

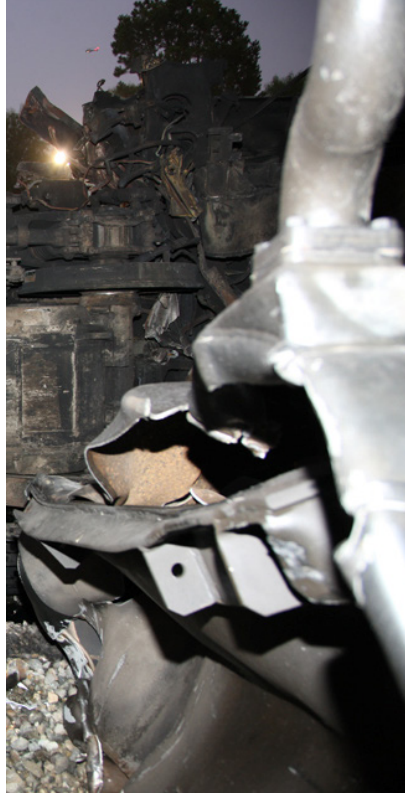
Figure A.3-4. Damage to Fuel Tank Leading End

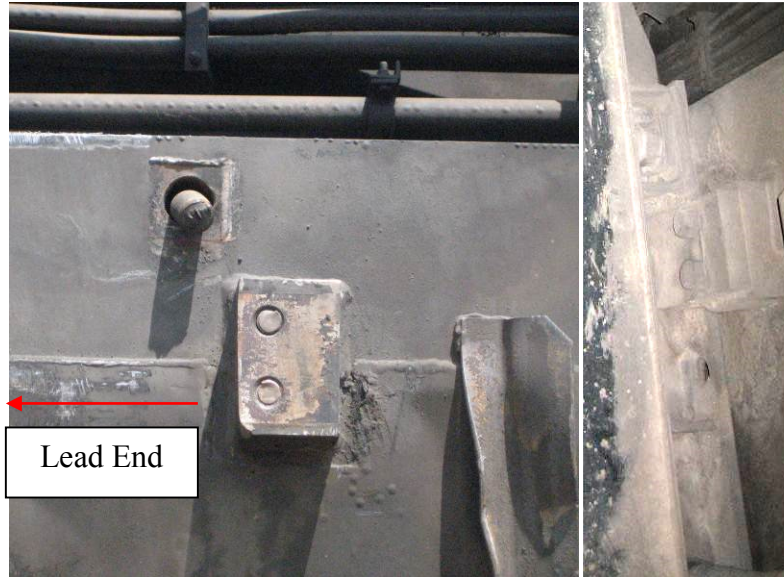
Figure A.3-7. Fractured Fuel Tank Mounting Arrangement (left), undamaged Exemplar Mounting Arrangement (right)
