EVALUATION OF FLOORPAN TEARING AND CABLE SPLICES FOR CABLE BARRIER SYSTEMS

MIDWEST ROADSIDE SAFETY FACILITY

MwRSF Research Report No. TRP-03-324-17

May 16, 2017

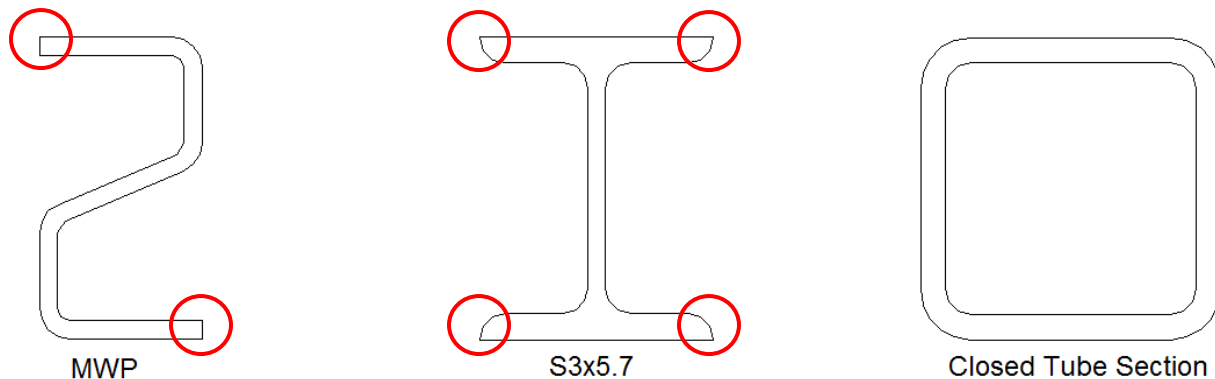
Figure 2. Post Shape Free Edges

The presence of free edges within the post's cross-section amplifies the effect of this restoration force. Free edges are characterized as areas of the post's cross section where an end of a flange, or another thin element, is exposed within the cross section. The location of free edges on common post shapes are shown in Figure 2. The thin elements and small contact areas of these free edges result in higher stress concentrations during impact events. Thus, under equivalent restoration forces, posts with free edges will impart higher stresses to the vehicle's floorpan than posts with continuous faces or closed cross sections.

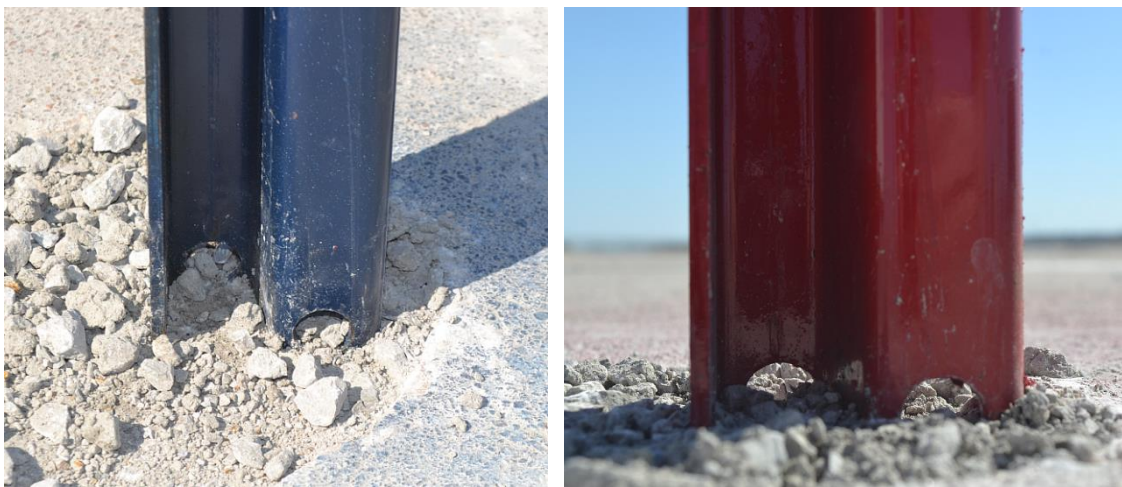
Figure 31. MWP with ¾-in. (19-mm) Diameter Weakening Holes

Test no. MWFP-3 was conducted on the modified MWP with ¾-in. (19-mm) diameter weakening holes in the weak-axis flanges at groundline, as shown in **Error! Reference source not found.** The posts were installed in 8-in. (203-mm) diameter concrete sleeves with a 0-degree orientation angle, thus creating an impact about the post’s weak-axis of bending. During the test, the bogie impacted the first post at a speed of 26.8 mph (43.1 km/h). Upon impact, a plastic hinge formed in the post at the groundline, and the post bent over until the bogie overrode it. As the crossbeams passed over the post, elastic restoration caused the top of the post to rebound upward and contact the simulated floorpan. The first post impacted the front and rear bays of the simulated floorpan 0.156 seconds and 0.286 seconds after impact, respectively. The bogie impacted the second post at 0.212 seconds and caused similar deformation and spring-back characteristics as observed in the first post. The second post impacted the front and rear bays of the simulated floorpans at 0.376 seconds and 0.504 seconds, respectively.

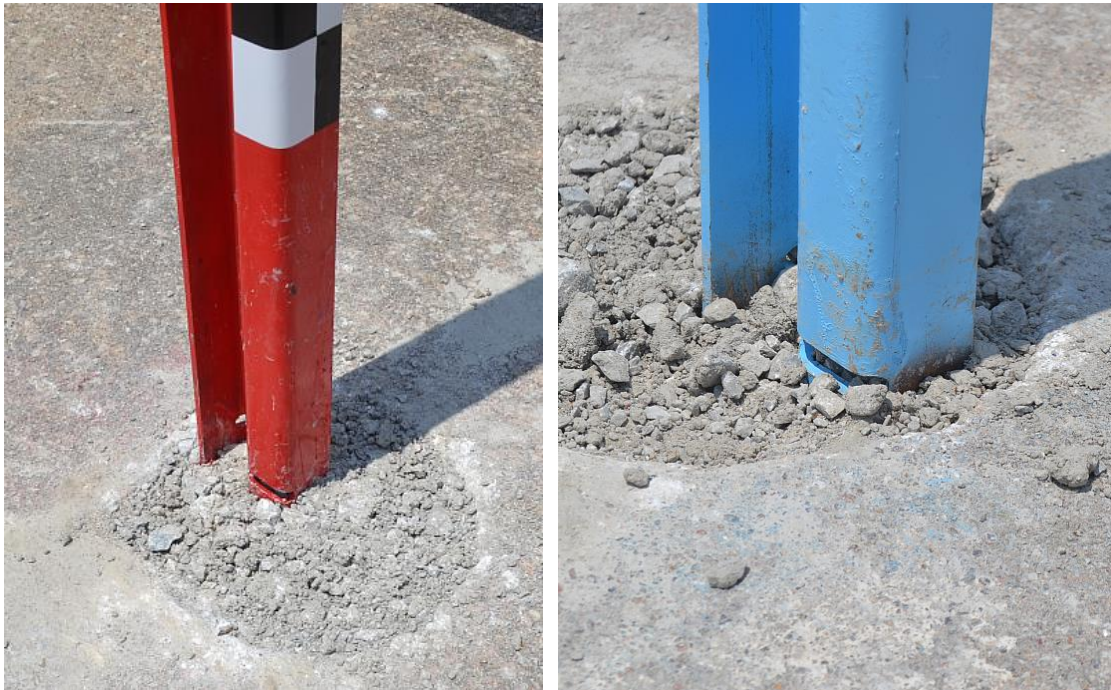
Figure 54. MWP with $\frac{3}{8}$ -in. x $1\frac{1}{8}$ -in. (10-mm x 29-mm) Weakening Slots

Test no. MWPF-12 was conducted on the MWP with $\frac{3}{8}$ -in. x $1\frac{1}{8}$ -in. (10-mm x 29-mm) weakening slots in the weak-axis flanges at the groundline, as shown in Figure 54. The posts were installed in 8-in. (203-mm) diameter concrete sleeves with a 0-degree orientation angle, thus creating an impact about the post's weak-axis of bending. During the test, the bogie impacted the first post at a speed of 24.4 mph (39.3 km/h). Upon impact, the post began to bend and tear near groundline, and the post bent over until the bogie overrode it. Eventually, the top of the post tore away from the bottom. Due to rupturing, the post never contacted the simulated floorpan. The bogie impacted the second post at 0.232 seconds and caused similar behavior as observed in the first post.

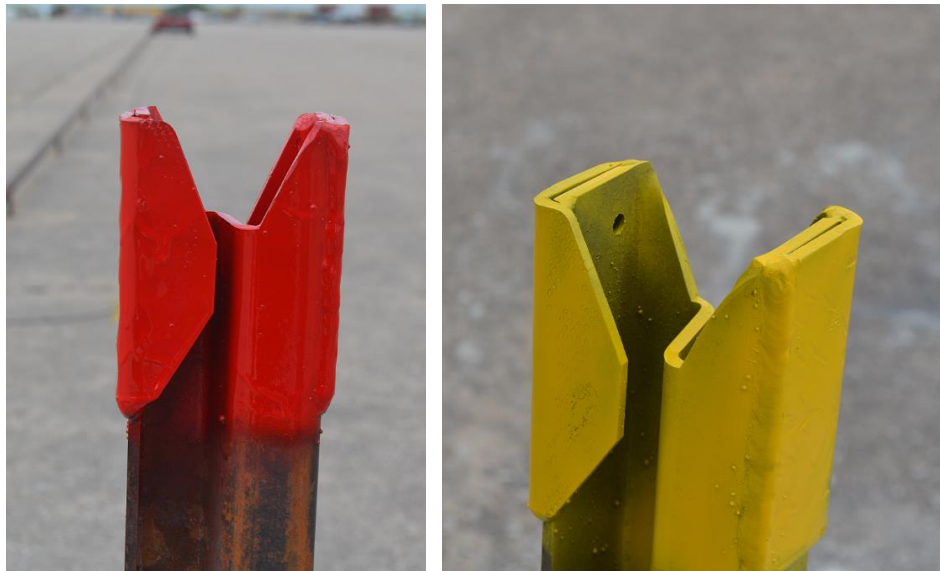
Figure 57. MWPs with Steel Plate Edge Protectors

Test no. MWPF-13 was conducted on the MWP with steel plate edge protectors welded to the top of the posts, as shown in Figure 57. The posts were installed in 8-in. (203-mm) diameter concrete sleeves with a 0-degree orientation angle, thus creating an impact about the post's weak-axis of bending. During the test, the bogie impacted the first post at a speed of 24.2 mph (38.9 km/h). Upon impact, a plastic hinge formed in the post near the groundline, and the post bent over until the bogie overrode it. As the crossbeams passed over the post, elastic restoration caused the top of the post to rebound upward and impact the simulated floorpan. The first post impacted the front and rear bays of the simulated floorpan at 0.170 seconds and 0.322 seconds after impact, respectively. The bogie impacted the second post at 0.238 seconds and caused similar deformation and spring-back characteristics as observed in the first post. The second post impacted the front and rear bays of the simulated floorpan at 0.426 seconds and 0.588 seconds, respectively.

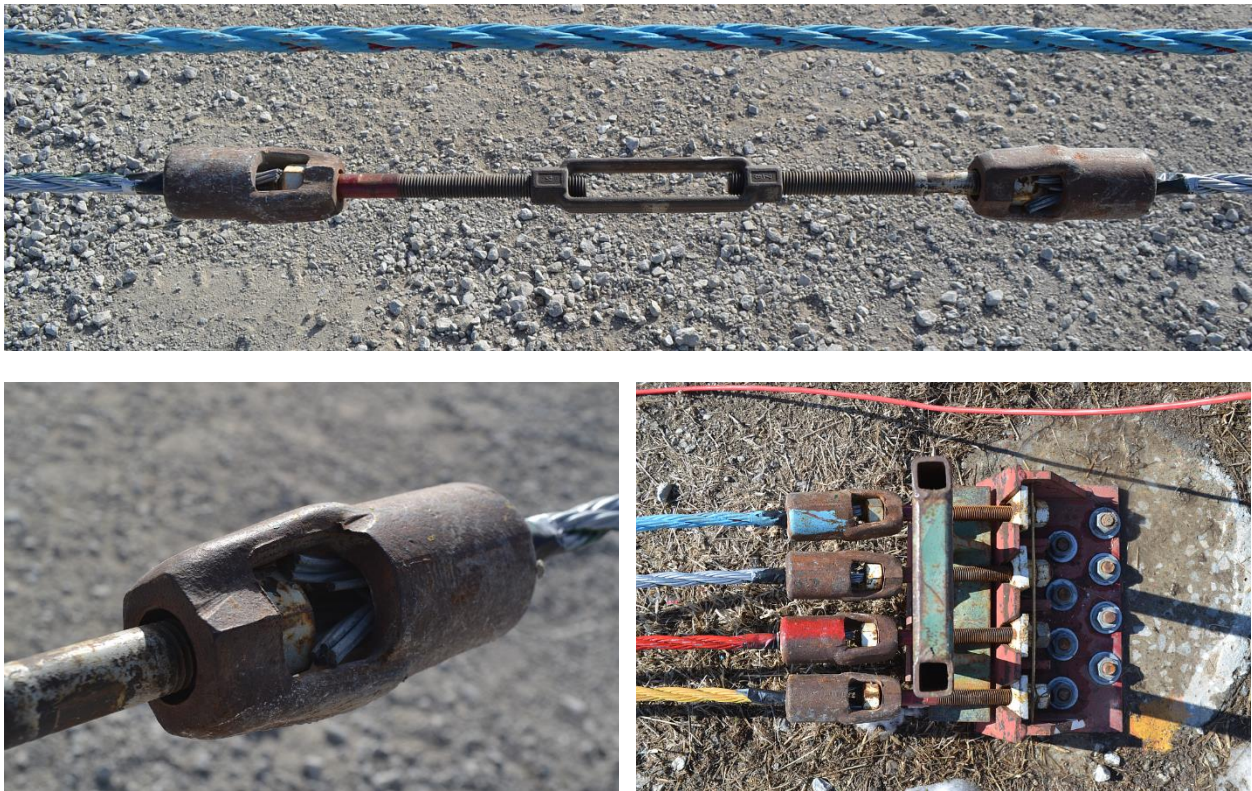
Figure 95. Bennett Bolt Works, Inc. Cable Coupler – Model No. CGBBHT

All of MwRSF's full-scale crash test installations for the prototype, high-tension, cable median barrier have utilized a cable coupler manufactured by Bennett Bolt Works, Inc., model no. CGBBHT. The cable is inserted through one end of the coupler, and a malleable iron wedge is placed between the three strands of the cable to prevent it from pulling out of the coupler. A threaded rod and nut is used on the opposite side of the coupler to complete the assembly. These couplers have been used on both sides of turnbuckle splices as well as for configuring end fittings within the cable anchorage system, as shown in Figure 95.

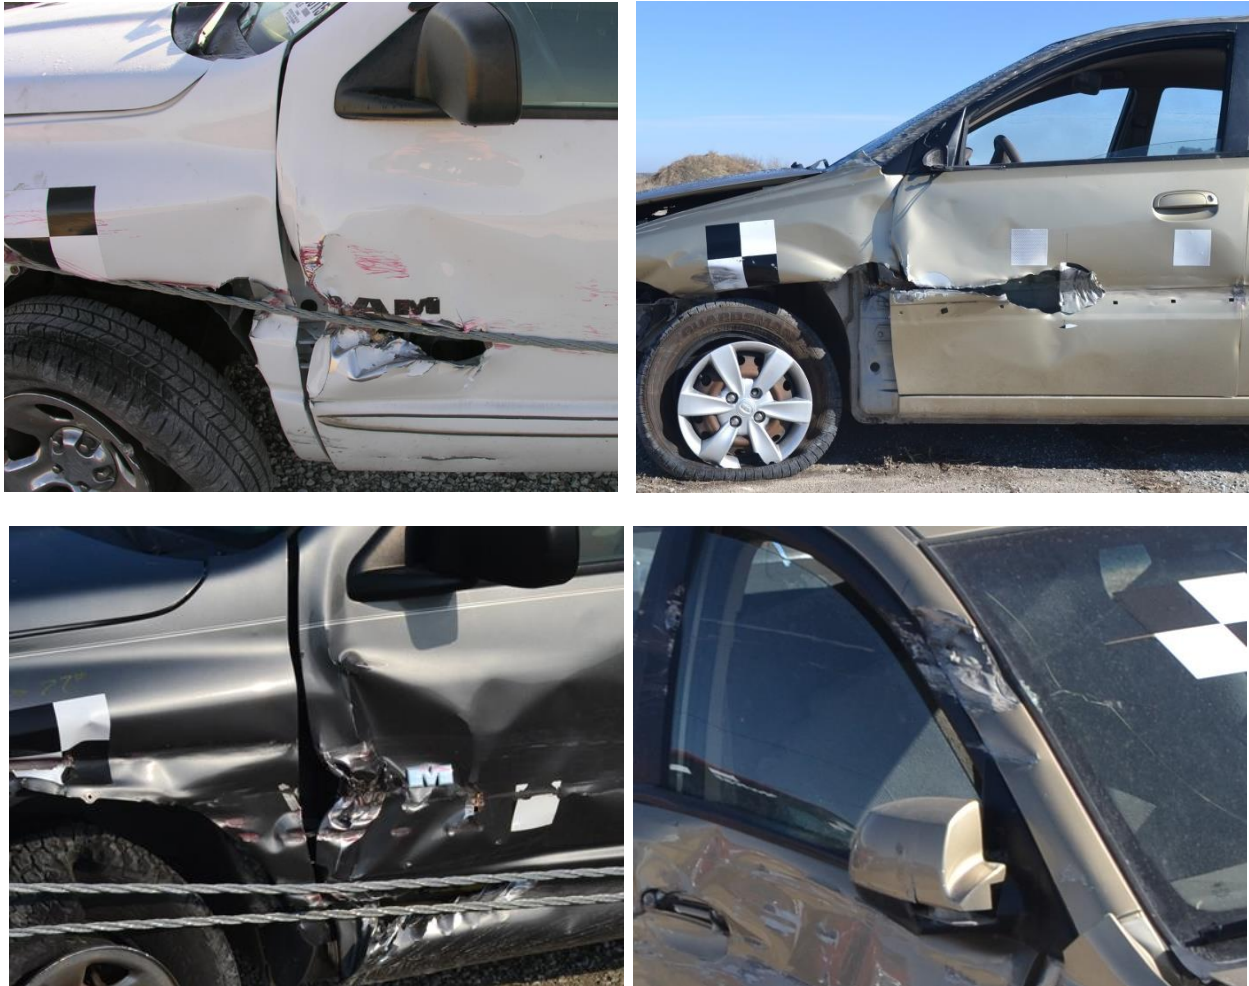
Figure 96: Vehicle Door and A-Pillar Damage from Splice Snagging

During full-scale crash testing, the cable splices located within the impact region of the barrier system have caused significant exterior sheet metal damage to the impacting vehicles. Due to the relatively large cross section of the coupler as compared to the cable, the couplers have snagged on vehicle doors and A-pillars, thus causing crushing and sheet metal tearing. Examples of this damage were observed in full-scale crash tests of small cars, sedans, and pickup trucks, as shown in Figure 96. The interaction between the vehicle and the couplers has not resulted in failure of the MASH safety performance criteria, but the undesired snagging and tearing did reveal some risk of eventual penetration into the occupant compartment. Therefore, an investigation was launched to investigate alternative cable splices that may mitigate snagging and decrease sheet metal damage.

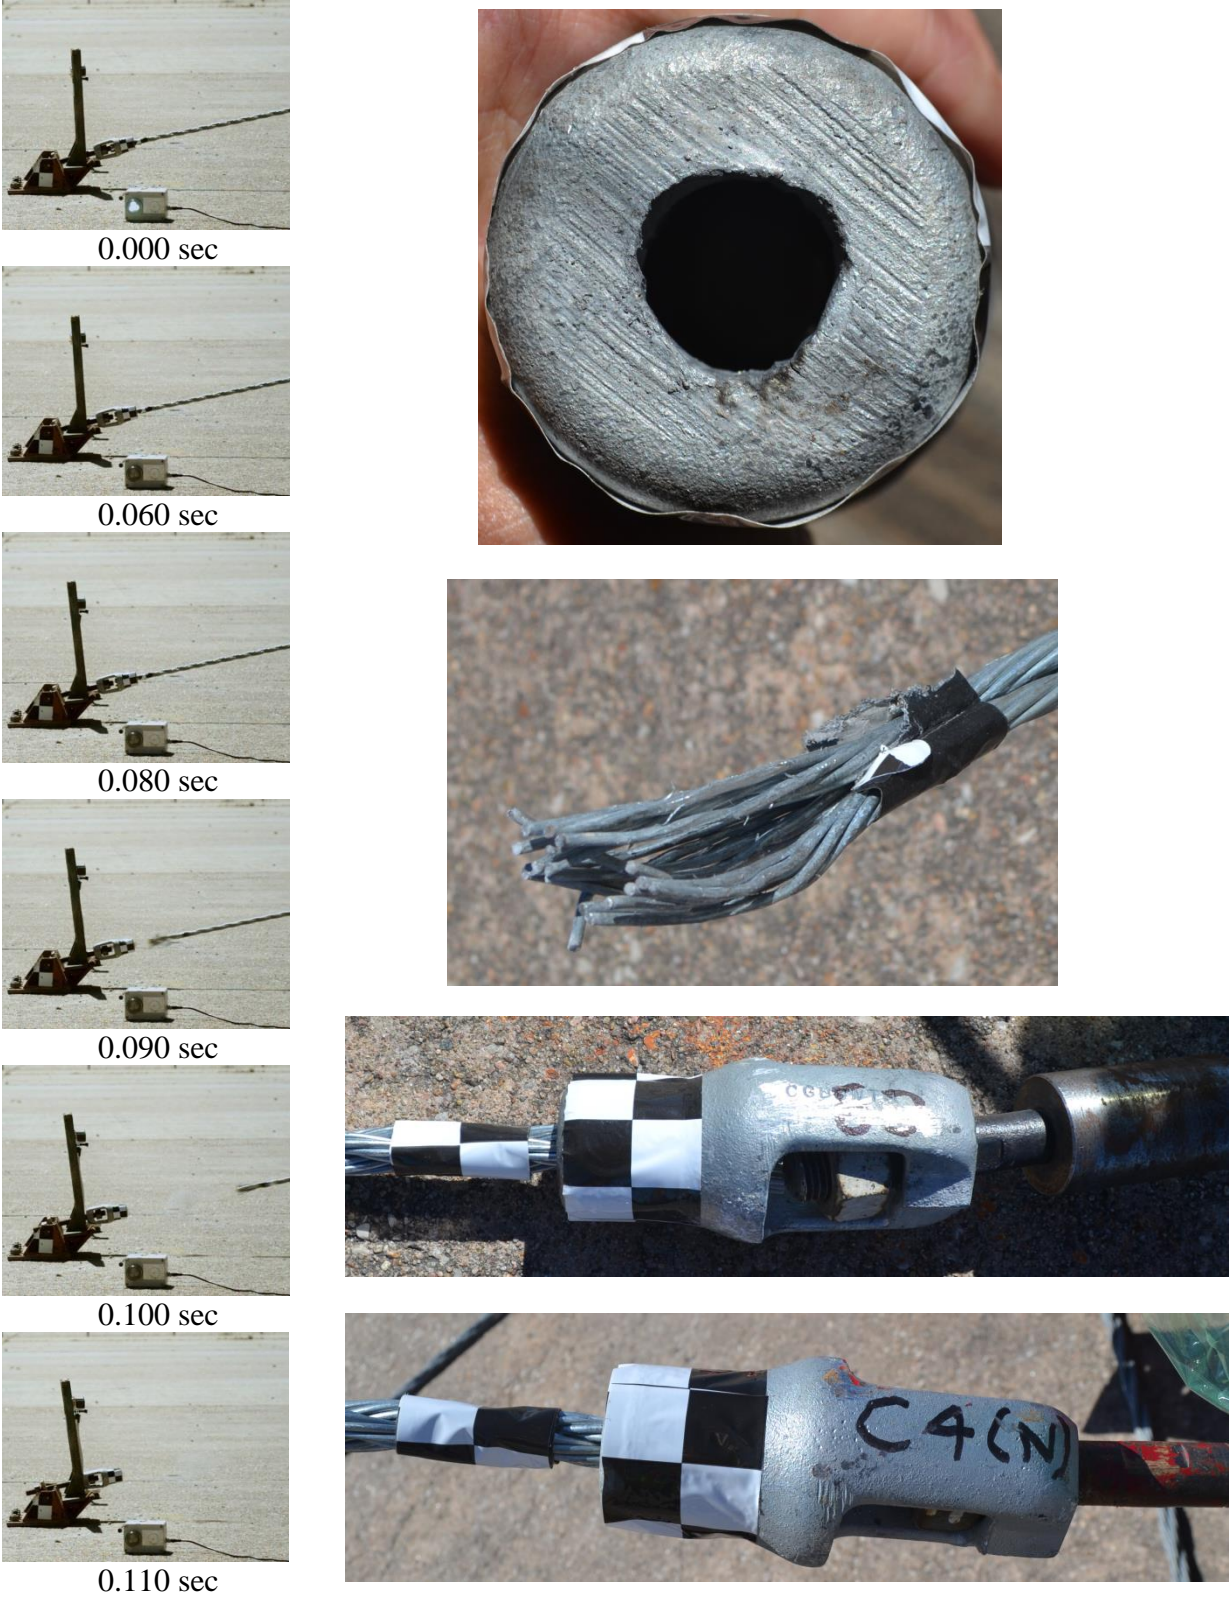
Figure 106. Time-Sequential and Post-Test Photographs, Test No. BBNC-1

The inside of the failed coupler contained striations, formed from the wire rope as it pulled through the opening, but the coupler was otherwise undamaged. The upstream end of the cable that pulled through the coupler was deformed and frayed, and the wedge was no longer entwined within the wire strands. The cable ends pulled $\frac{5}{8}$ in. (16 mm) out of the other three couplers.

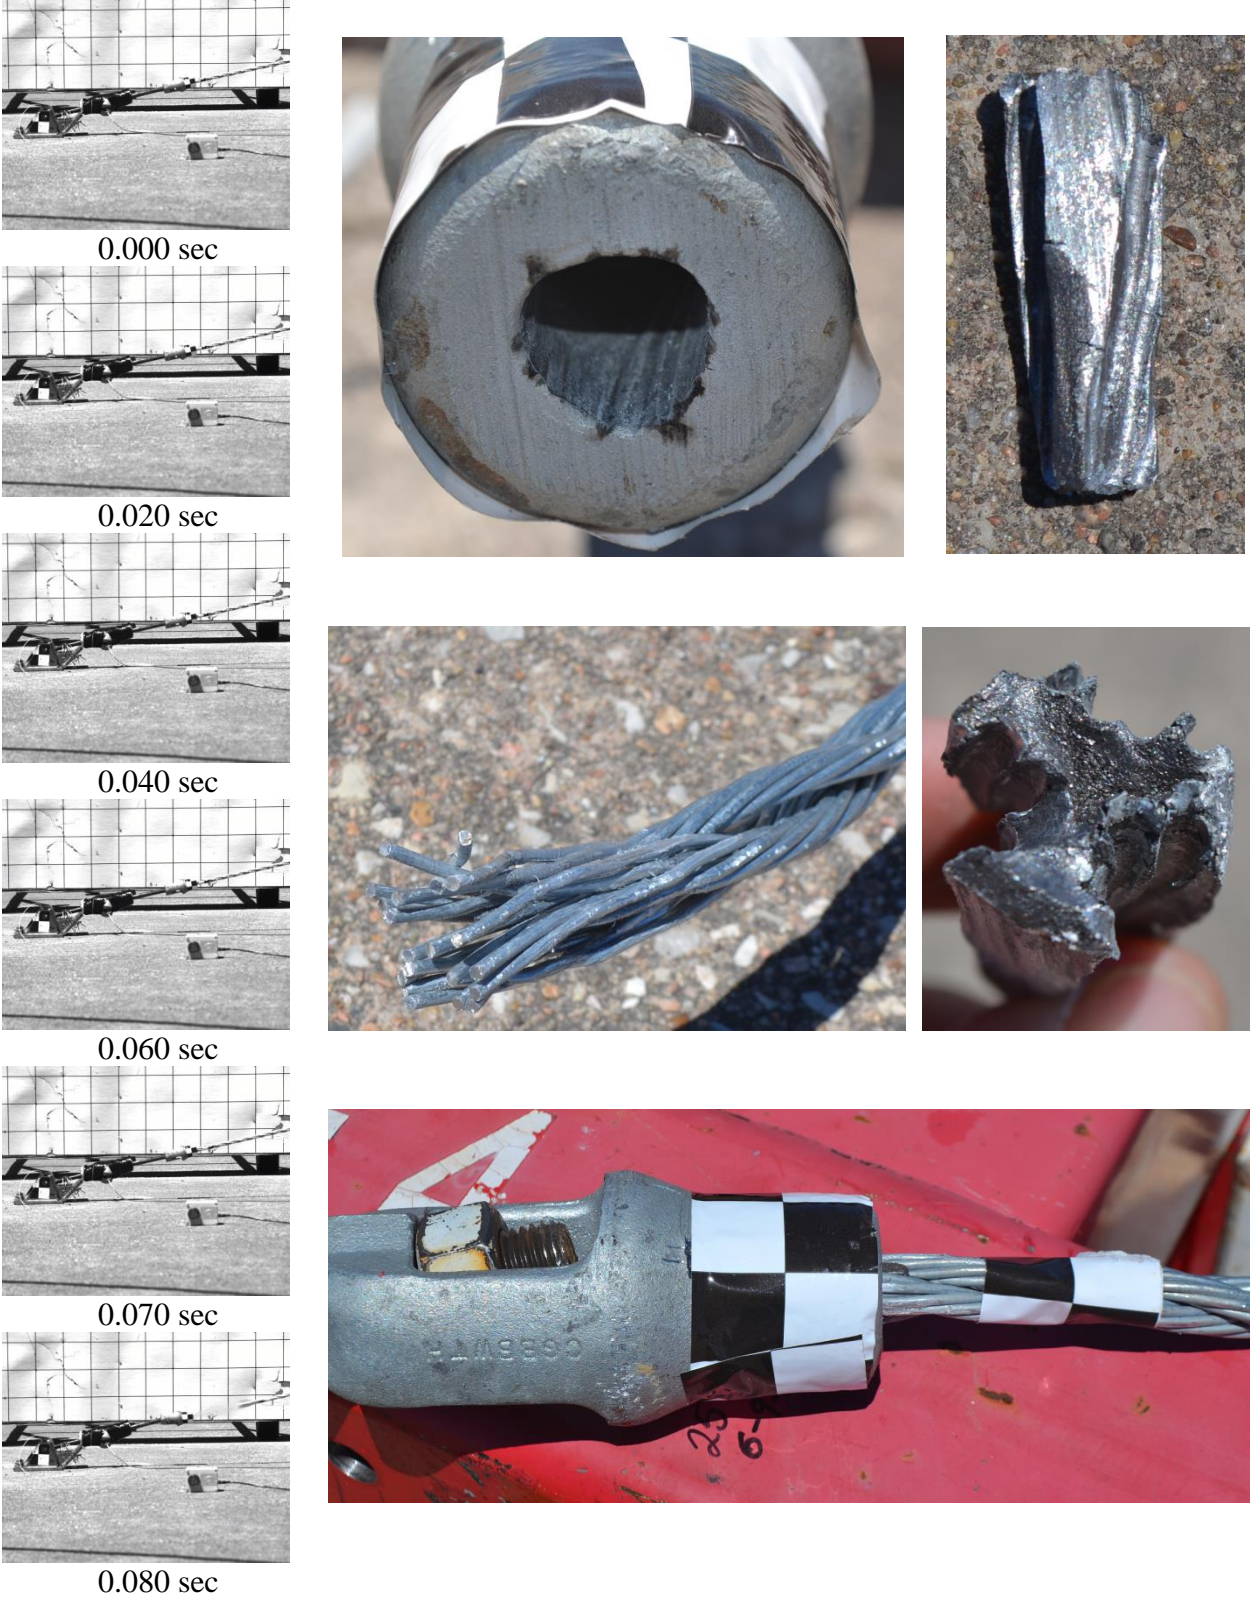
Figure 107. Time-Sequential and Post-Test Photographs, Test No. BBNC-2

The inside of the failed coupler had striations formed from the wire rope as it pulled through the opening, but the coupler was otherwise undamaged. The upstream end of the cable that pulled through the coupler was deformed and frayed, and the wedge was no longer entwined within the wire strands. The wedge was deformed and contained more pronounced striations than the coupler. The cable end attached to the bogie vehicle pulled $1\frac{1}{8}$ in. (29 mm) out of the coupler, and the wedge pulled $\frac{1}{4}$ in. (6 mm) out of the coupler.
