Final Report

Contractor's Name: Integran Technologies USA, Inc.

SBIR Topic Number, Title: 081-PH1, Pipeline Safety: Development of Tools for In-Field Pipeline Repairs

Project Title: Structural Repair of Steel Piping by In-Situ Sleeving of Nanostructured Materials.

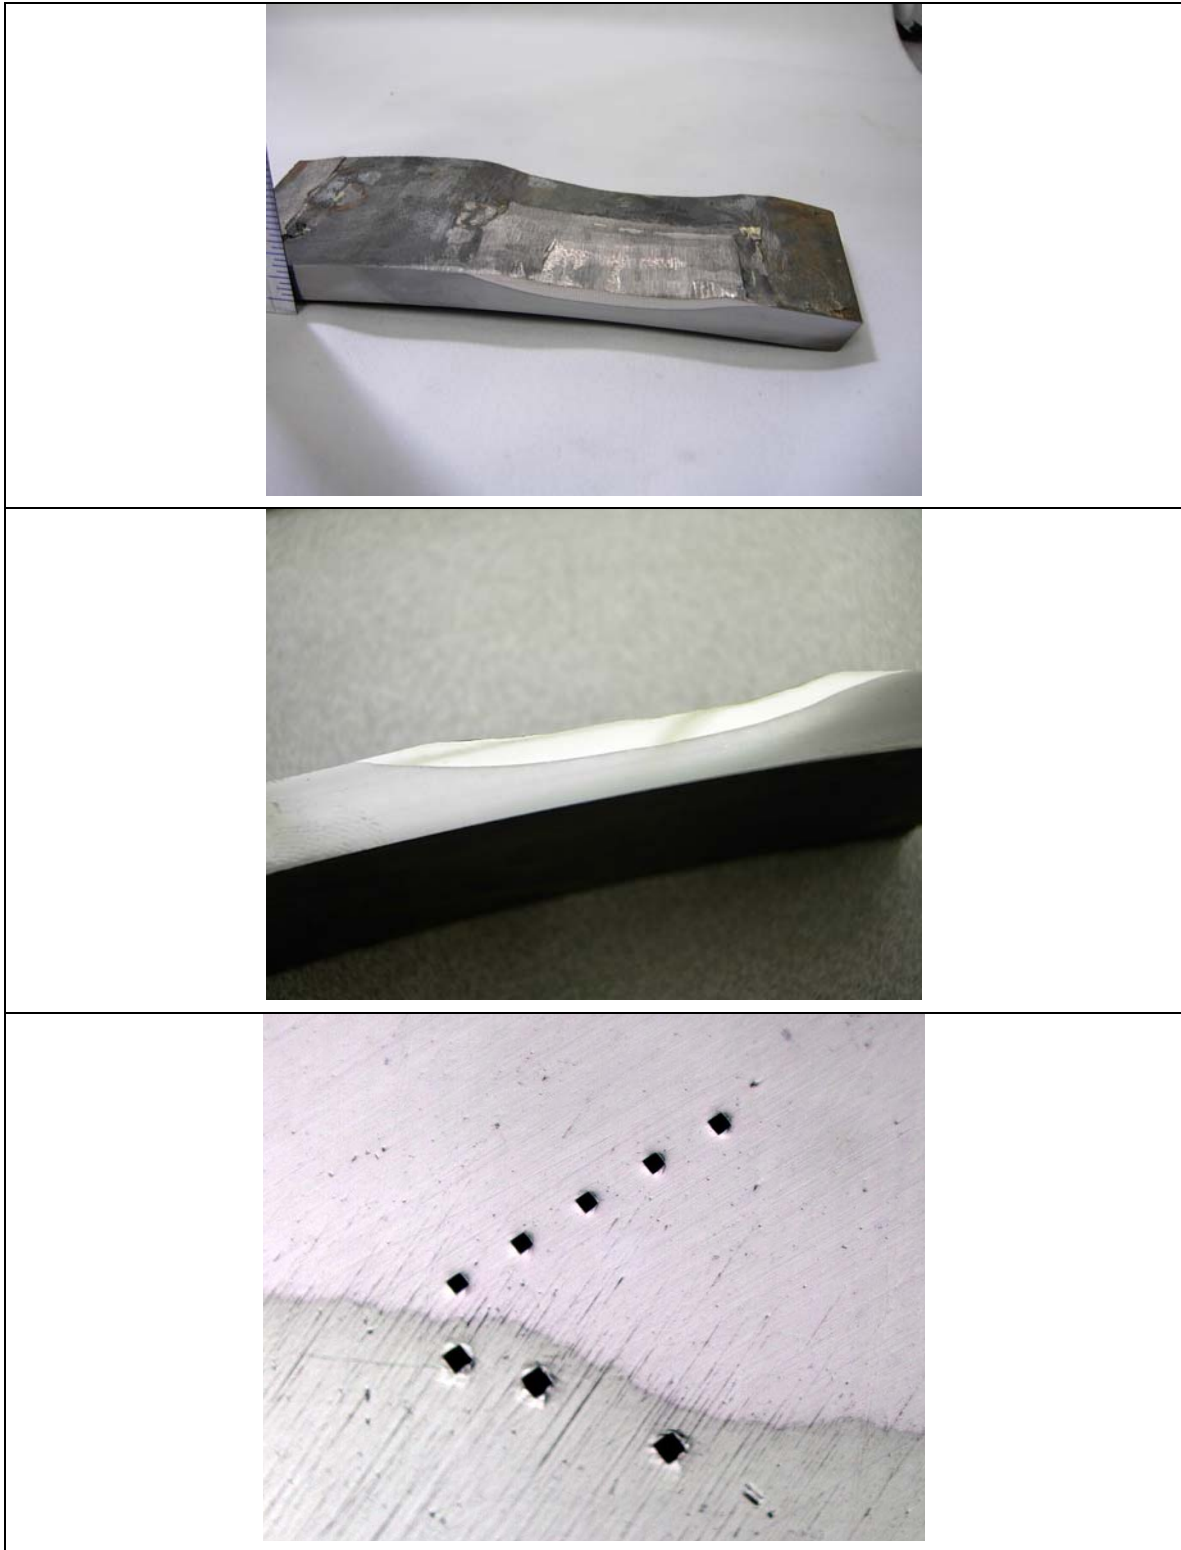
A series of practical nanocrystalline metal repair development trials were undertaken using this geometry and a typical example is shown in Figure 1(a) below. Here a 7" x 3" section of pipe has been gouged and subsequently filled in with a 3 mm-thick highly adherent patch of nanometal. A high magnification image of the same sample is shown in Figure 1(b) and Vickers microhardness indentations made on both the steel (bottom) and nanometal patch (top) are shown in Figure 1(c). The relative size of the indentations (made under the same load) is roughly indicative of 2.4 times increase in strength of the nanometal over the X65 steel. The X65 steel microhardness value was ~165 VHN ($\sigma_{UTS} = 77\text{ksi}/530\text{MPa}$) while the nanocrystalline Ni microhardness value was 380-410 VHN ($\sigma_{UTS} = 184\text{ksi}/1270\text{MPa}$). Samples of this geometry are currently being evaluated for Task 2 Mechanical Testing of the project.

Figure 1 – (a) artificially degraded (gouged) X65 pipeline steel section filled with a 3mm-thick nanometal patch; (b) higher magnification cross-sectional image; (c) microhardness indentations on the steel (bottom, 165 VHN) and nanometal (top, 380-410 VHN) indicating that the nanometal is roughly 2.4x stronger than the pipeline steel substrate.

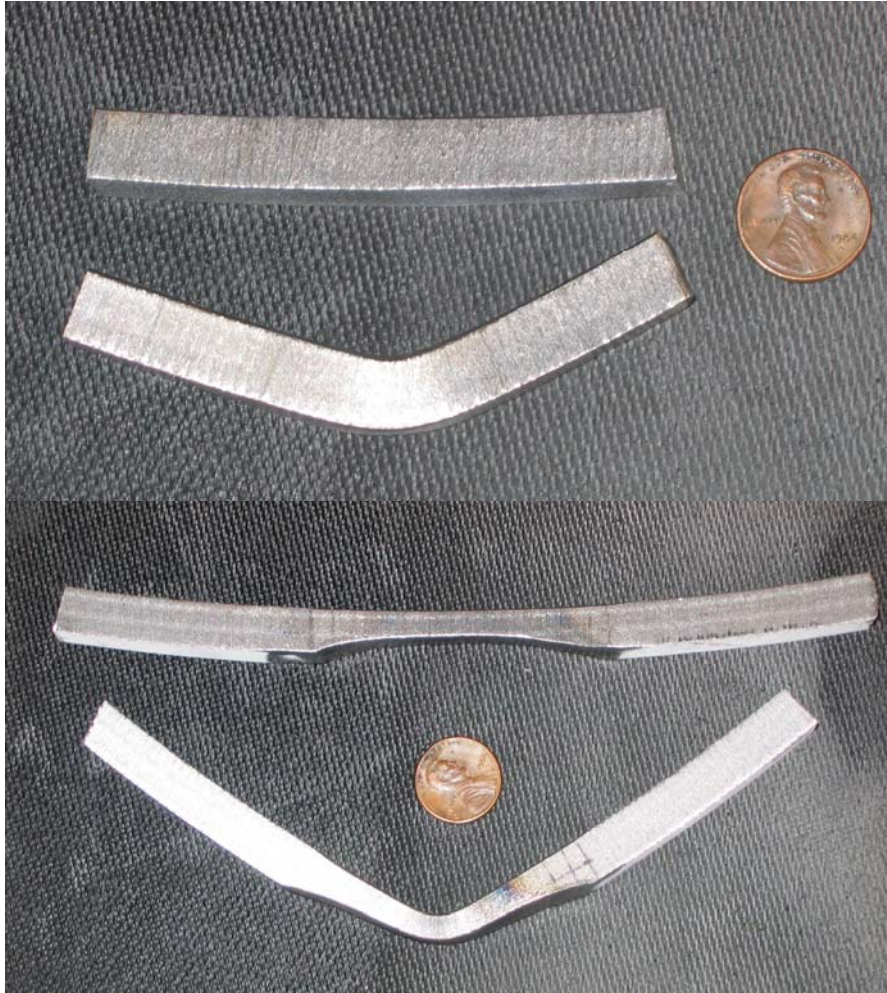
1. As-received X65 steel (full 3/8" wall thickness - see Figure 3 (top))
2. As-received X65 steel with ~40% wall loss (see Figure 3 (bottom(a) 3-point bend test apparatus (image from: www.testresources.com);))
3. As-received X65 steel with ~40% wall loss + Nanometal patch

Figure 3 –(top) “as-received” X65 steel strip sample before and after bending; (bottom) “as-received+40% wall loss” X65 steel strip sample before and after bending.
