# Forensic Study of Early Failures with Unbonded Concrete Overlays

*Prepared by:*  
Shad Sargand, Roger Green, Junqing Zhu, and Issam Khoury

*Prepared for:*  
The Ohio Department of Transportation,  
Office of Statewide Planning & Research

*November 2017*  
*Final Report*

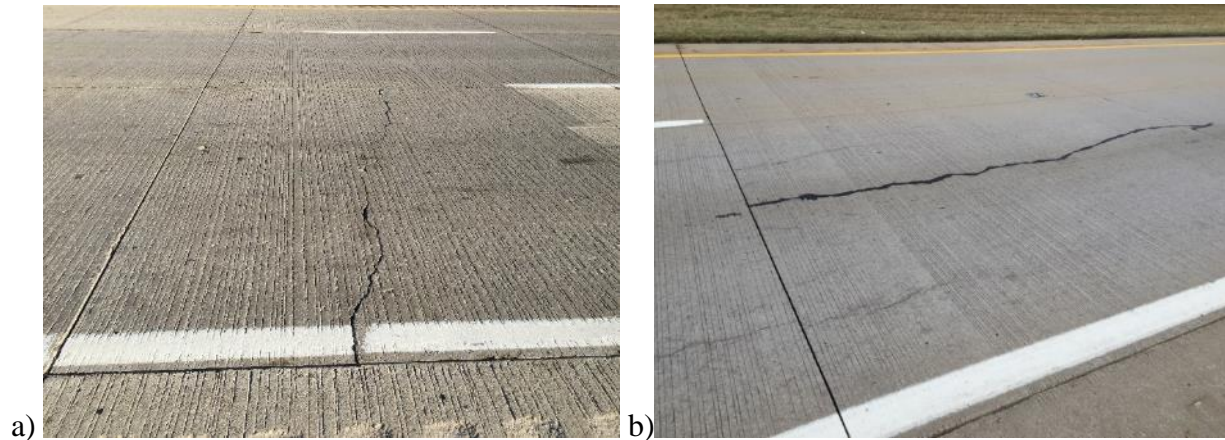
had cracks (the orientation of cracks was not identified). Results of the initial forensic study were inconclusive. The pavement continues to deteriorate and additional repairs have been made since 2009. Figure 2a) shows transverse cracking found on MAD-70.

Project 2005-3000 overlaid an existing 9 in (230 mm) jointed, reinforced, dowelled concrete pavement on I-77 in Washington and Noble Counties (WAS/NOB-77) with an 8 in (200 mm) jointed, plain, dowelled concrete (Item 452) pavement on a 1 in (25 mm) asphalt (Item 448) bondbreaker in 2006. The ODOT PCR data indicates transverse cracks appear immediately in the southbound lanes. Longitudinal cracking appeared in the northbound lanes in 2008 and the southbound lanes in 2010. Spalling of the joints appeared in the southbound direction in 2010 and the northbound lane in 2015. In 2014, corner breaks appeared in the southbound direction and pressure damage appeared in the northbound lanes. In 2015, pumping was rated in both directions. Figure 2b) shows longitudinal cracking found on WAS/NOB-77.

**Figure 2 a) Transverse cracking on MAD-70; b) Longitudinal cracking on WAS/NOB-77**

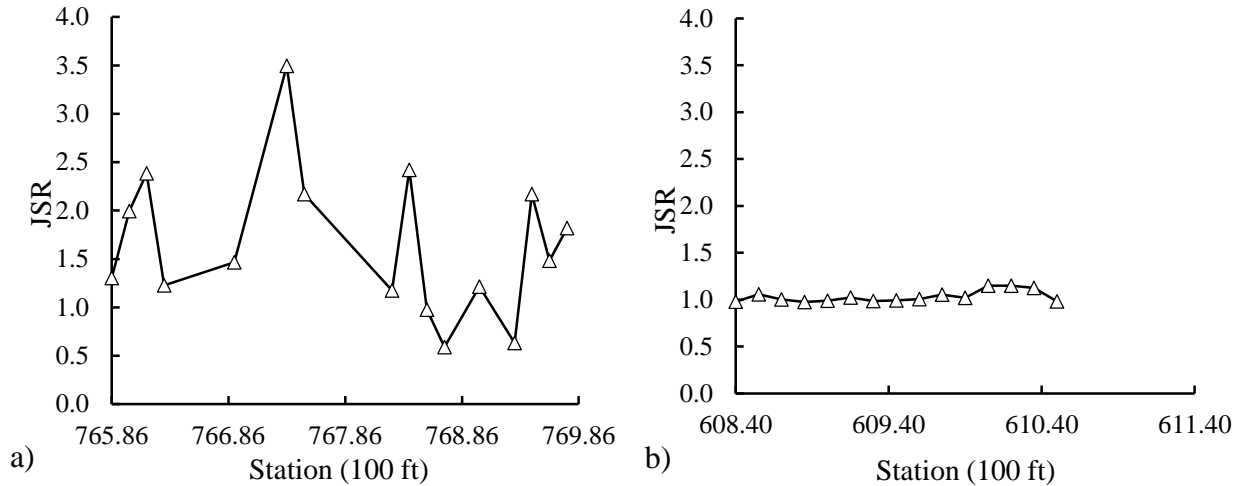
Figure 32 presents the Joint Support Ratio (JSR) results and Figure 33 presents mid-slab spreadability (SPR) results. For MAD-70 EB distressed section direction, JSR values are significantly greater than 1, which indicates joint support condition is unbalanced; the joint leave side has much greater deflection than the joint approach side. This indicates voids under joint leave side. This is consistent with distresses found on the leave side, as shown in Figure 18. Joint 6, 14, and 15 with high JSR values all had large corner break slab on the leave side. All JSR values on westbound control section of MAD-70 are close to 1, which means equal joint support condition on both sides of joints. Mid-slab SPR values are variable in the eastbound direction distressed section, while SPR values on westbound direction control section are uniform and close to 0.75. This indicates a lower level of deterioration than on the distressed section, consistent with observations of pavement condition.

**Figure 32 a) MAD-70 EB distressed section Joint Support Ratio; b) MAD-70 WB control section Joint Support Ratio (100 ft = 30.5 m).**

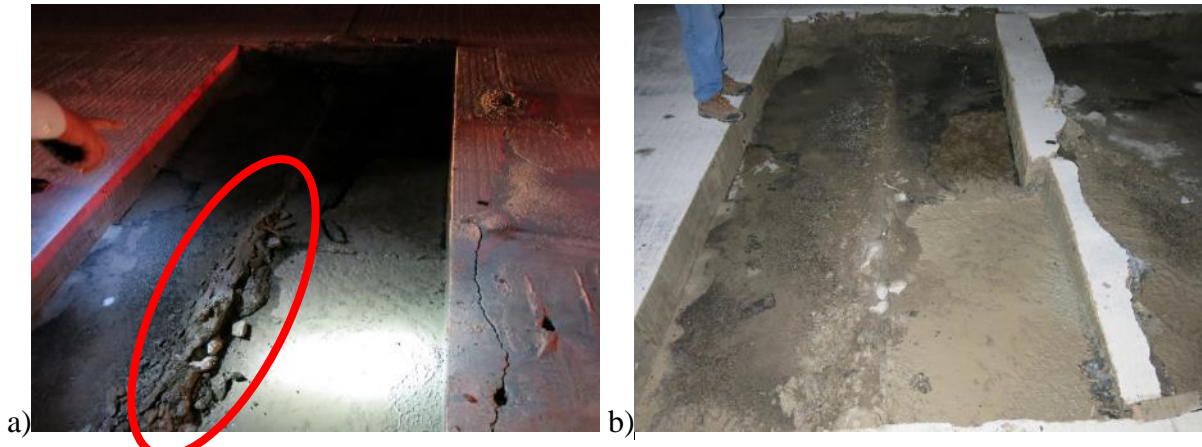
**Figure 35 a) Area under segment after removal showing tenting distress (circled); b) Same area under different lighting showing saw slurry from trapped water at lower right.**

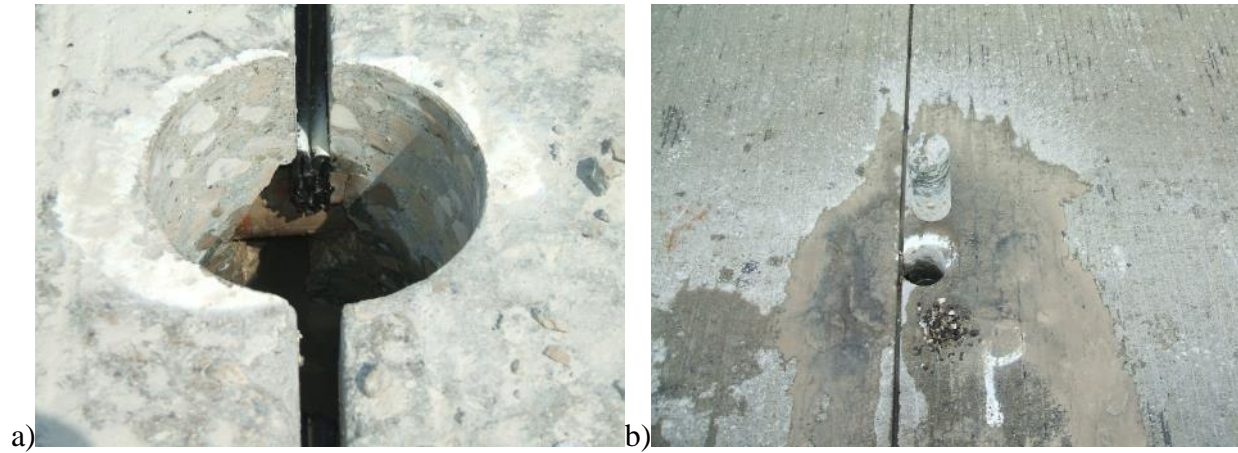
**Figure 37 a) Tenting in a failed joint; b) Deteriorated AC bondbreaker. Photos taken August 19, 2015.**

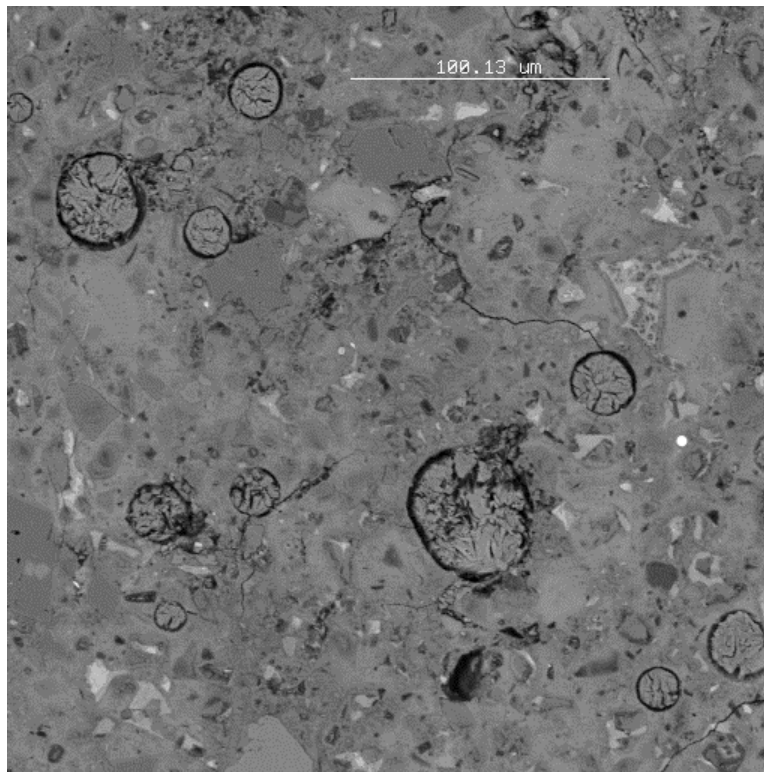
- Concrete from both directions were found to be well cured. Air void content and spacing factor were generally acceptable.
- Infilling of the air voids with Ettringite leads to a durability problem in the PCC, such as the tenting/joint deterioration found in both the eastbound and westbound direction.
- Friedel's salt deposits were frequently found in almost all tested cores. Friedel's salt comes from chlorides in dissolved road salt that fills voids. This potentially lowers the freezing temperature and leads to more freeze-thaw cycles.
- Slag cement is beneficial because it typically reduces the permeability of the concrete, eliminating or at least delaying the infilling of air voids.

**Figure 41 Ettringite infilling of air voids on Core E2 bottom sample (100.13  $\mu\text{m}$  = 3.94 mil).  
From report by Dr. Jan Olek of Purdue University.**

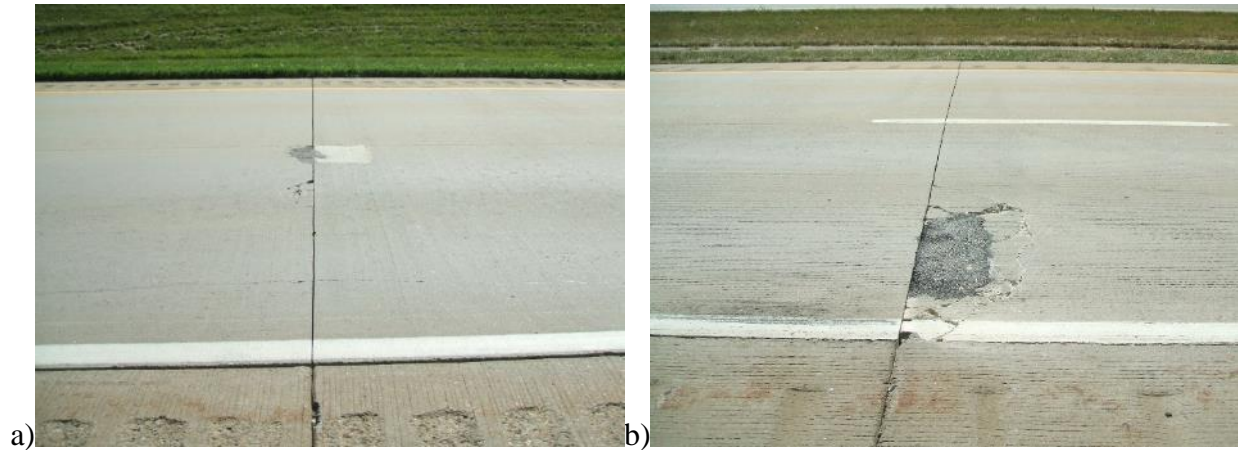
A visual assessment of the condition of WAS/NOB-77 was conducted on December 8, 2014. The dominant distress found in the UBCO was longitudinal cracking, such as the example in Figure 49a). Other distresses such as transverse crack, patching, and joint spalling, seen on Figure 49b), were also found on I-77. Figure 50 shows the bondbreaker being wetted before placing the concrete overlay, in accordance with specifications.

**Figure 49 a) longitudinal cracking and joint spalling found on WAS/NOB-77 SB; b) joint spalling found on WAS/NOB-77 NB. Photos taken December 8, 2014.**

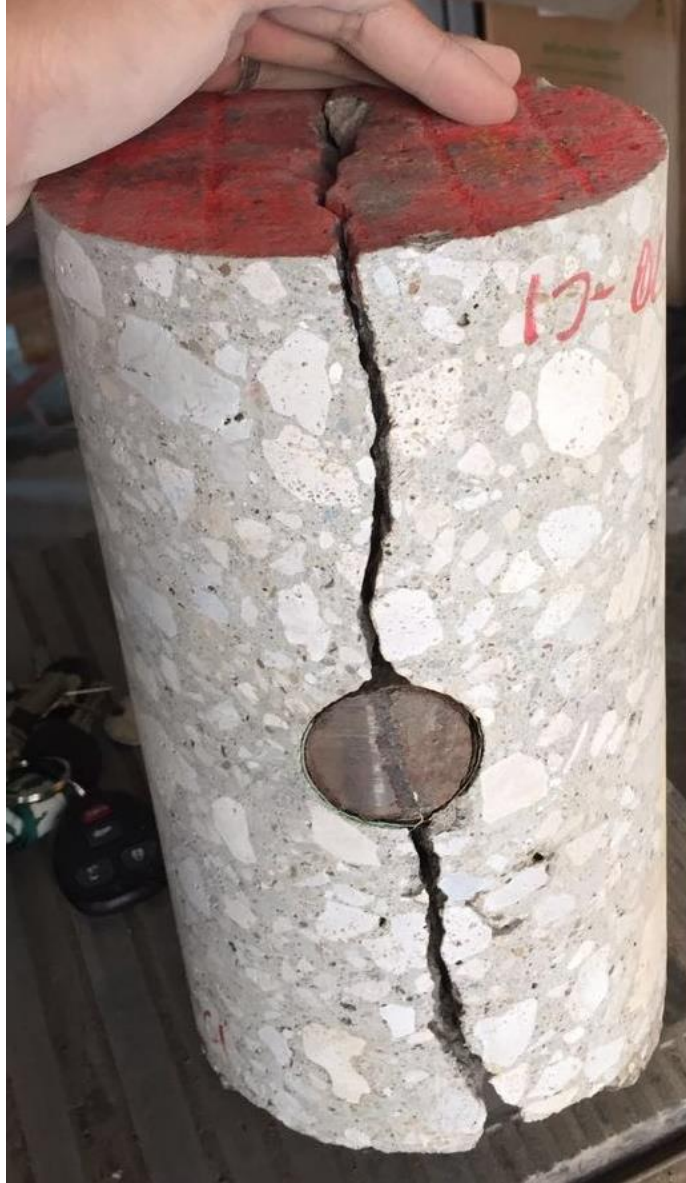
Figure 64 shows a tangential core collected at a location on WAY-30 with longitudinal cracking. The crack runs between pieces of aggregate above the dowel bar, while it runs through the aggregate below it, which is an indication that the cement was stronger below. The core is opened at the crack to show one half in Figure 65, where some entrapped air voids are visible, along with a gap above the dowel bar and some corrosion of the steel. Figure 66 shows a tangential core before cutting; note the gap visible above the dowel bar. Figure 67 shows two sliced cores with the dowel bars exposed; the bar in the half-core on the right is held in place with adhesive tape, which can also be seen in Figure 68, along with the space above the bar. Figure 69 shows the other half-core, which also has some space above the bar, but also some large entrapped air voids showing some moisture intrusion. Figure 70 shows the middle slices from two WAY-30 tangential cores, showing more evidence of entrapped air voids and smaller aggregate above the dowel bars.

**Figure 64 Tangential core collected over a dowel bar from WAY-30 at a location with a longitudinal crack. Note crack runs between aggregate above dowel bar, then runs through the aggregate underneath, indicating the concrete is stronger underneath.**

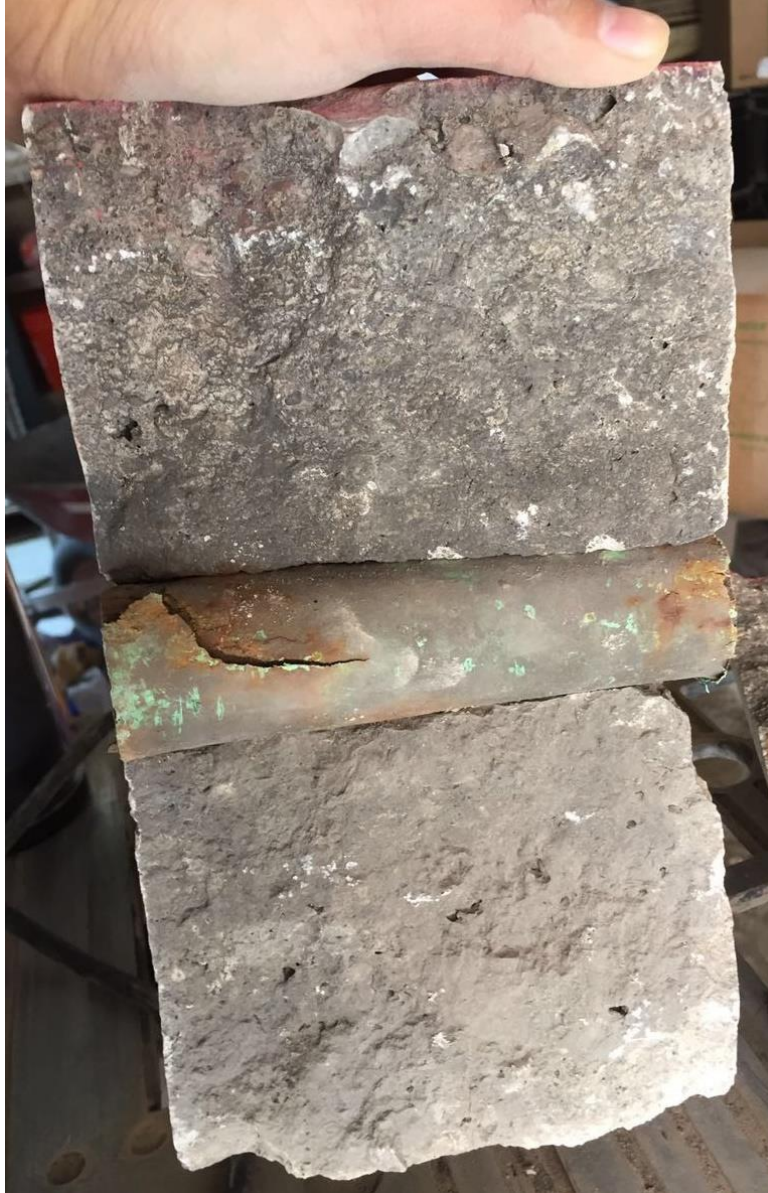
**Figure 65** Tangential core with longitudinal crack, opened to show deterioration of concrete, gap above dowel bar, and corrosion of bar.

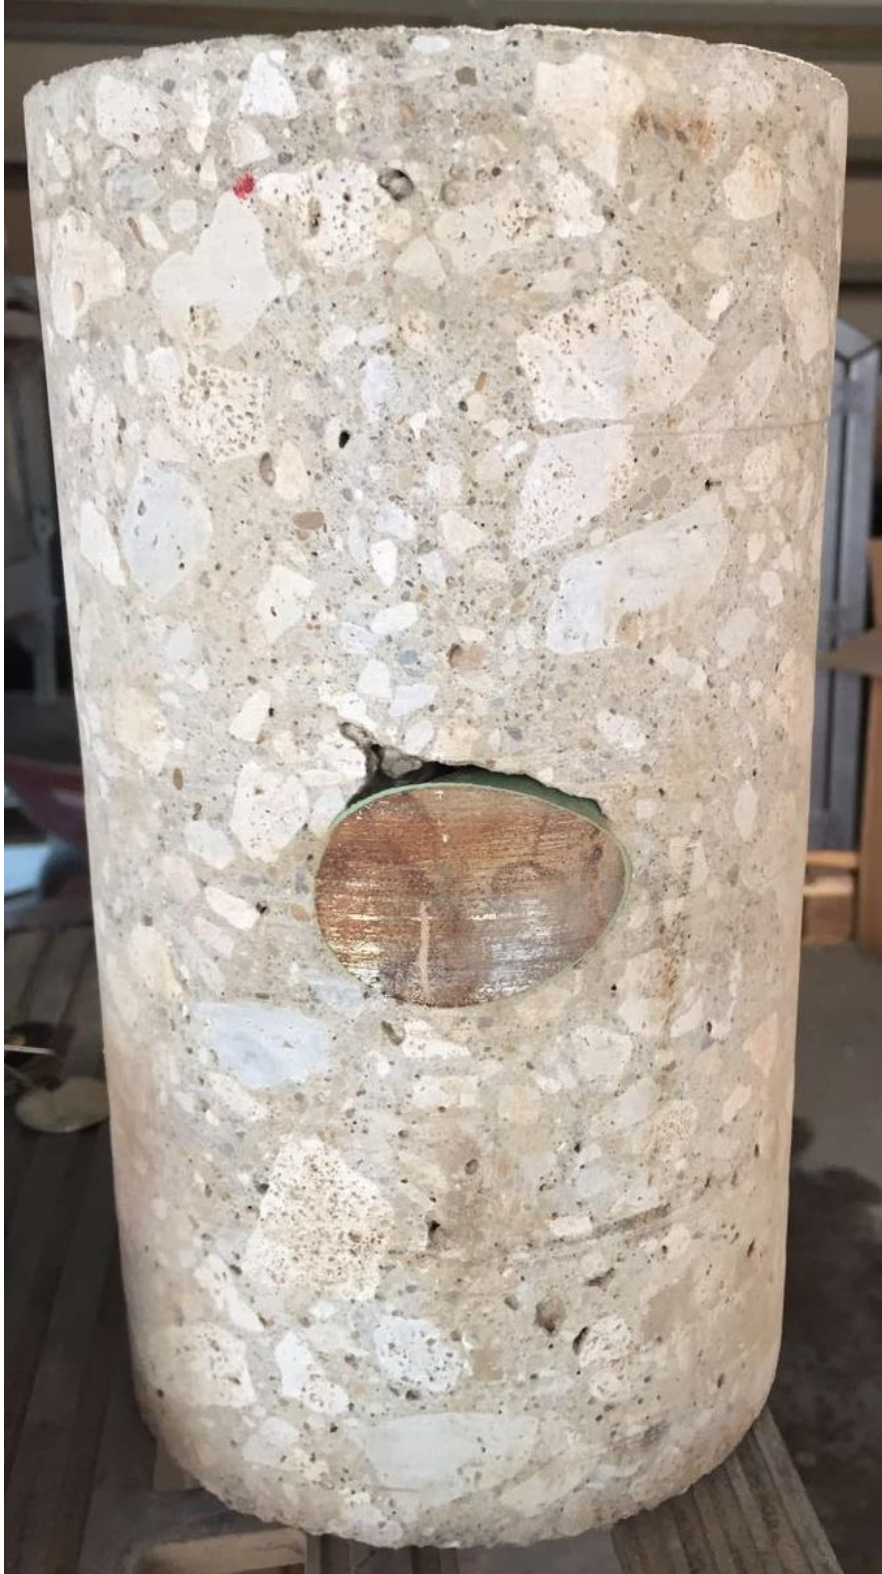
**Figure 66 Uncut tangential core form WAY-30 showing gap above dowel bar.**

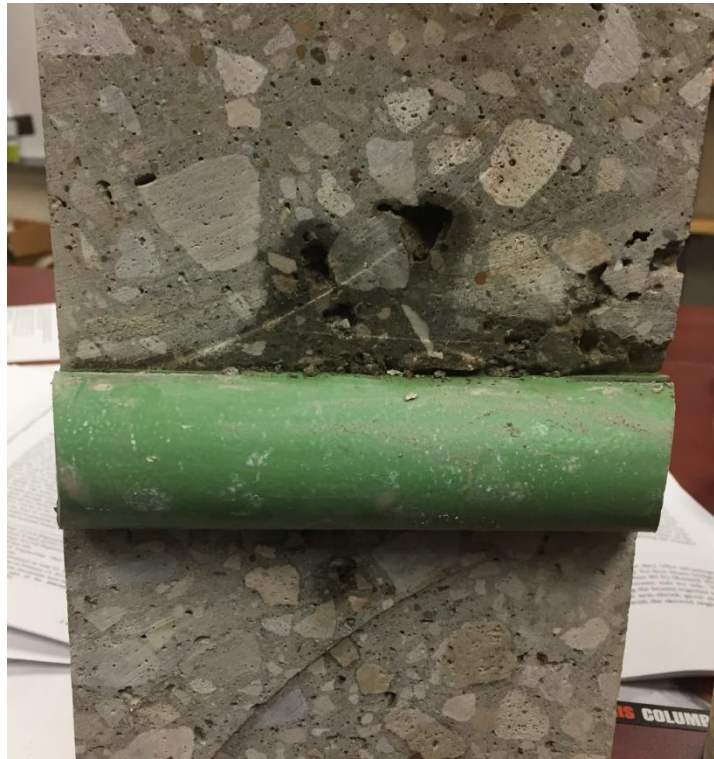
**Figure 69** Close-up of tangential core from WAY-30 showing entrapped air voids and moisture penetration above dowel bar.

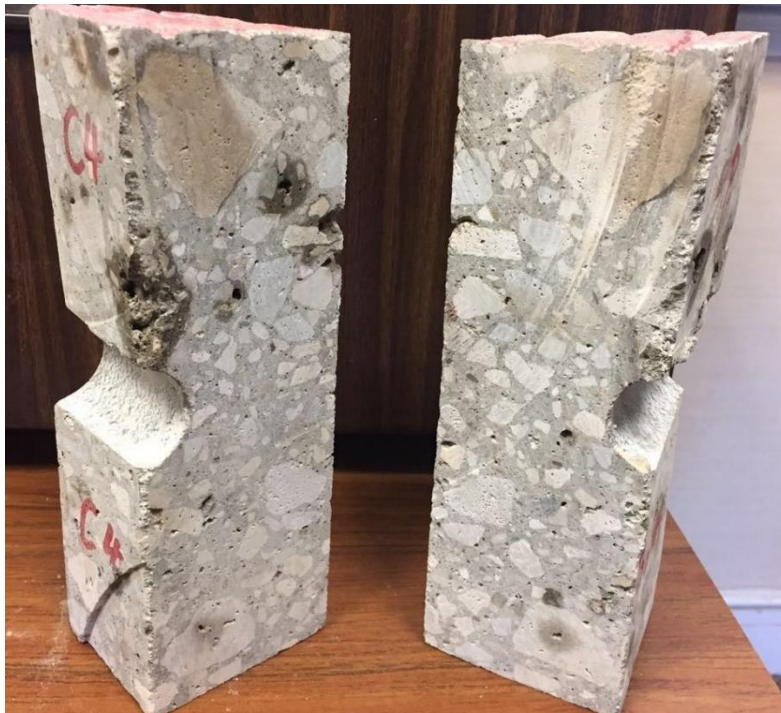
**Figure 70** Slices from WAY-30 tangential cores showing more detail of entrapped air voids in area above dowel bars.

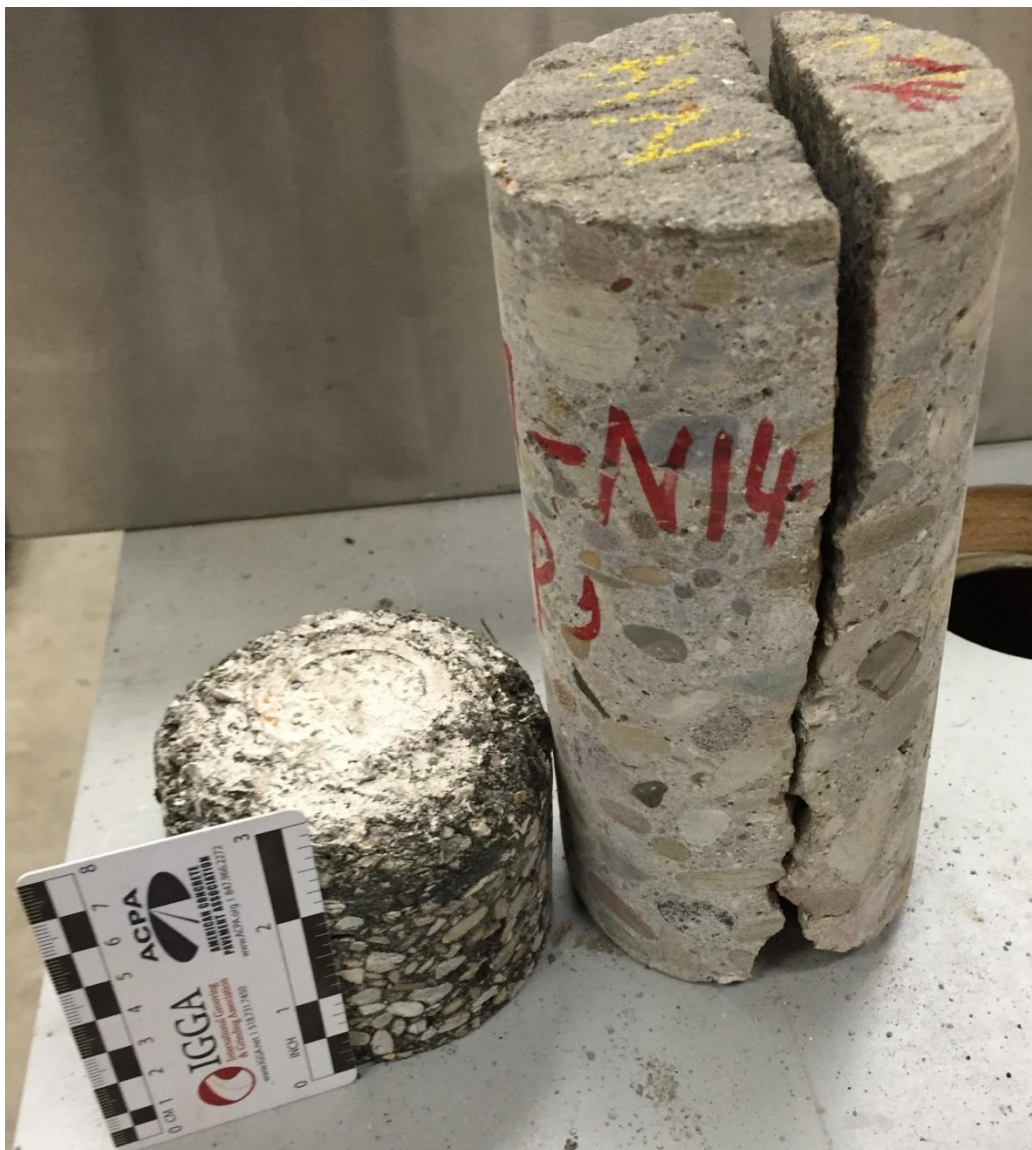
The procedures used to collect cores described in Section 3.6 were followed to obtain cores from I-77 on October 8, 2015. The coring plan is presented in Figure 58 above. Bondbreaker was found in almost all core holes, except S4 and S7. The thickness of the bondbreaker was significantly greater than the design thickness of 1 in (25 mm). Figure 71 shows a core (N14) collected from WAS/NOB-77 northbound at a joint away from a dowel bar. Figure 72 shows a core (N7) drilled near a joint on the northbound side showing a horizontal crack at dowel bar level, while Figure 73 shows a more severe horizontal crack in a core (S14) near a joint in the southbound direction. Even though longitudinal cracking was not widespread, there were differences in the concrete above and below the dowel bar due to the DBI vibrations.

**Figure 71 Core collected at a joint on WAS-NOB-77 northbound.**

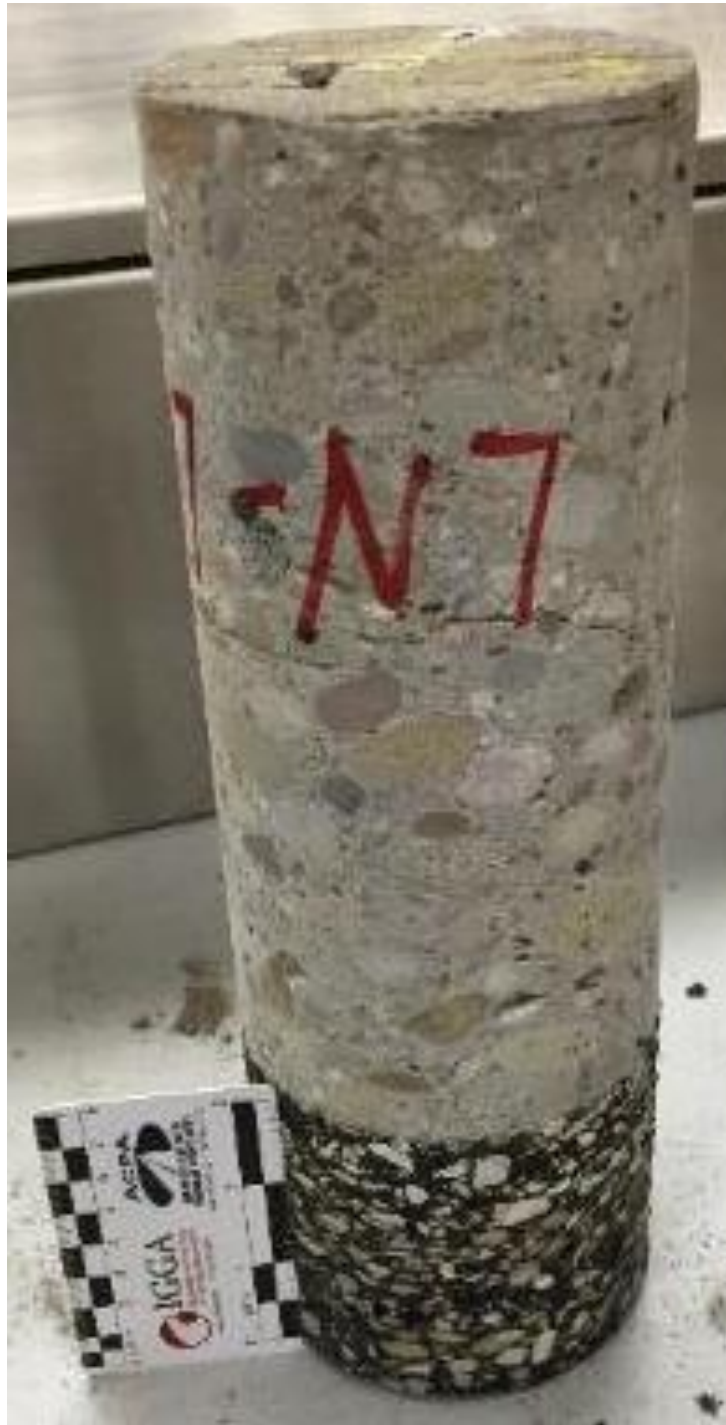
**Figure 72 Horizontal crack at dowel level near joint from northbound side of WAS/NOB-77.**

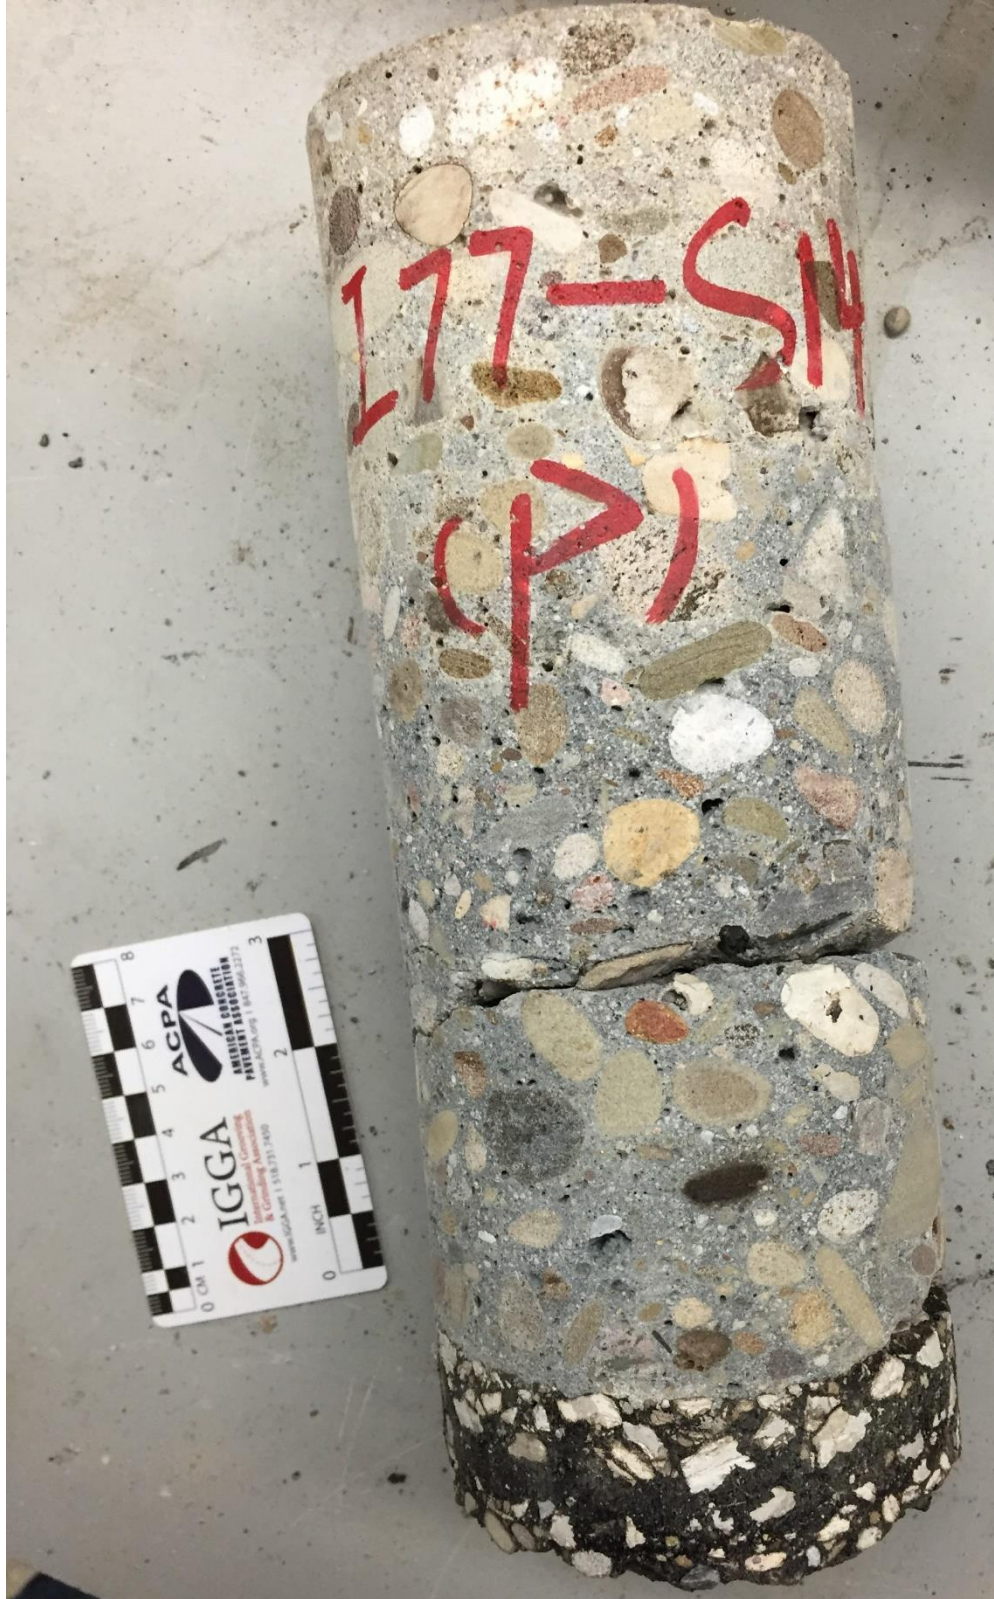
Figure 73 Core with horizontal crack at dowel level from southbound side of WAS/NOB-77.

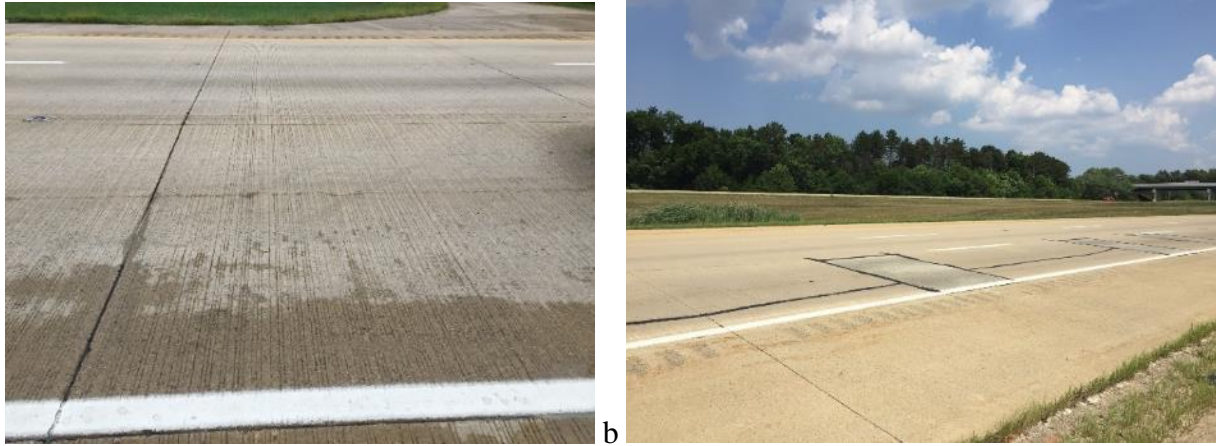
Figure 77 below shows longitudinal cracking found on both directions of LAK-90 during a visual assessment on August 5, 2016.

**Figure 77 a) longitudinal cracking on WB I-90; b) repaired longitudinal cracking on EB I-90. Photos taken August 5, 2016.**

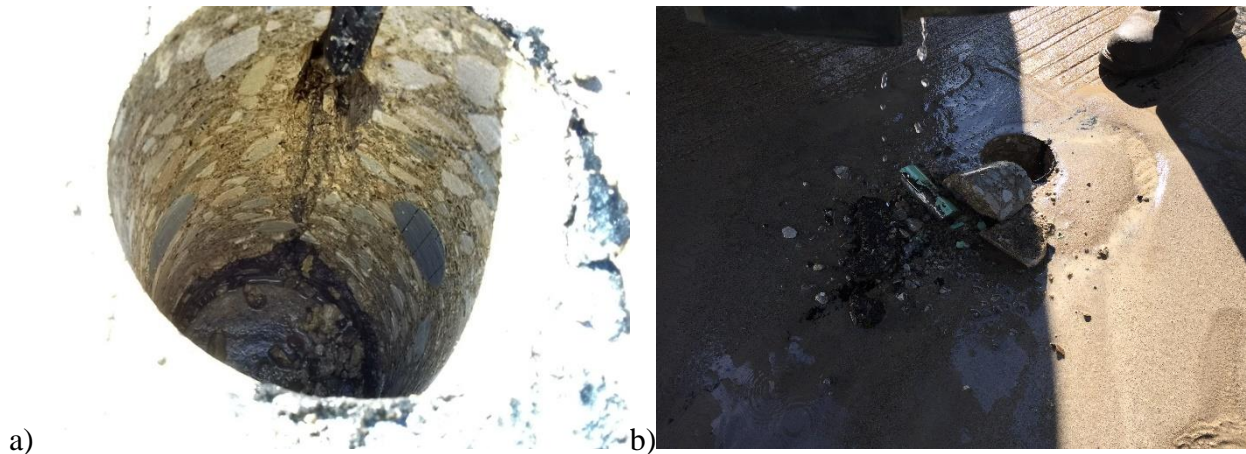
**Figure 104 Horizontal crack at the dowel level**
