# Pilot Construction Project for Granular Shoulder Stabilization

**Final Report  
September 2013**

**Sponsored by**  
Iowa Highway Research Board  
(IHRB Project TR-634)  
Iowa Department of Transportation  
(InTrans Project 11-405)

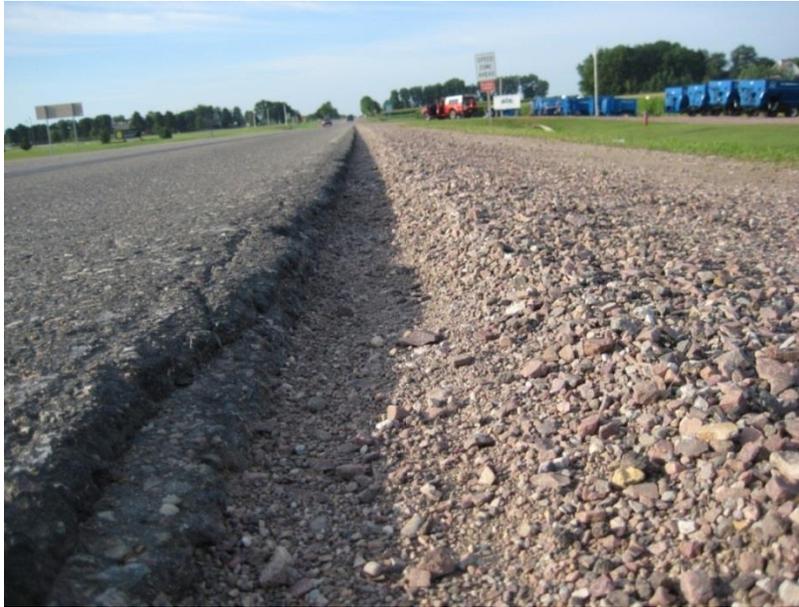
**Figure 1. Edge rutting on granular shoulder (Jahren et al. 2011)**

Edge rutting on granular shoulders, as shown in Figure 1, is a serious traffic safety issue because it can cause vehicles to run off the road, which can lead to loss of control and even loss of life (Jahren et al. 2011). Edge rutting is caused by three factors: wind and air currents, vehicle off-tracking, and drainage.

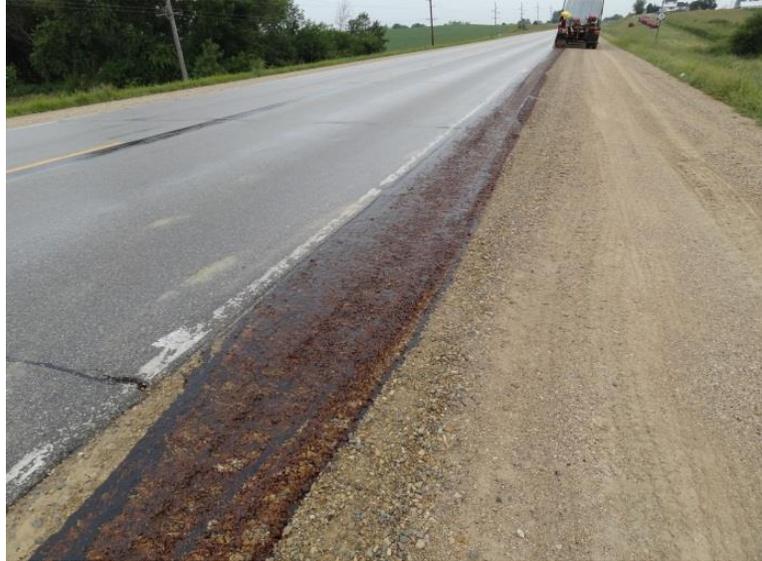
**Figure 12. Spraying in the rain on IA 3 near Allison, Iowa**

On August 18, 2011, rain occurred during the time that the application process was executed around Allison and Shell Rock. Figure 12 shows the result of the soapstock application on the westbound (WB) shoulder of IA 3 nearby and east of Allison during the rain.

- During the soapstock application, rain should be avoided because too much moisture can prevent soapstock from staying firmly on the shoulder. Too much or too little moisture compromises the effectiveness of the application. If the shoulder is too dry, water should be applied to add more moisture. If the shoulder is too wet, soapstock application should be delayed until it is dry enough.

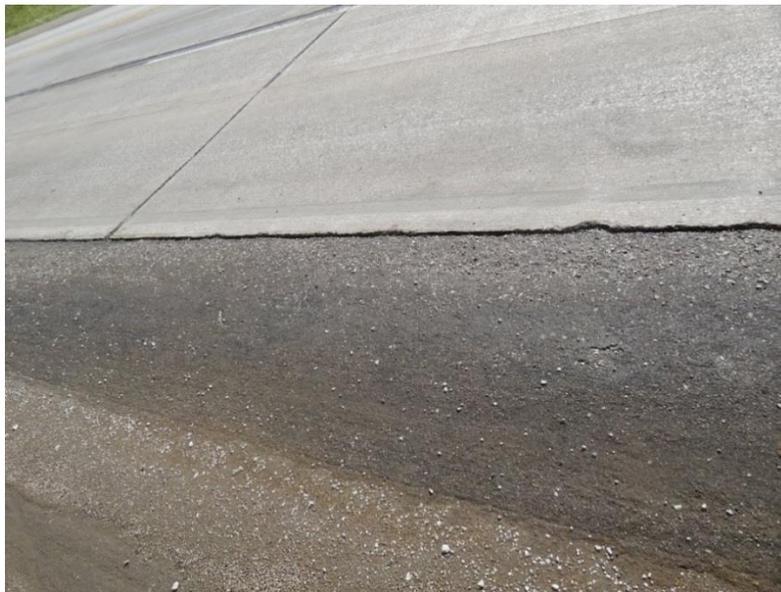
**Figure 20. Southbound shoulder of US 169 south of Algona, Iowa**

Figure 20 provides an example of good shoulder performance for this area. This shows a section of the US 169 shoulder adjacent to the SB lane just south of Algona, where a thin layer of soapstock remained firmly on the shoulder. Another example is shown in Figure 21. The shoulder section was on US 18 near Garner with a thicker layer of soapstock on surface.

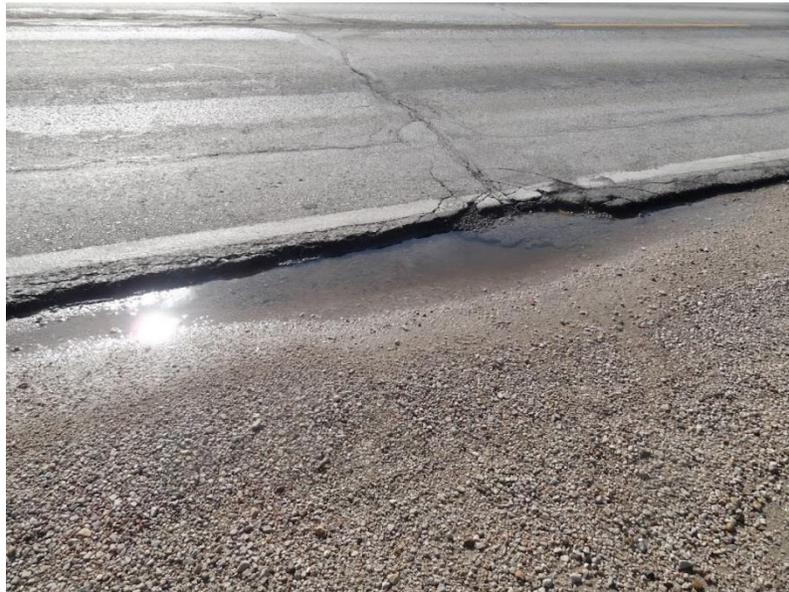
**Figure 22. Edge rut developed south of Algona, Iowa**

The possible reason for this failure might be water erosion. There is an uphill grade adjacent to this location, which results in water runoff that erodes the edge drop off area.

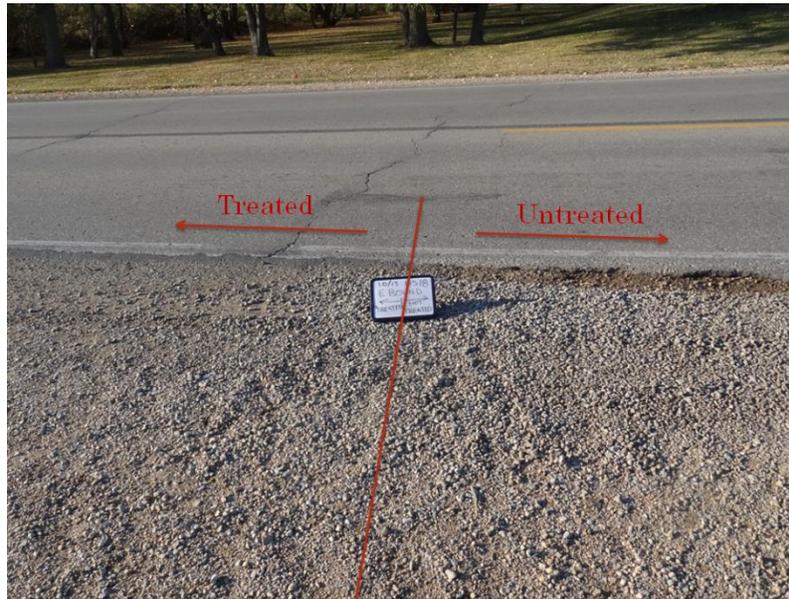
**Figure 23. Results compared for treated and untreated shoulder edge**

Figure 23 shows an example of a comparison of an untreated shoulder edge and the untreated one.

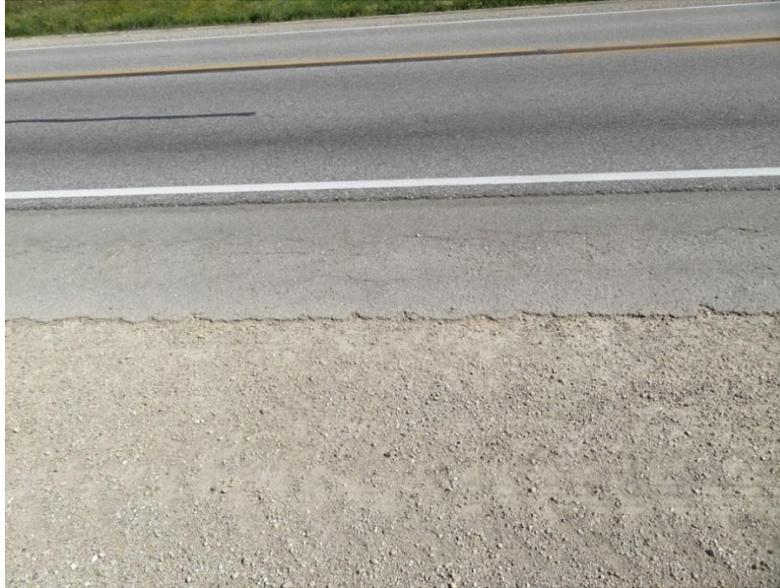
**Figure 24. Eastbound shoulder of IA 3 east of Waverly, Iowa**

Figure 24 provides an example of good shoulder performance for this area. This shows a shoulder section of IA 3 on adjacent to the EB lanes just east of Waverly, where a thick layer of soapstock remained firmly on the shoulder. Another example is shown in Figure 25. This shoulder section was on US 63 near Denver, where soapstock had penetrated into the shoulder and could not be seen easily.

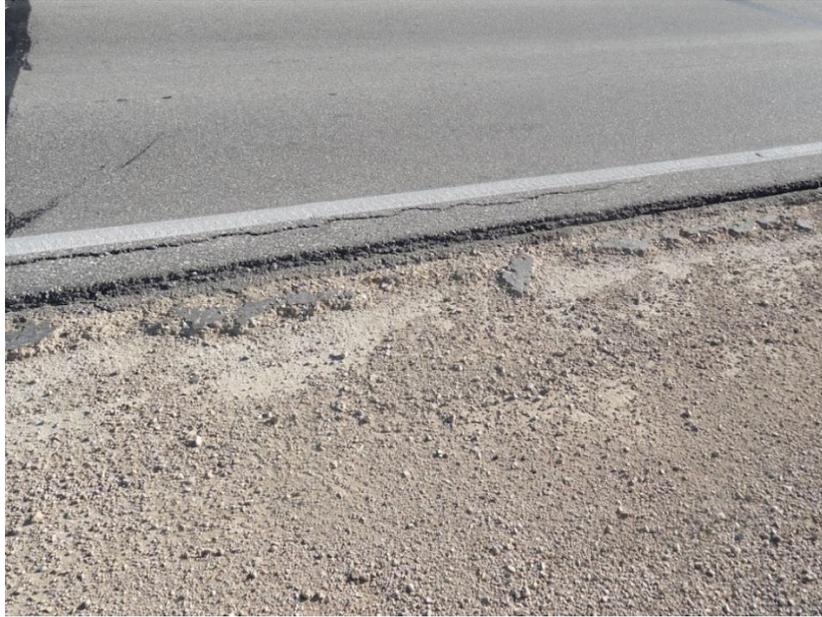
**Figure 26. Soapstock missing east of Allison, Iowa**

Figure 26 shows one example of an undesired situation where most soapstock was abraded away by traffic, although neither edge ruts or potholes developed. This was part of the shoulder of IA 3 EB east of Allison. However, an edge drop-off did exist because there was not enough shoulder aggregate in this area to maintain the designed cross slope and fill flush to the pavement edge.

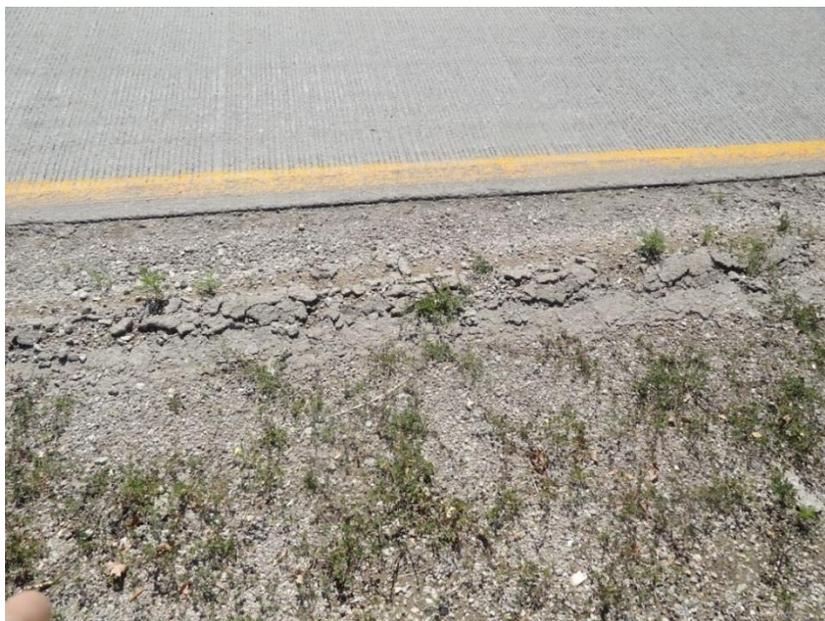
**Figure 27. Northbound inside shoulder of US 63 near Denver, Iowa**

Figure 27 shows another undesired situation where the soapstock was not remaining on the inside shoulder of US 63 NB near Denver. Part of the shoulder materials had been displaced by traffic. Researchers observed that the inside shoulder material was less stable in comparison to the outside shoulder material and was easily prone to displacement.

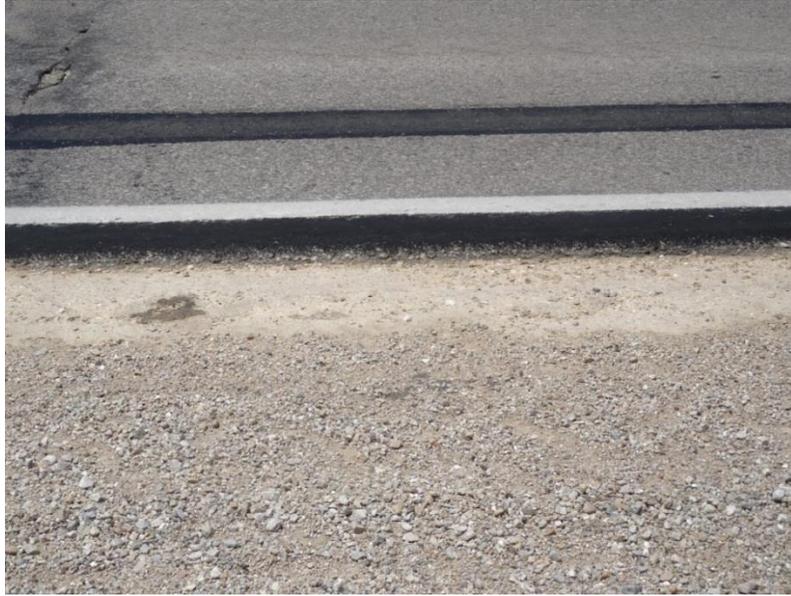
**Figure 28. Shoulder of US 18 eastbound east of West Union, Iowa**

Figure 28 shows one shoulder section of US 18 EB east of West Union. Although the shoulder had been regraded, the hard surface resulting from the soapstock could still be observed. Another example is shown in Figure 29. The shoulder was also along US 18, west of Clermont, where the whole section was regraded with new gravel.
