Longitudinal Joint Repair Best Practices for the Ohio Department of Transportation

Keeping Ohio's Pavement Joints Zipped Up

July 2017

Final Report

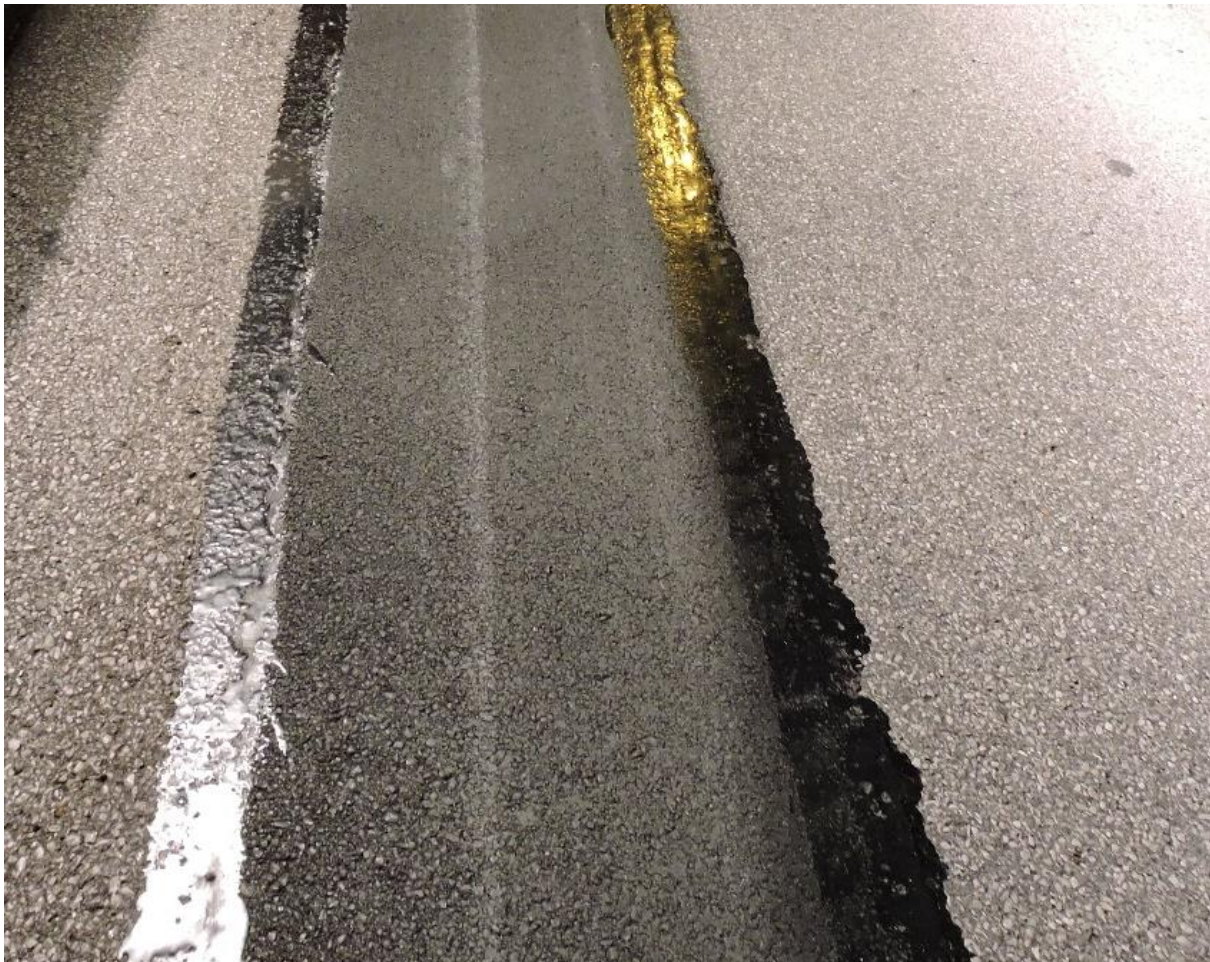
Figure 5. Typical 2-ft slot paving placed on I-70 Westbound. (Site 1)

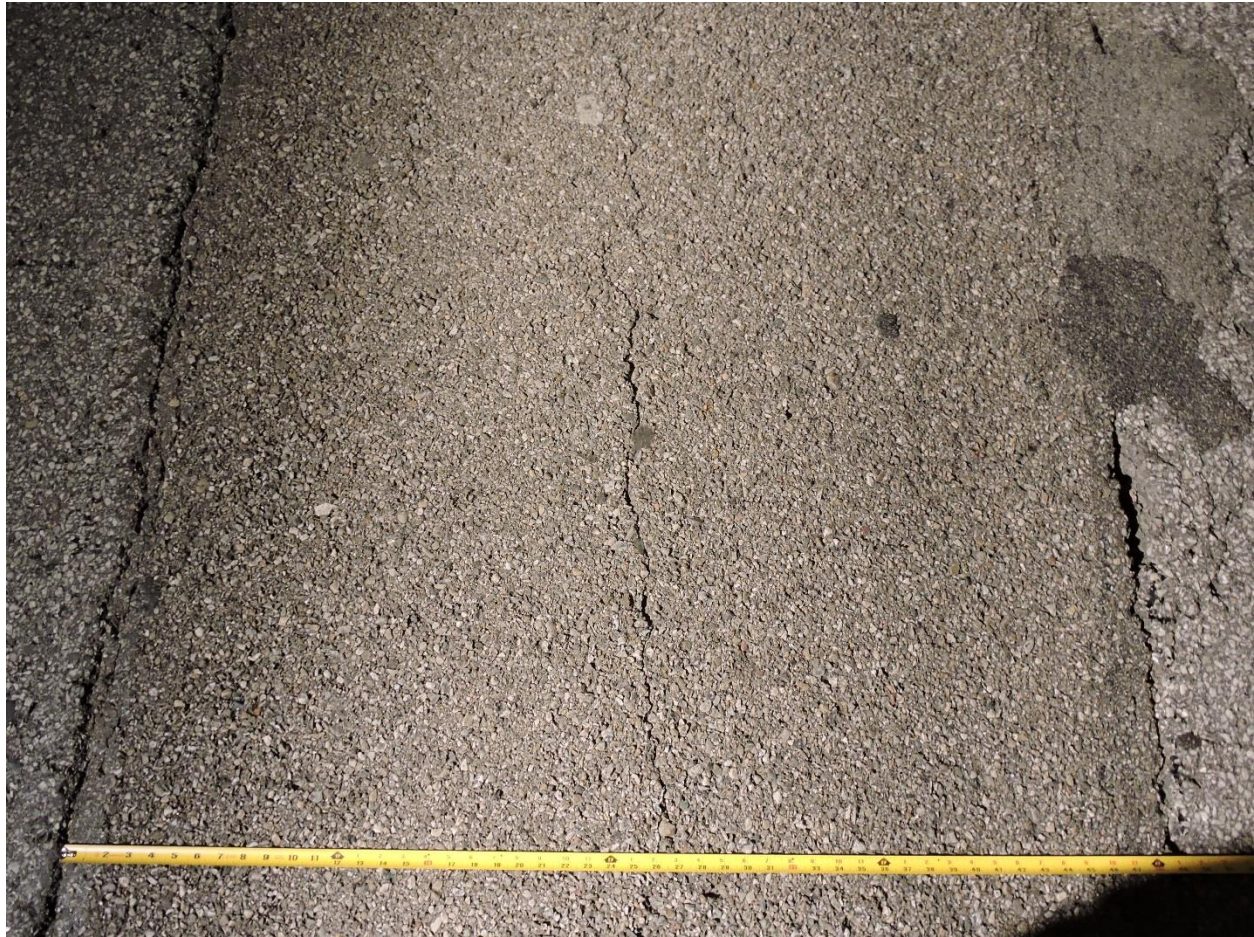
likelihood that a distressed joint existed prior to the overlay. Reflection cracking could also exacerbate the deterioration at these locations. The photo in figure 6 shows distresses in the 4-foot slot paving including a reflection crack forming at the underlying LJ, secondary cracking and edge deterioration occurring around the perimeter of the patch, and slight rutting within the patch.

Figure 6. Reflection cracking, secondary cracking, and minor rutting occurring in 4-foot slot paving on I-670 in Franklin County. (Site 4)

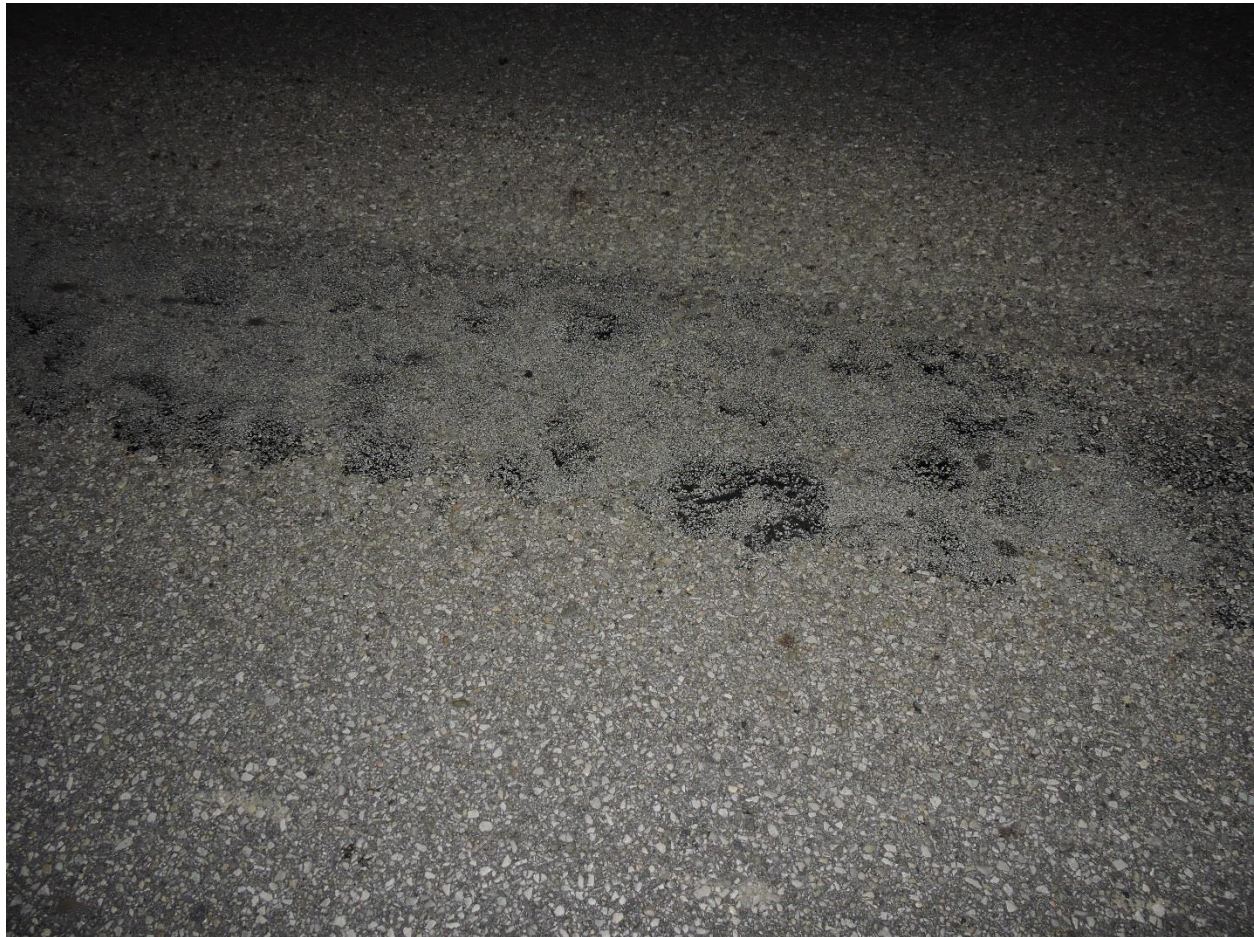
Figure 7. Typical spray injection LJ repair site. (Site 6)

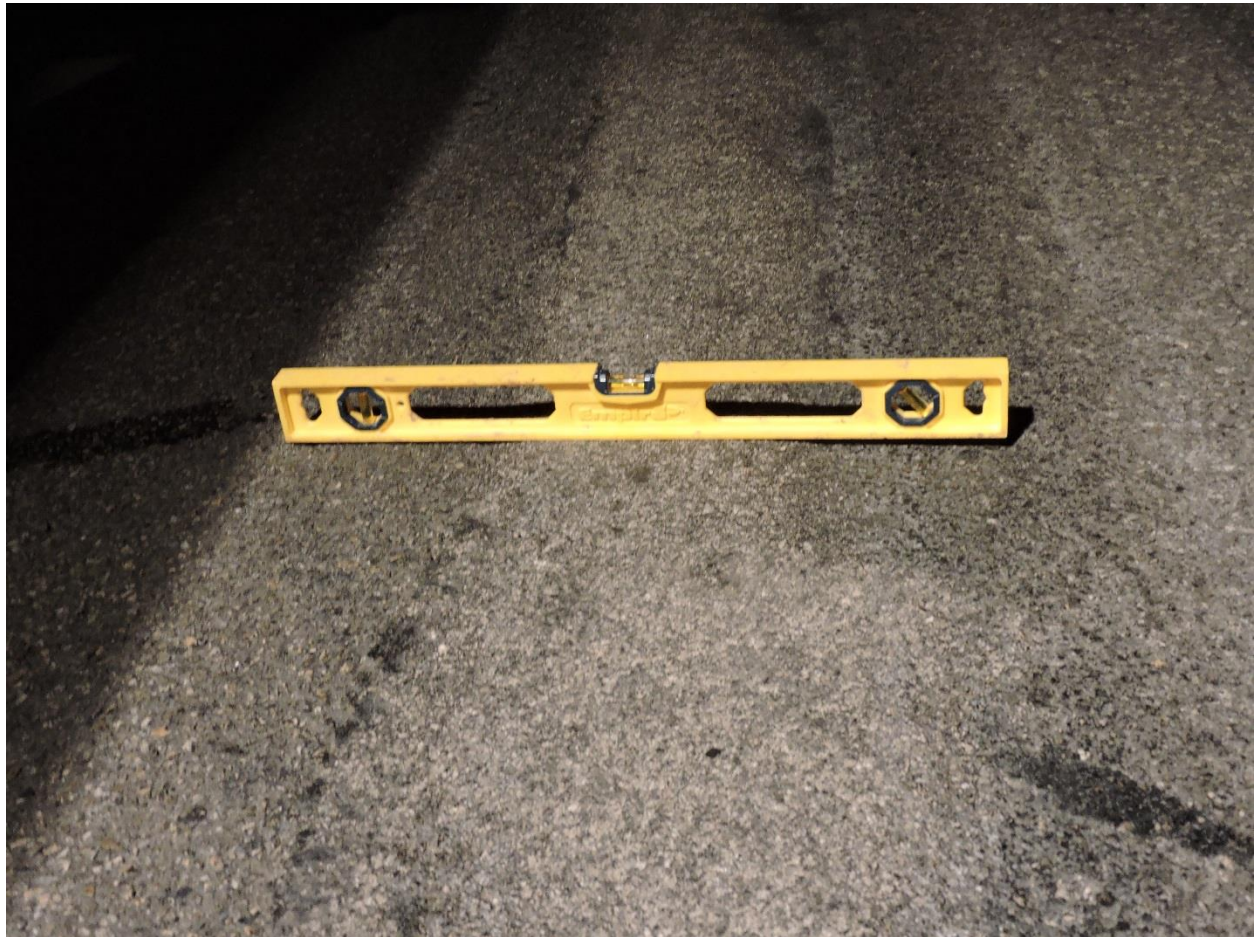
As a final repair dressing, contractors recommend sweeping loose chips from the repair surface with a hand broom and using a static steel wheel roller or vehicle tire to compact the repair area. The compacted, final surface should be in close conformity with the grade of the adjacent pavement. Excessive mounding could prohibit water draining from the pavement surface freely, and a depressed surface could hold water and develop damage under freezing conditions. An uneven surface, whether high or low, will also be disruptive to vehicles as they change lanes. Mounding was a typical observation of the in-service spray repairs, and typical mounding of 0.5 inch to 0.75 inch is illustrated in figure 8.

Figure 8. Slight mounding may occur with spray injection. (Site 8)

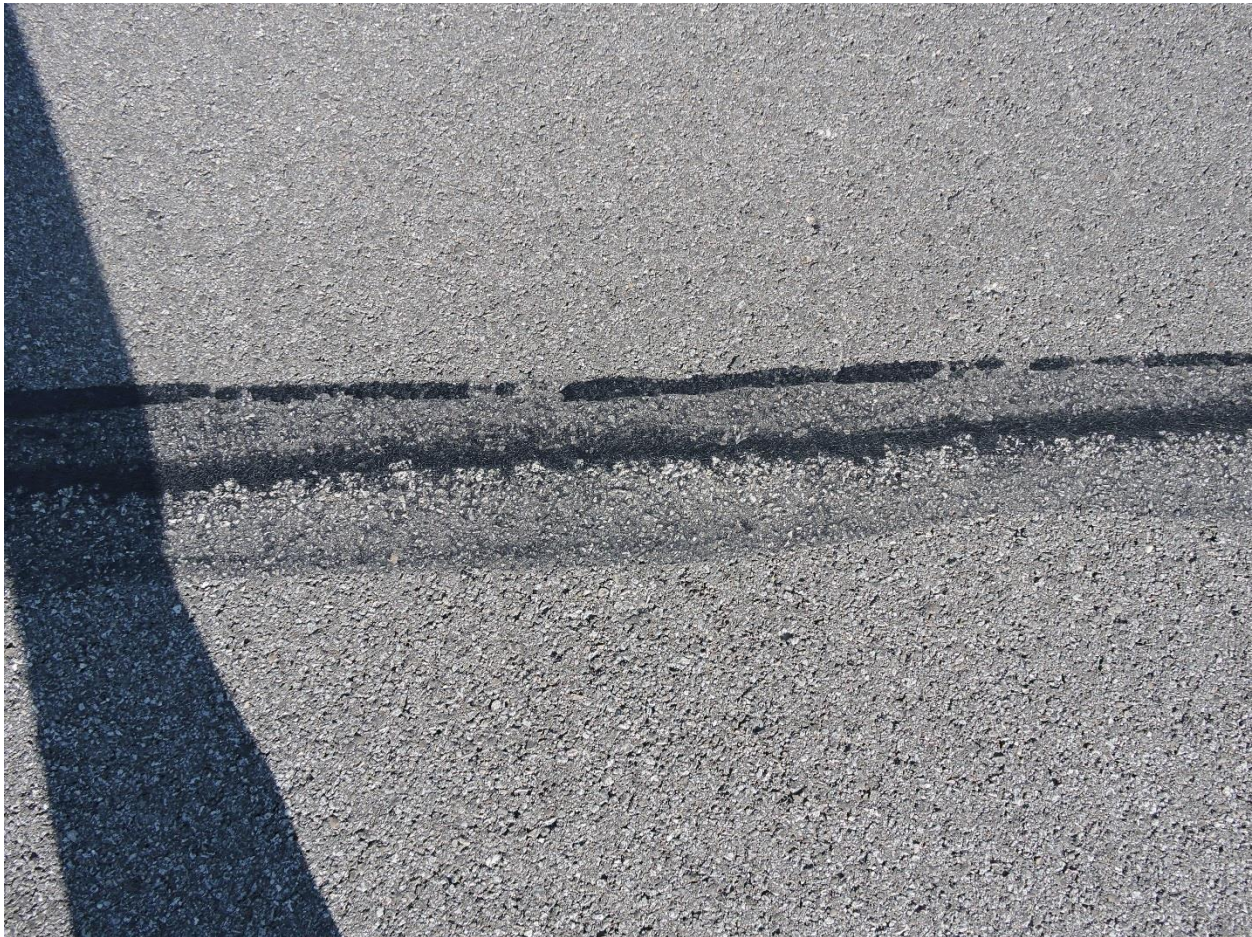
Figure 9. Section of crack sealing showing signs of wear (Site 12).

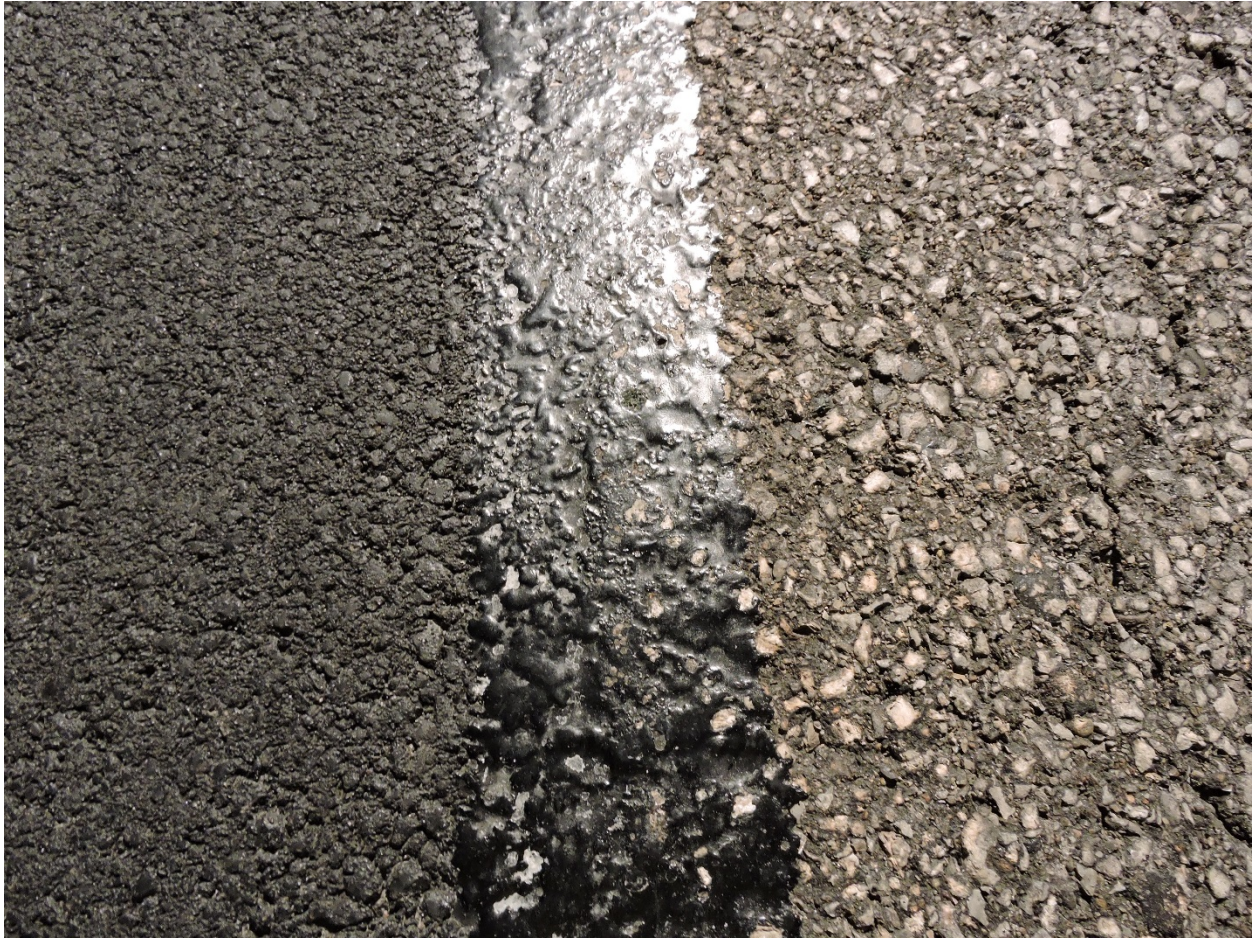
Figure 1-3. Typical AC band condition and the minor sporadic secondary cracking (repair on left).

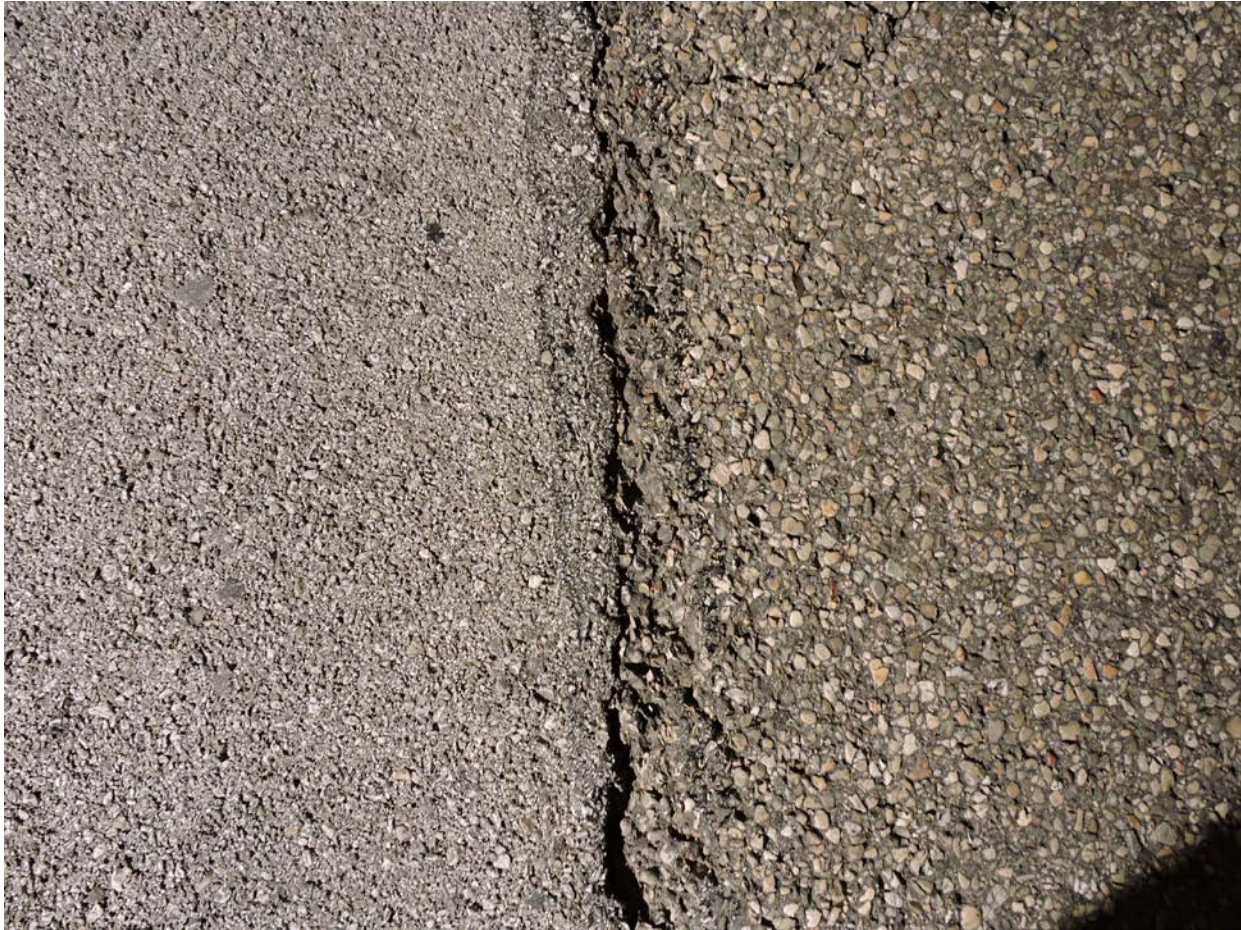
Figure 2-2. Cracking along edge of repair (repair pavement is left side).

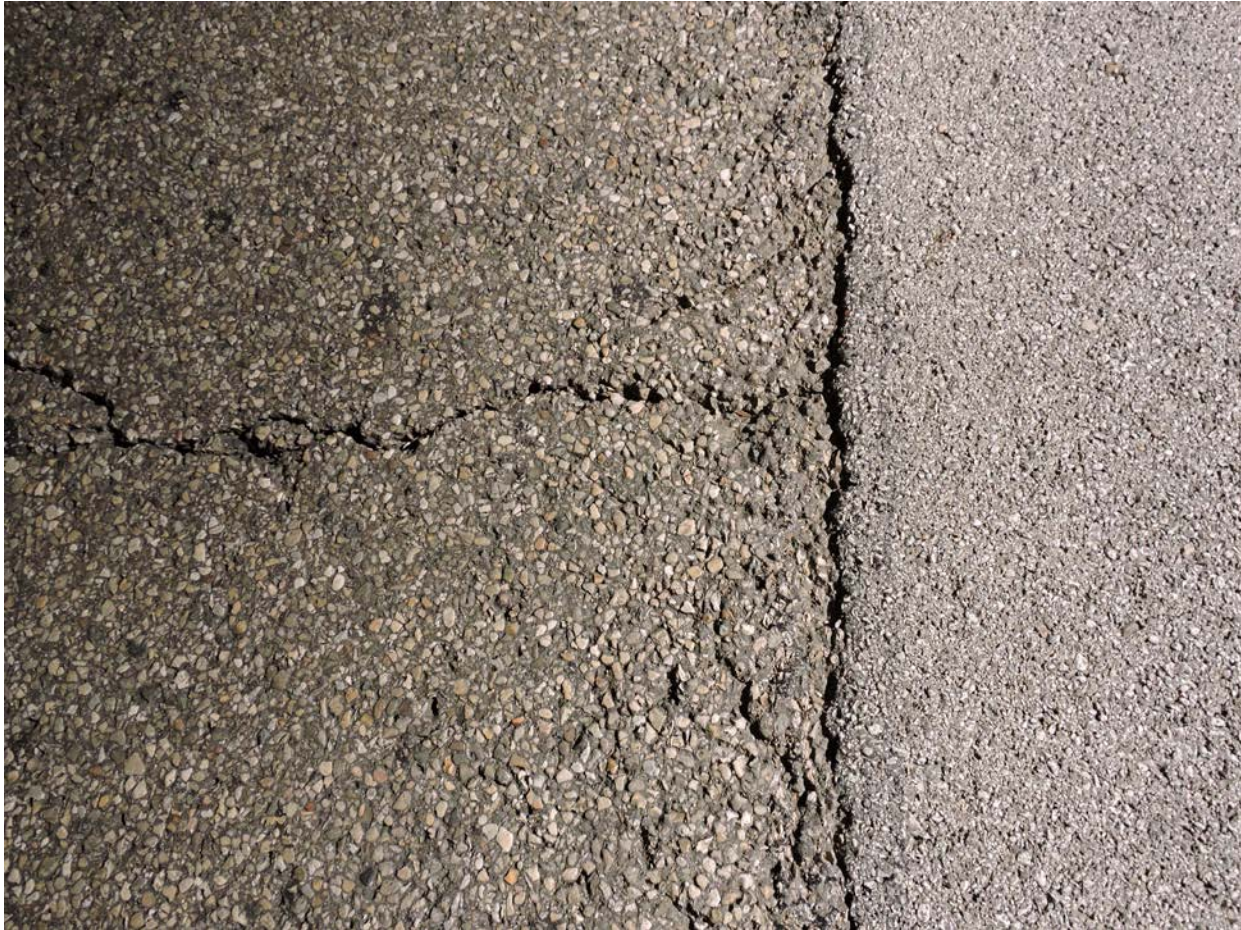
Figure 2-3. Deterioration secondary cracking along repair area (repair pavement on right).

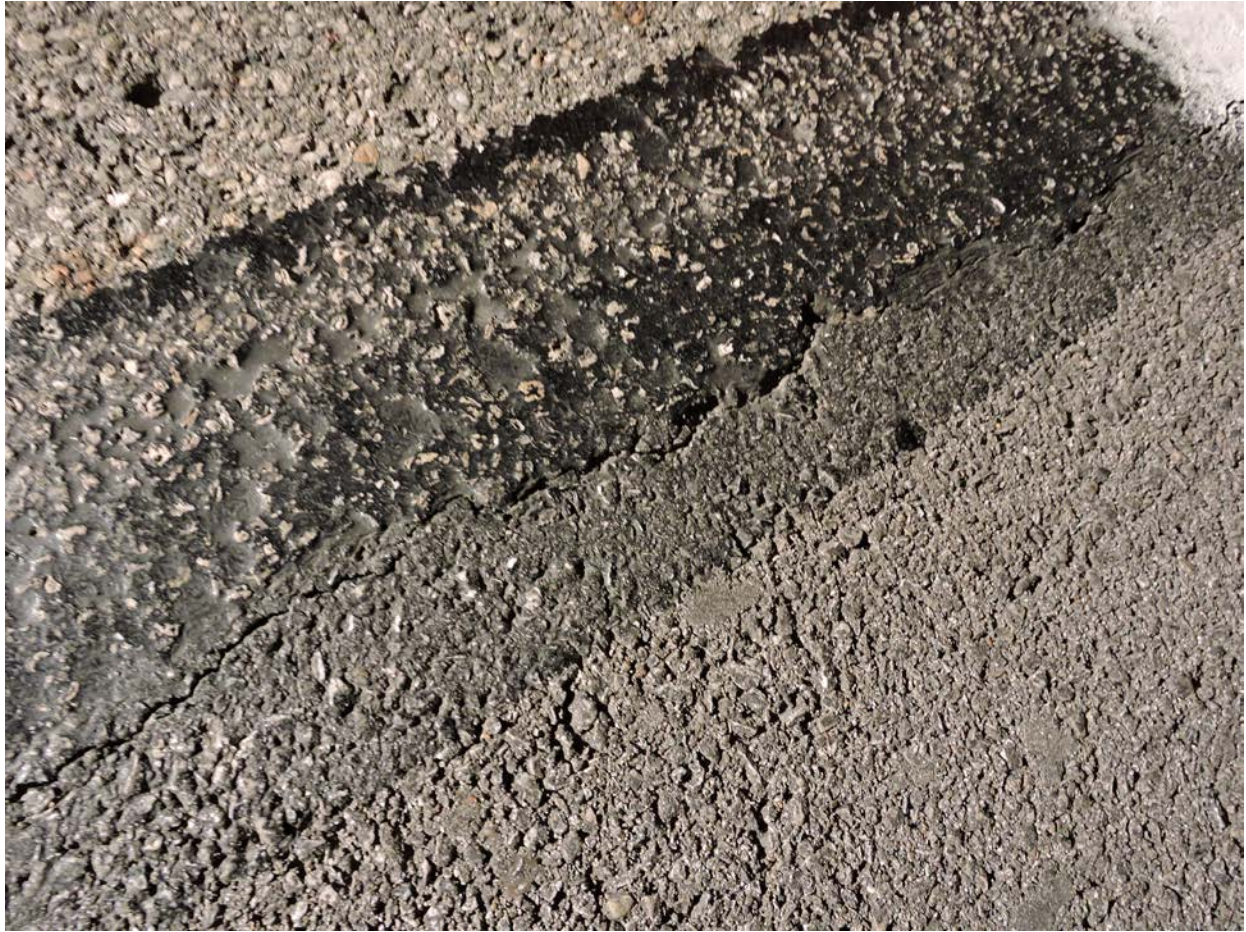
Figure 3-3. Typical cracking along the slot paving edge located within pavement markings.

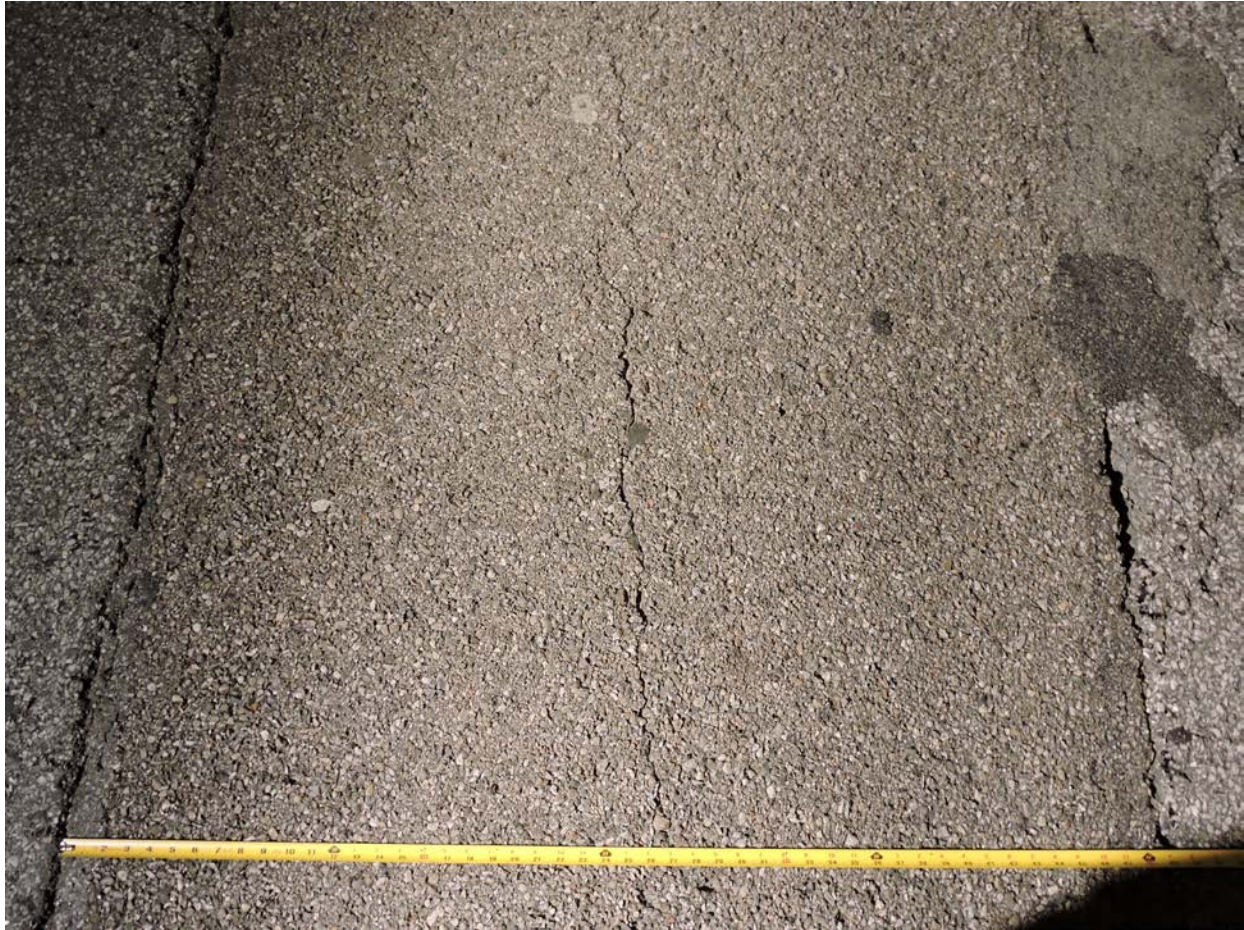
Figure 4-2. $\frac{1}{4}$ cracking through center of slot repair.

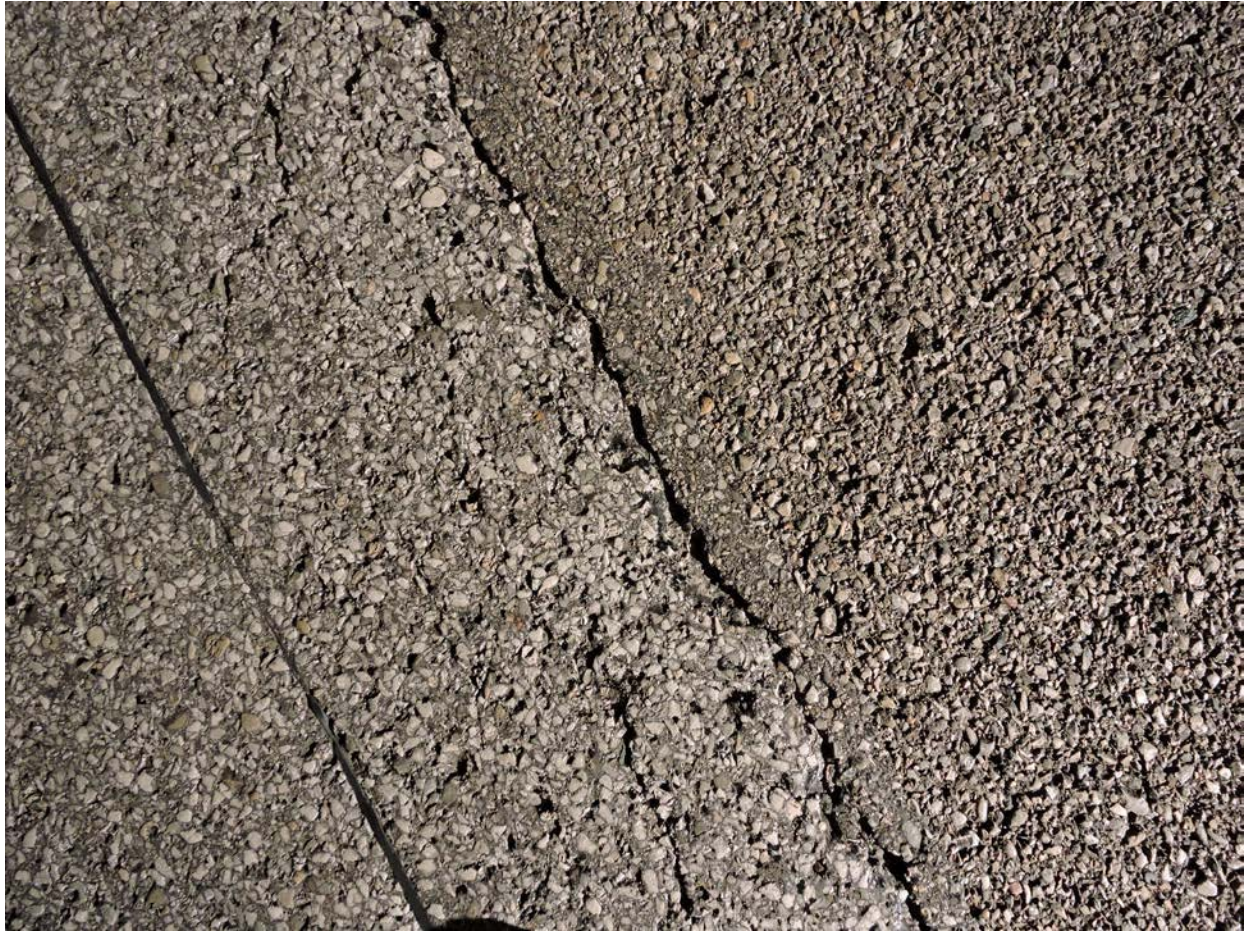
Figure 4-3. Typical north edge of slot paving (upper right portion of photo is repair asphalt).

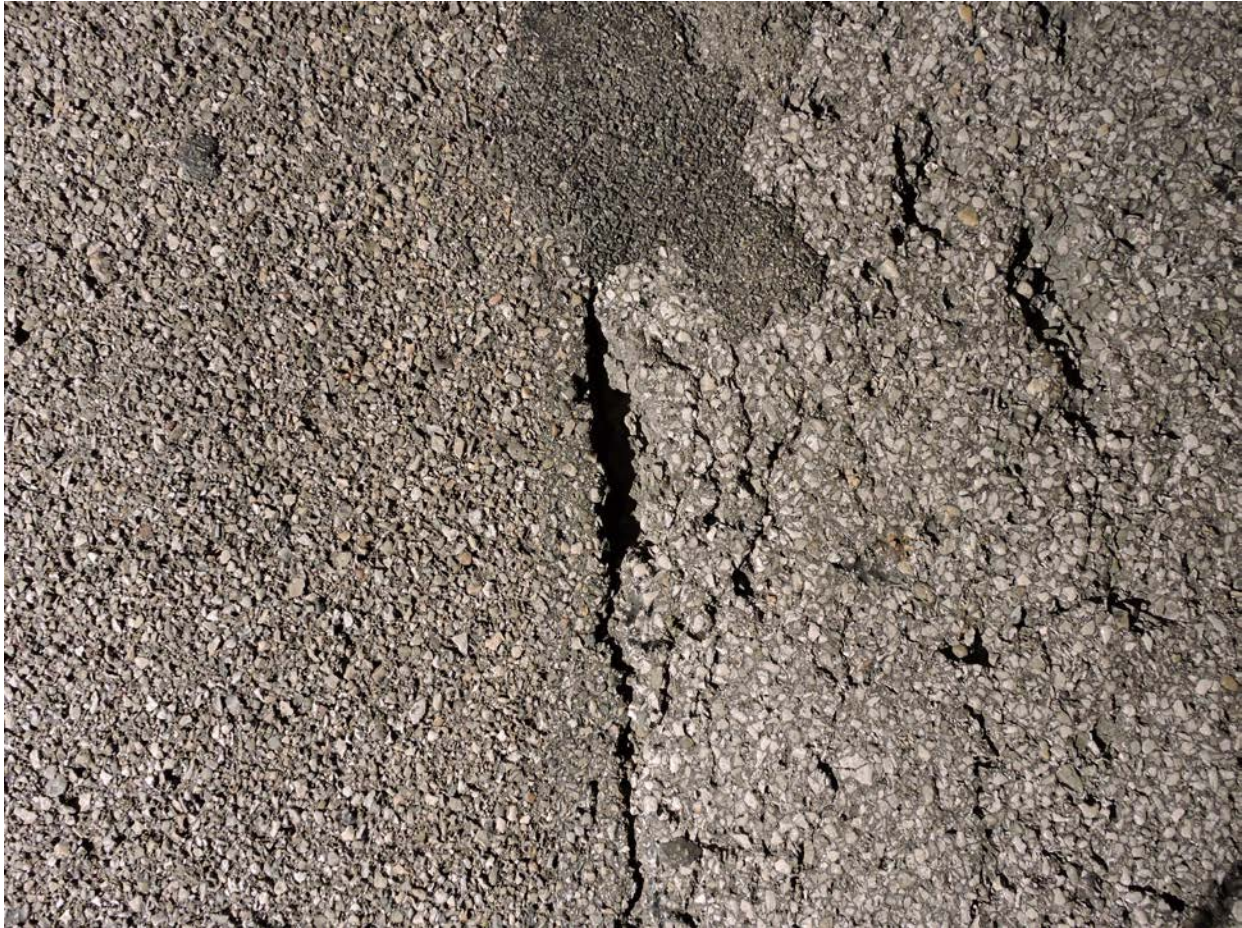
Figure 4-4. Secondary cracking on north edge of repair (left portion of photo is repair asphalt).

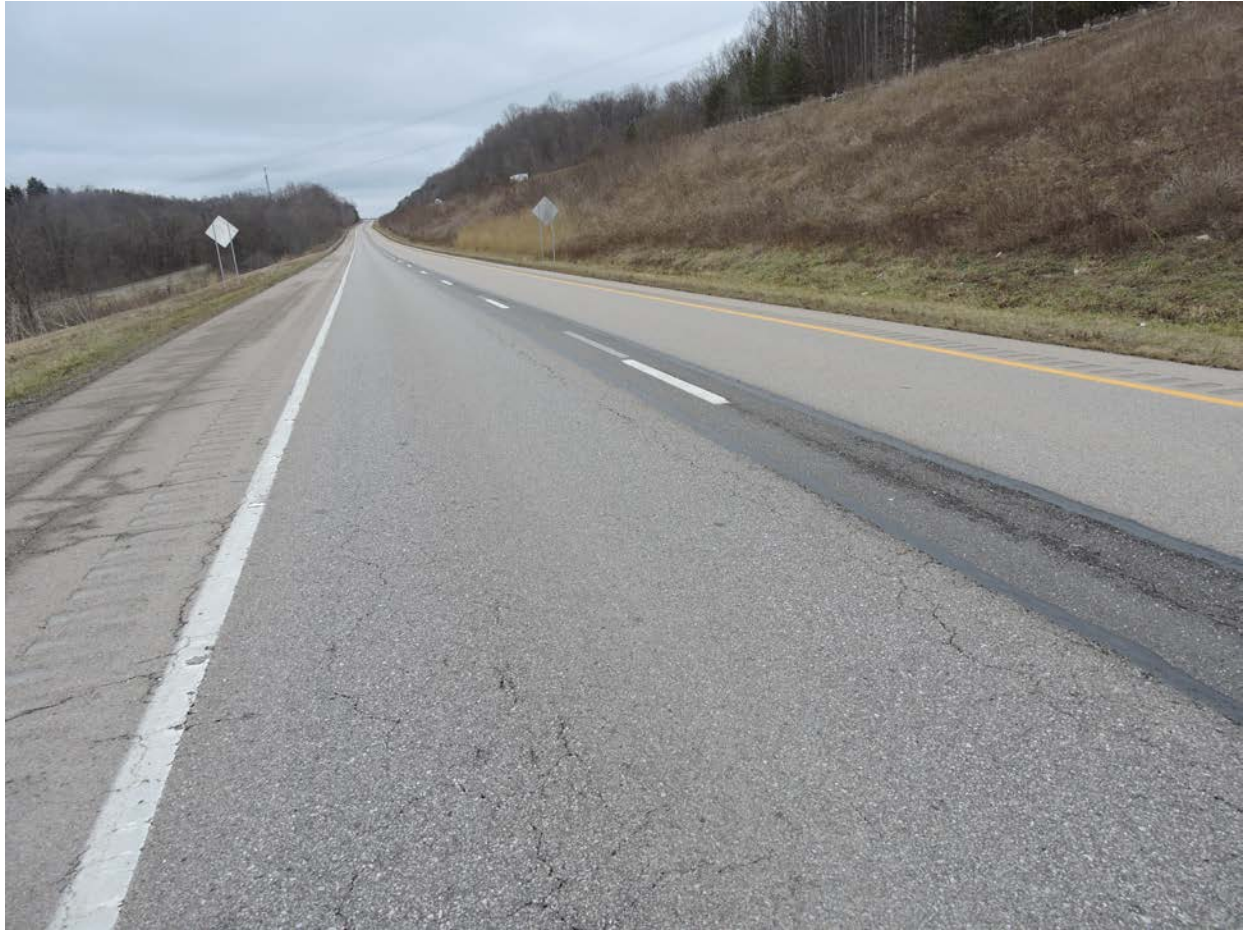
Figure 5-1. Typical slot paving repair area, secondary cracking on inside lane, and cracking through slot pave from original joint.

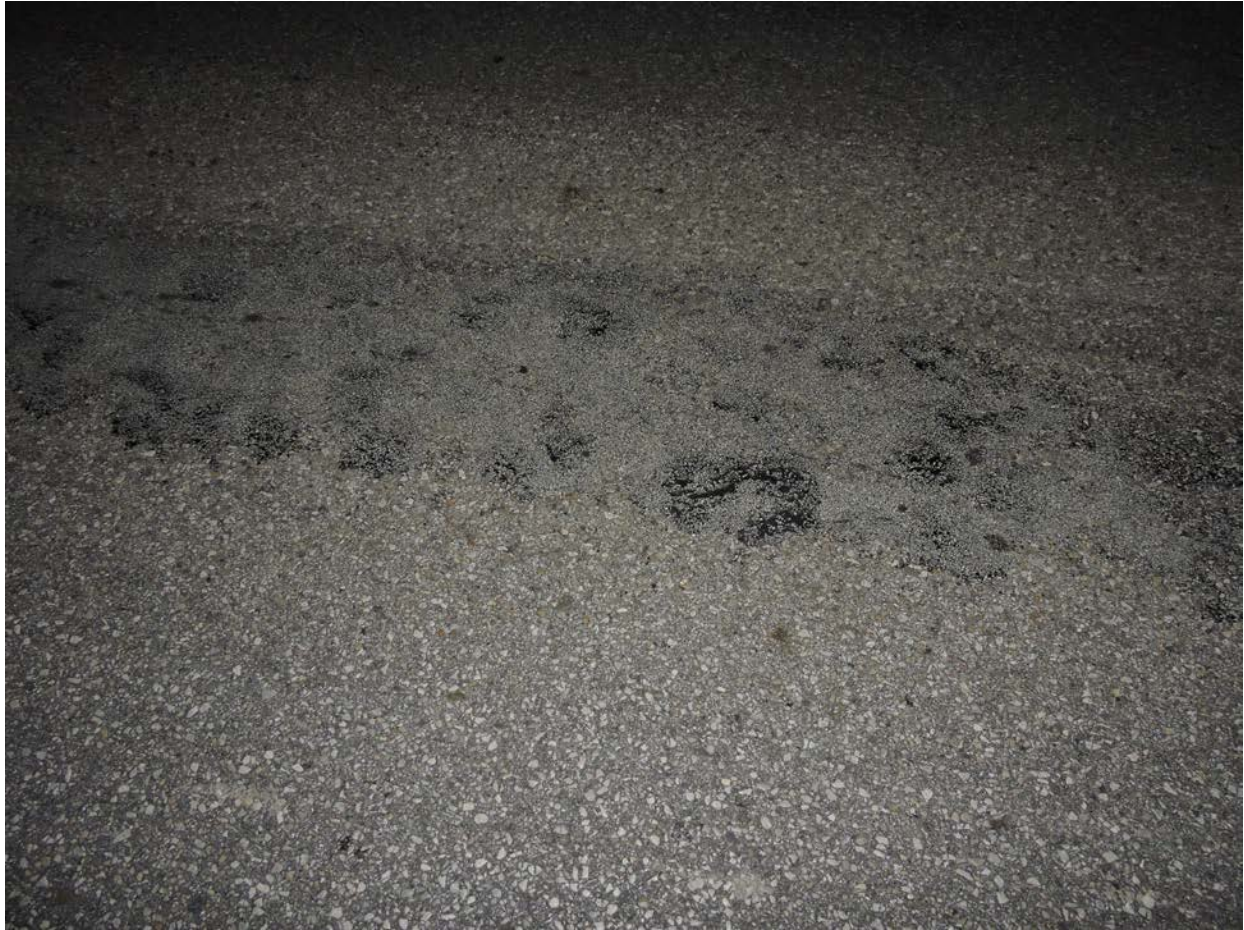
Figure 6-2. Typical spray patch condition.

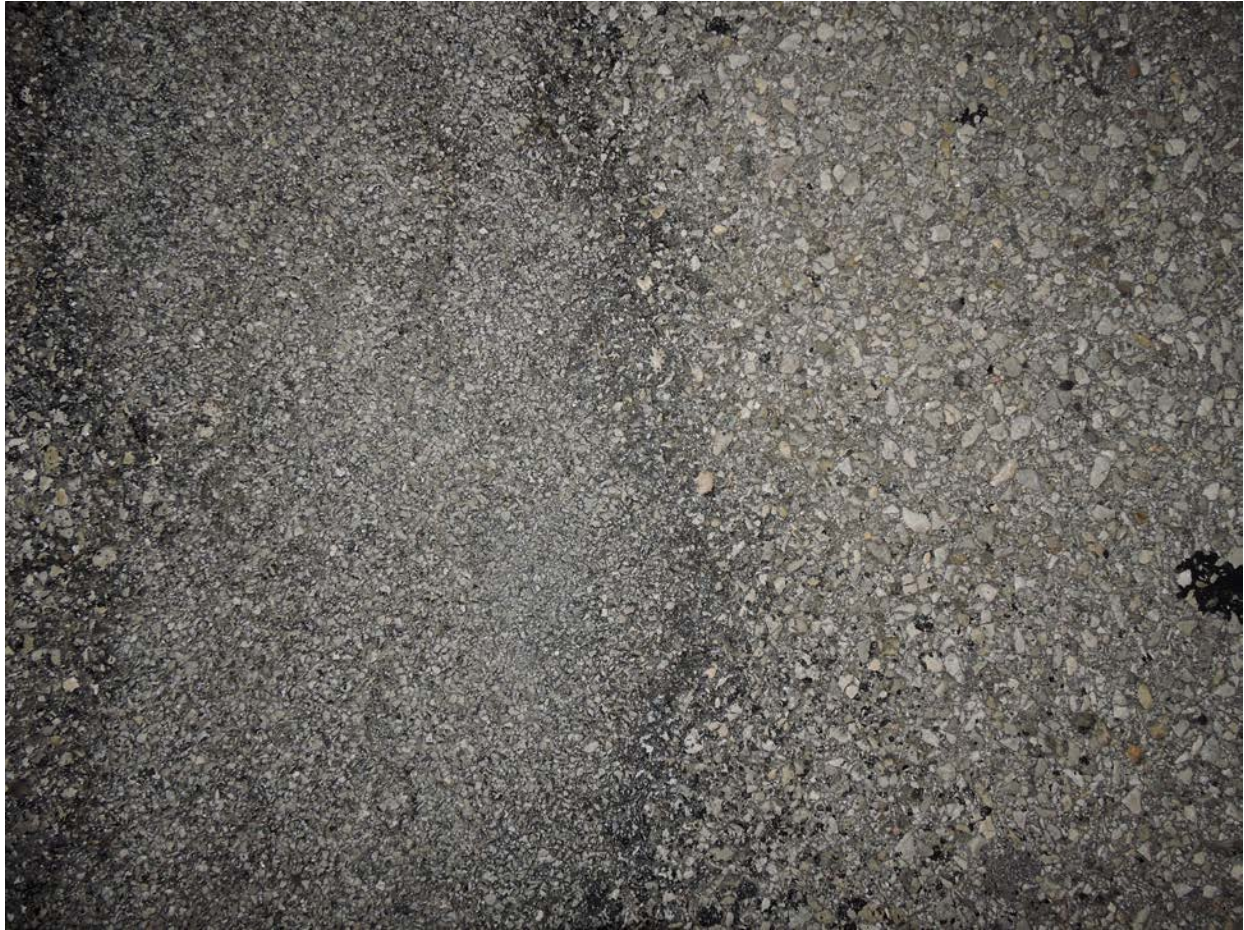
Figure 7-2. Typical spray patch with material beginning to show signs of distress.

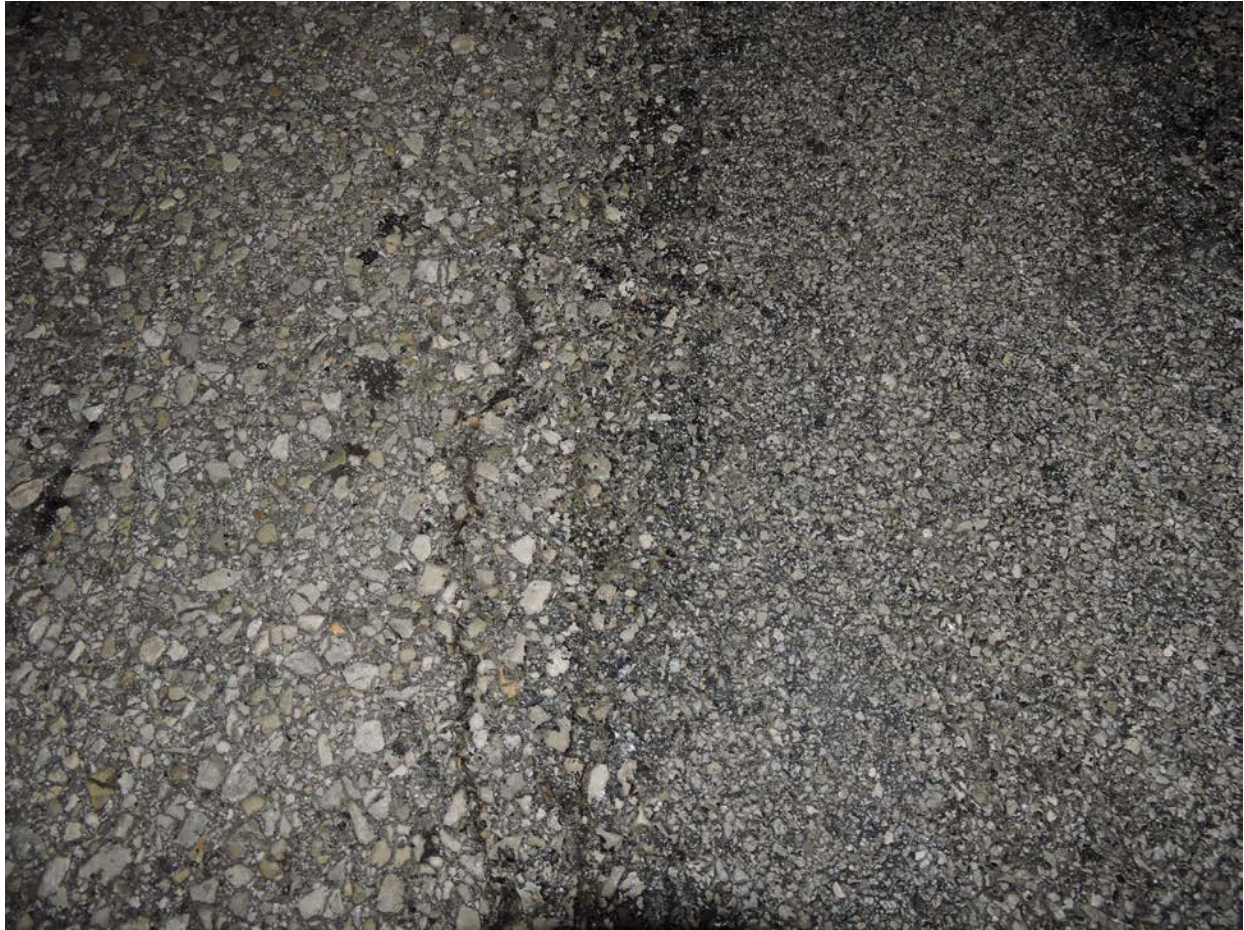
Figure 7-3. Typical secondary cracking forming outside of the patching material.

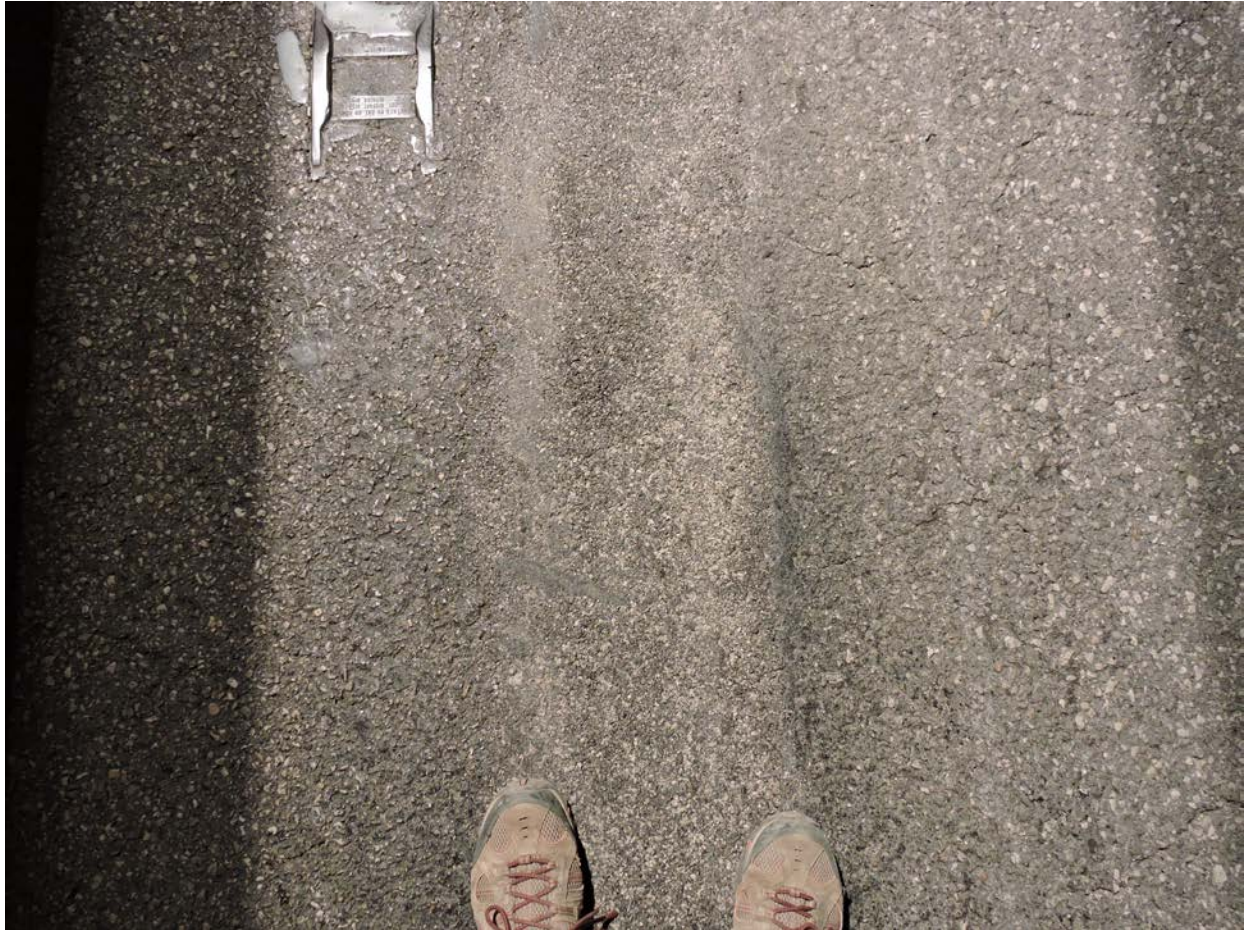
Figure 8-3. Spray patch area with perpendicular cracking running into repair area.

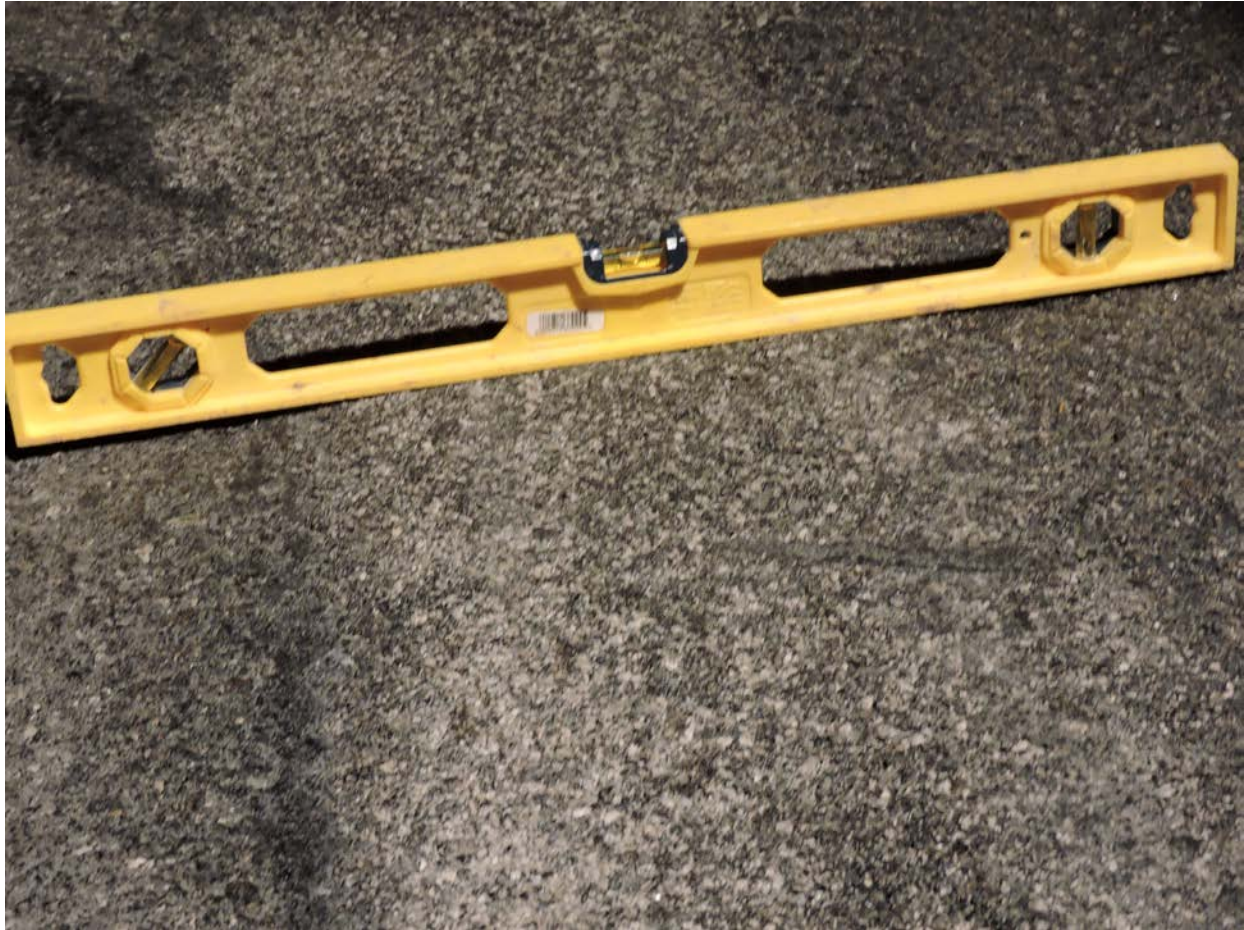
Figure 8-4. Typical mounding of spray patch material.

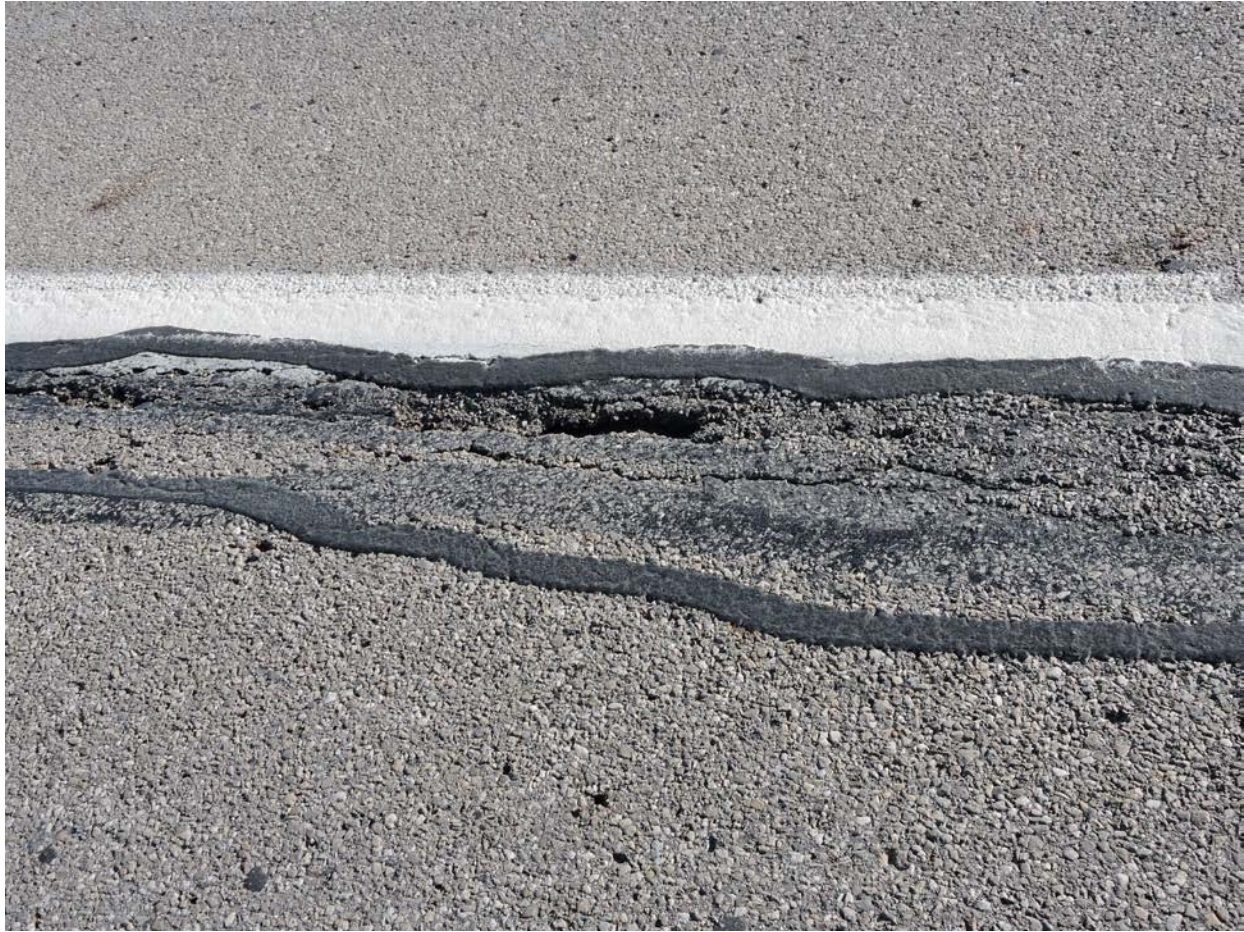
Figure 9-3. Section of spray patching that has broken down with secondary cracking.
