Longitudinal Joint Repair Best Practices for the Ohio Department of Transportation

Keeping Ohio's Pavement Joints Zipped Up

July 2017

Final Report

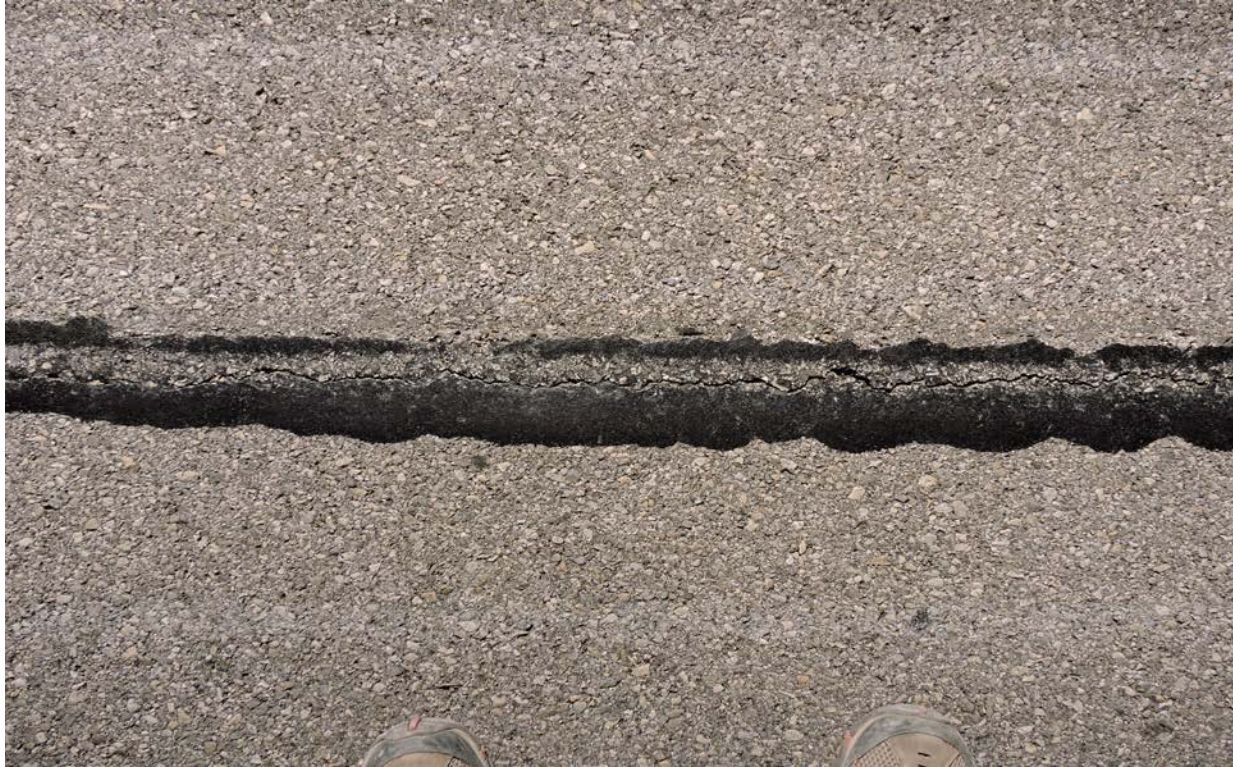
Figure 11-1. Typical crack sealing section with deterioration in center of seal

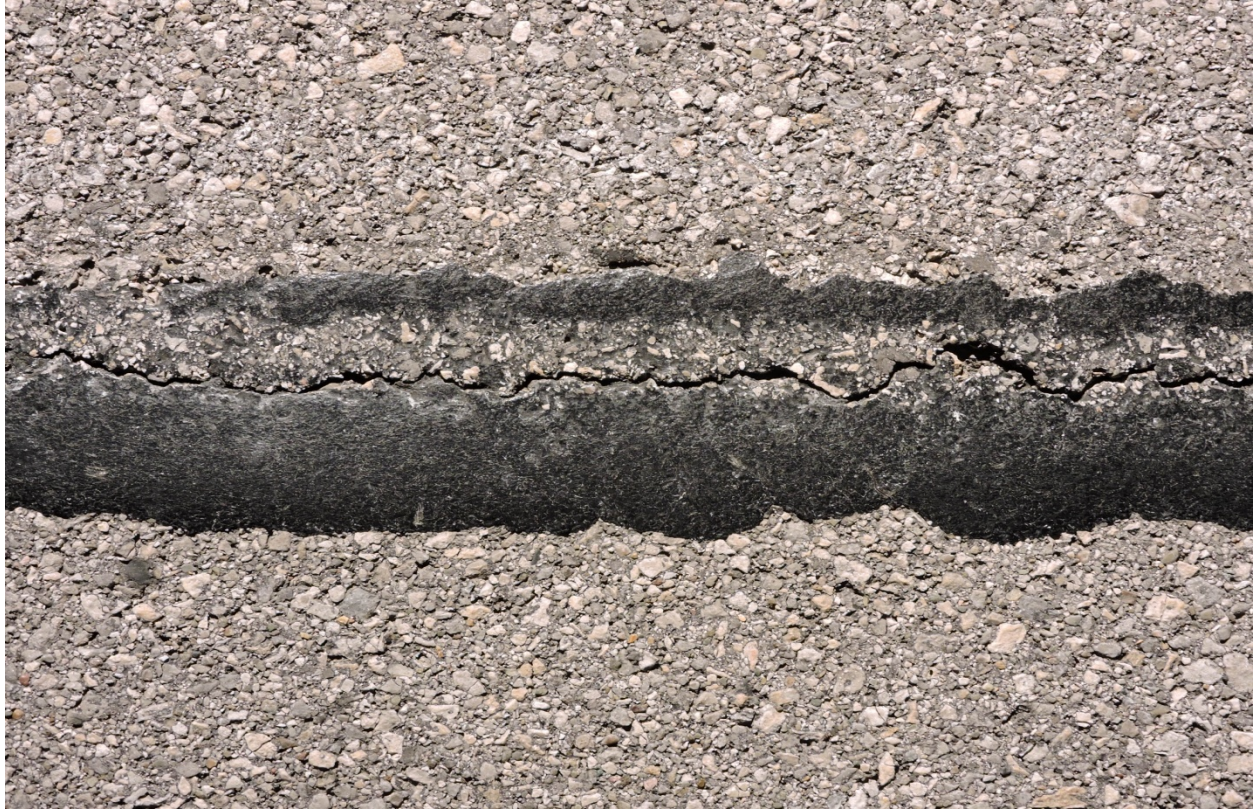
Figure 11-2. Typical cracking through the crack seal material.

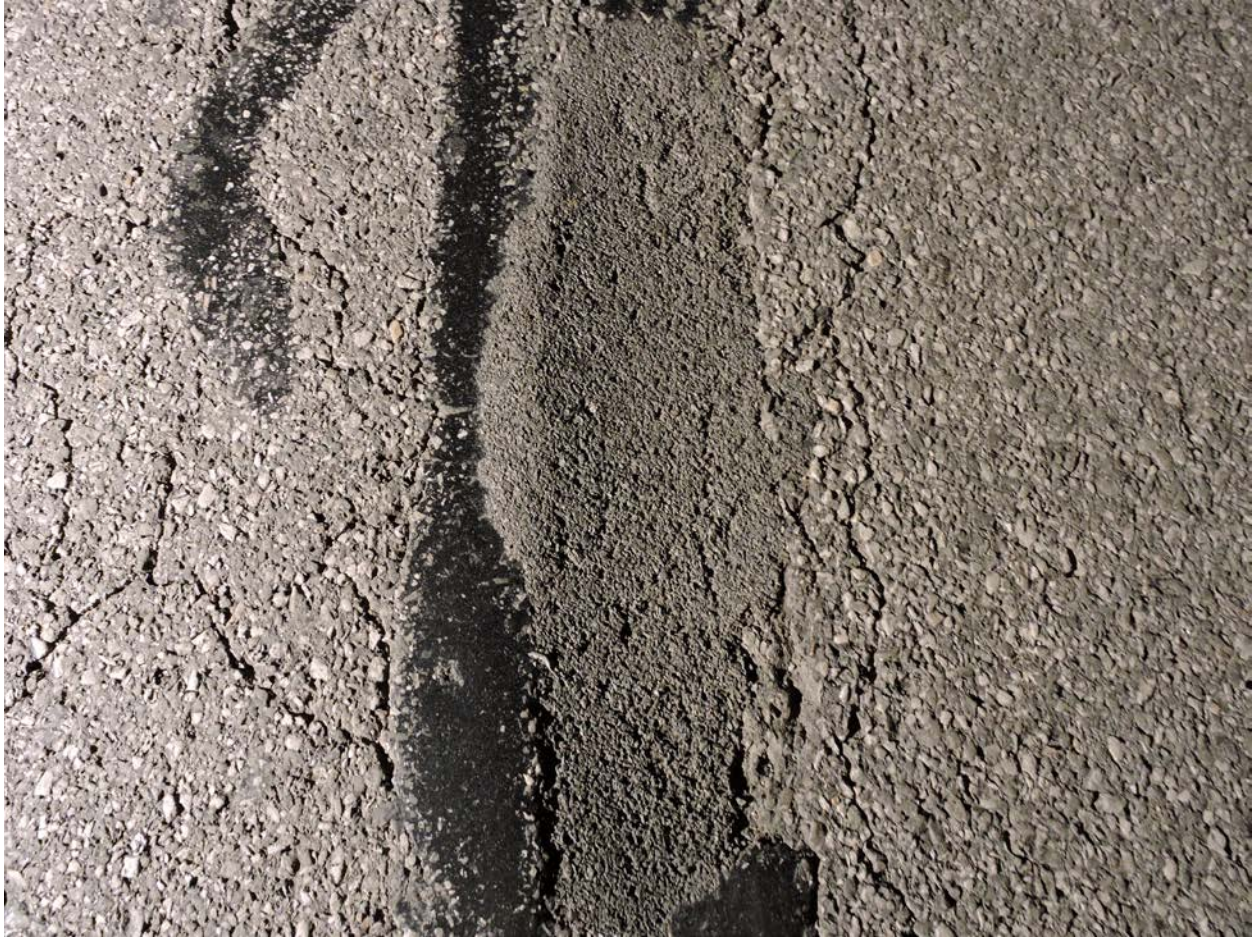
Figure 11-3. Area repaired due to large separation in longitudinal joint.

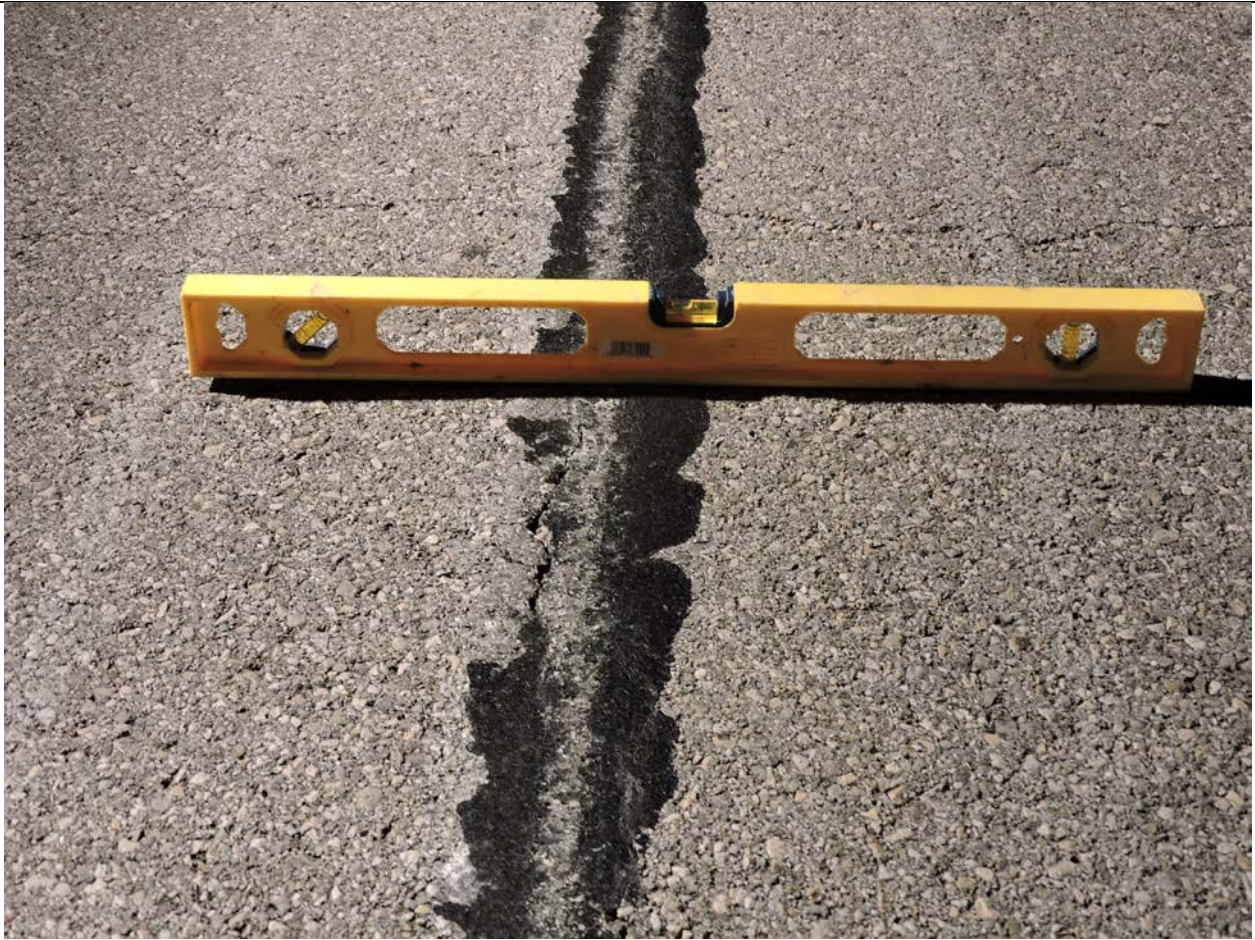
Figure 11-4. Slight mound in the crack seal

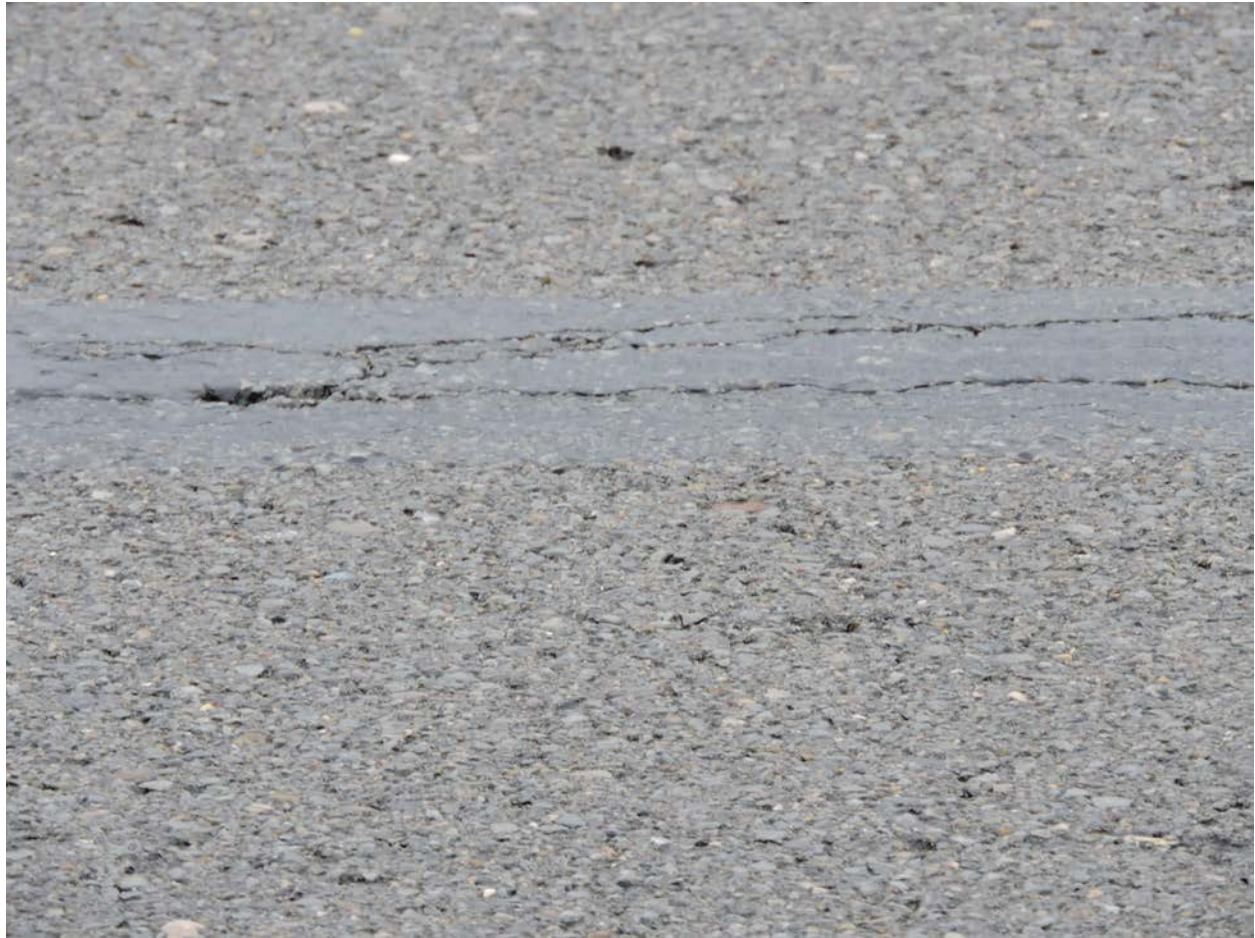
Figure 12-2. Perpendicular secondary cracking.

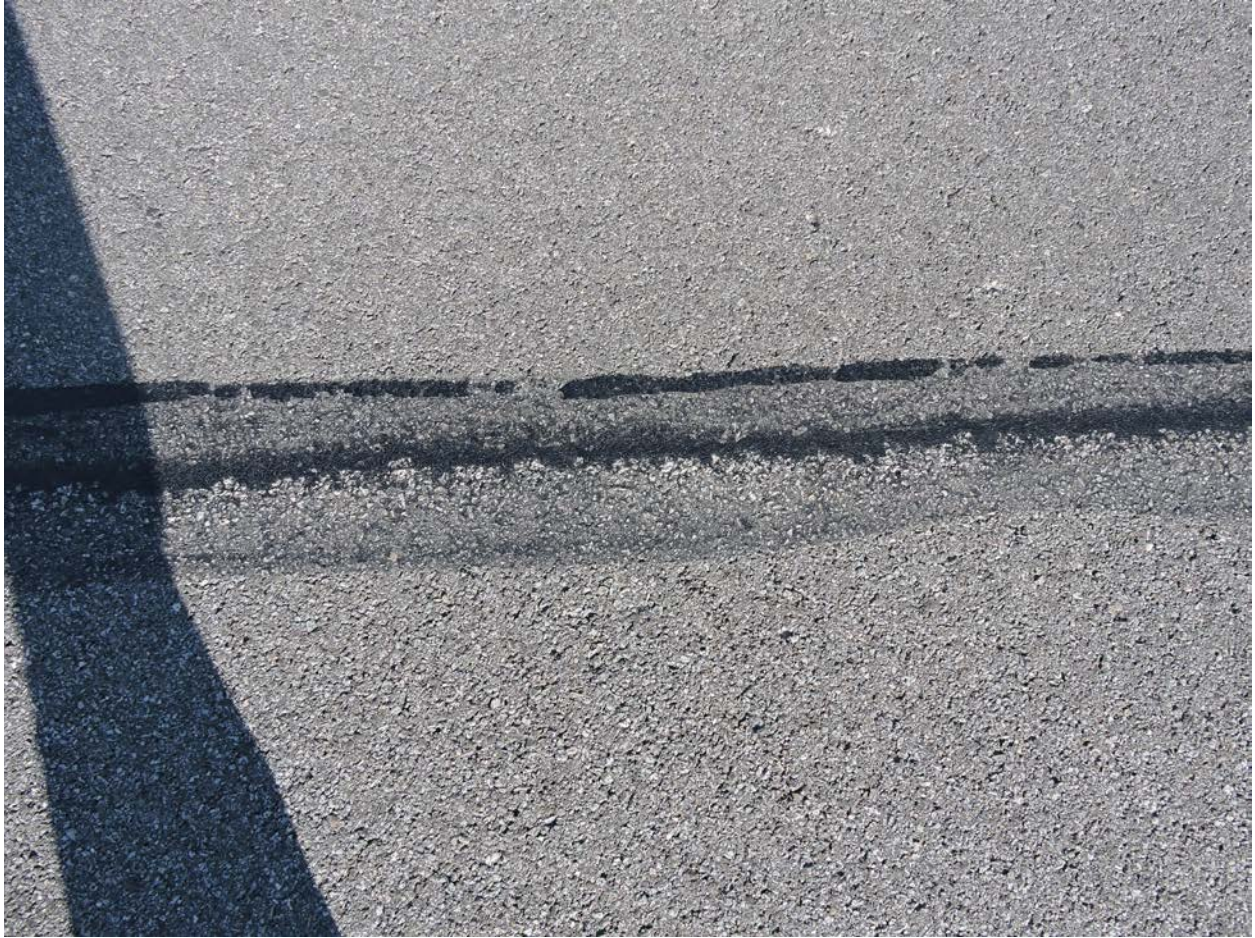
Figure 12-3. Section of crack sealing showing signs of wear.
