"CAPTIVE COLUMN" CRASH TESTS

March 1981
Final Report

1. Report No. FHWA/ RD-81/501		2. Government Accession No.		3. Recipient's Catalog No.	
4. Title and Subtitle "Captive Column" Crash Tests Crash Testing of a Light Standard Luminaire Pole.				5. Report Date March 1981

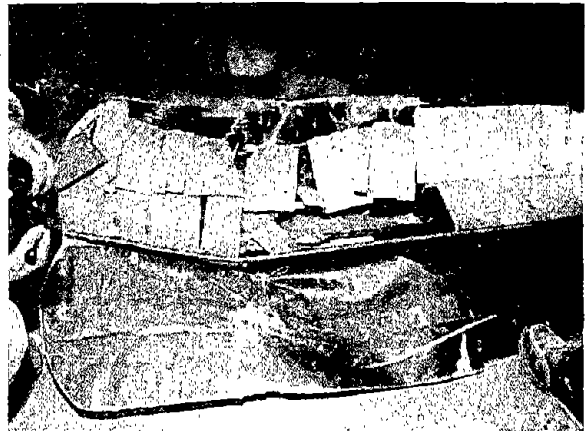
Upon completion of the four impact tests, the fiberglass covering on light standard four was cut away approximately three feet (3') (9.0 dm) above the point where the standard was fractured from the impact (Figures 4 and 24). Upon examination it was noted that the structure wire binding the rod and frame together did not unravel as a result of the impact, nor were any of the rods broken.

Figure 4. Internal structure following impact. The collapse was in the area of impact and did not destroy total integrity of geometric design.

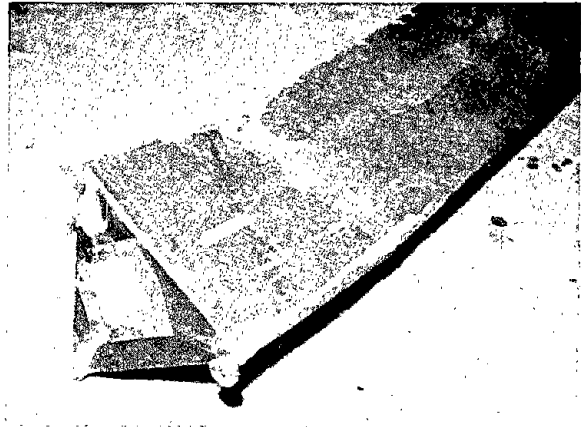
In run No. 1, the test vehicle traveled at a speed of 22.4 mph (9.96 m/s). The light standard was mounted on a slip base and was impacted at 1'9" (5.25 dm) above the base. A breakaway bushing was found 4'9" (14.25 dm) directly forward of the base. The light standard was fractured 2'8" (7.2 dm) above the point of impact. The remainder of the light standard appeared to be intact. The test vehicle came to rest 46'10" (14.05 m) from the point of impact. Damage to the test vehicle was insignificant with the only noticeable damage being paint smudges on the leading edge of the hood, on the right front of the roof and on the right rear of the trunk lid (Figures 11 and 13). These smudges were from the light standard when it passed over the top of the vehicle and were not damage to the vehicle paint. There were also two small dents in the test vehicle; one was approximately 1½" (3.75 cm) long and 1/8" (0.31 cm) deep at the forward edge of the roof on the driver's side, and the other approximately 1/2" (1.25 cm) long and 1/8" (0.31 cm) deep in the windshield molding above the driver's seat. The base of the standard hit the trunk lid of the vehicle as the vehicle passed under the standard, but it caused no damage other than the paint smudge.

Figure 12. Extent of damage to light standard shown for test run #1. Note: Sheared bushing (lower left) which broke loose at impact. See text under results for explanation.

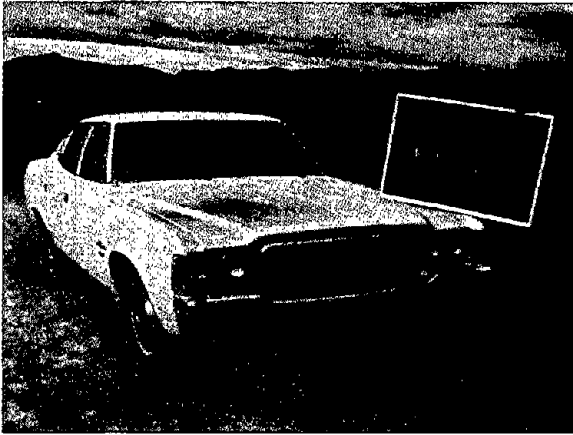
Figure 13. Test vehicle prior to test run #2. Limited amount of damage from test #1 is apparent.

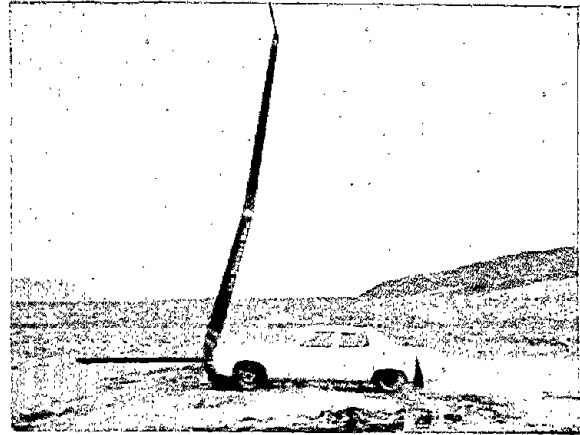
Figure 14. Impact during test run #2. Note: Fracture at midpoint in light standard. See text for explanation.

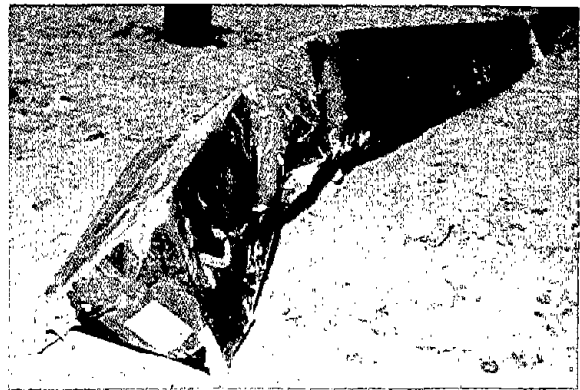
In run No. 2, the test vehicle was traveling at 24.0 mph (10.67 m/s) and impacted the standard 1'10" (5.5 dm) above the base, which was a fixed base. After breaking away from its base the light standard was pushed 16'5" (4.93 m) by the test vehicle before rotating up and over the test vehicle. All rods affixed to the base plate separated above the top retaining nut. The light standard was fractured at a point 2'10" (8.5 dm) above the impact point with a second fracture occurring 14' (4.2 m) from the top of the light standard (Figure 14). The second fracture occurred as a result of the impact and not as a result of striking the ground. The second fracture was also noted to be at the point which connects the top and bottom sections of the column. The second fracture did not separate the two column halves and the column fell as a unit structure. Of the three base plate nuts, with the remaining rod portion intact, only the one on the left rear attachment (farthest from impact) was still secured tightly. The forward bolt (left front) and the right center bolt were loose in their mounting.

Figure 16. Extent of light standard damage shown for test run #2. Sheared rods shown at bottom of standard; also, midpoint fracture can be seen above lettering.

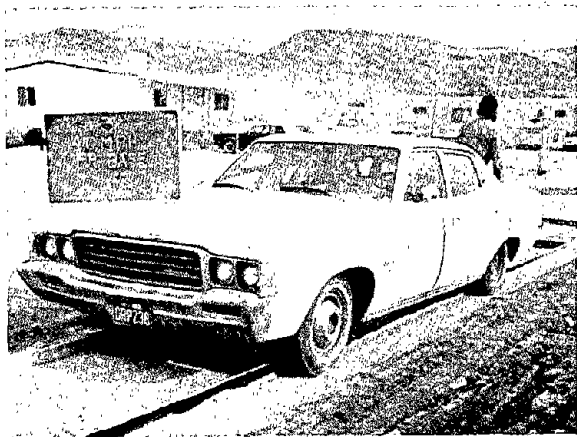
Figure 17. Test vehicle prior to test run #3. Vehicle damage is minimal following test #2 which was the most violent of the four test runs.

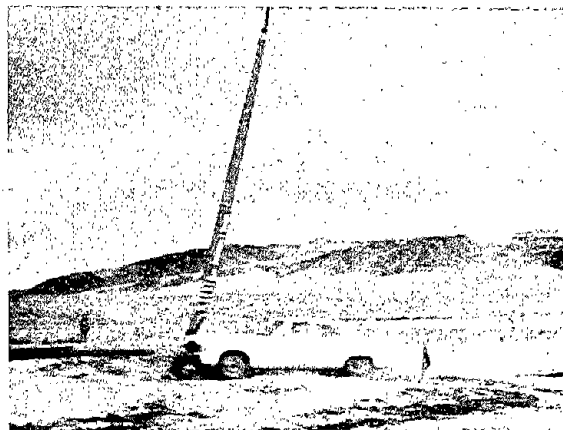
Run No. 3 was made at 38.1 mph (16.93 m/s) and the light standard was mounted on a slip base. The light standard was impacted by the test vehicle 1'9" (5.25 dm) above the base (Figure 18). The extreme right bolt of the slip base sheared off at impact and upon examination it appeared that the nut securing the breakaway bushing had been tightened to the point that the bushing could not rotate, thus putting all impact energy directly into the base plate bolt. The light standard, after separating from the base plate, was pushed 21' (6.3 m) by the test vehicle before it rotated up and over the vehicle. The light standard was fractured at a point 4'4" (13.0 dm) above the point of impact. The remainder of the column appeared to be intact.

Figure 18. Impact during test run #3. Breakaway was quick in this and run #1 due to the use of a slip base in both tests.

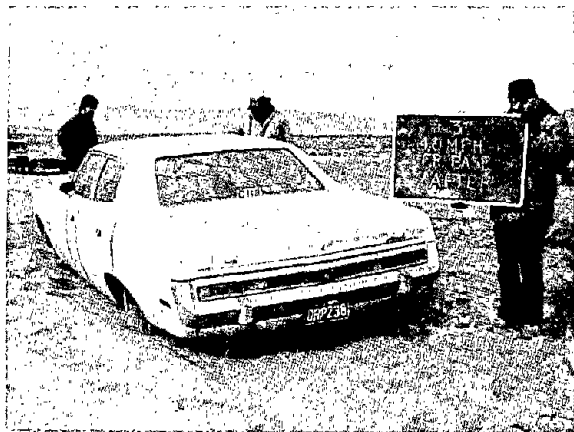
The test vehicle came to a stop 55'4" (16.6 m) from the point of impact. There were only two small paint smudges in the center of the hood and one on the right front of the roof of the test vehicle following impact (Figures 19 and 21).

Figure 19. Test vehicle in braking area following test run #3. Damage to rear deck is shown.

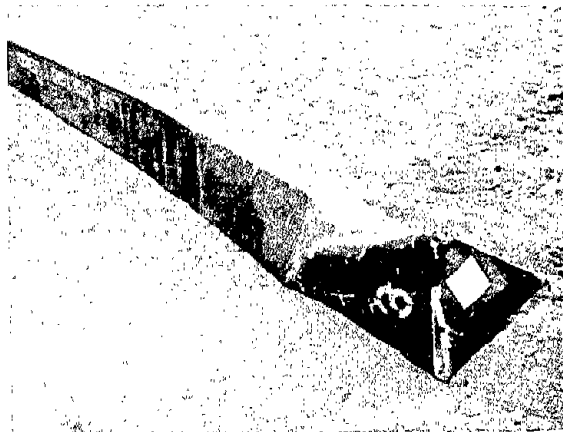
Figure 20. Extent of damage to light standard is shown to be slight. Sheared rod (lower left) with missing bushing is pictured at the bottom of light standard. See text for explanation.

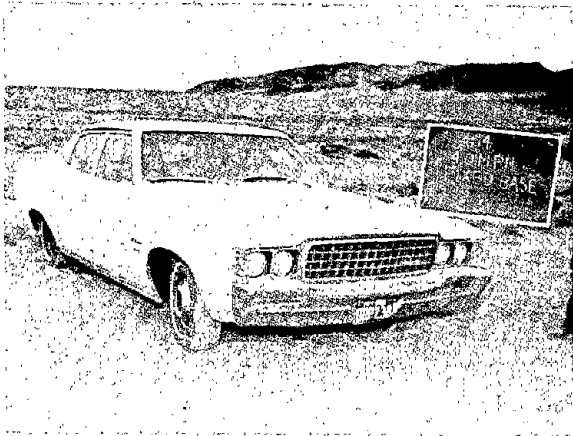
Figure 21. Test vehicle prior to test run #4. Prior test run marks circled in black to distinguish each mark made by test run number.

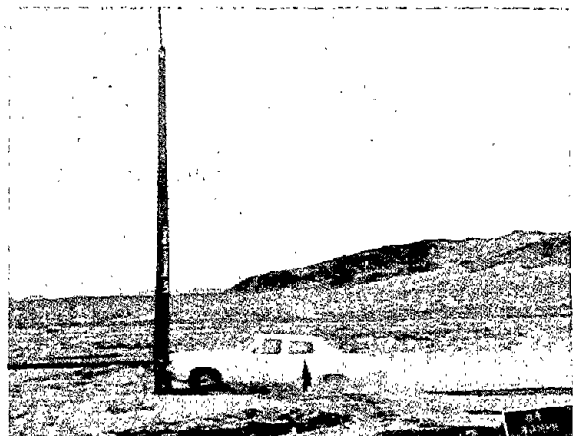
In run No. 4 the light standard was mounted on a fixed base and the test vehicle speed was 39.9 mph (17.73 m/s). The impact point was 1'9" (5.25 dm) above the base of the standard (Figure 22). The front rod of the light standard was stripped out of the threads of the bottom retaining nut upon impact and was later determined not to have been seated to the same depth as the other two rods. The other two rods were sheared off over the retaining nuts as in the previous test at 20 mph (8.9 m/s). The light standard was fractured at a point three feet (3') (9.0 dm) above the impact point. The remainder of the standard appeared to be intact. The test vehicle pushed the light standard 14'11" (4.48 m) off the base before it rotated up and over the vehicle.

Figure 22. Impact point during test run #4. A secondary fracture did not occur on this fixed base run as it did in test run #2.

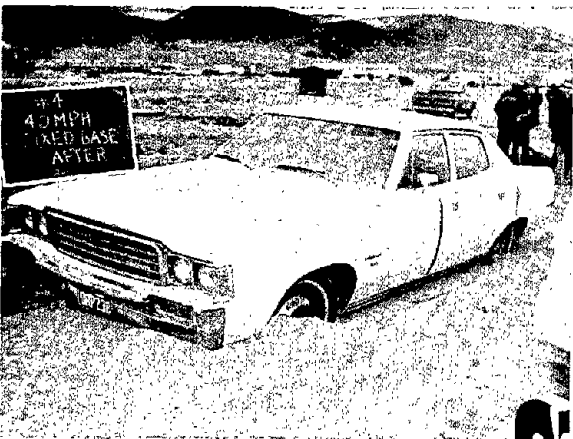
Following the test vehicle halt in the sand pit, examinations revealed no damage was sustained (Figure 23). Viewing films at a later date confirmed the suspicion that the standard had not touched the test vehicle in any way following impact. The test vehicle came to rest in run No. 4 at a point 62'9" (18.83 m) from the point of impact.

Figure 23. Test vehicle in braking area following test run #4. No new damage was noted following test run #4.

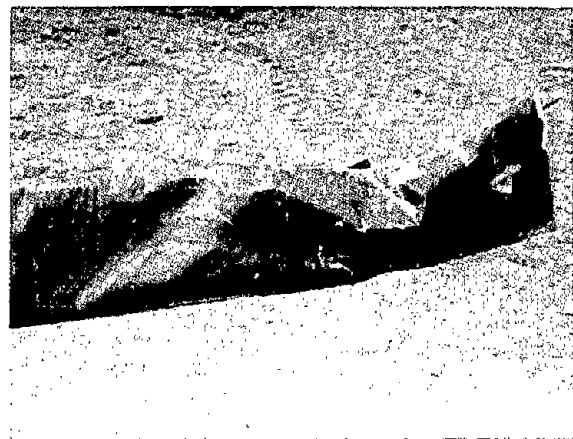
Figure 24. Extent of damage to light standard is shown to be greater on the fixed base runs than for the slip bases.

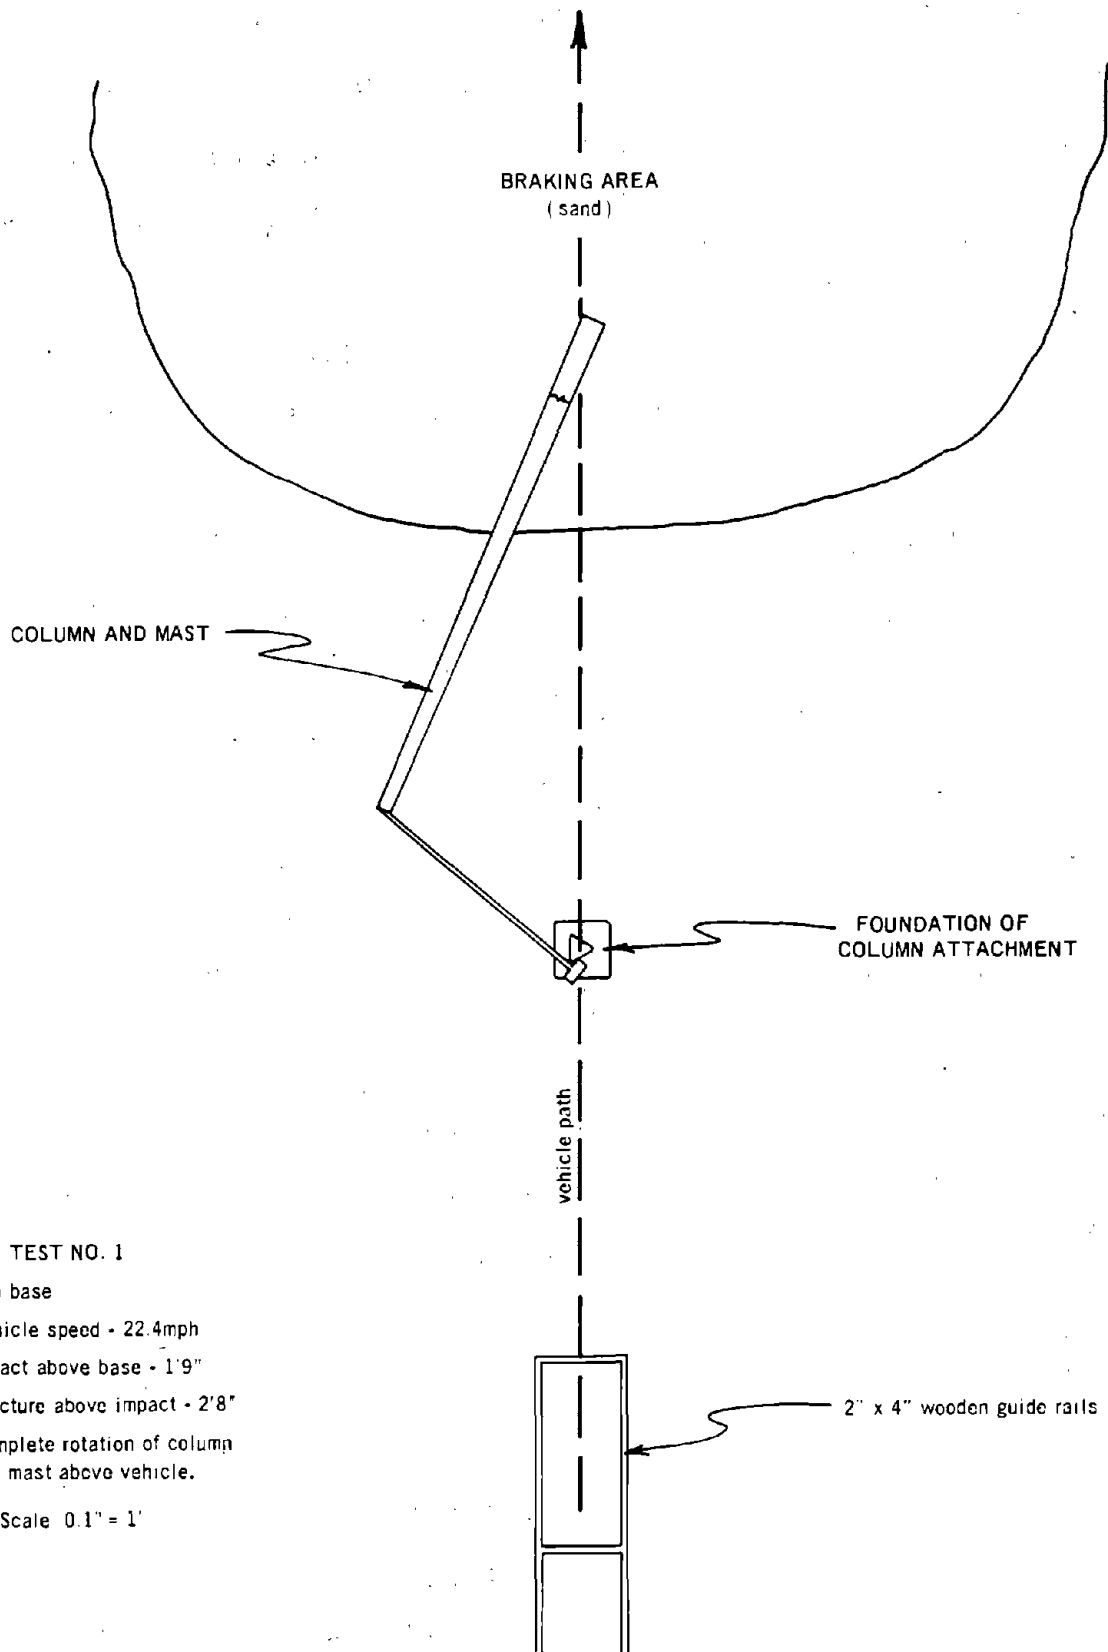
Figure 29. Resting position of column and mast after impact in test No. 1

1. The top of the light standard was 12'6" (3.75 m) forward of the base and 53° to the left of the base.
2. The bottom of the light standard was 32'9" (9.83 m) forward of the base and 1° to the right of the base.
3. The top of the luminaire arm was 1'3" (3.75 dm) directly to the rear of the base.

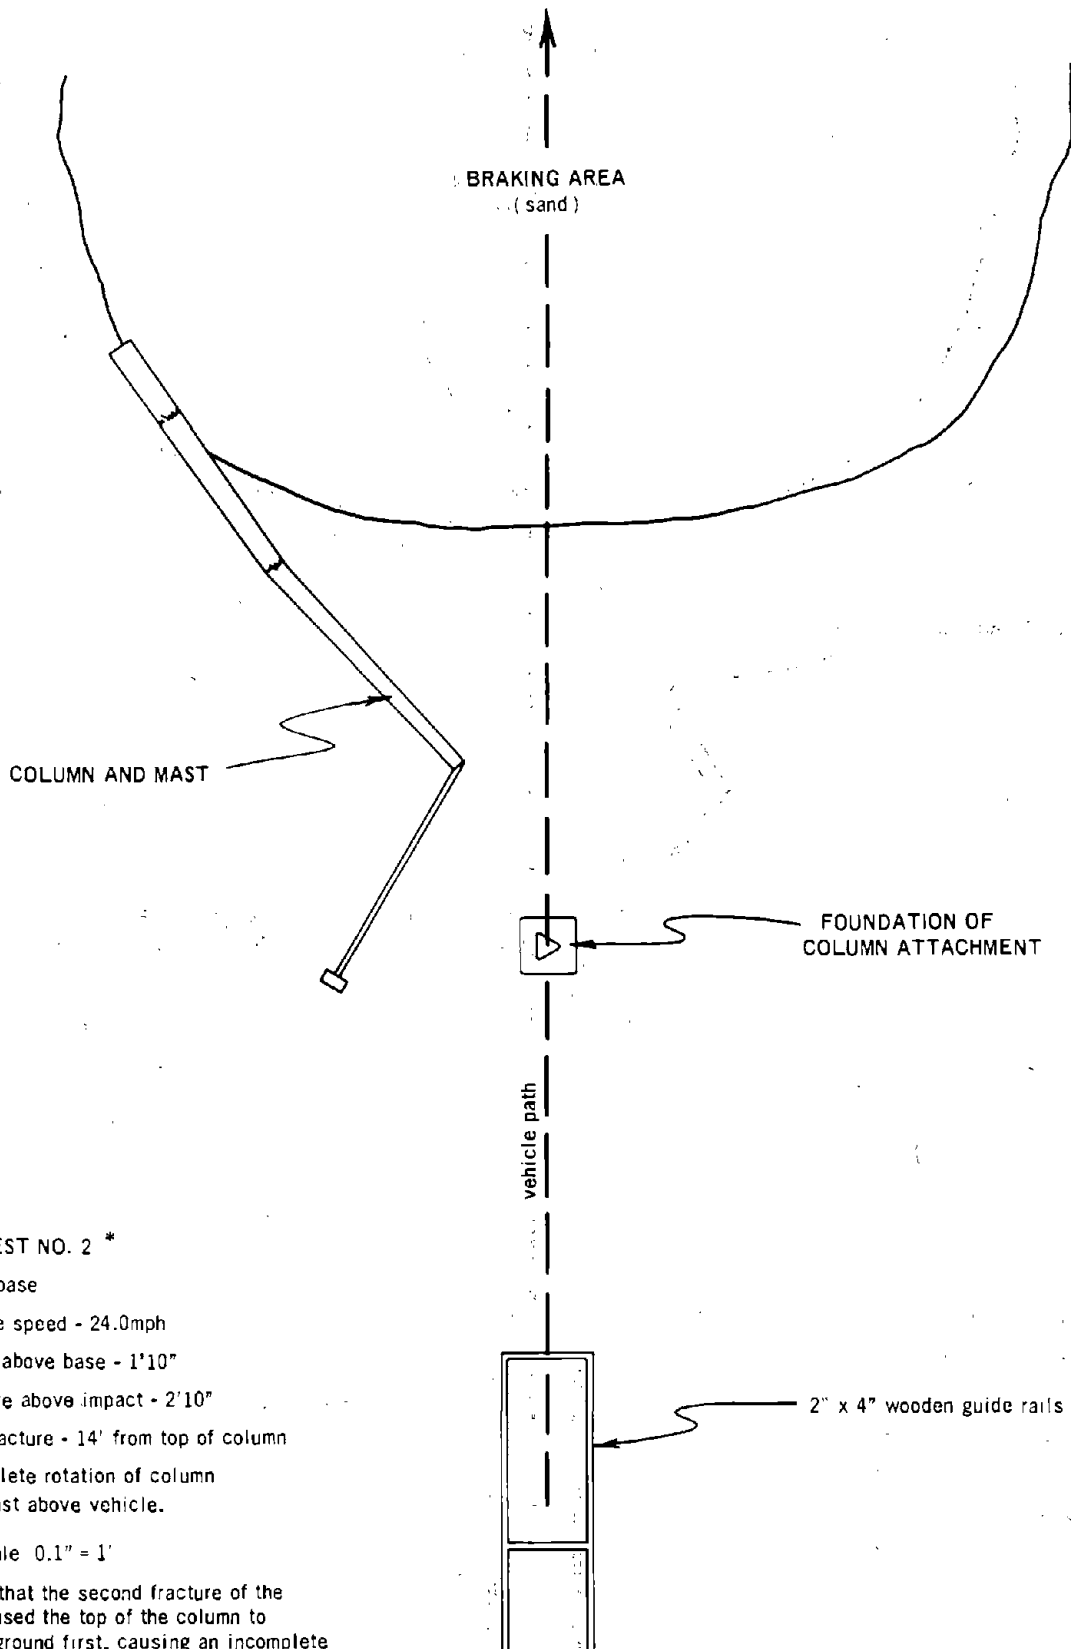
Figure 30.- Resting position of column and mast after impact in test No. 2

1. The top of the standard was 10'6" (3.15 m) forward of the base and 25° to the left of the base.
2. The bottom of the standard was 38'5" (11.53 m) forward of base and 35° to the left of the base.
3. The top of the luminaire arm was 11'7" (3.48 m) to the left of the base and almost parallel with the base.

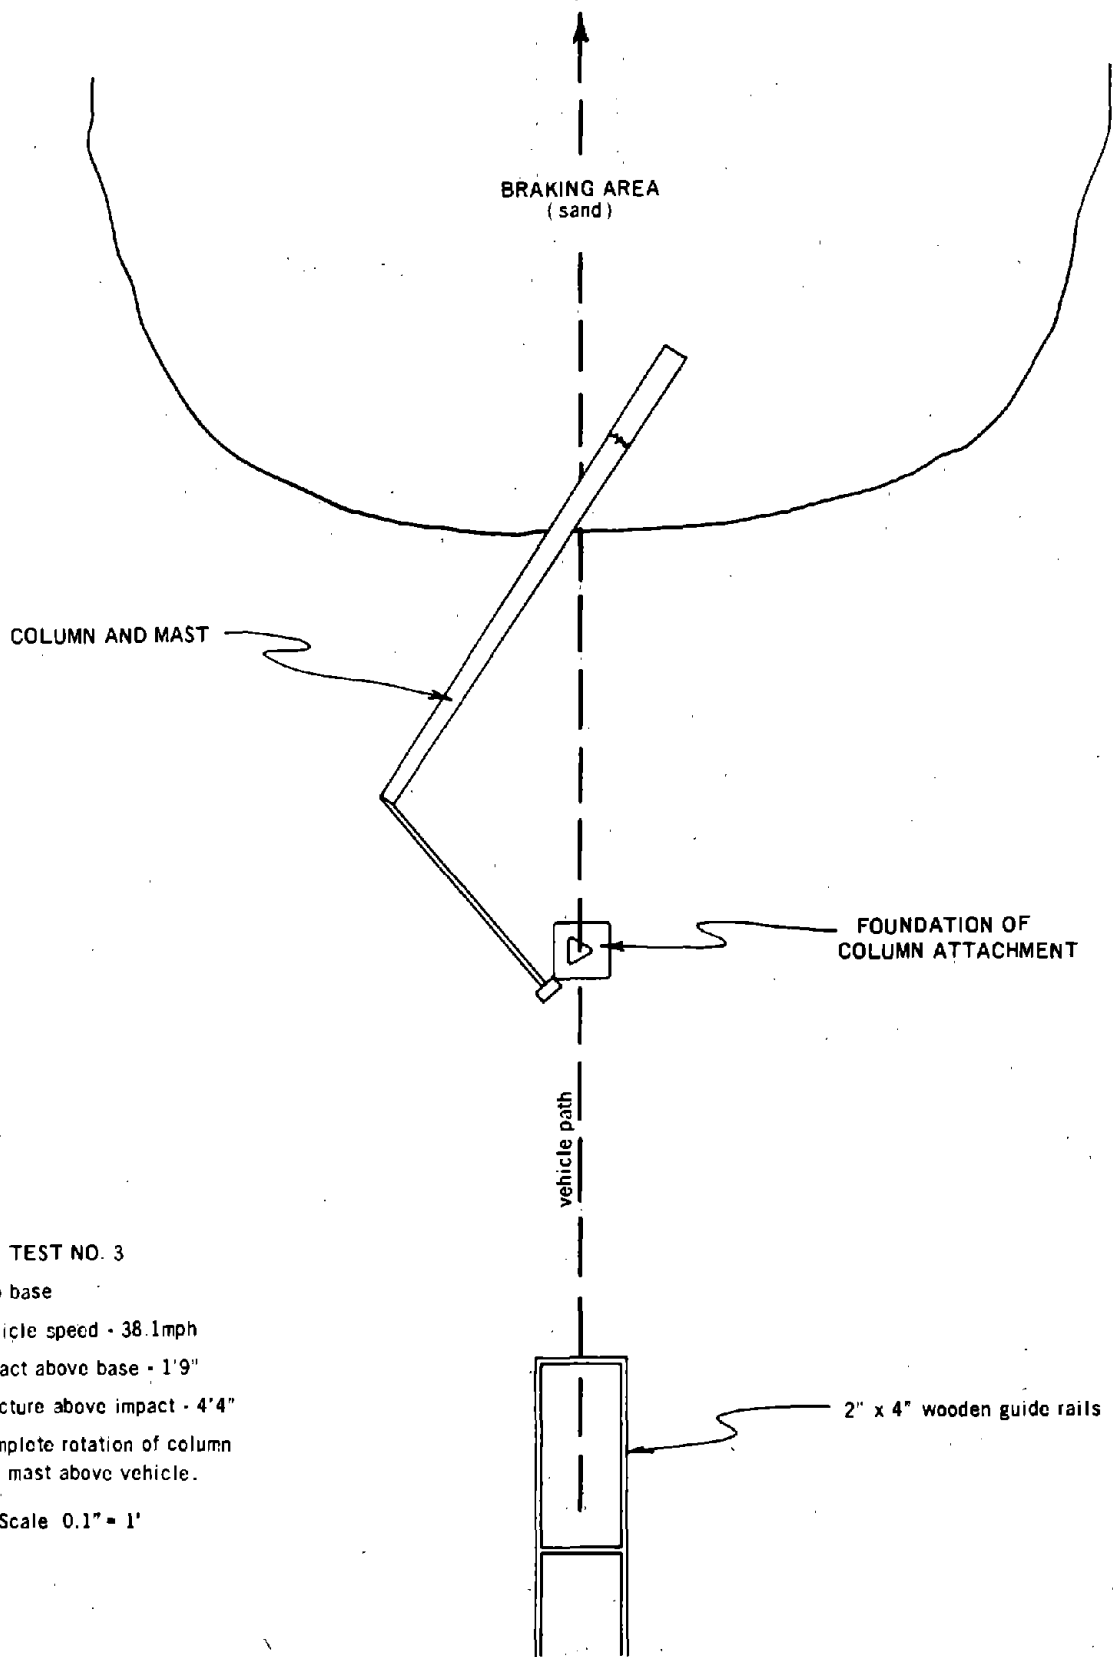
Figure 31. Resting position of column and mast after impact in test No. 3

1. The top of the light standard was 12'9" (3.83 m) forward of the base and 52° to the left of the base.
2. The bottom of the light standard was 31'5" (9.43 m) forward of the base and 9° to the right of the base.
3. The top of the luminaire arm was 2'10" (8.5 dm) from the rear of the base.

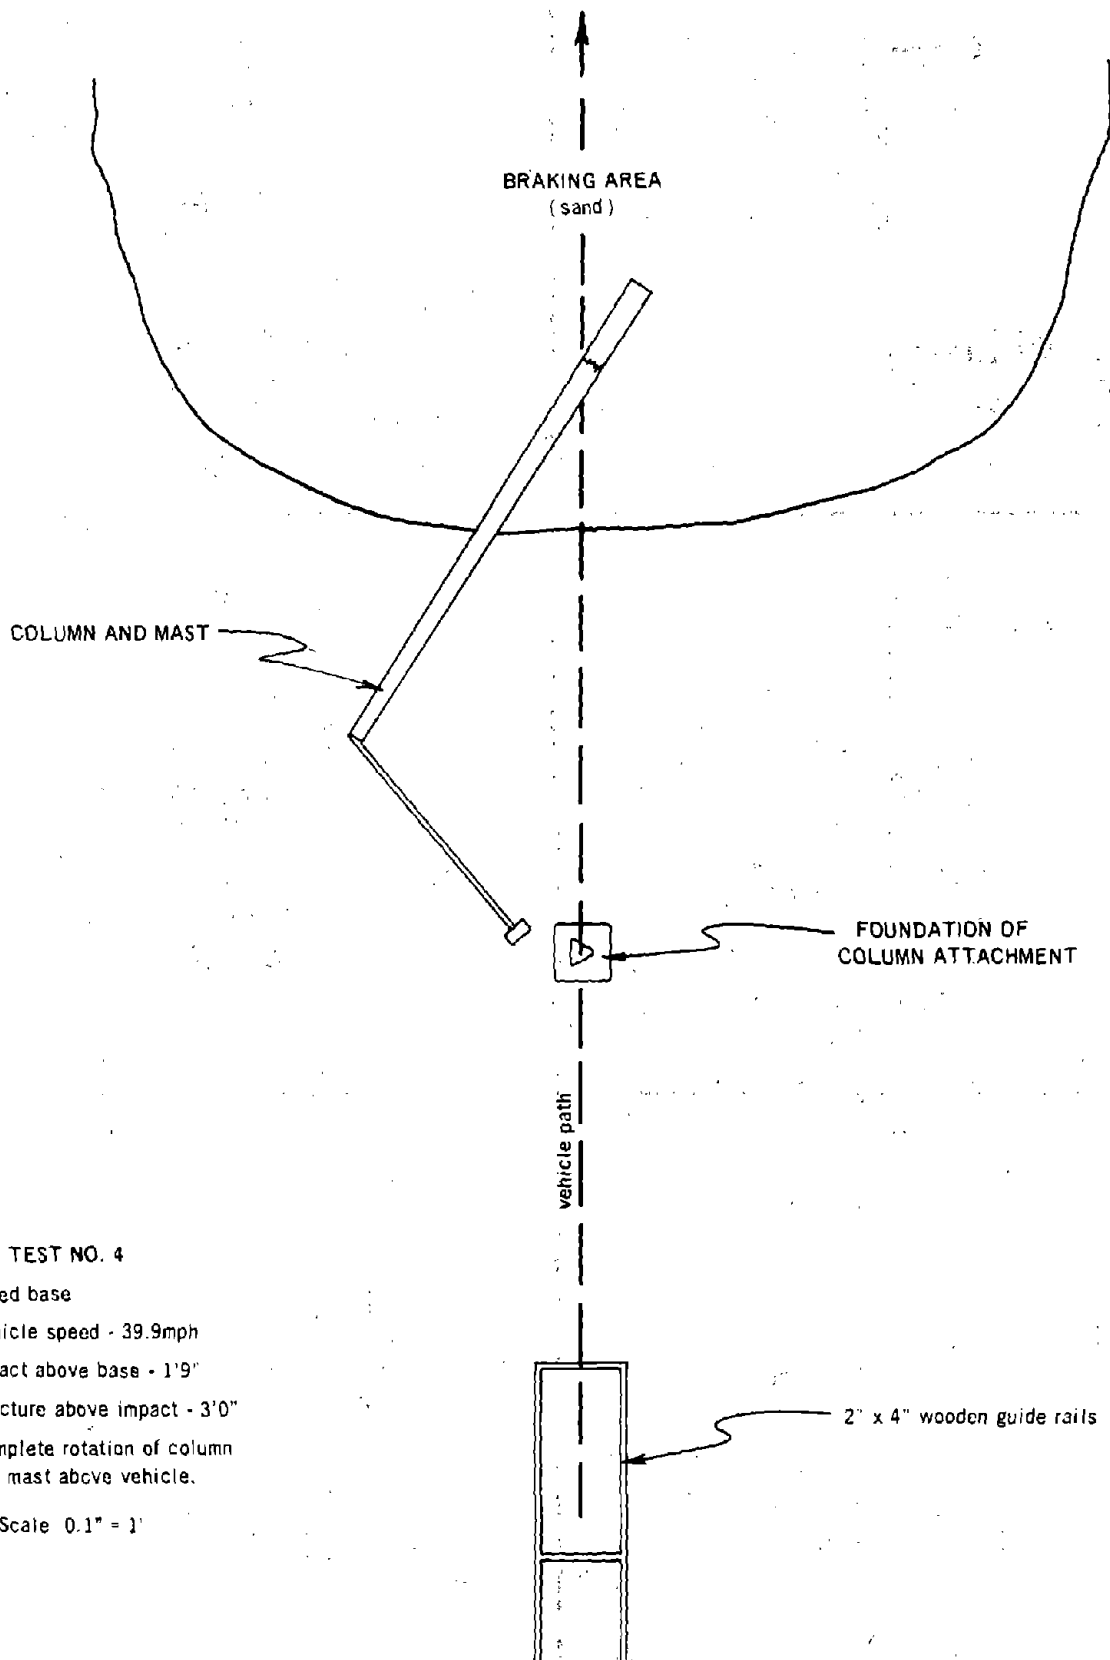
Figure 32. Resting position of column and mast after impact in test No. 4

1. The top of the light standard was 16'7" (4.98 m) forward of the base and 45° to the left of the base.
2. The bottom of the light standard was 34'4" (10.3 m) forward of the base and 5° to the right of the base.
3. The top of the luminaire arm was 3'4" (10.0 dm) directly left of the base.

- o Fixed base
- o Vehicle speed - 39.9mph
- o Impact above base - 1'9"
- o Fracture above impact - 3'0"
- o Complete rotation of column and mast above vehicle.

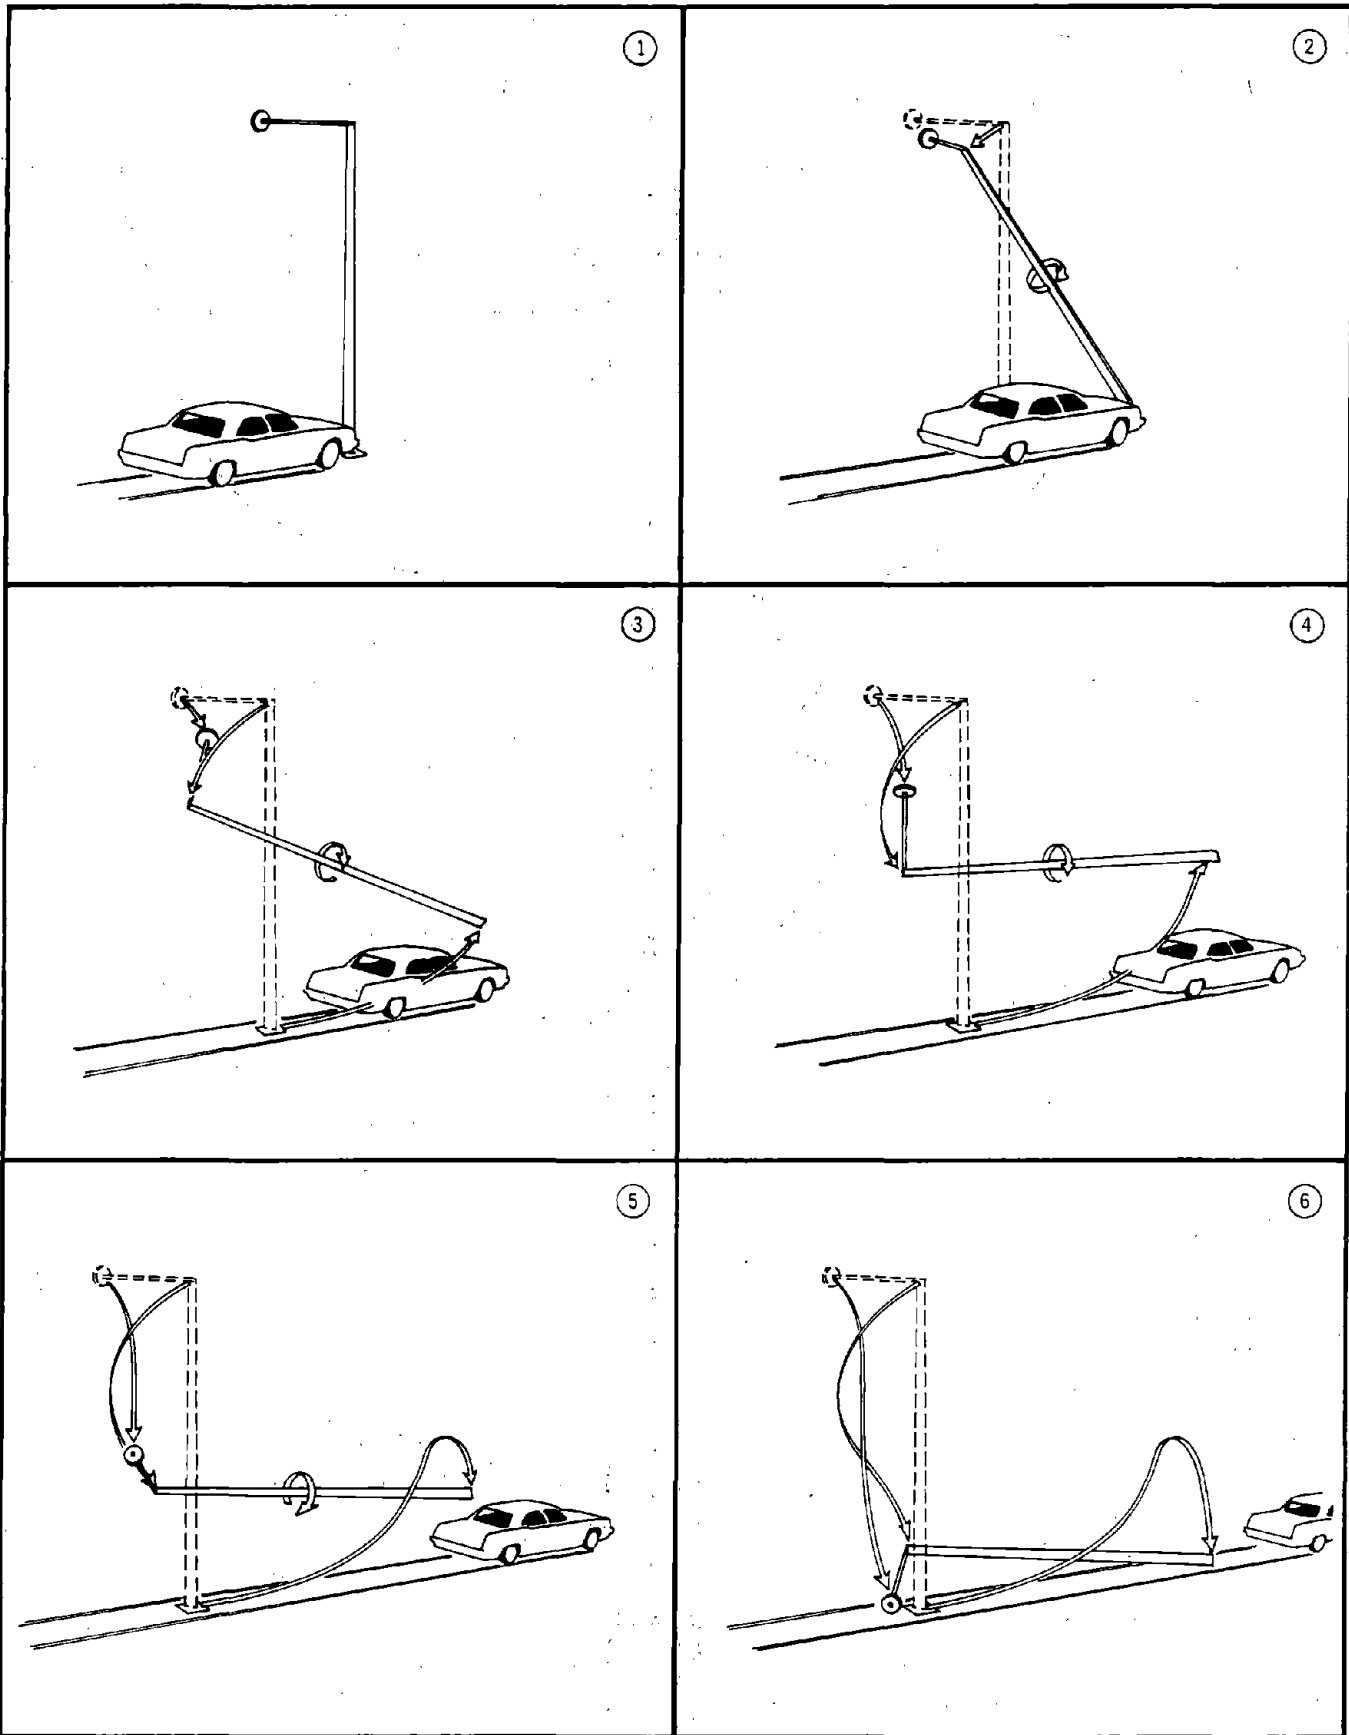
Figure 33. General direction, rotation and landing position of impacted column and mast arm.

The "Captive Column" light standard, with 35 lbs. (15.75 kg) of weight on the luminaire arm, landed in approximately the same position after each impact, regardless of the base used or speed of impact (Figure 33). The resting position of the light standard after impact would have created an insignificant hazard to oncoming or following vehicles.
