Texas Tech University Multidisciplinary Research in Transportation

# **Research on Joint Sealant Materials to Improve Installation and Performance: Final Report**

Research Project 0-6826 Research Report 0-6826-1 http://www.techmrt.ttu.edu/reports.php

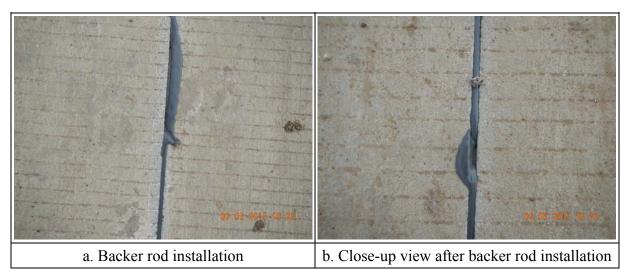
Figure 2.10 Inadequate sealant installation

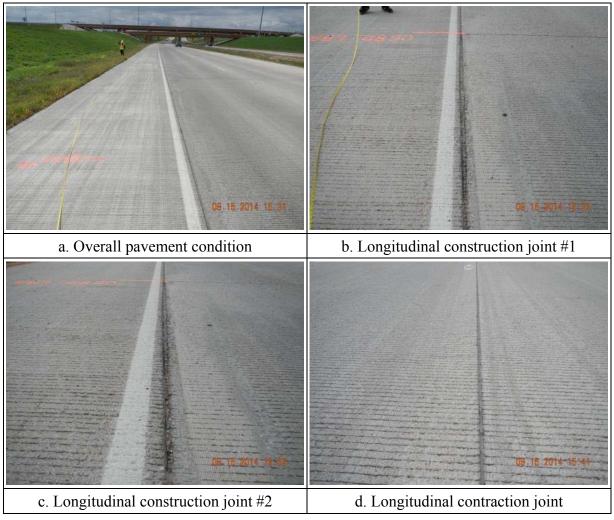
Figure 3.3 Sealant condition on US 82-LBB [NO. 29]

Figure 3.3 shows a typical sealant condition in CRCP where the pavement age is less than 10 years old. The NO at the end of the figure label indicates the project number in Tables 3.1 through 3.3. This pavement was built in 2011 in the Lubbock District. As shown in Figures 3.3(b) and (c), although the pavement is only three years old, minor distress in the form of chipping occurred due to inadequate saw cuts in longitudinal construction joints. On the other hand, the condition of the sealant at longitudinal contraction joint was excellent, as shown in Figure 3.3(d).

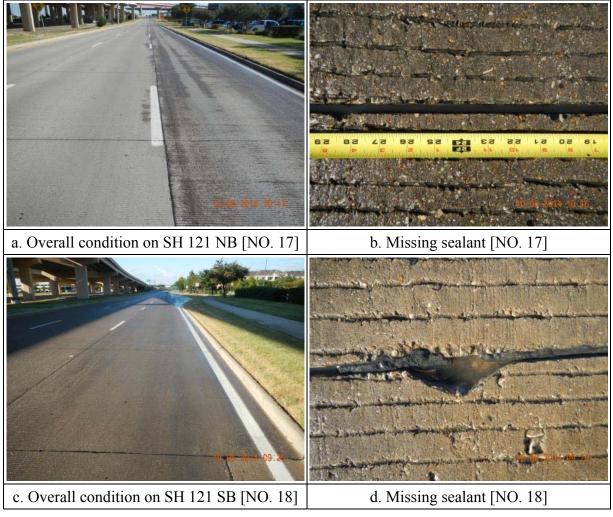
Figure 3.4 Sealant condition on SH 121-DAL [NO. 17 and NO. 18]

It was a rainy day when the section was surveyed. Water was observed in the joint areas where joint sealant was missing, which indicates that the areas seem to serve as a reservoir for rainwater. It also indicates that it is difficult for rainwater to permeate into the pavement base layer through joints even when joint sealant is missing. Figures 3.4(c) and (d) show the pavement condition on SH 121 SB. It is observed that water stayed at the joint even though sealant was missing. The overall condition of the pavement was quite good.

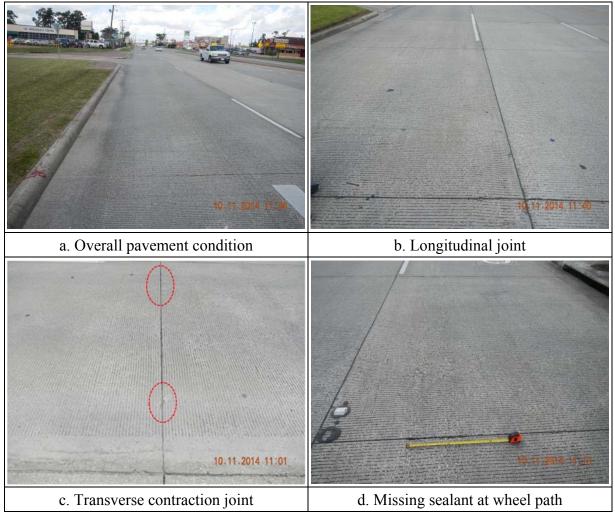
Figure 3.5 Sealant condition on US 90 BR-BMT [NO. 27]

Figure 3.5 shows the adhesion failure in the wheel paths on US 90 Business Rd in the Beaumont District. This section was completed in 2005. It is observed that the adhesion failure occurred near the wheel paths. The cause for the adhesion failure of sealant near the wheel paths is not known.

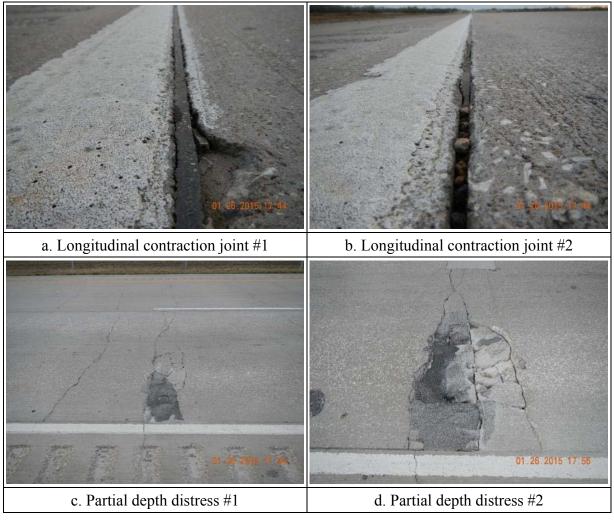
Figure 3.6 Sealant condition on IH 35-LRD [NO. 42]

Figures 3.6(a) and (b) show the sealant condition at longitudinal contraction joint on IH 35 in Webb County, Laredo District, which was built in 2002, showing adhesion failure, missing sealant, and spalling. However, distresses related to sealant issues were not observed. On the other hand, as shown in Figures 3.6(c) and (d), partial depth distresses were observed. This type of partial depth distress occurs when delamination exists at the depth of longitudinal steel. One of the reasons for delamination is an increased stress around longitudinal steel due to the applications of heavy wheel loading. The SCN of this section was estimated to be close to 0, which indicates a good sealant condition. The distress observed here is not related to the sealant condition.

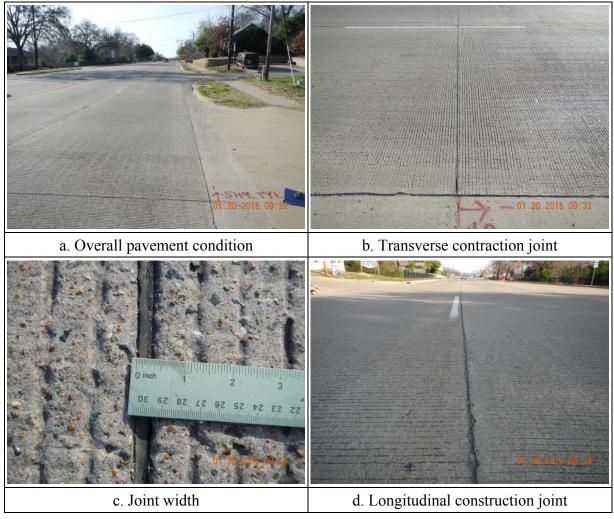
Figure 3.7 Sealant condition on SH 9-TYL [NO. 40]

SH 19 was built in May, 2003 with a 9-in CPCD over 4-in asphalt stabilized base in Van Zandt County, Tyler District. Figure 3.7(a) shows the overall pavement condition on SH 19. Figures 3.7 (b) and (c) show the transverse contraction joint and joint width, respectively. As shown in these two figures, adhesion failures were observed at transverse joints. Figure 3.7 (d) presents the longitudinal joint condition. Even though the pavement was 12 years old at the time of the condition survey, the overall joint condition was good.

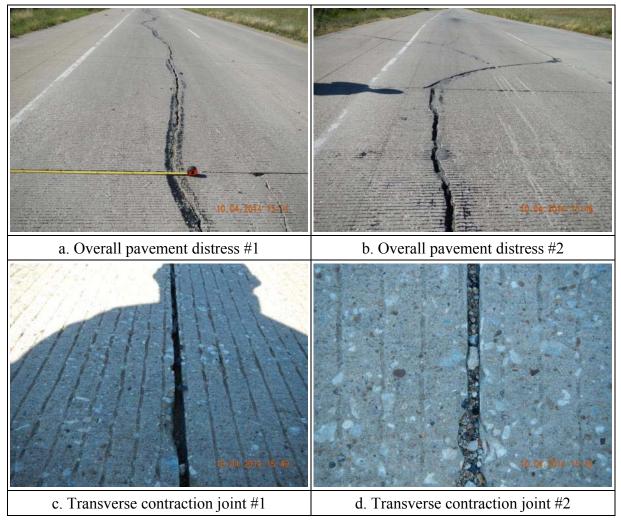
Figure 3.8 Sealant condition on SL 288-DAL [NO. 47]

Figure 3.8 shows the pavement condition on SL 288 in the Dallas District, which was built in 1999 with a 9-in CPCD. The survey was conducted on 14 October, 2014. This section was constructed with a 4-in. ASB (asphalt stabilized base) and 8-in. lime treated subgrade (LTS). Significant pavement distress was observed in the form of wide longitudinal cracks as shown in Figures 3.8(a) and (b). Most of the sealant in the transverse contraction joints were missing. However, the overall condition of the joints was good. The SCN was estimated to be at about 6, which implies the worst sealant condition. It implies a rather poor correlation between SCN and overall joint condition.

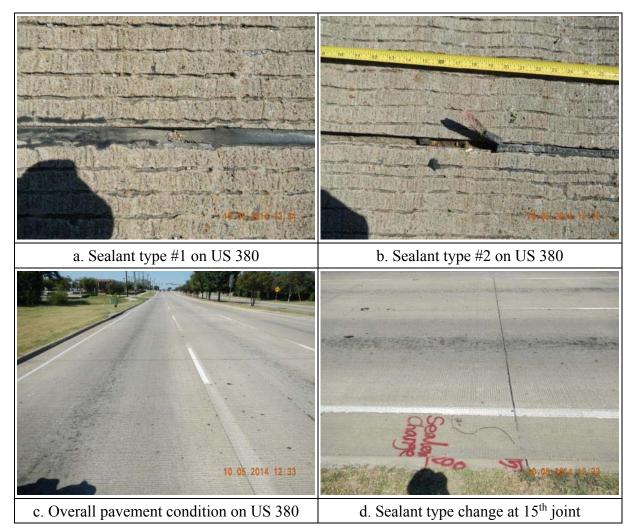
Figure 3.11 Sealant condition on US 380-DAL [NO. 39]

US 380, built in 1994 with a 9-in CPCD in the Dallas District, was investigated on 5 October, 2014. As shown in Figures 3.11(a) and (b), two types of sealant were applied when the resealing was conducted. As can be seen Figure 3.11(a), no missing sealant or adhesion failure was observed where the sealant type #1was used. On the other hand, as shown in Figure 3.11(b), missing sealant and adhesion failures were observed where the sealant type #2 was used. However, field survey results show that the overall joint and pavement condition was good regardless of sealant types, as shown in Figure 3.11(c). This result implies that the SCN and seal rating (SR) of joints may have a weak correlation with pavement performance. In other words, the mean of SCN and SR indicates only the condition of the joint sealant, not necessarily the performance of joints or pavement.

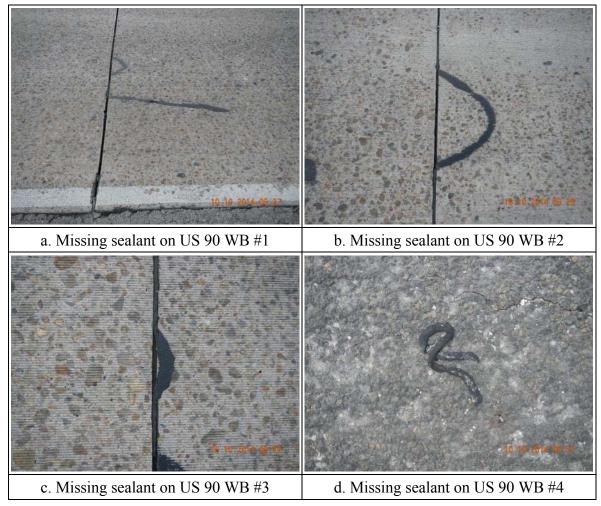
Figure 3.13 Sealant condition on US 90 WB-BMT [NO. 32]

Figures 3.13(a), (b), (c), and (d) show the missing sealants on US 90 WB. It appears that diamond grinding operation caused extrusion of the sealant.

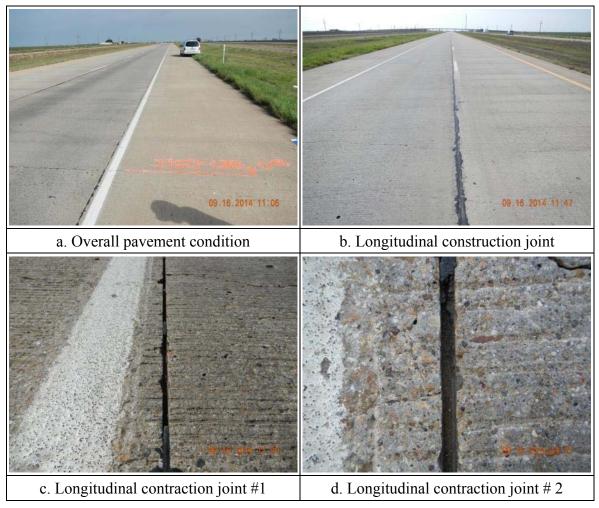
Figure 3.14 Sealant condition on IH 27-LBB [NO. 46]

Field survey results on CRCP indicate that, regardless of pavement ages, joint or pavement performance does not appear to be affected by the condition of sealants.

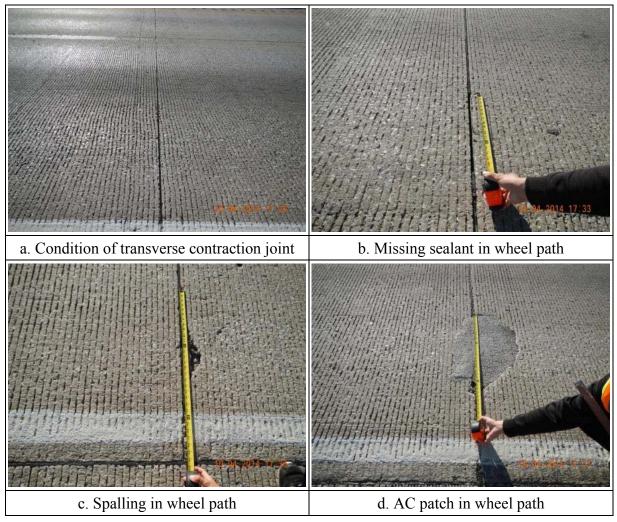
Figure 3.15 Sealant condition on IH 35-DAL [NO. 45]

Figure 3.15 shows the pavement condition on IH 35 in Denton County, Dallas District. In 1988, this section was overlaid with 11-in CPCD over 2-in asphalt interlayer, on top of existing 10-in CPCD. The original CPCD was built in 1960, which means that the 10-in CPCD provided 28 years of service before the unbounded overlay was applied. The condition of transverse contraction joints was in a good condition except for a few joints. A missing sealant was observed in the wheel paths as shown in Figure 3.15(b) and spalling was observed as shown in Figure 3.15(c). Also, an asphalt concrete patch was applied at large spalled areas in transverse contraction joints, as shown in Figure 3.15(d).

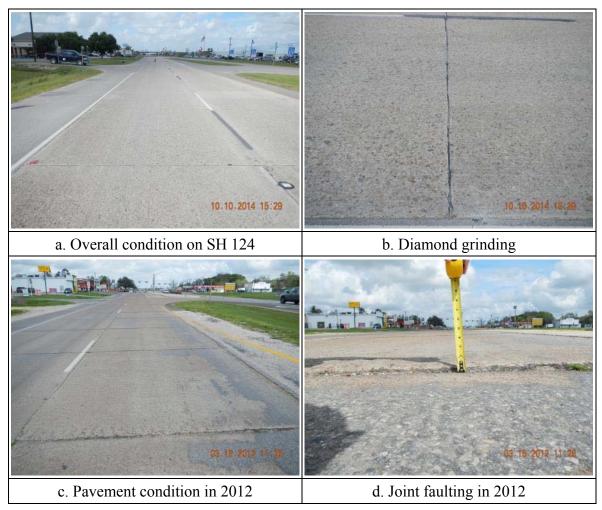
Figure 3.16 Sealant condition on SH 124-BMT [NO. 57]

SH 124 in Chambers County, Beaumont District was built in 1962 with a 10-in CPCD. The age of the pavement when the condition survey was conducted was 52 years. Dowel bars were not used in this section. Diamond grinding was done to correct joint faulting as shown in Figures 3.16(a) and (b), which also shows missing sealants. When the section was surveyed in 2012 for the rigid pavement database project (0-6274), severe faulting was observed as illustrated in Figures 3.16(c) and (d). It appears that diamond grinding was applied to correct faulting and diamond grinding might have caused the breakage of sealants.

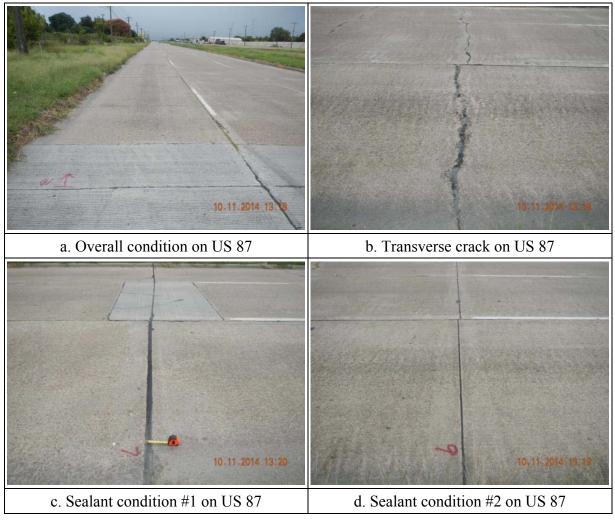
Figure 3.17 Sealant condition on US 87-BMT [NO. 61]

US 87 was built in 1951 with a 9-in JRCP in Jefferson County, Beaumont District. The age of pavement when the condition survey was conducted was 63 years. Figure 3.17(a) shows the overall pavement condition on US 87. Several concrete patches were installed at transverse expansion joints. In addition, transverse cracks occurred in most JRCP slabs and were sealed as shown in Figure 3.17(b). Figures 3.17(c) and (d) show the transverse expansion joint condition.

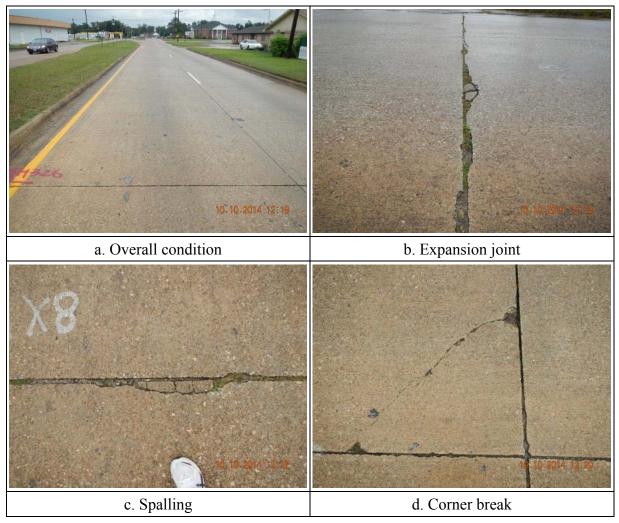
Figure 3.18 Sealant condition on SH 326-BMT [NO. 55]

SH 326 was constructed in 1967 with 10-in JRCP over 4-in cement stabilized base. The field survey was conducted on October, 2014. As shown in Figure 3.18, sealant was not present at all joints. Minor spalling was observed at some joints as shown in Figures 3.18(b) and (c), which might have occurred due to missing sealants, resulting in 'a high severity rating related to water infiltration criteria.' All the joints were also filled with dirt or other materials, which implies that the number affecting the SCN in terms of incompressible material is 'a high severity debris or stone retention rating.' Because of these two criteria for estimating the SCN, the SCN was estimated at 6.

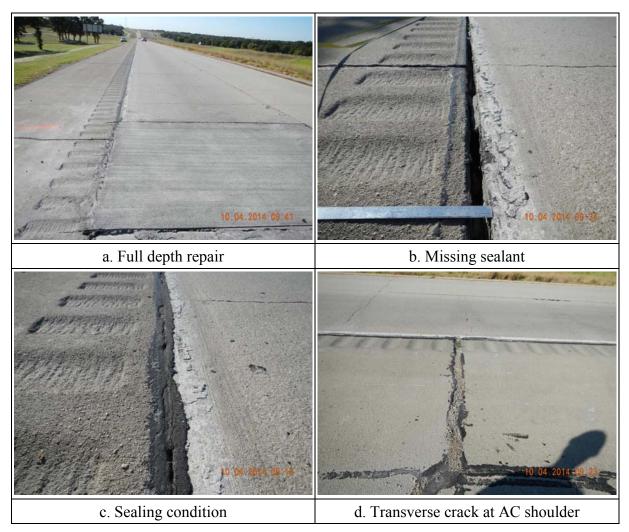
Figure 3.21 Sealant condition on US 287-WFS [NO. 51]

available to keep the concrete lanes and asphalt shoulders tight, the best option would be to keep the joints sealed.

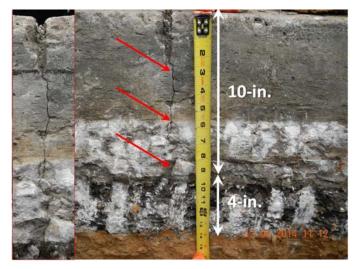
Figure 4.6 Joint condition on SH 288

little deficient; however, a crack developed under the saw cut. The overall condition of the joint was good.

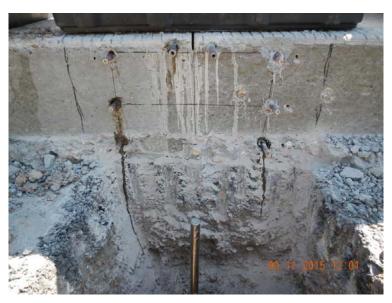
Figure 4.19 Joint condition before gage installation

Figure 4.19 shows joint condition after one day of concrete placement, which was September 11, 2015. It shows quite shallow saw cut depth at the edge of the slab. The cut is shallow because the concrete was placed with forms, and the saw cut operation was stopped a few inches away from the form. However, the saw cut depth was adequate through the joint except at the edge of pavement as shown in Figure 4.20. Figure 4.19 shows a crack already developed at the bottom of the saw cut.
