Construction Report 17-10 Underwater Fiber Reinforced Polymer (FRP) Wrap Experimental Project 1/30/18

Underwater FRP Wrap Experimental Project

Rices Bridge (#2715) over the York River

York, Maine

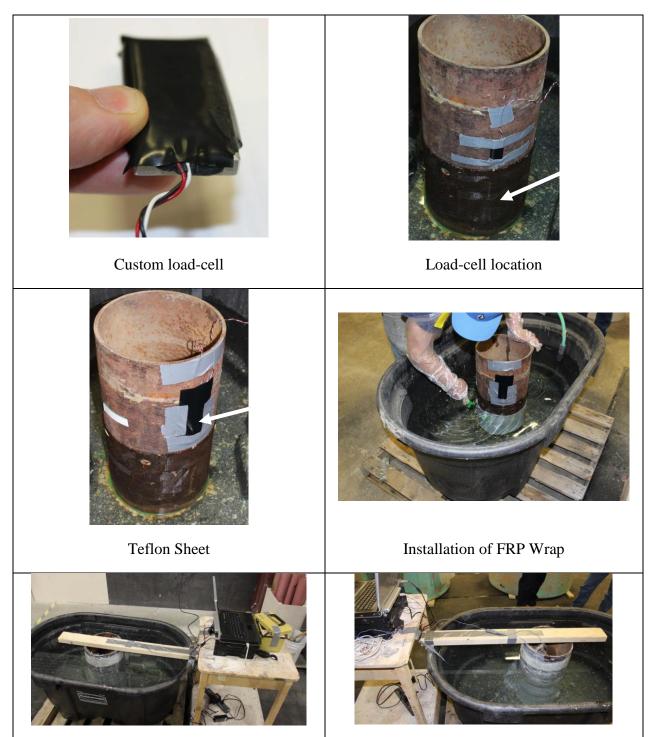
Mock-up after installation complete with thermocouples to monitor temperatures and load-cell

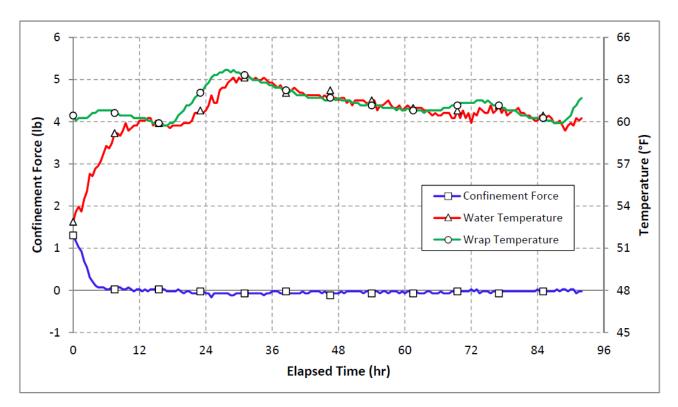
Instrumented mock-up after starting the data acquisition.
