**PROJECT NO. B371
ACOUSTIC EMISSION AND STRAIN GAGE MONITORING
OF WIDOT STRUCTURE B-5-158,
TOWER DRIVE TIED ARCH - GREEN BAY, WISCONSIN**

Technical Report #1

June 16, 1993

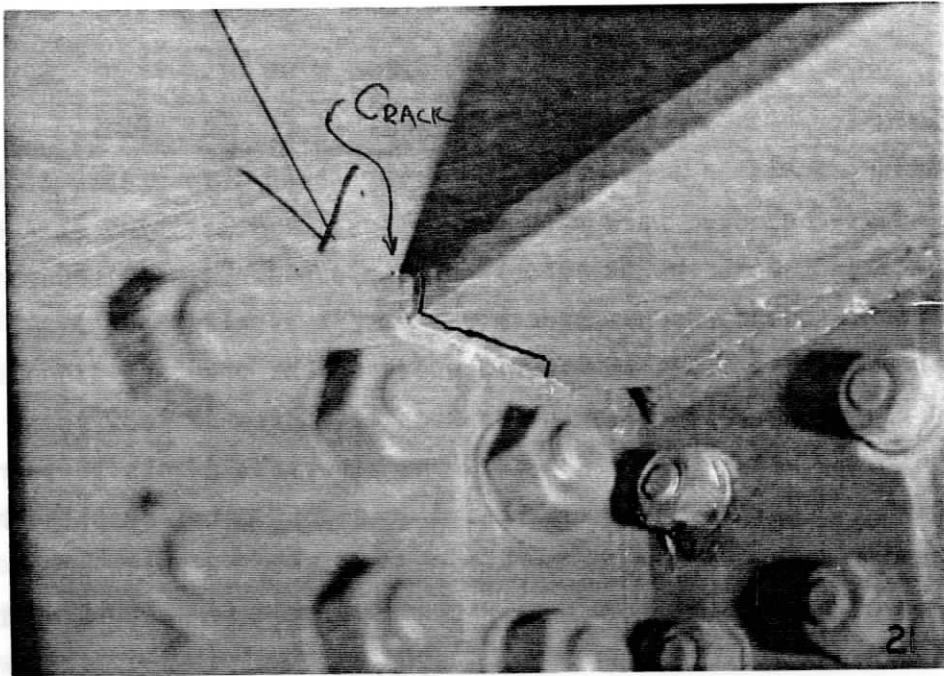
FIGURE 1. Typical test site inside tie girder

This approach is the only known way that AE can be successfully applied to details that are adjacent to or part of bolted splices. The fundamental problem with AE monitoring these details is the noise produced by the bolts. The bolt fretting imitates AE very well, and, if the area to be monitored is not locationally isolatable from the bolts, the noise rejection algorithm must be used to eliminate the irrelevant bolt noise. Figure 1 shows an overall view of a typical location inside the tie girder that was monitored during these tests. The end of the stiffener is adjacent to bolts in the hanger diaphragm, and the bolts

from the floor beam attachment run parallel to the stiffener. Clearly, there would be no way to locationally isolate these bolts from the areas being monitored.

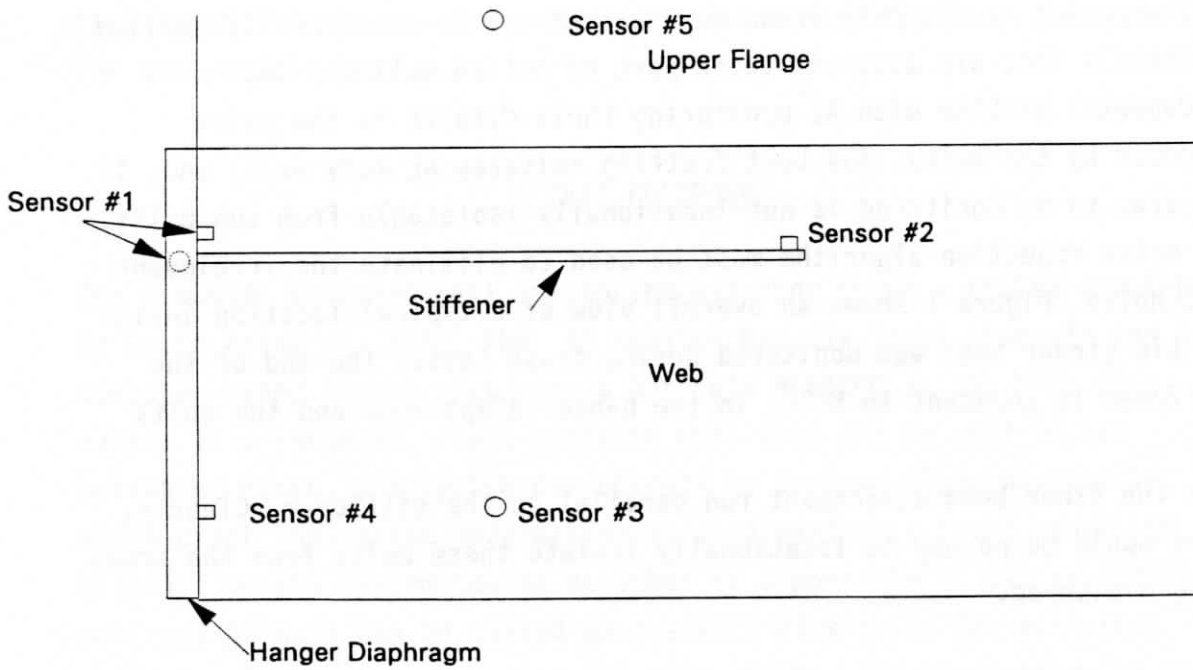
FIGURE 2. AE sensor layout

The AE sensors used for these tests were resonant devices with a pass band from 100 Khz to 300 KHz. A total of five sensors were used in an array as shown in Figure 2. Sensors 1 and 2 were the active monitoring sensors and were located so as to listen along a line that included the entire length of the stiffener. Sensor 1 was mounted in either of two positions depending on local conditions at the monitoring site. The first setup had Sensor 1 mounted on the outside surface of the tie girder on line with the stiffener in the gap between the splice plates that attached the floor beam to the tie girder. A second variation with Sensor 1 mounted on the hanger diaphragm approximately 1 inch above the stiffener top surface had to be used when the gap on the outside surface was too small to allow insertion of the sensor and its magnetic hold-down clamp. Calibration tests with a pulsed AE simulator showed that both setups worked in a satisfactory manner.

The remaining three sensors were used as guard sensors. These sensors were necessary to eliminate AE signals that originate from sources outside our linear location array. Proper source location is a critical element of the noise-rejection algorithm. Location is accurate to less than 1 inch along a line drawn between the Number 1 and 2 sensors. Any sources located outside of this linear array will be improperly located and cause errors in the noise-rejection process. The flaw model evaluates the order of receipt of the AE signal at the various array members. If the burst arrives at any of the guard sensors first, it is rejected. The array layout used for this set of tests was designed to eliminate bolt signals and other noise sources that originate far enough outside the listening array to cause locational errors.

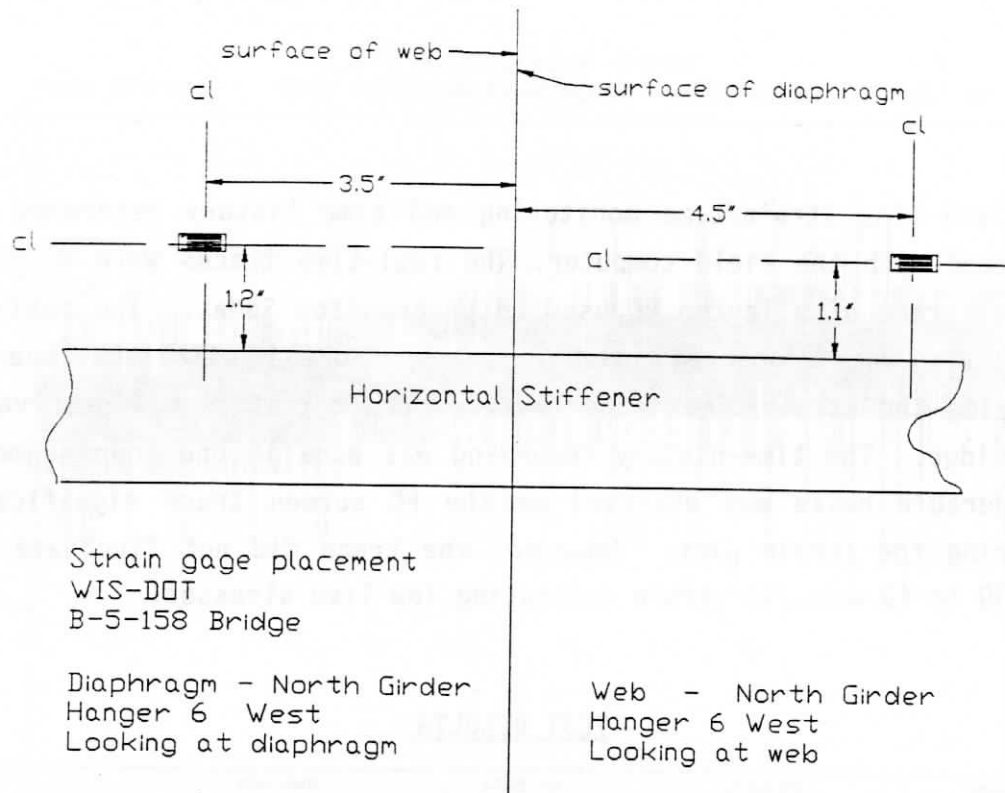
FIGURE 3. Typical strain gage layout for north tie girder

Strain gages were attached to the web and diaphragm on both sides of Hangers 4 and 6 on both the north and south tie girders. On the north girder, the strain gages were located approximately 1 inch above the stiffener. The web-mounted gages were located as close as possible to the diaphragm (approximately 3-1/2 inches) and the diaphragm-mounted gages were centered over the stiffener. On the south girder, a slightly different mounting position was used for the diaphragm-mounted gages. These gages were mounted approximately 1 inch from the edge of the stiffener and even with its centerline. Position of the gages varied slightly due to surface condition of the steel and our ability to adequately prepare the steel substrate about the welds. Typical strain gage layouts are shown in Figures 3 and 4 respectively.

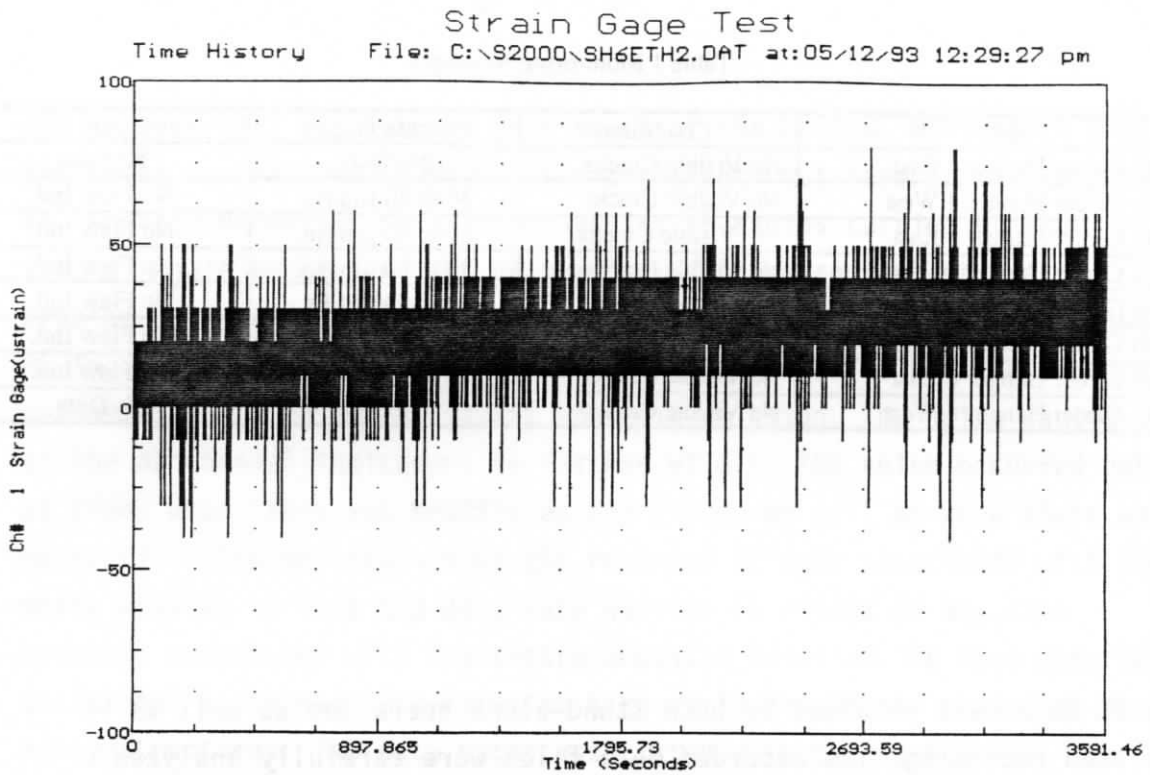
FIGURE 5. Time-history strain gage data for a web-mounted gage

The strain gage data were remarkably similar from all of the sites tested. Higher live strains were consistently seen on the web-mounted gages than were seen on the diaphragms. In all cases the values were small with most of the data being between 30 μ in./in. strain with scattered peaks up to 50 (0.870Ksi to 1.160 Ksi with peaks to 1.450 Ksi). Typical time-history data for a web- and a diaphragm-mounted gage are shown in Figures 5 and 6.
