**ACOUSTIC EMISSION MONITORING OF THE
TRUNNION SHAFTS ON OREGON DOT BRIDGE #1377A**

**I-5 (Interstate) Columbia River Bridge East Lift Span
Portland, Oregon**

Technical Report #6

November 30, 1994

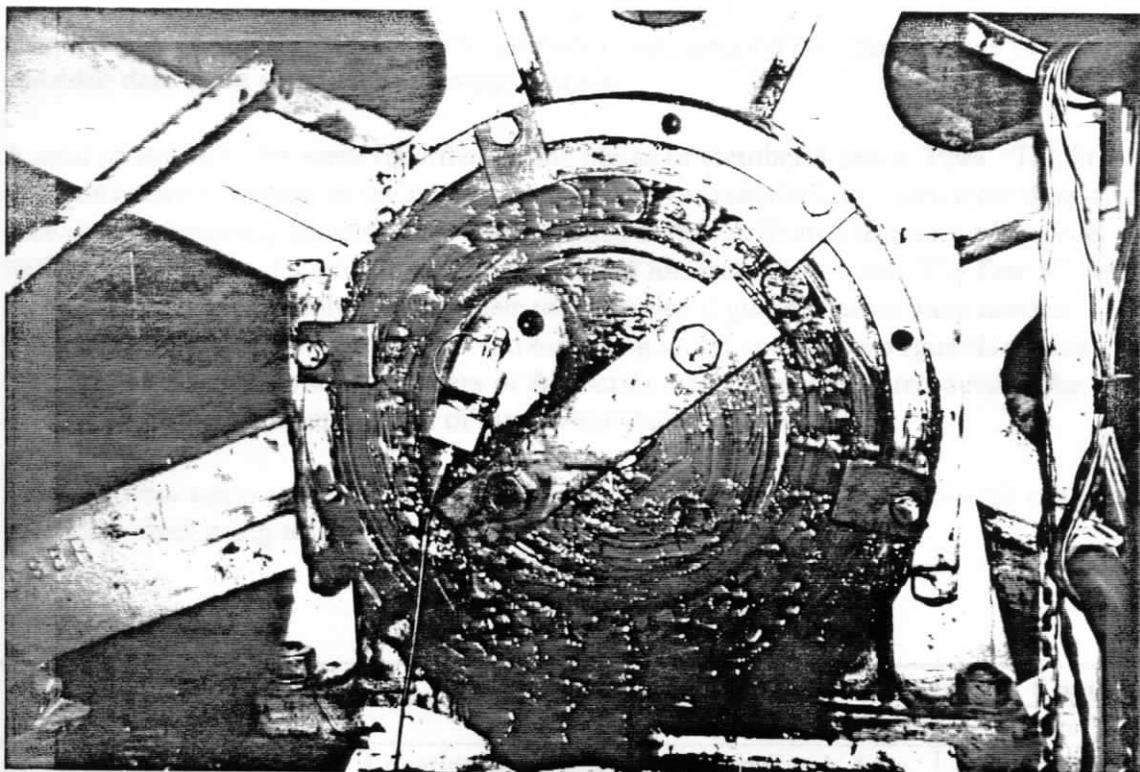
FIGURE 1. AE sensor mounted on end of NE shaft.

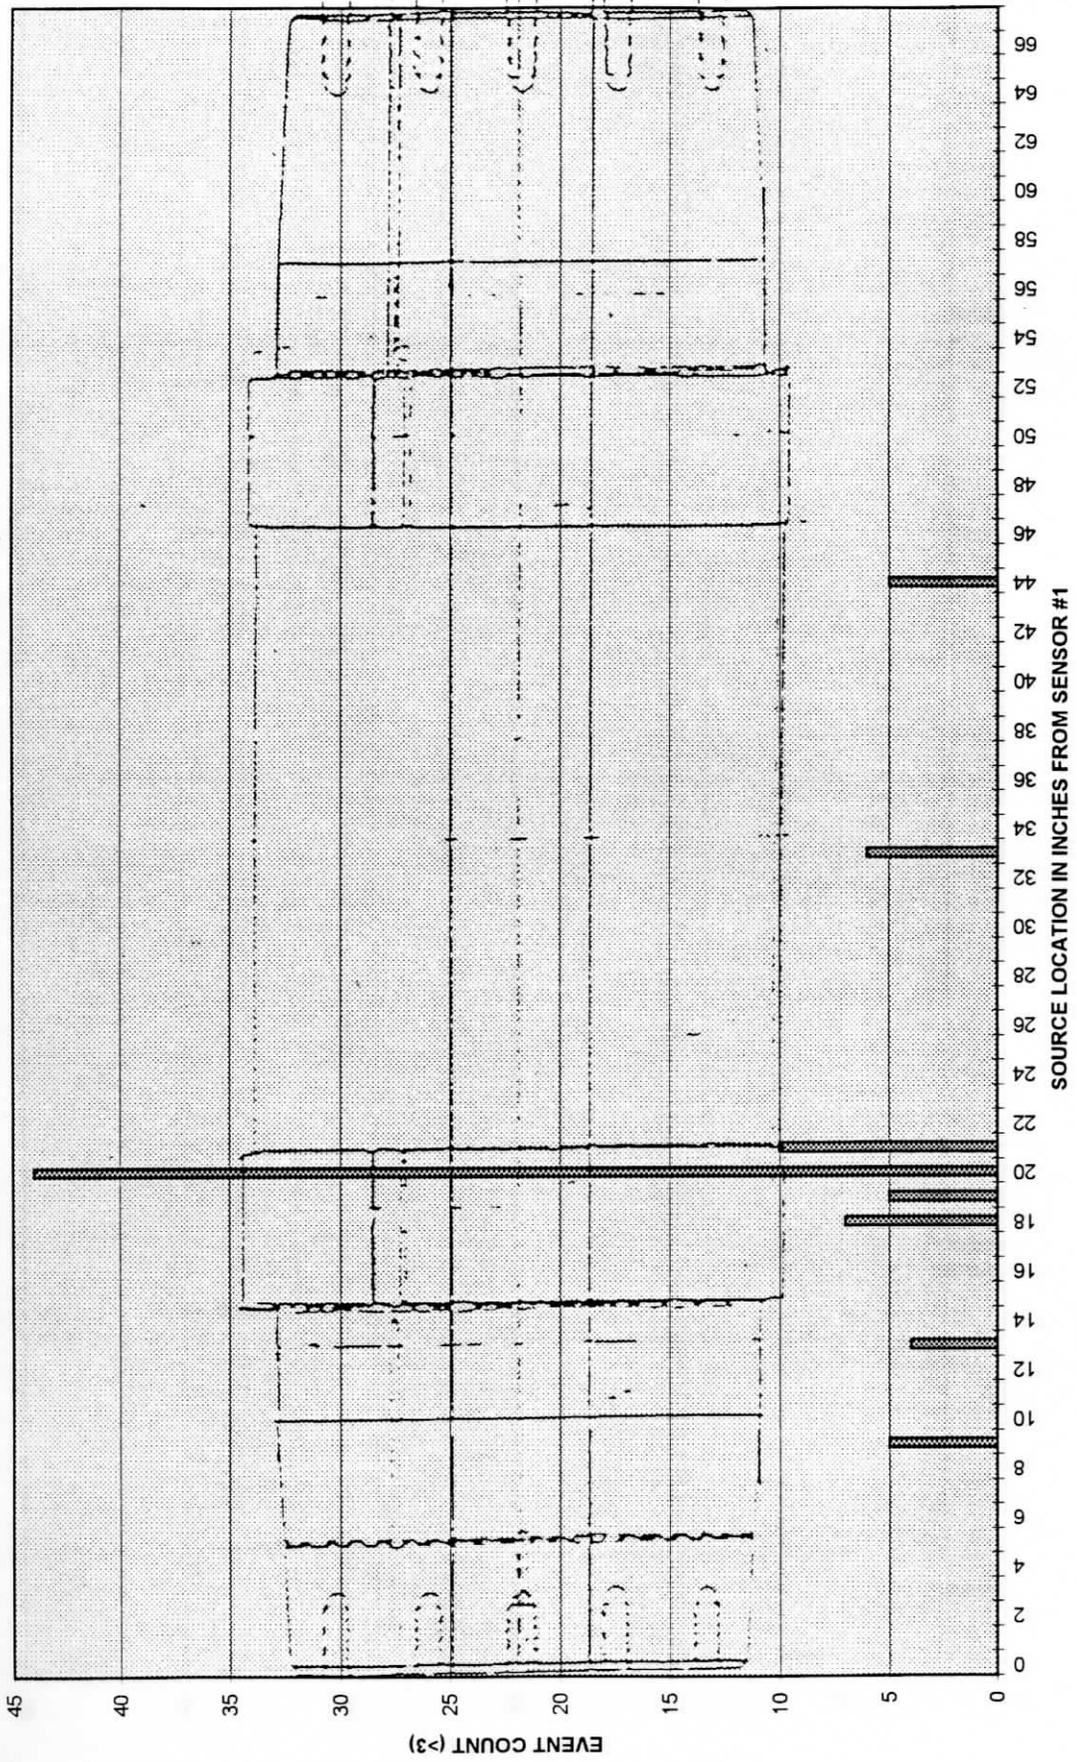
clustering was applied to these plots. Source locations with event counts equal to or greater than 3 are plotted. Superimposed on each figure is a sketch of the trunnion shaft drawn to scale so that AE sources can be associated with specific shaft features. The largest event count peaks in most of the runs coincide with the area of the shaft that is in contact with the sheave. This AE is probably being generated by slippage of the sheave on the trunnion shaft. This clustering can be clearly seen on runs 2, 3, 4 and 7, 8 and 9. Runs 2, 3, and 4 (Figures 3, 4, and 5) were recorded on the N.E. Shaft. Sensor # 1 was on the outboard end of this shaft so the maximum slippage is occurring at the outboard end. Runs 7 and 8 (Figures 9 and 10) were recorded on the S.E. shaft. Run 9 was recorded on the S.W. shaft. The application of clustering analysis to source location allows us to identify the areas of the shaft that produce significant AE signals. If we examine the source location clustering data for the shoulder region of the shaft (15 inches) with a window of plus or minus 2 inches, we see locational clustering only on the N.E. shaft outboard shoulder region (runs 2, 3, and 4) between 13 and 17 inches, and the outboard shoulder region of the S.E. shaft (run 8). Close examination of the recorded data for these clusters shows that only the N.E. shaft indications exhibit time clustering. Event rates in excess of three per second occur in runs 3 and 4 on the N.E. shaft at a source location of 13 inches. Event rates in excess of two in one second occur at 13 inches, 16 inches, and 17 inches on the N.E. shaft (runs 2, 3, and 4). The three event cluster on the S.E. shaft at 15 inches has a minimum time interval between events of over 3 seconds thus failing the time clustering test for both 3 in one second and two in one second. Extensive experimental observations using a time cluster criteria of three events in one second has shown very high correlation with the presence of crack growth. This analysis shows that only the N.E. shaft produces AE events in the shoulder area of the shaft that satisfy our location and time clustering criteria. This is the location that includes the ultrasonic crack indication so AE seems to add additional credibility to the UT findings with an indication of possible crack growth.

FIGURE 3. AE SOURCE LOCATION I-5 RUN 2 NE SHAFT (RDC>100)

These tests point out the usefulness of applying multiple NDE methods to a difficult inspection problem. Either UT or AE by itself does not provide data that is positively conclusive. However, when we combine the two and the results correlate as they did in these tests, confidence in the test results is considerably improved. Positive confirmation of crack presence can only be obtained by performing a very expensive disassembly procedure to expose the shaft surface. These test results tend to indicate that such an effort is warranted on the N.E. shaft.

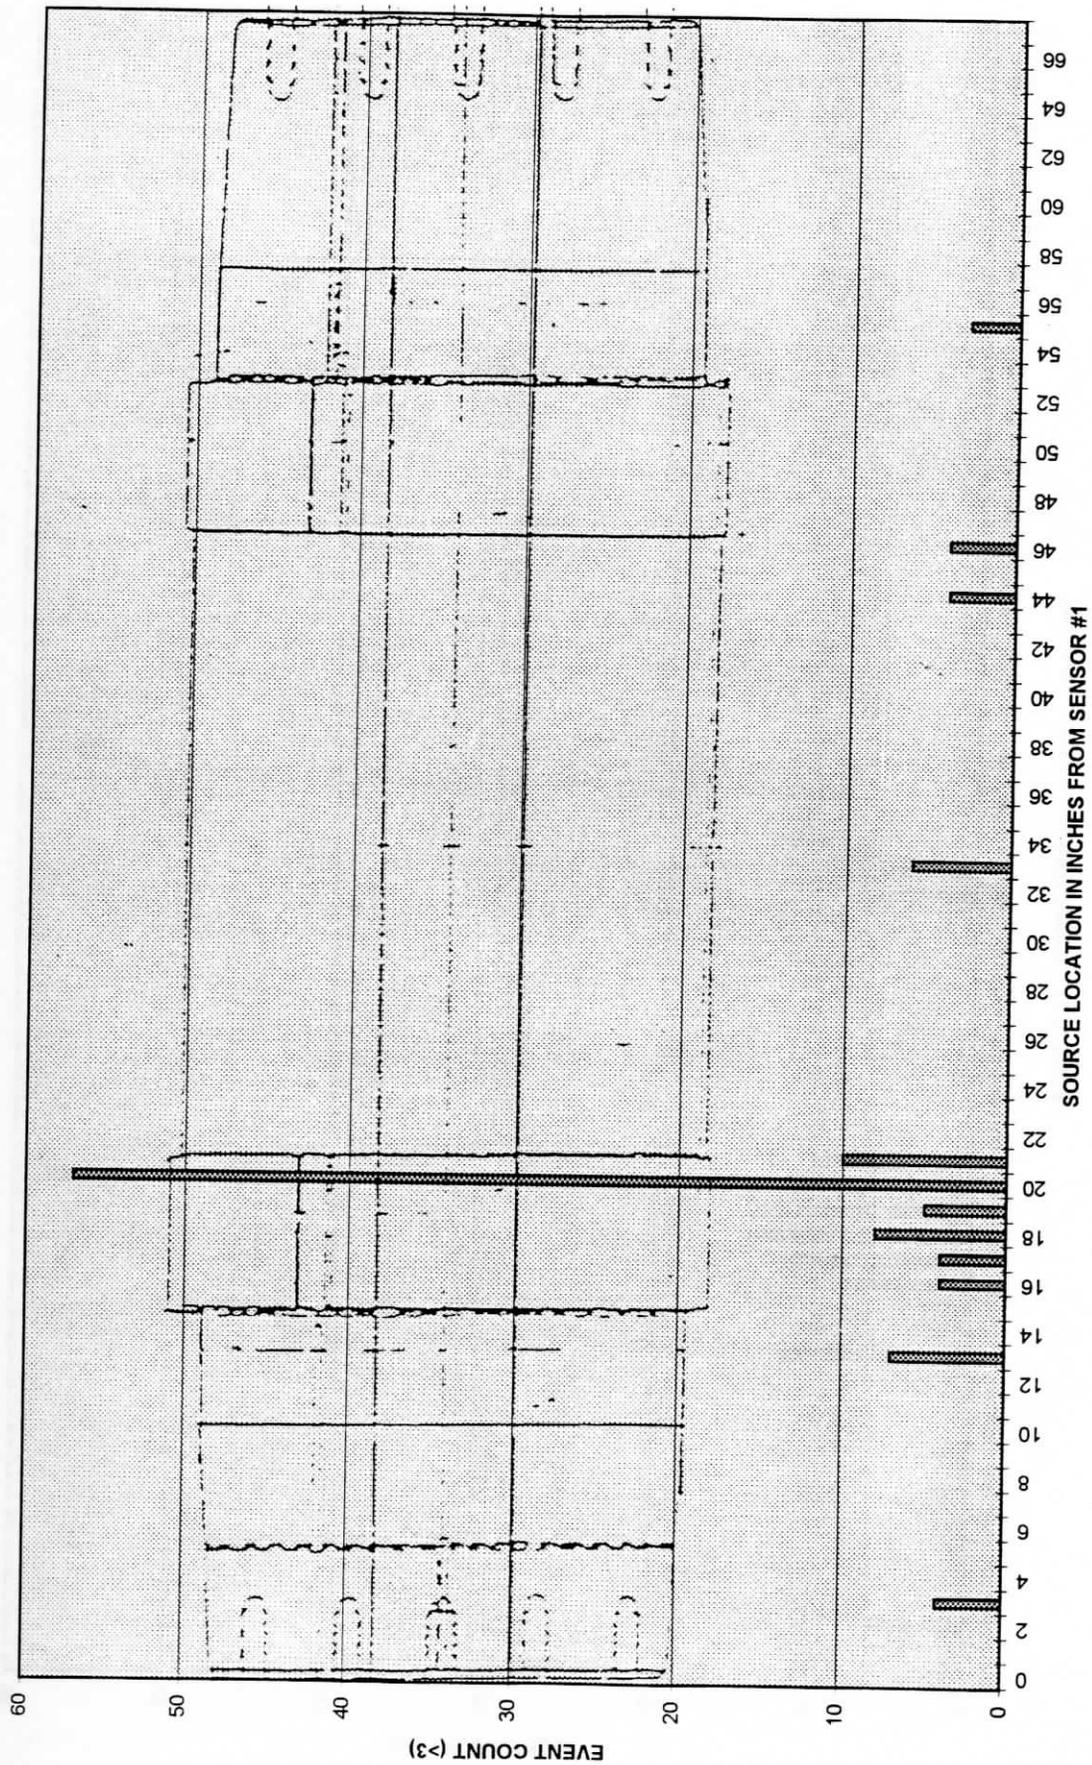
FIGURE 4. AE SOURCE LOCATION I-5 RUN 3 NE SHAFT (RDC>100)

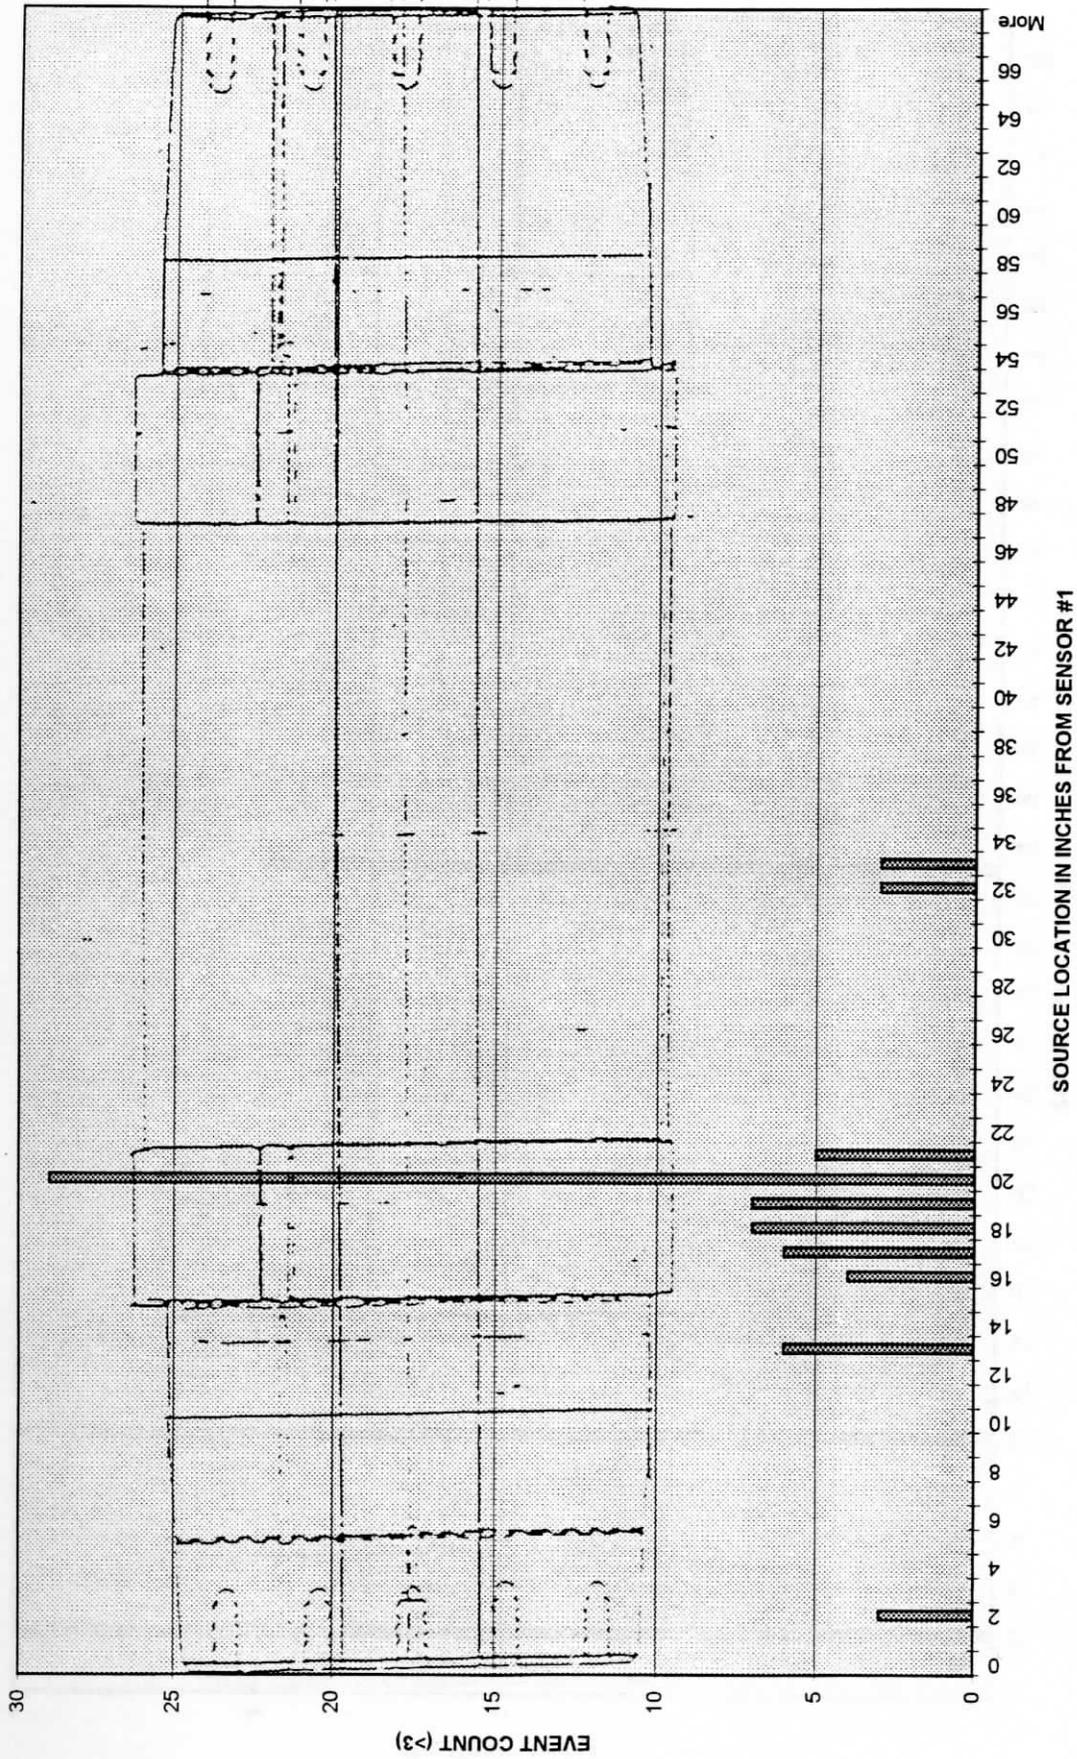
FIGURE 5. AE SOURCE LOCATION I-5 RUN 4 NE SHAFT (RDC>100)

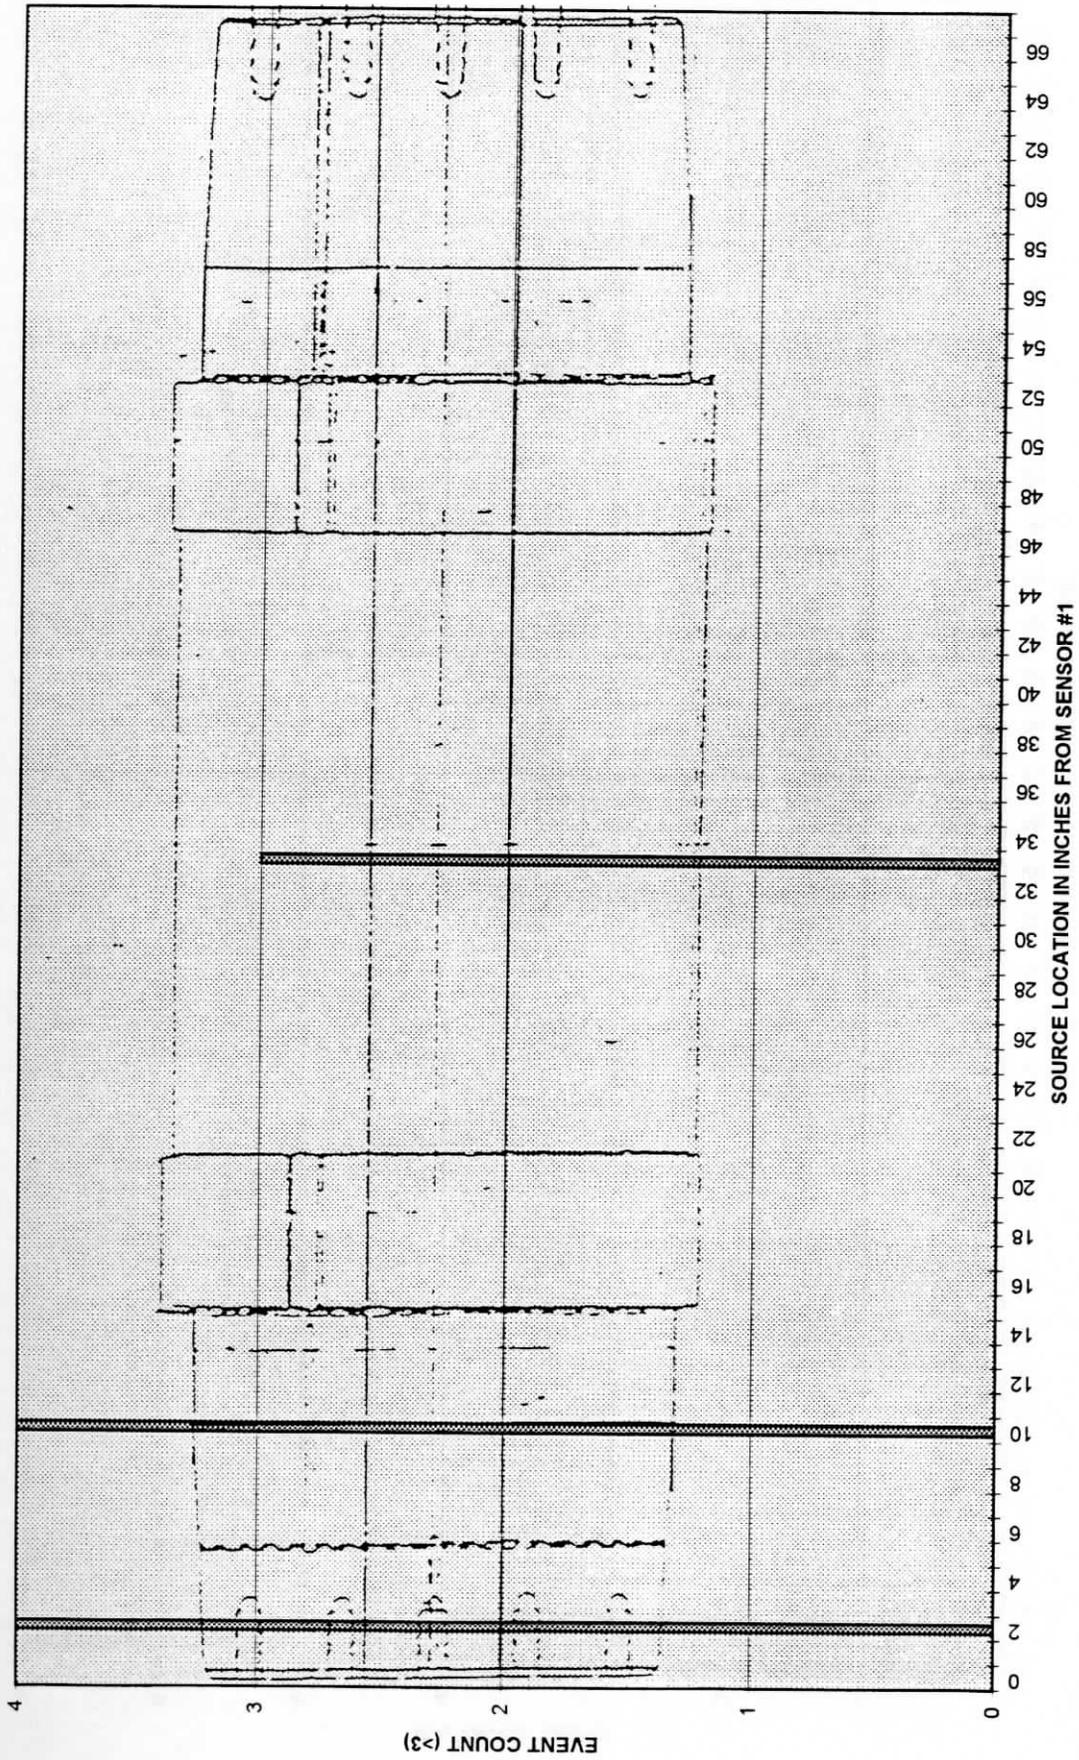
FIGURE 6. AE SOURCE LOCATION I-5 RUN 5 NW SHAFT (RDC>100)

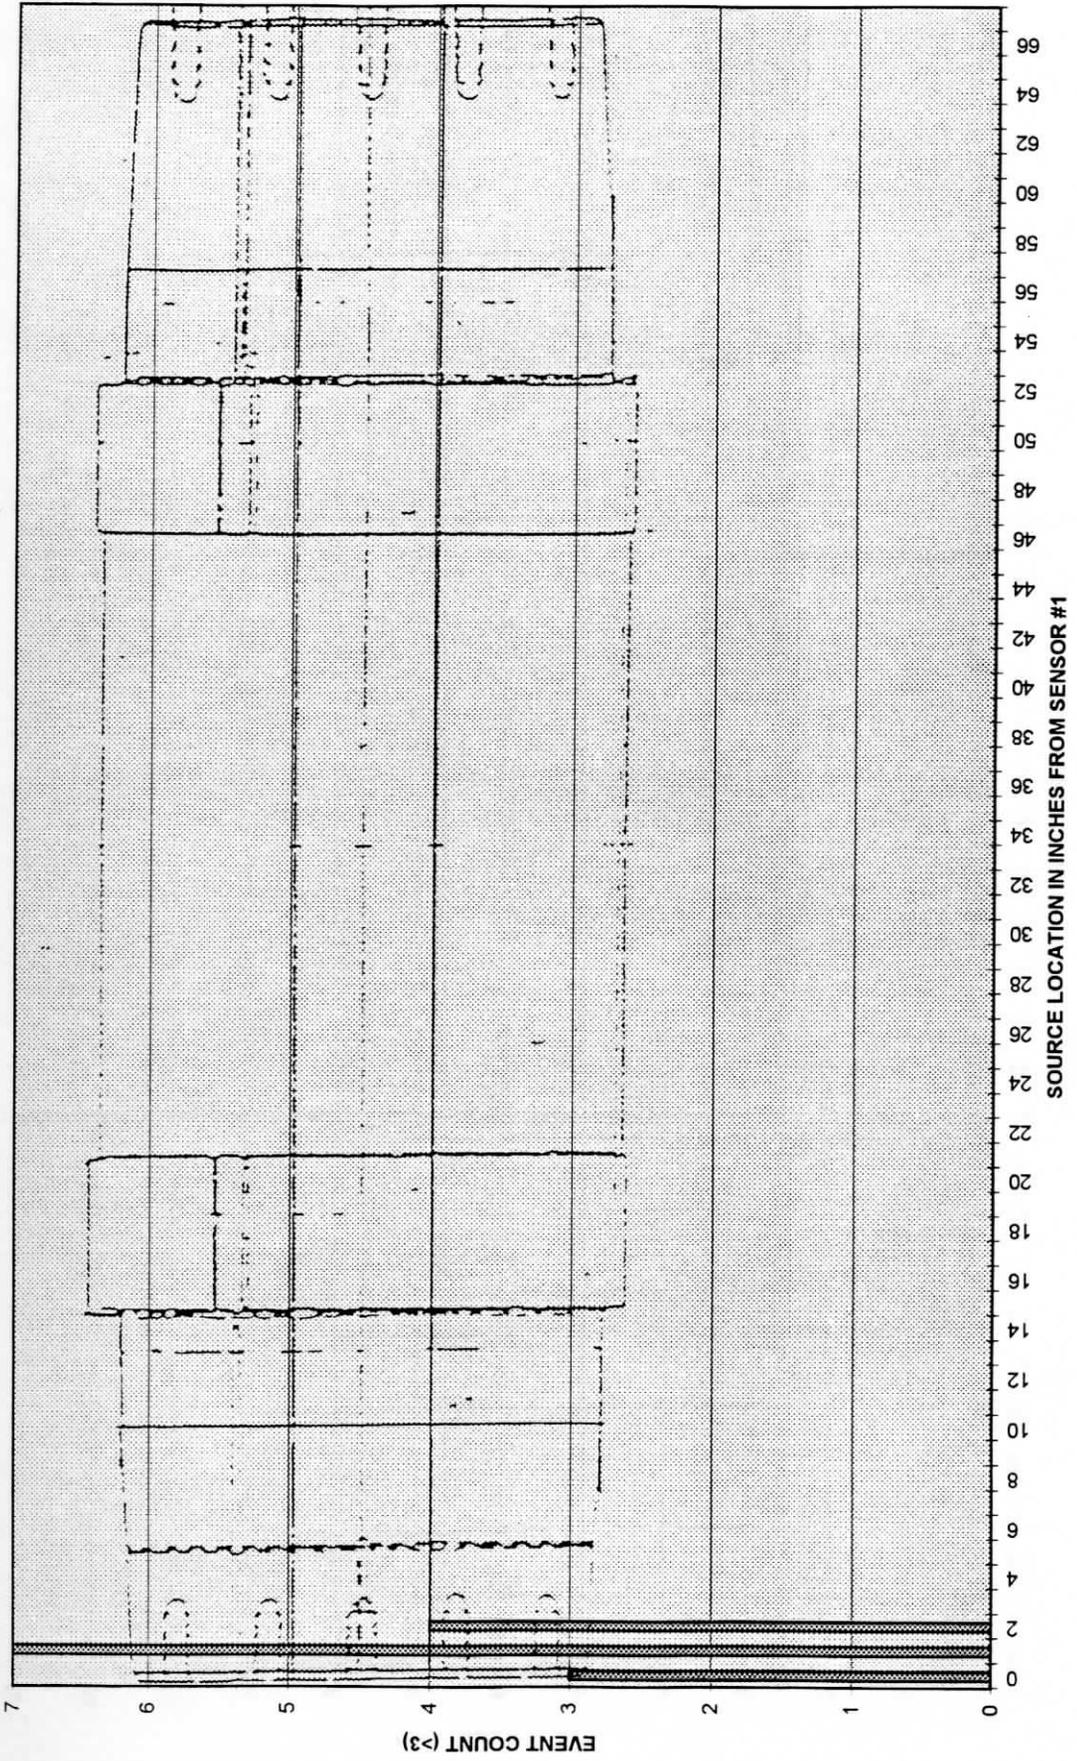
FIGURE 7. AE SOURCE LOCATION I-5 RUN 6 NW SHAFT (RDC>100)

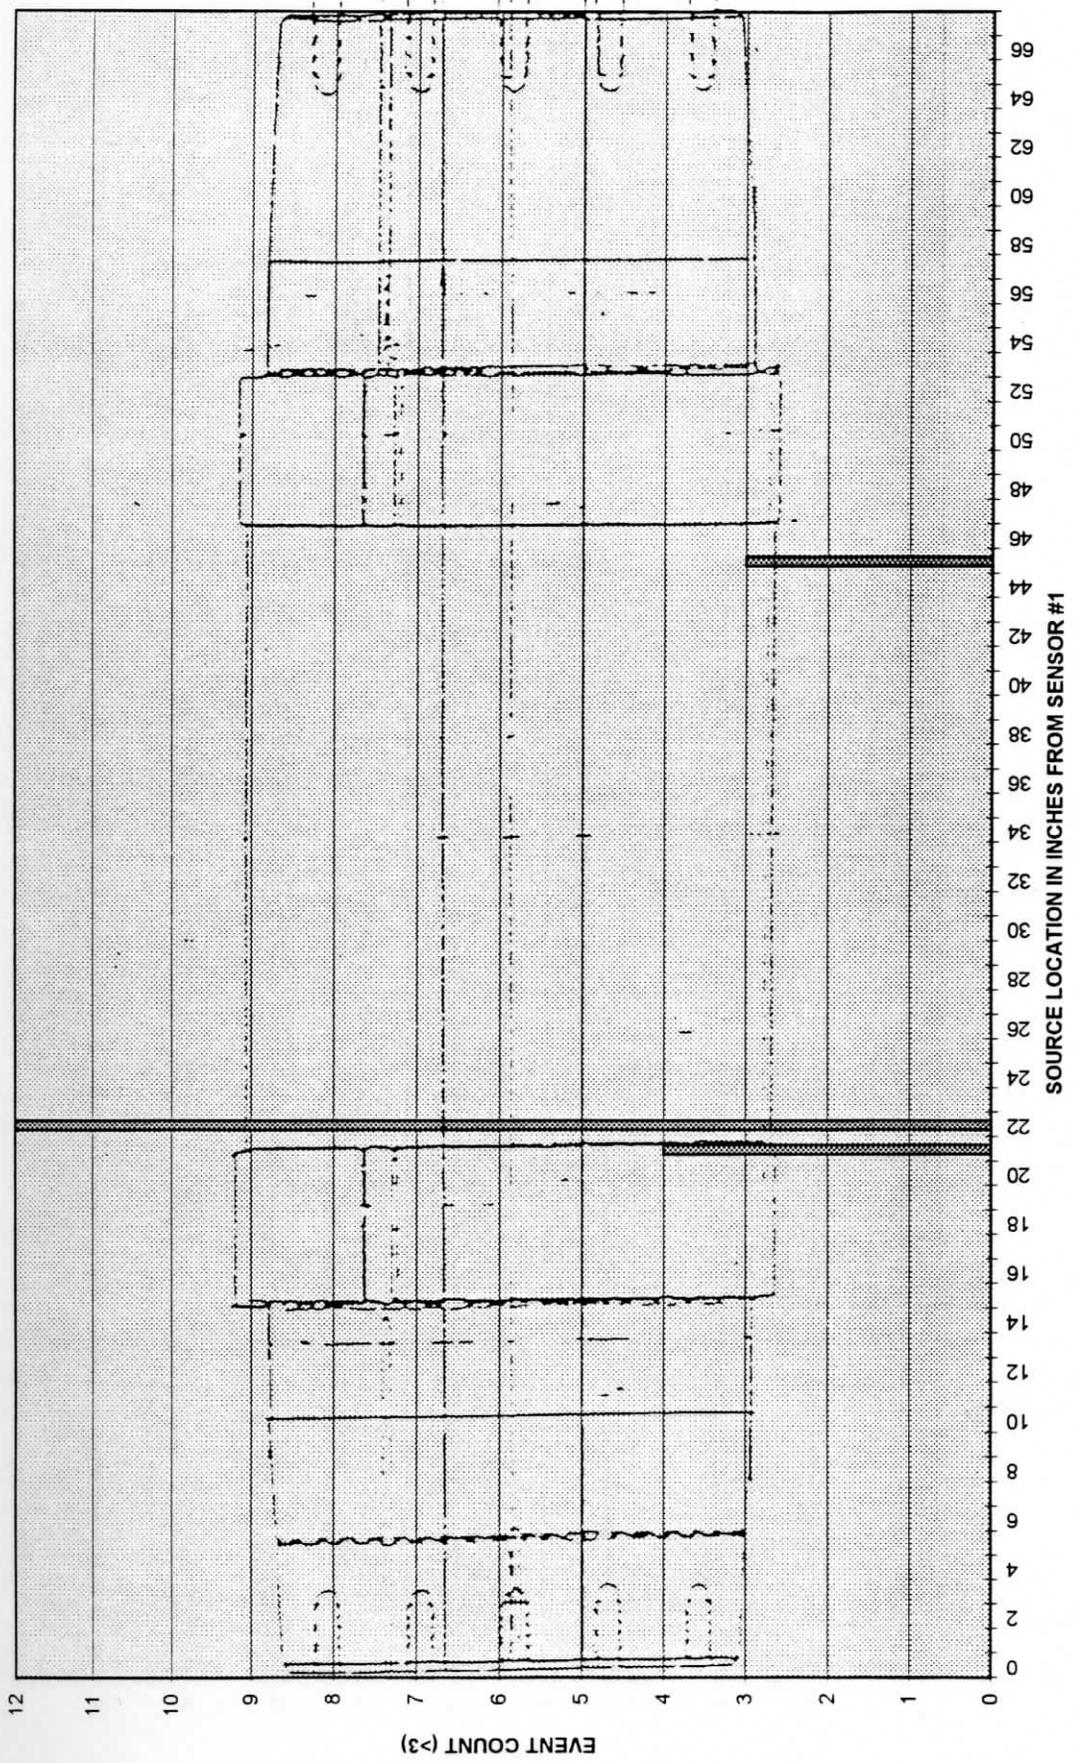
FIGURE 8. AE SOURCE LOCATION I-5 RUN 7 SE SHAFT (RDC>100)

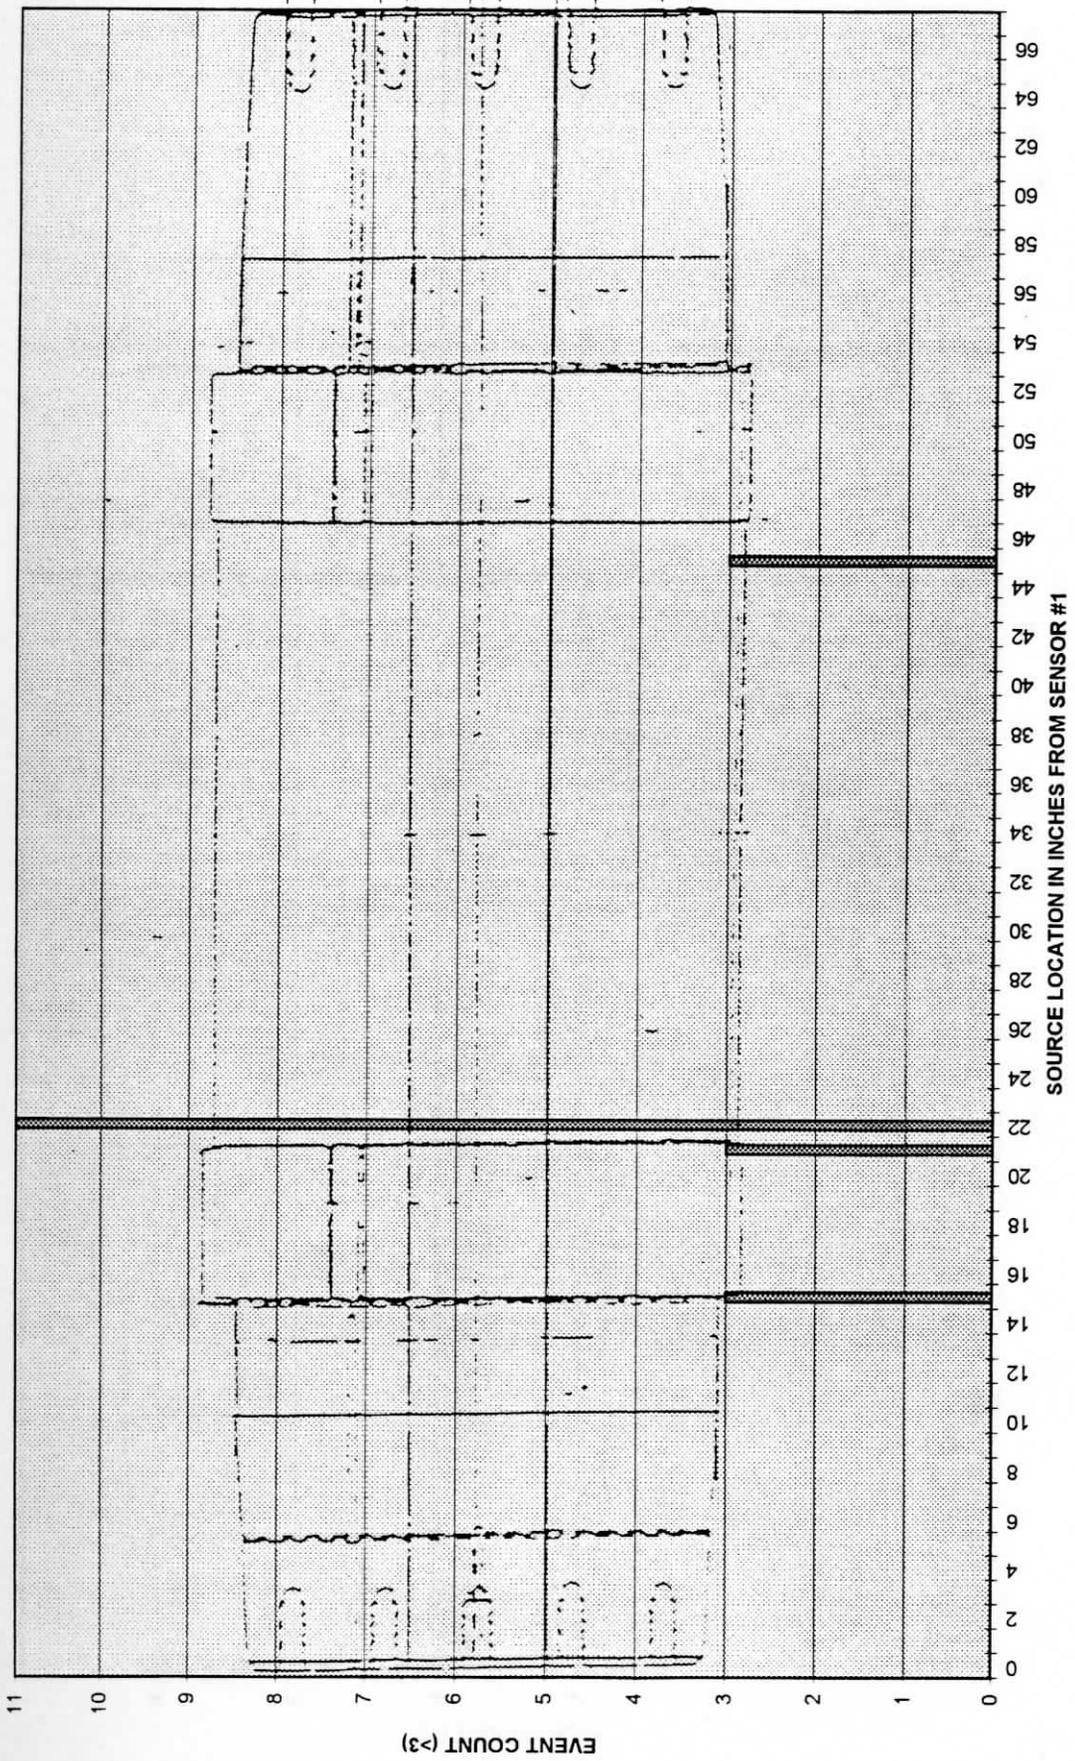
FIGURE 9. AE SOURCE LOCATION I-5 RUN 8 SE SHAFT (RDC>100)

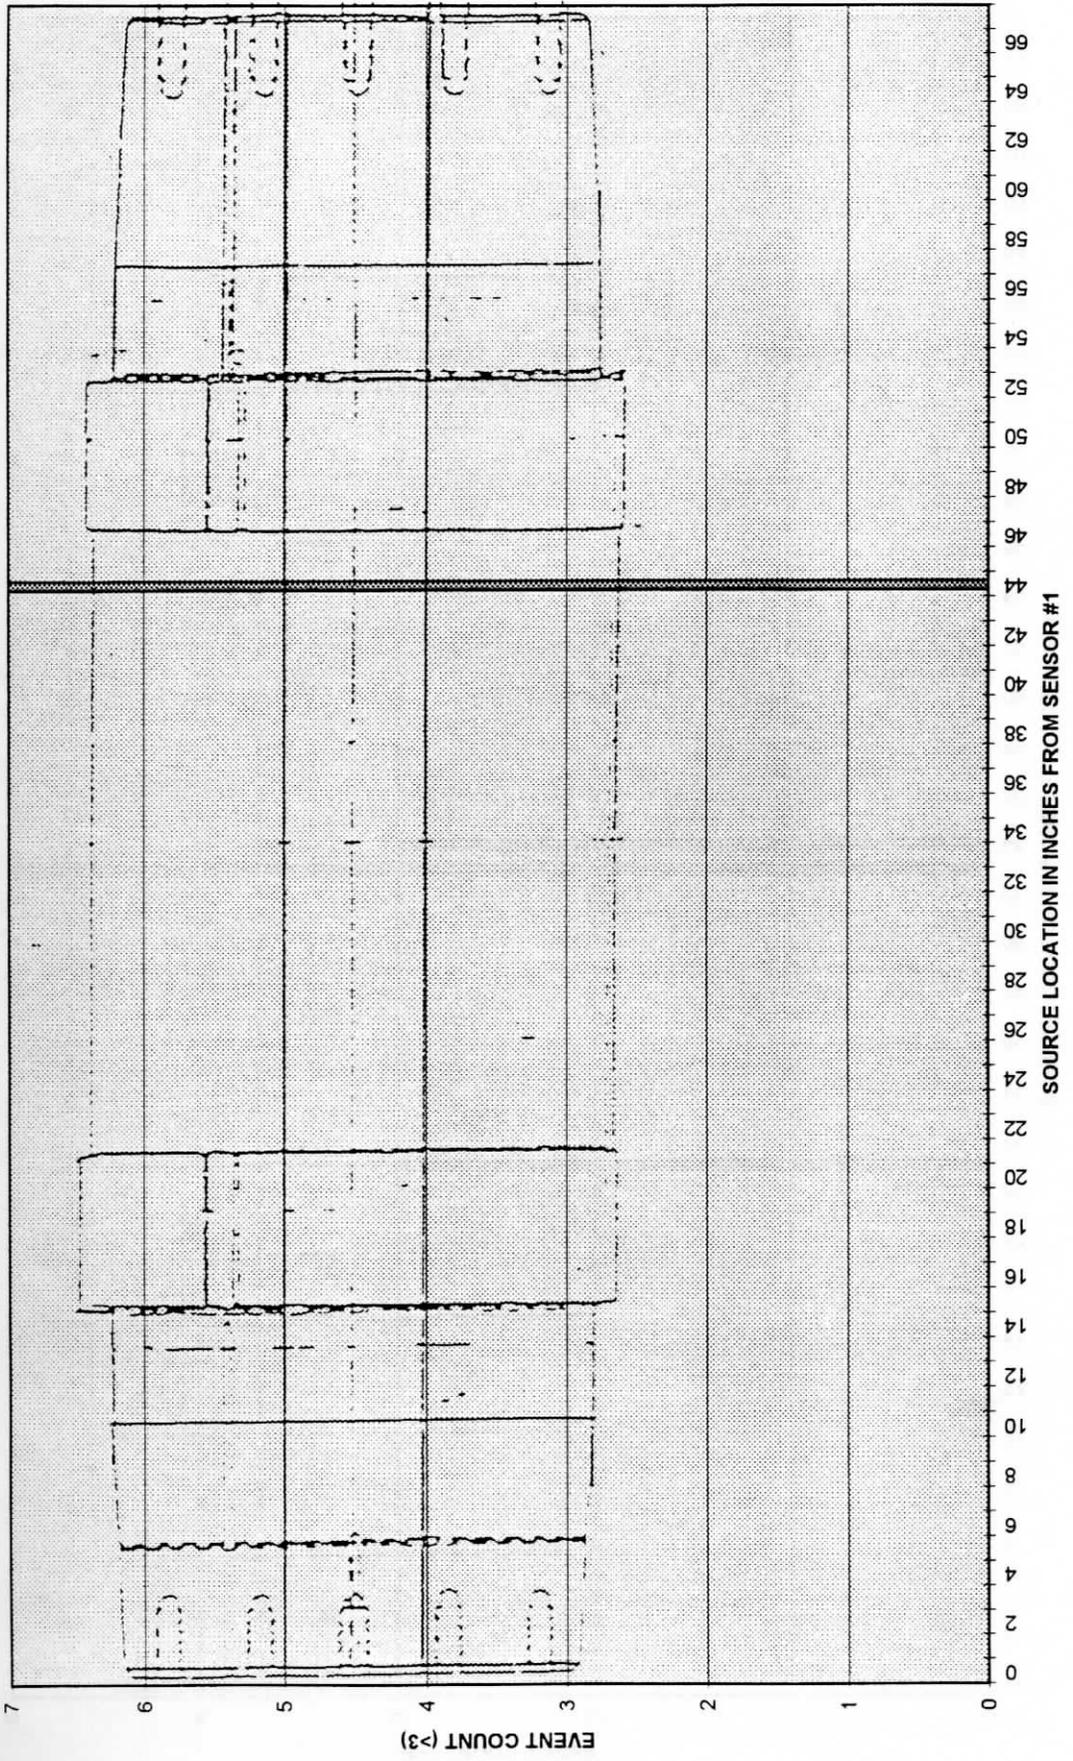
FIGURE 10. AE SOURCE LOCATION I-5 RUN 9 SW SHAFT (RDC>100)

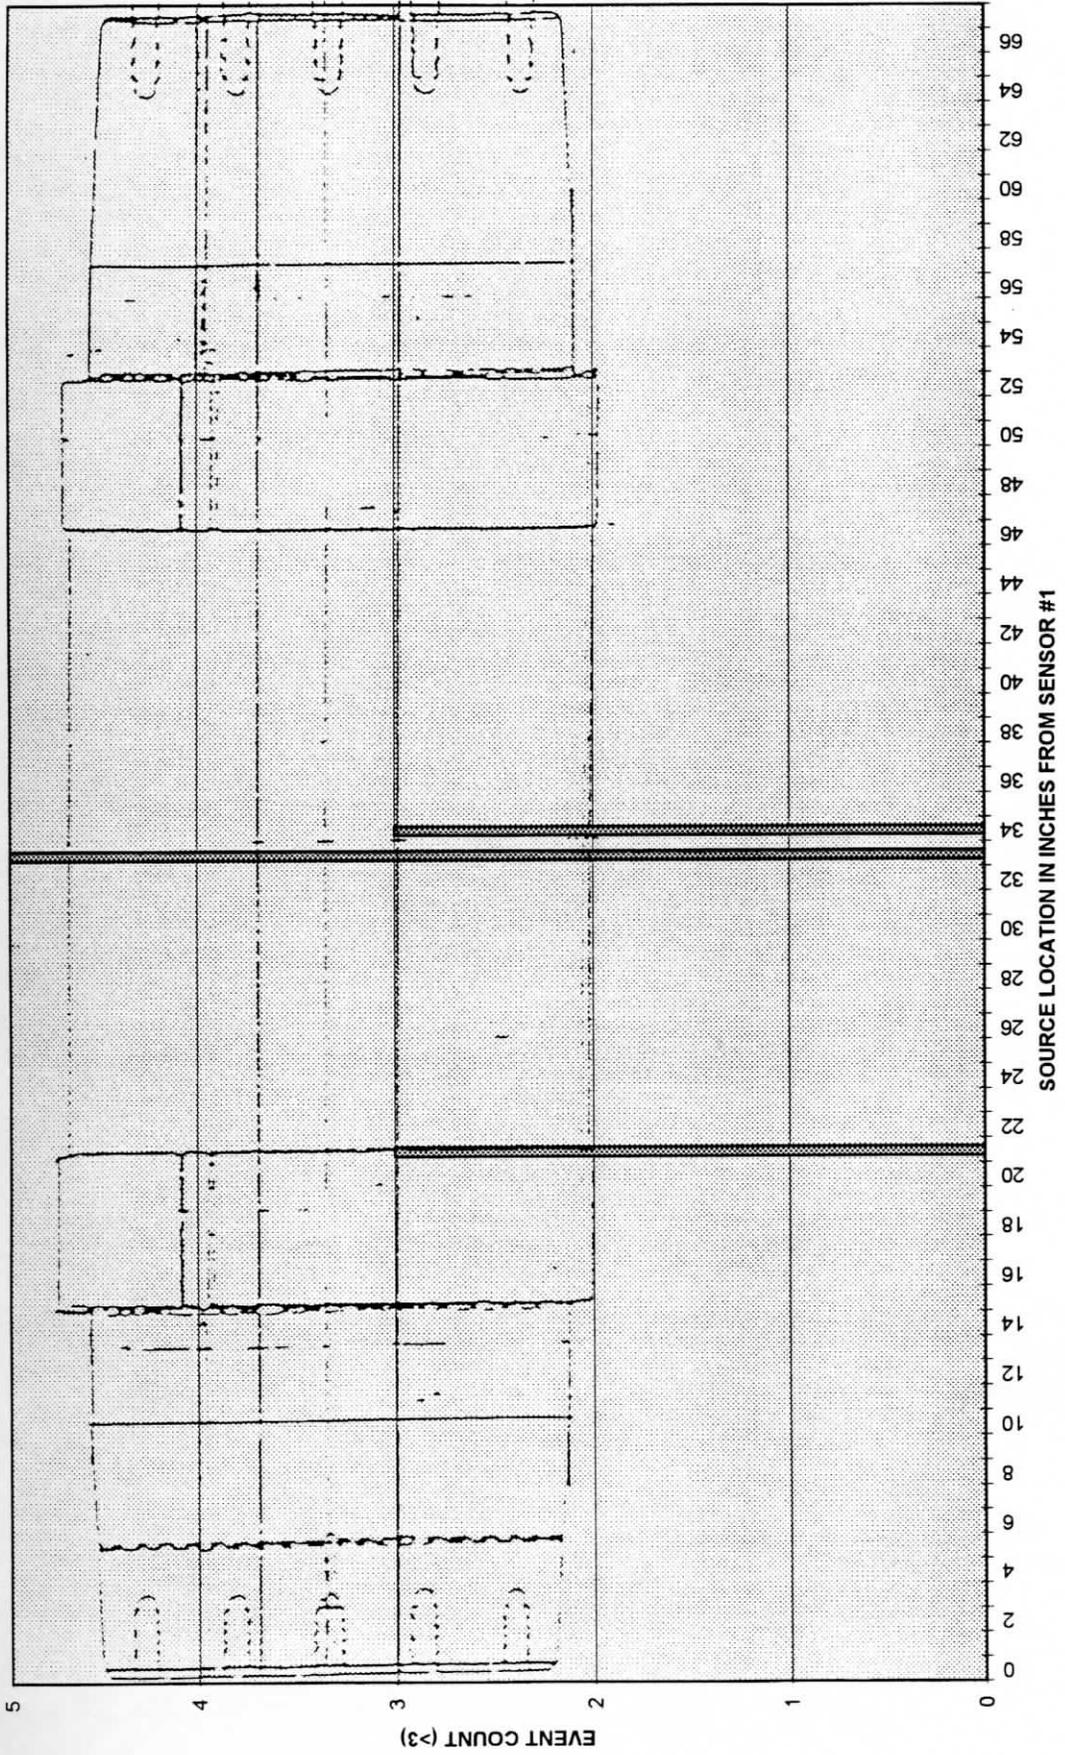
FIGURE 11. AE SOURCE LOCATION I-5 RUN 10 SW SHAFT (RDC>100)
