# FINAL REPORT

## FHWA-WY-00/01F

## EVALUATION OF SHREDDED TIRES AS BACKFILL AT DOUBLE NICKEL SLIDE

January, 2000

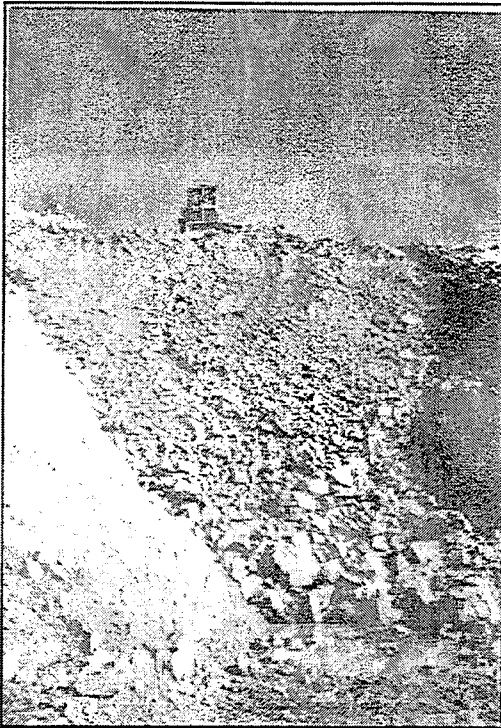
The toe trenches were installed first to increase the stability within the slide system. Four trenches were dug east of the original three toe trenches, where the new movement was greatest. The trenches were backfilled with the iron ore rock from the nearby mine (maximum size 1 meter) and covered up with topsoil. Water was intersected in each trench and was allowed to flow out the bottom of the trench (see Figure 2).

Figure 2. Excavated toe trench being backfilled with iron ore rock.  
Water is flowing from bottom of trench.

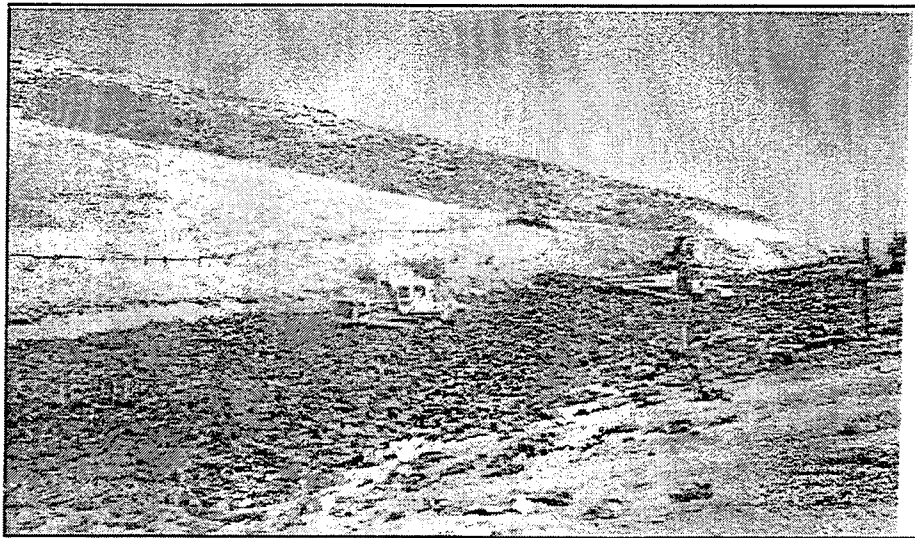
A 26 meter alignment shift was integrated into the design to remove as much of the existing fill as possible. This would unload the top of the slide and allow access to the spring. The existing ditch to the north of the alignment was over 4.5 meters deep and would need to be filled with a lightweight material to minimize driving forces (see Figure 3).

Figure 3. Ditch north of alignment being filled with shredded tires and compacted with a bulldozer.

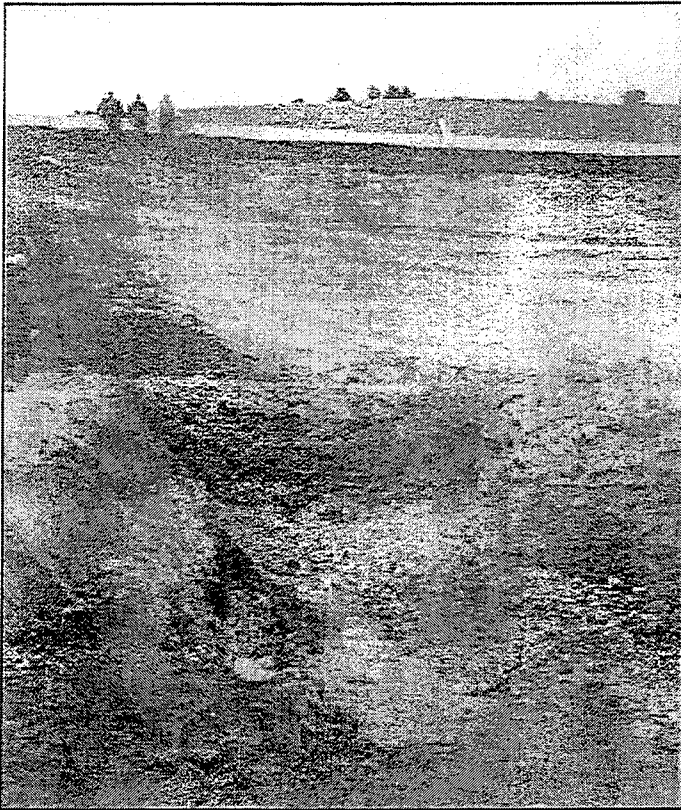
Figure 4. Excavation to expose spring and build box culvert to span spring outlet. Spring flowing 1135 liters per minute shown at lower center of photo.

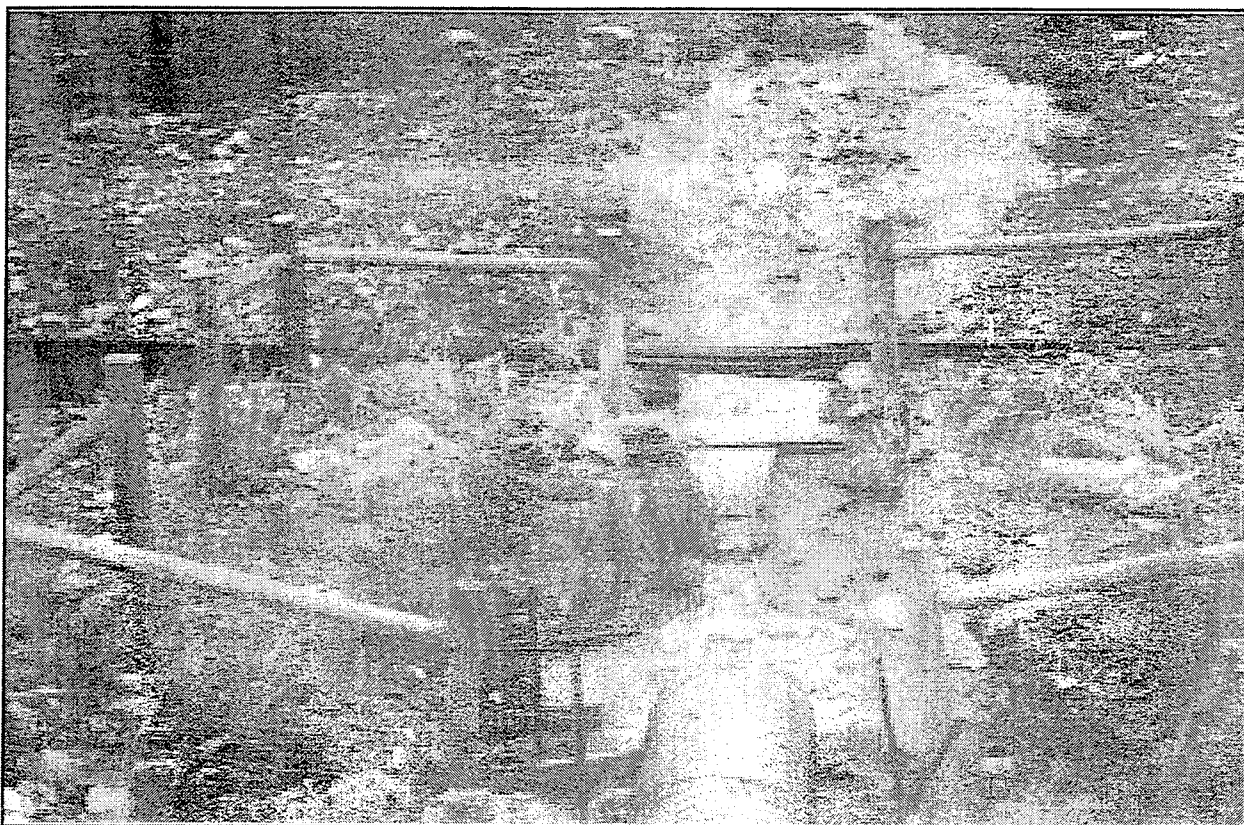
Figure 5. Spring outlet channeled into weir to measure flow rates. Fence built to protect weir from livestock.

underneath the box culvert, and the flows have increased to over 1135 liters per minute (see Figure 5).

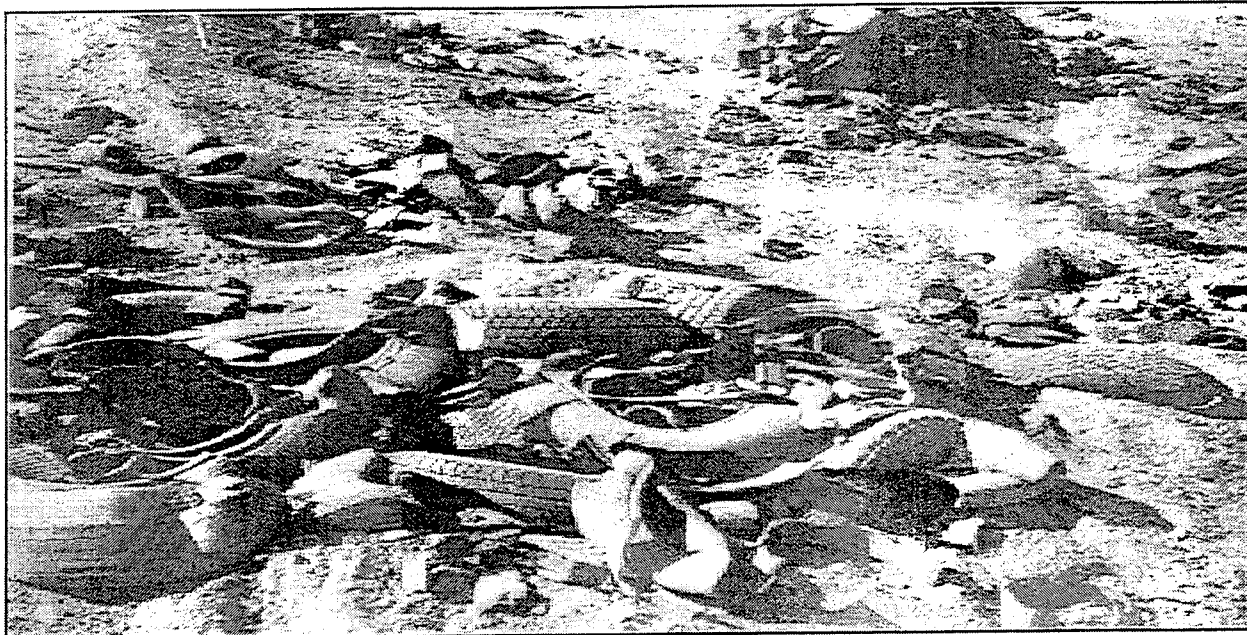
To allow for better compaction, a maximum 100 mm tire shred width was specified. When the machine cut the tires to specifications, the shreds were comprised of very long strips derived from the sides of the tire. Some of the tire shreds were larger than the 100 mm specification (see Figure 6). Compaction was achieved by a specification that required five passes of a crawler type tractor with a minimum 56.5 kPa ground pressure for every 300 mm lift of tires. Three passes were parallel to the highway and two passes were perpendicular to the highway (see Figure 7). A late spring storm dropped 25 mm of snow on the newly placed tire shreds and the melting snow facilitated compaction by lubricating the tires when the fill was recompacted. The top grade of the tires dropped 30 mm after recompaction.

Figure 6. Typical tire shreds from 100 mm wide tire shredder.

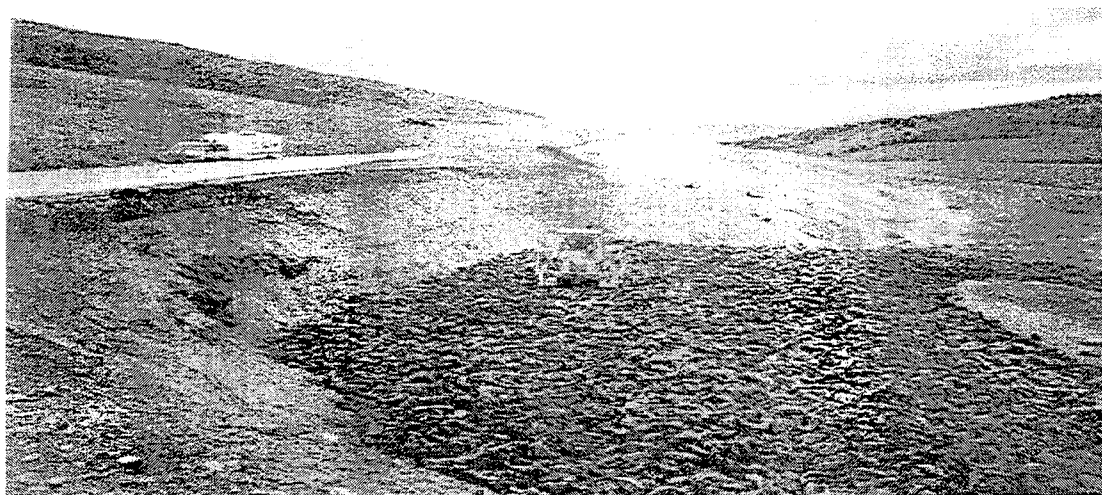
With a total Wyoming population of under 500,000 people, the entire state's supply of stored discarded tires was consumed in the project. A shortage of available tires resulted in the thickness of the lightweight fill being reduced from 4.5 to 3.4 meters.

Figure 7. Lightweight tire fill under construction over the spring box culvert.

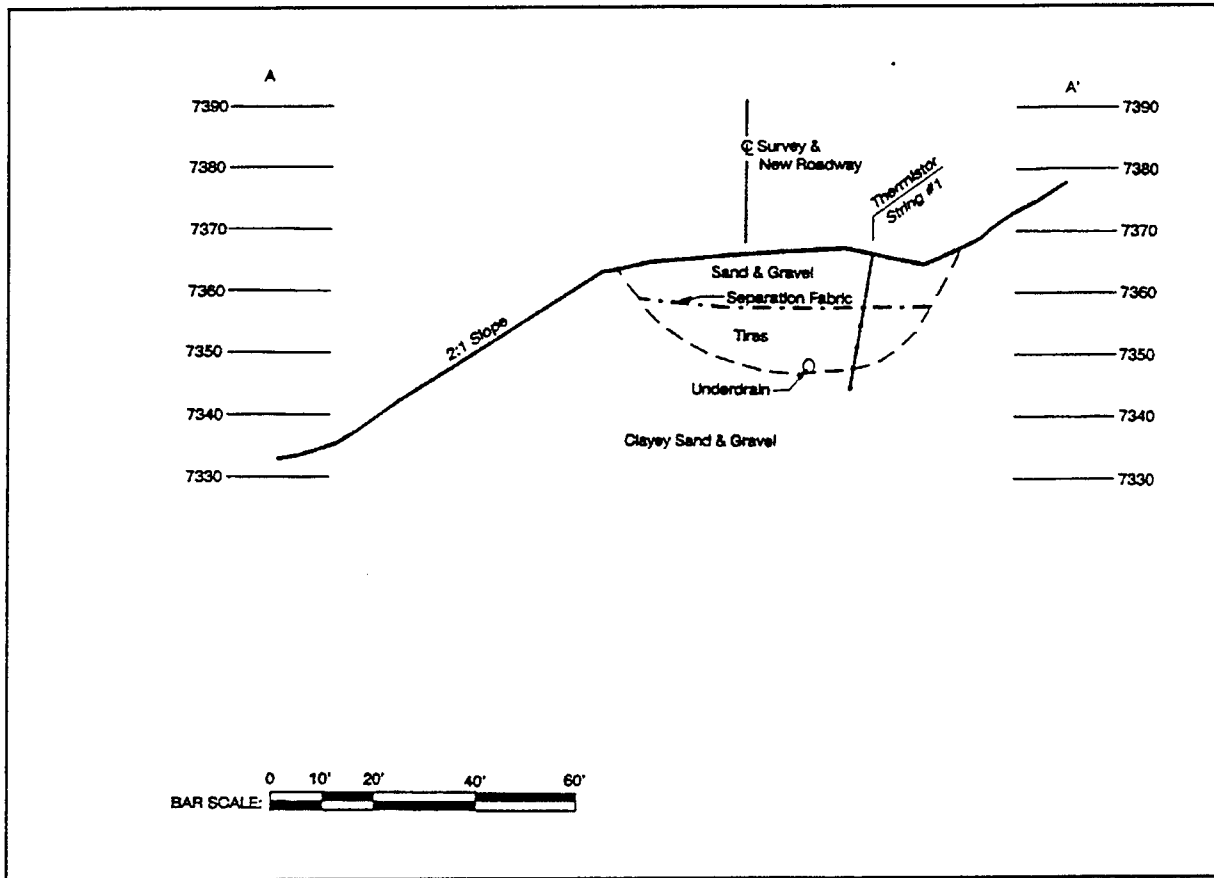
Figure 8. Cross-section at Station 735+00 showing Thermistor String No. 1. Three of the five thermistors are within the tire fill.

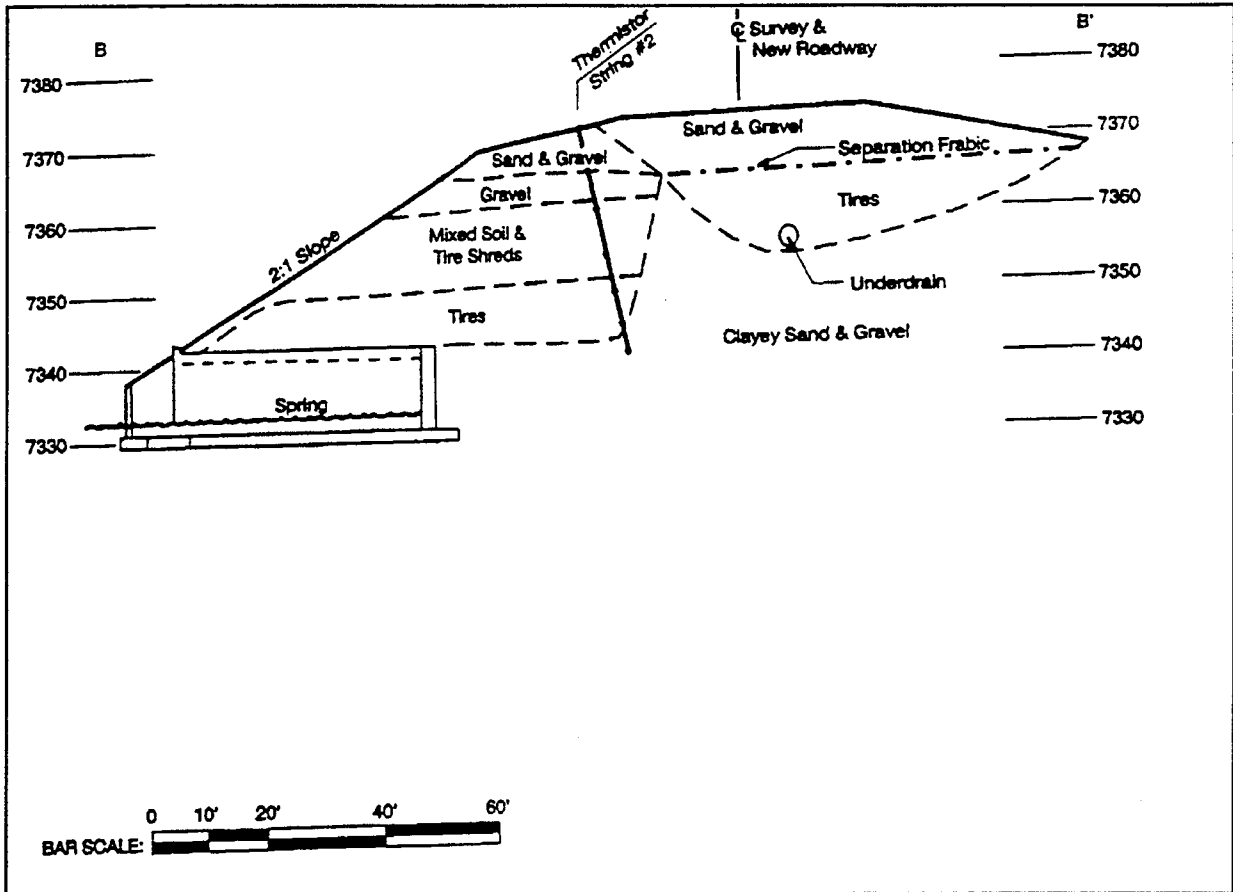
Thermistor string No 2 was placed on the south side of the road, just behind the back wall of the box, which is a potential route for additional oxygen to enter the tires (see Figures 1 and 9). The thermistors are located at depths of 3.66, 5.64, 7.1, 8.63 and 9.91 meters. The tires were found to be only slightly moist at thermistor site #1, but were moist to saturated at the site above the box. At thermistor site No.1, 2.44 meters of tires were penetrated and 2.13 meters of tires at thermistor site No.2. The initial readings showed temperatures as high as 71.1 degrees C within the tires, however, the high readings are attributed to the residual heat left from friction between the rubber and the augers during drilling.

Figure 9. Cross-section through B-B', showing the location of Thermistor String No. 2. Two of the five thermistors are within the tire fill.

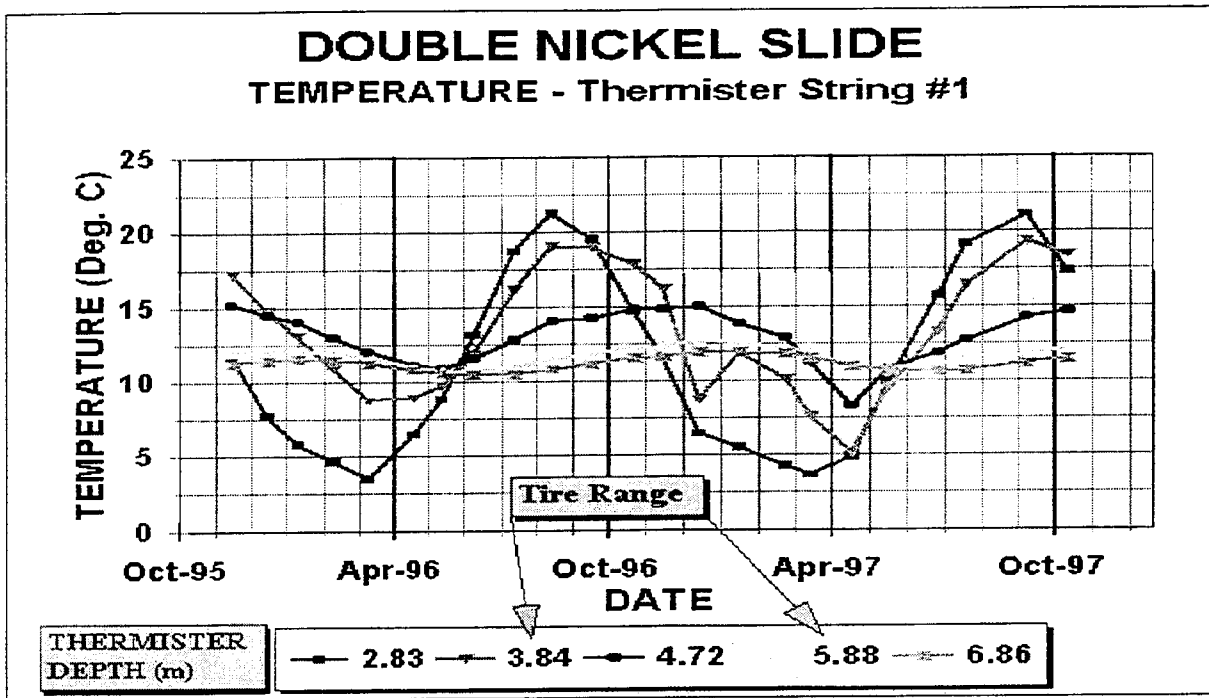
Subsequent readings obtained once a month since December of 1995 have shown a yearly rise and fall in temperature, and the average annual temperature is roughly 10.6 degrees C. However, it is possible that scattered hot spots are present in the fill, which are not penetrated by the two widely spaced thermistors. Figures 10 and 11 illustrate the temperature fluctuations of the thermistors at various depths to-date. It is interesting to note that due to the thermal properties of the soil and the tires the thermistors nearest the surface peak in temperature nearly two months after the summer highs in August, and the deepest thermistors don't register the change for five to six months. The same delay is seen for the detection of cold surface temperatures. June is the month when all thermistors are reading within two degrees of each other. To search for evidence of a hot spot undetected by the thermistors, Geology personnel have

Figure 10. Twenty three months of Thermistor String No. 1 readings.

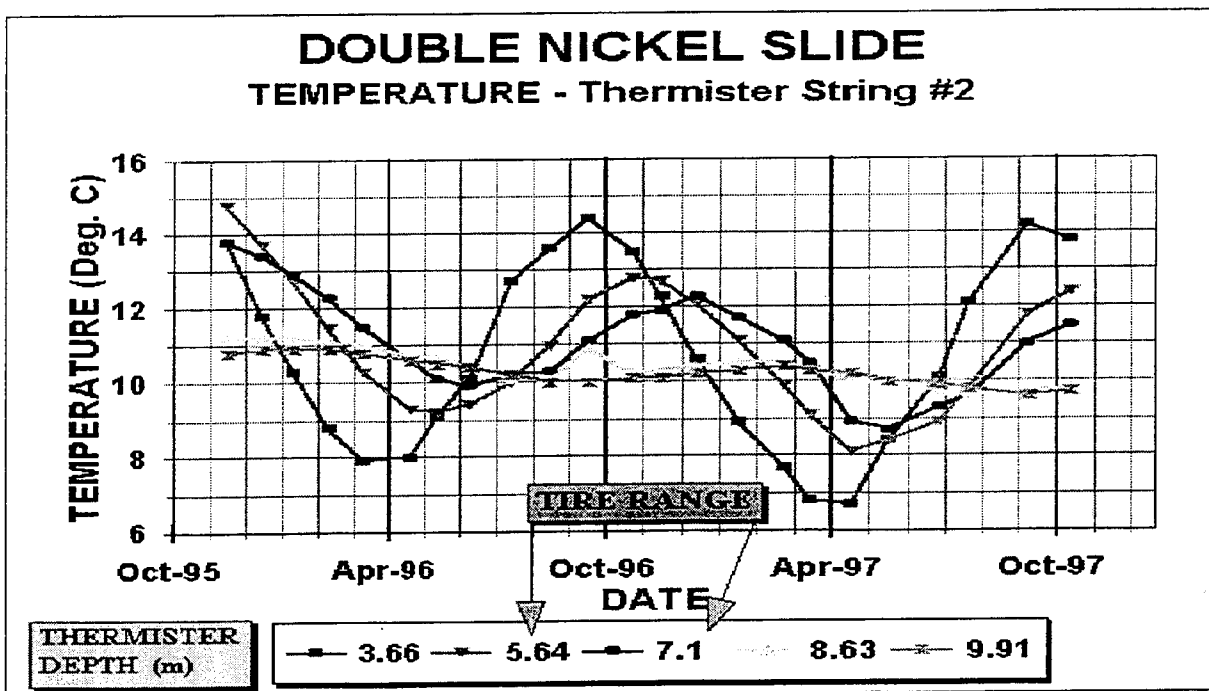
Figure 11. Twenty three months of Thermistor String No. 2 readings.

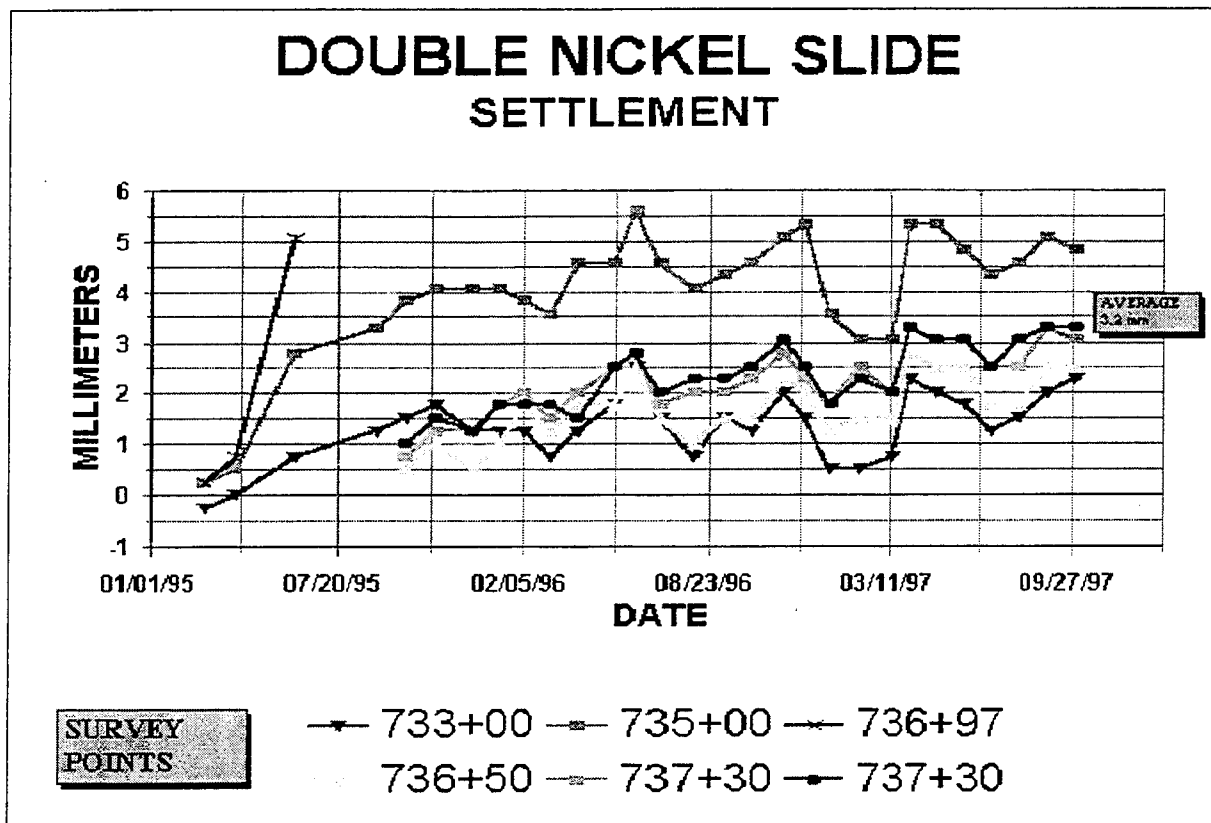
Survey monuments were set along the highway to detect and measure potential settlement of the tire fill. Three monuments were set before construction and 3 more were set after construction was complete. They have been measured every month since February 1995. One the of the initial monuments was destroyed during construction. The roadway shows very little evidence of settlement and this is reflected in the survey measurements which have indicated a maximum 5.5 millimeters of settlement. Figure 12, is a plot of the survey measurements and an analysis of the plot indicates that there is a seasonal vertical movement of as much as a 2 millimeters drop every February and August. The general settlement trend is flattening out and stabilizing.

Figure 12. Graph of the settlement measurements taken at six survey monuments along the highway. The maximum settlement registered is 5.5 millimeters and the average is 3.2 millimeters.
