**Federal Railroad  
Administration**

## **Passenger/Freight Train Collision**

**September 12, 2008, Chatsworth, CA:**

### **Main Report**

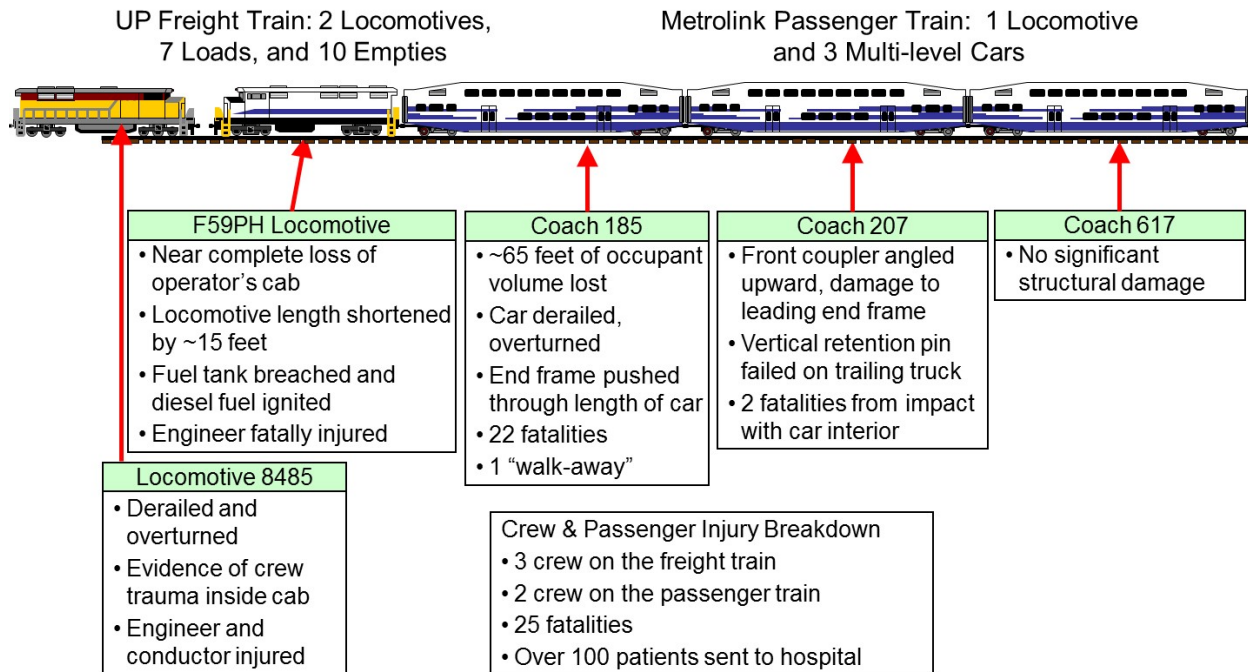
**Figure 3. Summary of Equipment Damage and Injury/Fatality Distribution**

Figure 3 shows a schematic and a summary of the equipment damage. In the passenger train, the locomotive cab was crushed, eliminating the survival space. The first passenger car, originally 85 feet in length, was crushed approximately 65 feet, back to the trailing boarding doors. The survival spaces in the forward mezzanine level and bi-level section were lost. Survival space was maintained in the trailing mezzanine level. In the two trailing passenger cars, survival space was maintained. Survival space was maintained in the freight locomotives, although a significant portion of the roof of the second freight locomotive was torn off.

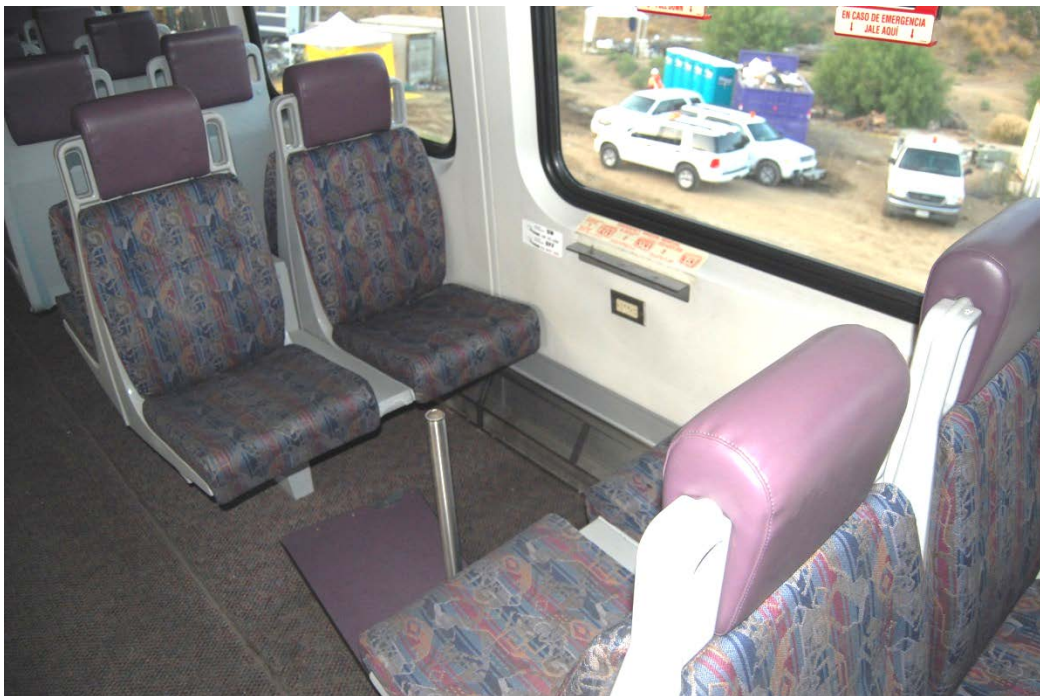
Figure 8 shows a table that has broken off its mounts, on the upper deck of Car #207. A number of people seated forward-facing at a table suffered serious abdominal injuries due to impact with the table. Injuries included fractured ribs, lacerated liver, mesenteric tear, and damage to the spleen.

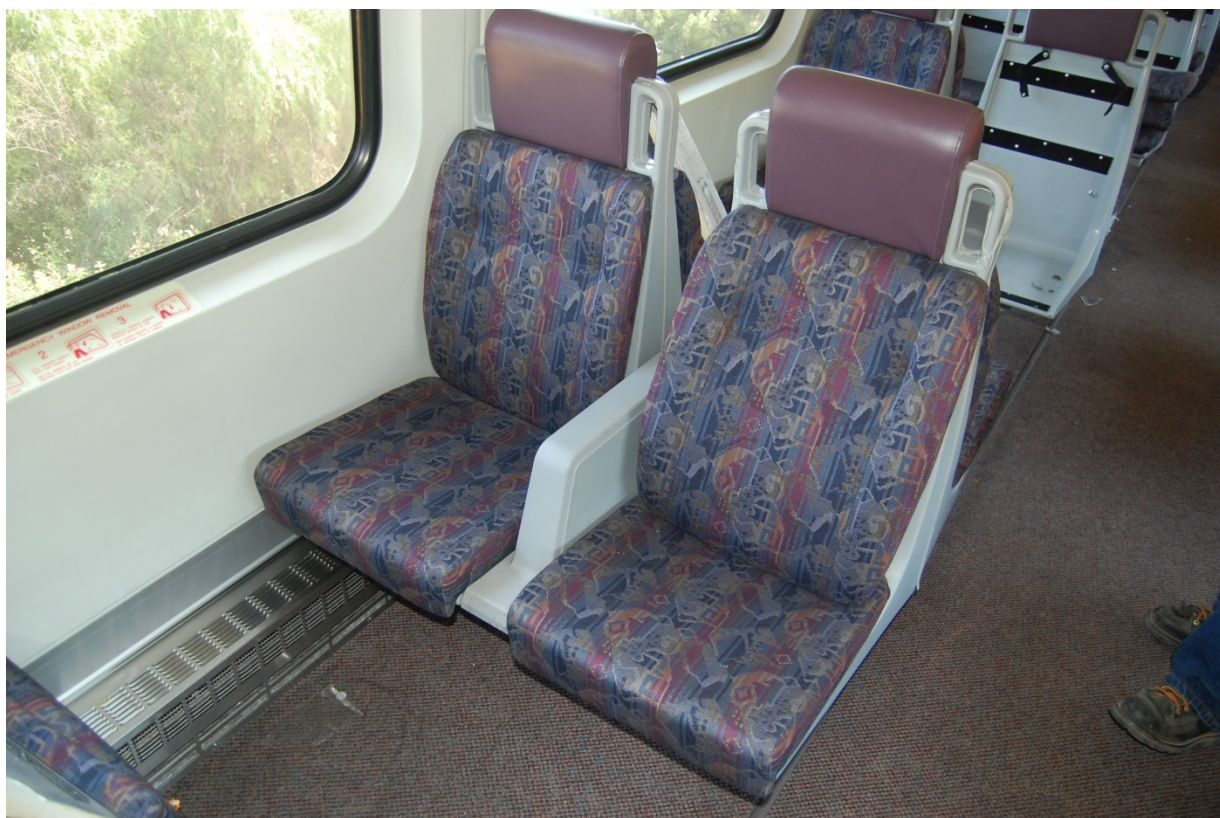
**Figure 9. Example of Forward-Facing Open Bay Seats**

The likely initial location of Passenger #8 is in the aisle-side seat shown in Figure 9. Injuries incurred by Passenger #8 include a fractured tibia, fibula, humerus, and rib, dislocated shoulder, head laceration and concussion. Interviewed forward-facing passengers that remained compartmentalized, or contained in the space between open bay seats, experienced fractures of the femur and patella, concussion, and facial lacerations.

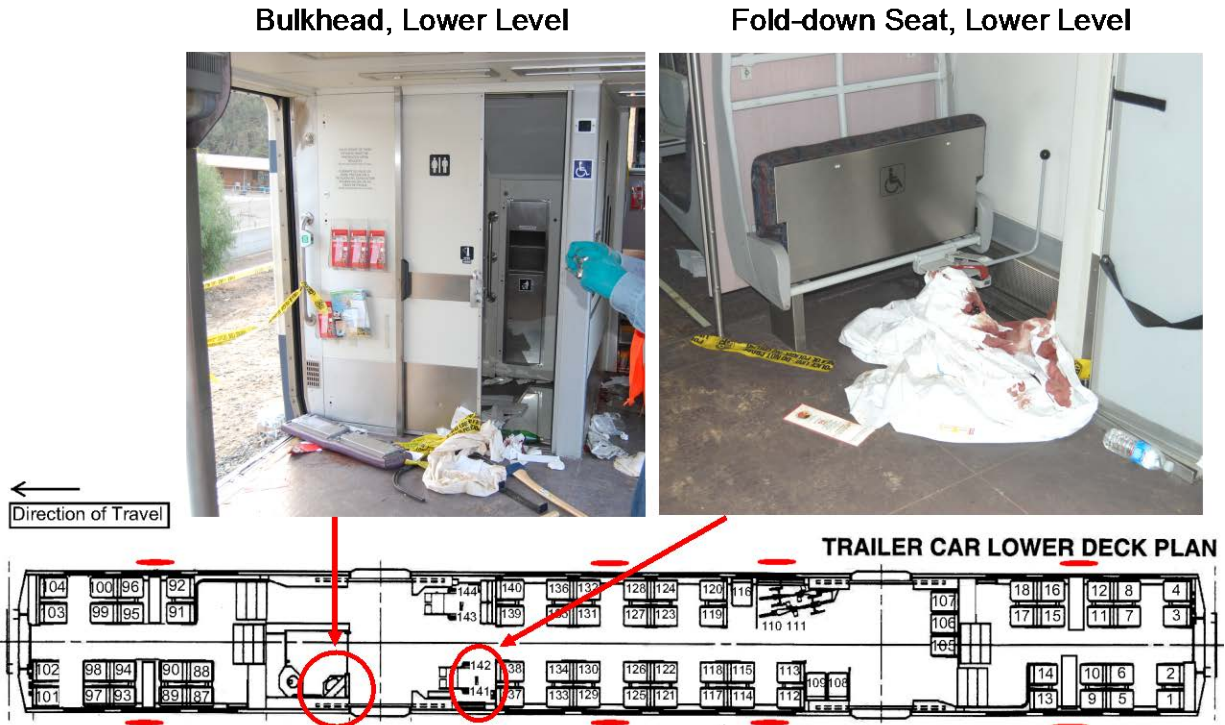
**Figure 10. Forward Stepwell, Lower Level to Mezzanine Level, and Lower Level Fold-down Seat, Car #207**

Interviewed Passenger #7 was seated on the flip-down seat on the left side of Car #207 and impacted the bulkhead about 10 feet away (see Figure 10). This passenger suffered serious injuries, including four fractured ribs, four fractured vertebrae, fractured tibia, fractured forearm, and a fractured finger. This increased severity of the injuries to these passengers was likely caused by an extremely high SIV and very rigid impact surfaces, i.e., the stairs and the bulkhead wall.

Figure 10 shows the bulkhead wall, which is next to the bathroom door, and the fold-down seat where Passenger #7 was likely initially located.

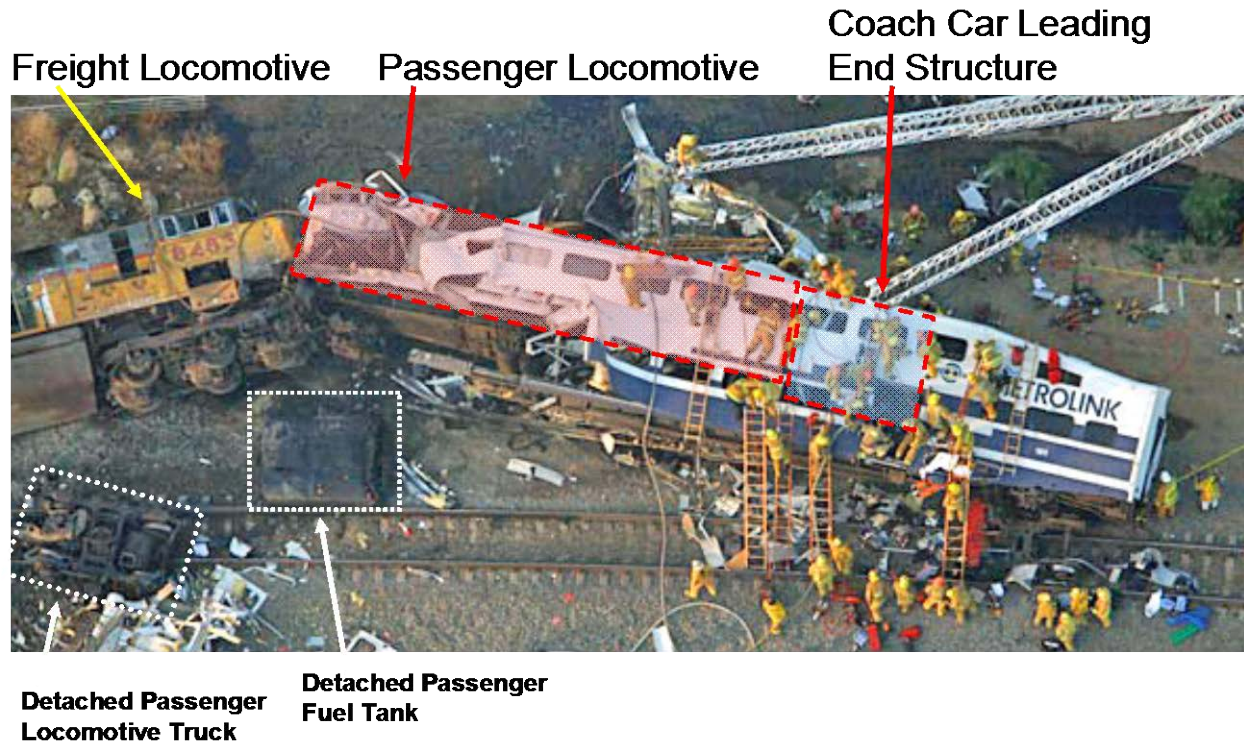
**Figure 12. Annotated Photograph of Lead Freight Locomotive, Lead Passenger Locomotive, and First Passenger Car (Photograph from *LA Times* Web site)**

The photograph in Figure 12 shows the lead freight locomotive, lead passenger locomotive, and first passenger car. The photograph is annotated to highlight the damage. Little of the passenger locomotive is visible, since it is telescoped into the passenger car. The illustration shows that the leading end structure (mezzanine level) has penetrated the bi-level section to the stairs of the trailing mezzanine level. The location of the detached passenger locomotive lead truck and fuel tank, both of which have been separated from the locomotive, are illustrated.

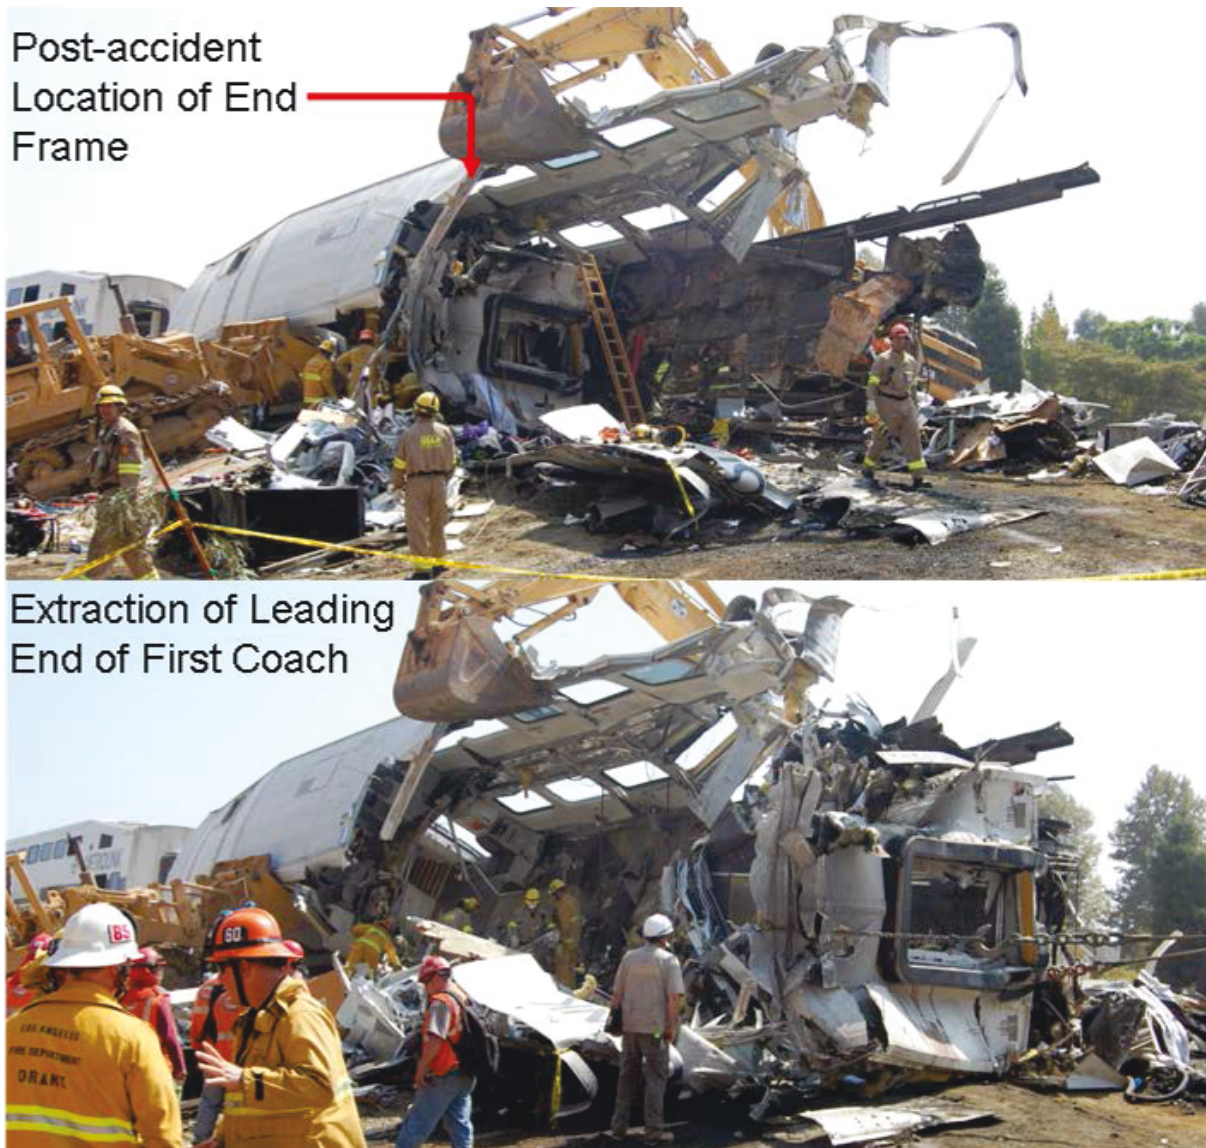
**Figure 14. First Passenger Car Structural Damage**

The top photograph in Figure 14 shows the lead passenger car after the passenger locomotive was cleared away. The bellows and end frame from the front of the car are visible, pushed into rear portion of the car, with the left side wall ahead of it held up by the backhoe. The side sill can be seen, pointing to the right. Close inspection shows the threshold for the left side door on the side sill. The lower photograph shows the end frame being pulled from the interior of the car. Though not visible in this figure, the underframe of the separated leading end of the car is essentially intact, with the lead truck still attached.

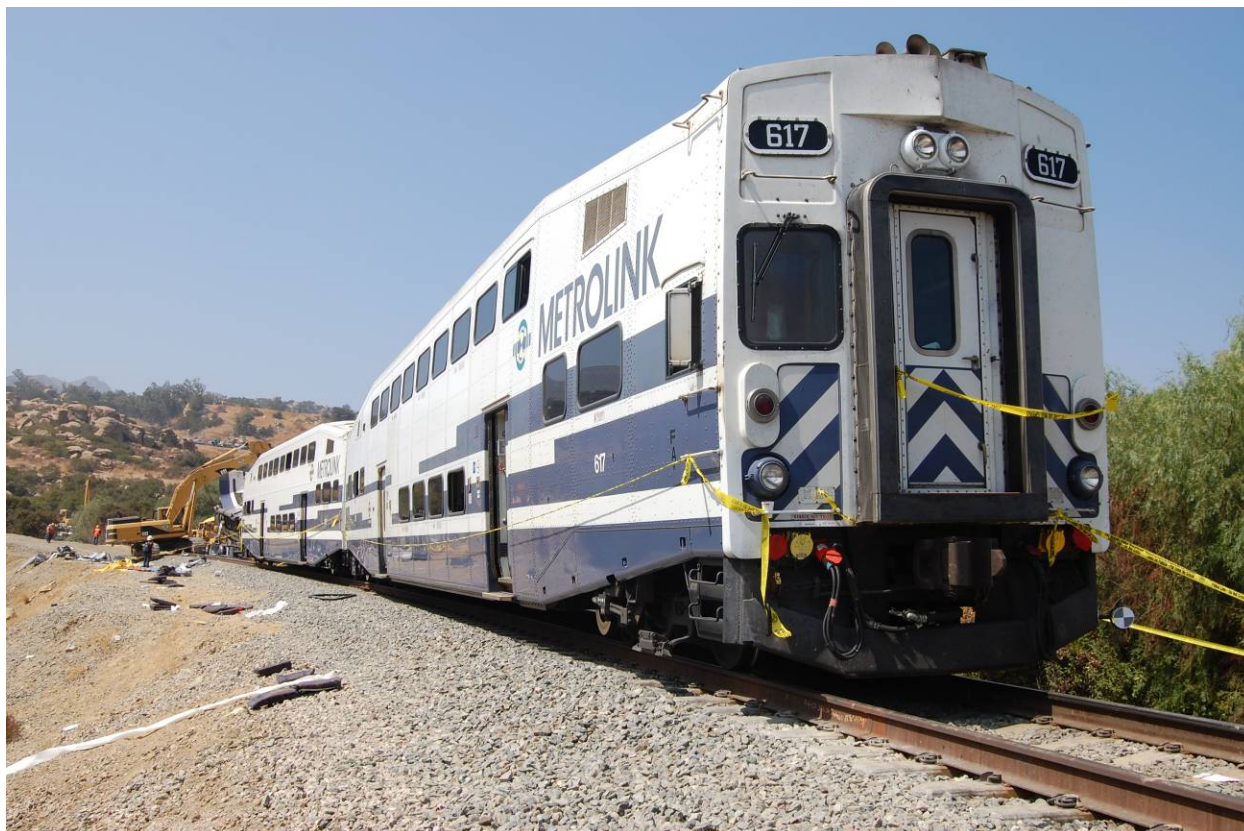
**Figure 16. Second and Trailing Passenger Cars, (#207 and #617)**

Figure 16 shows the second passenger car, Metrolink Trailing Passenger Car #207. Damage to this car was relatively minor. There was some damage to the leading end, which was coupled to the first passenger car. There was also some wrinkling of sidewall panels and damage to the lead truck attachment. There appeared to potentially be some distortion to the leading end draft sill, however, it was difficult to tell conclusively with only a visual inspection. Measurements were not possible with the truck in place. The leading bellows showed damage from contact with the car ahead. There were dents on the bellows frame, just above the spring loaded buffer beam. There was also damage to the fiberglass end cap above, just above the bellows. This damage was consistent with the leading car attempting to override this car.

Figure 16 also shows the third passenger car, Metrolink Trailing Passenger Car #617. There was very little structural damage to this car. The truck retention mechanism did fail, but the running gear remained intact and the truck remained in place beneath the car. Similar failures have been observed in an impact test of like equipment [1].

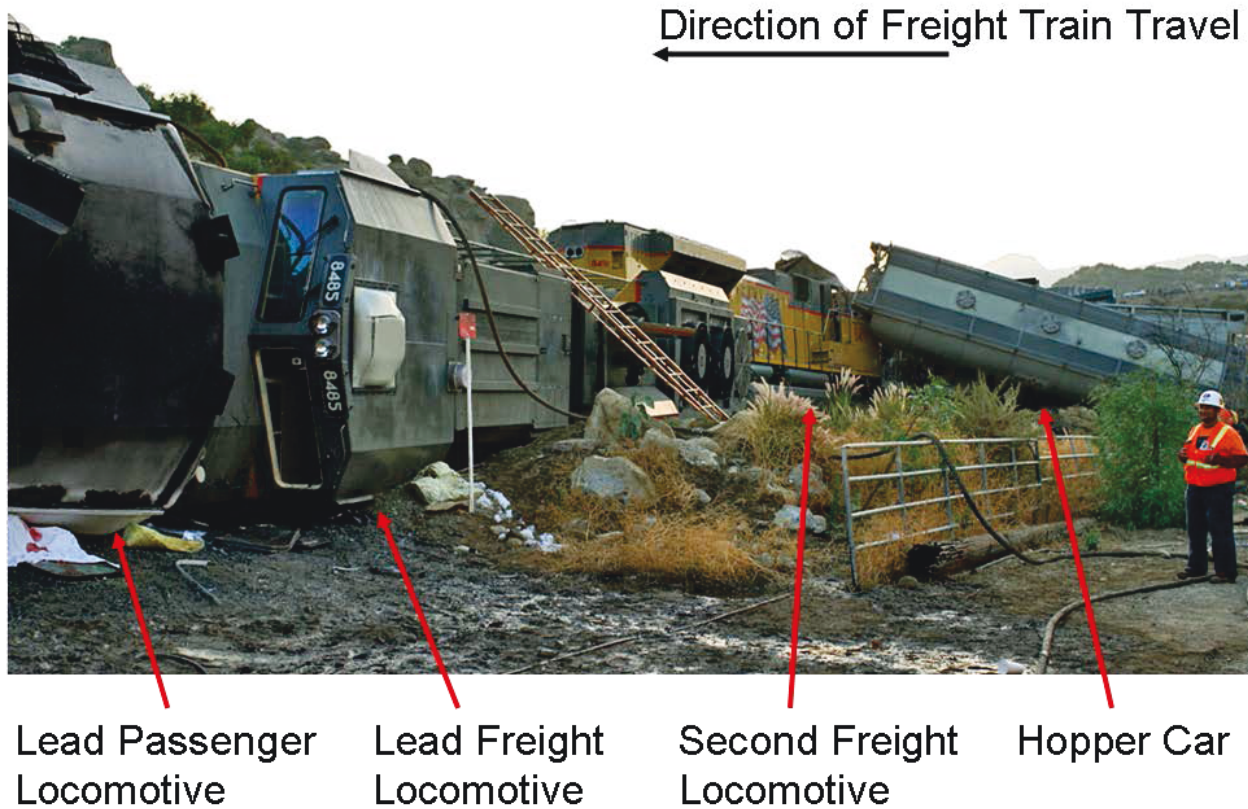
**Figure 17. Annotated Photograph: Lead Passenger Locomotive, Lead and Second Freight Locomotives, and Trailing Freight Equipment**

Figure 17 shows the damage to the freight train, which consisted of 1 forward-facing locomotive, 1 rear-facing locomotive, and 17 trailing freight cars. The leading end of the lead passenger locomotive is shown on the left side of the photograph. This locomotive is on its side. The leading freight locomotive is also on its side. As they collided, the lead passenger and freight locomotives apparently rolled outward, away from the center of the curve. The second, rear-facing freight locomotive is shown upright, with a freight car resting on its roof. Damage to the roof is evident. On the right side of the photograph, two of the stacked-up freight cars can be seen.

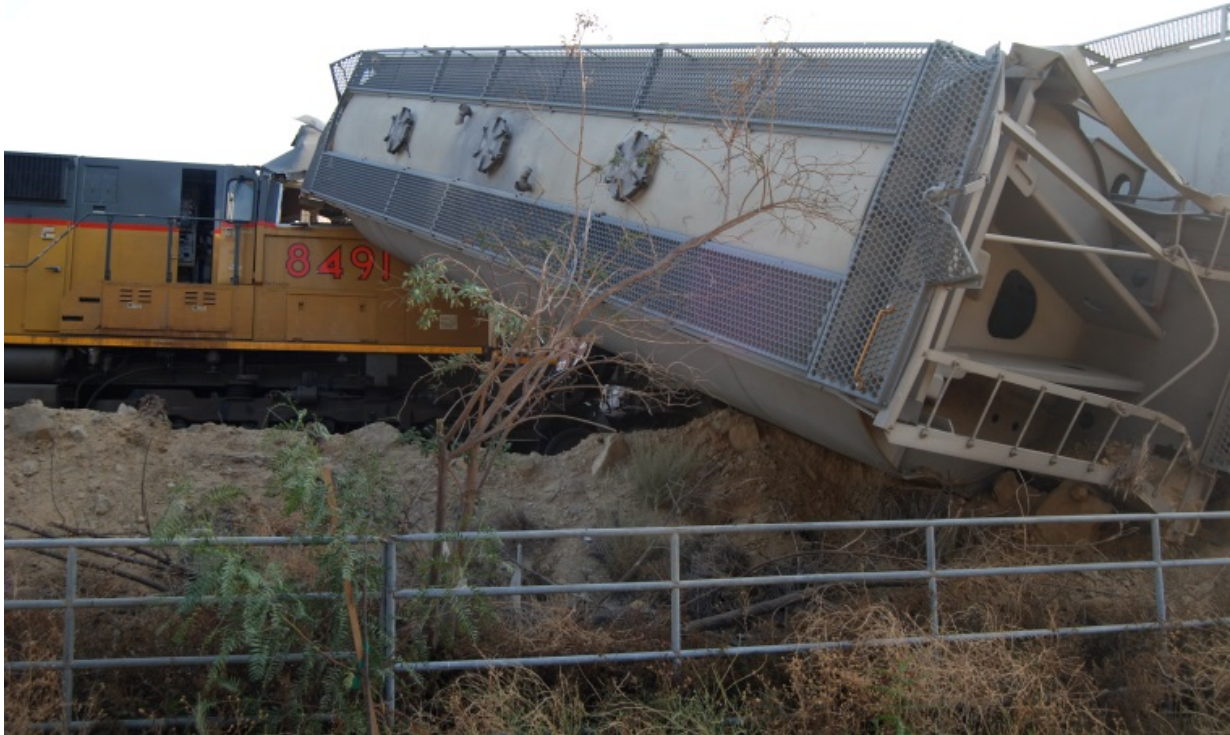
The photographs in Figures 19a and 19b show the second freight locomotive and a hopper car that collided with it. This locomotive was travelling long-hood forward. On the left side of Figure 19a, the lead locomotive can be seen to be on its side. On the right side of this photograph, the roof of an empty covered hopper car can be seen. The end of the covered hopper car is resting on the short hood of the locomotive. The roof of the locomotive was apparently significantly damaged owing to the impact from the covered hopper car.

**Figure 19a. Second Freight Locomotive Structural Damage**

**Figure 19b. Second Freight Locomotive Structural Damage**

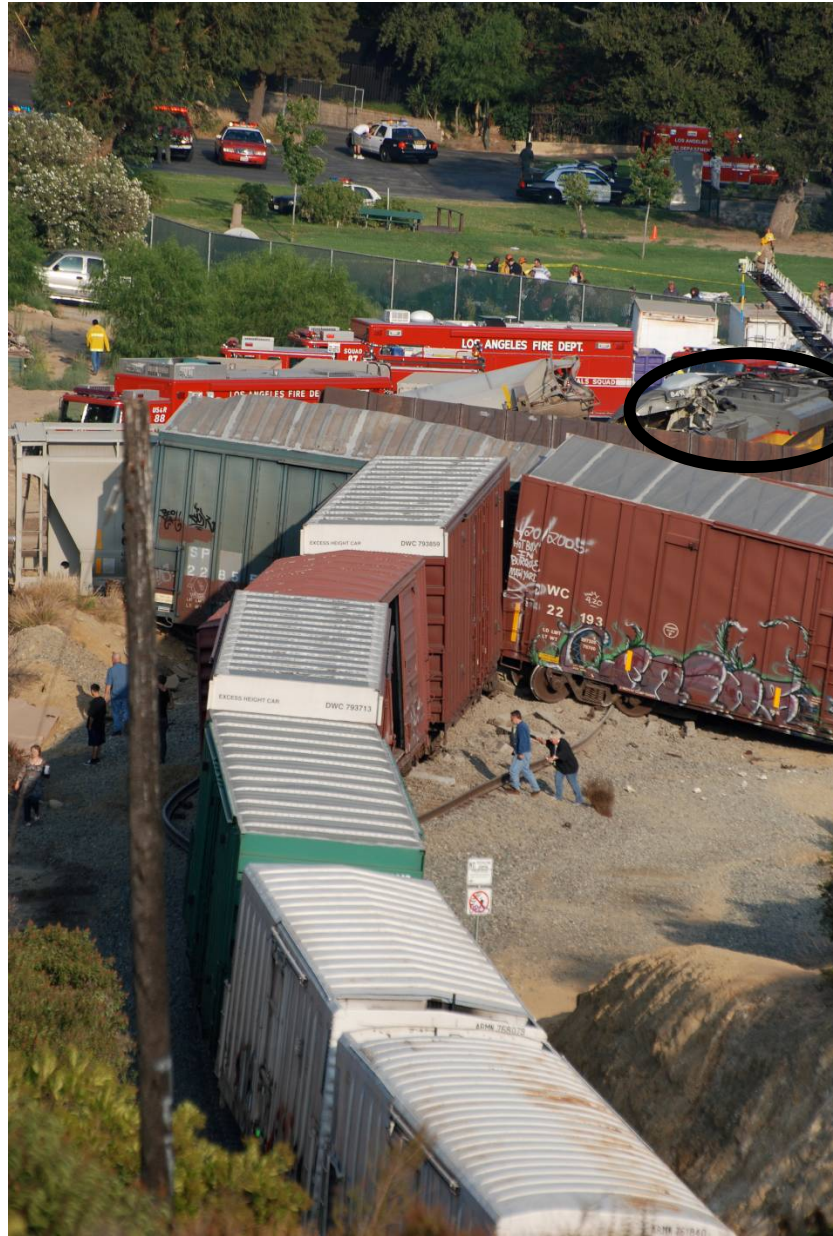
**Figure 20. Freight Equipment Structural Damage**

Figure 20 shows the trailing freight equipment. The second freight locomotive and its damaged roof can be seen in the upper-right portion of the photograph. The end of the covered hopper car resting on the short hood can also be seen. The end of a second covered hopper car can be seen on the left side of the photograph. Three box cars are then stacked up sideways to the track. The next three box cars are upright and derailed. A rail can be seen near the two-people walking up to the middle upright and derailed freight car. The three freight cars near the bottom of the photograph are upright and on the track, as well as remaining four trailing freight cars, which are not visible in the photograph.

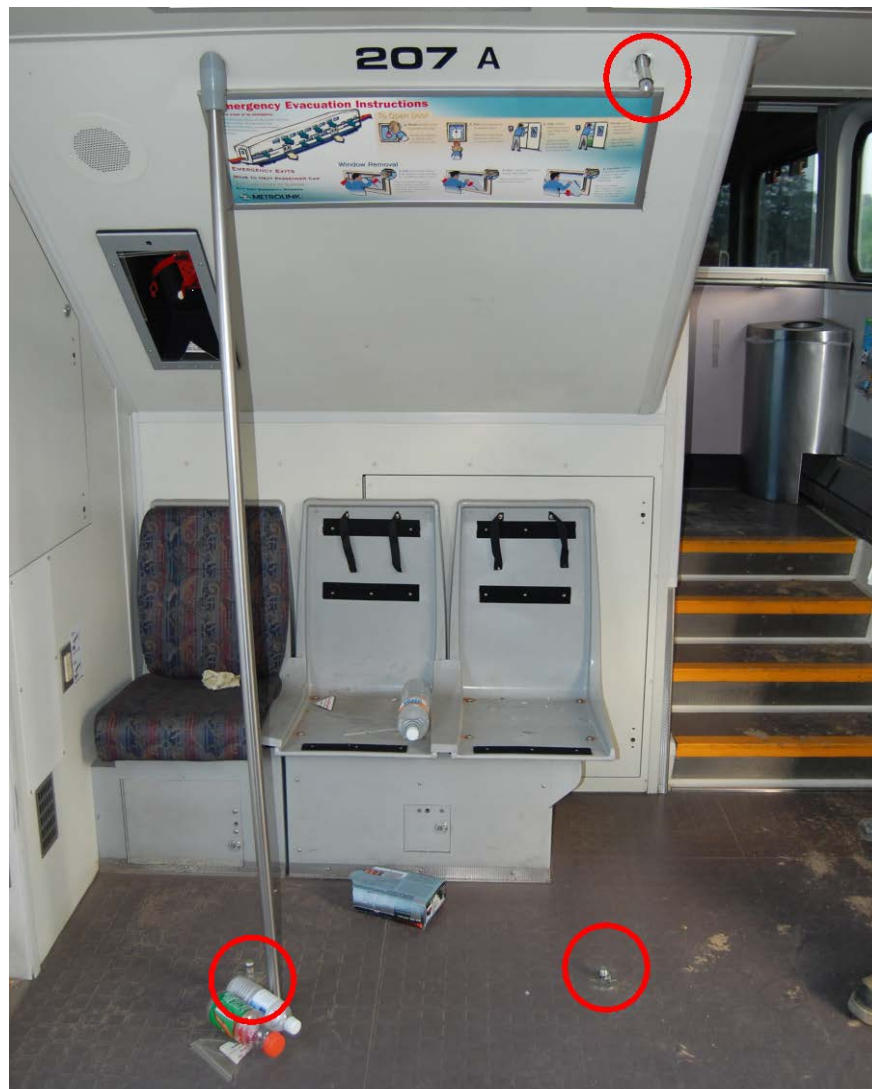
was observed on two seats. Numerous seat cushions were missing or displaced. A stanchion was completely separated from the floor and wall on the lower level, near the aft doors (see Figure 21).

**Figure 21. Detached Stanchion Near Aft Doors, Lower Level, Car #207**

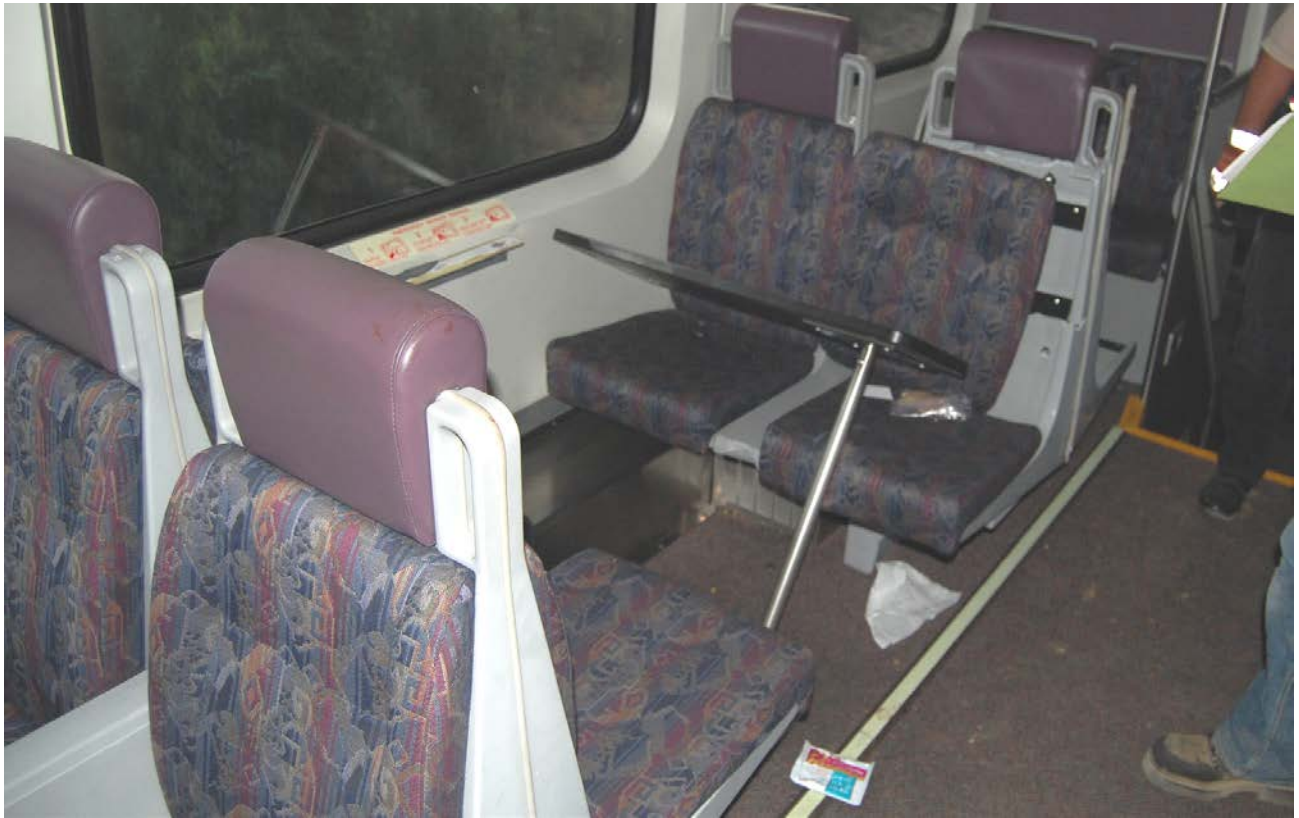
**Figure 22. Detached Table, Upper Level, Car #617**

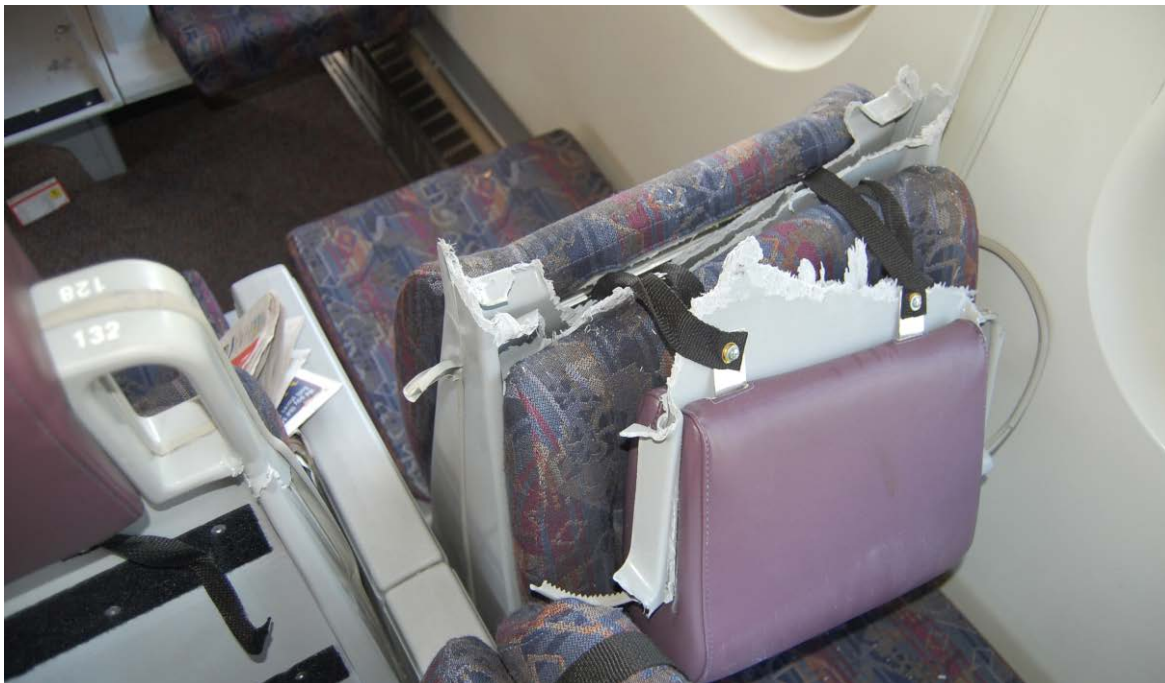
**Figure 23. Broken Head Rests in Lower Level, Car #617**
