Long-Term Monitoring of Pavement Maintenance Materials Test Sites

PUBLICATION NO. FHWA-RD-98-072

JUNE 1998

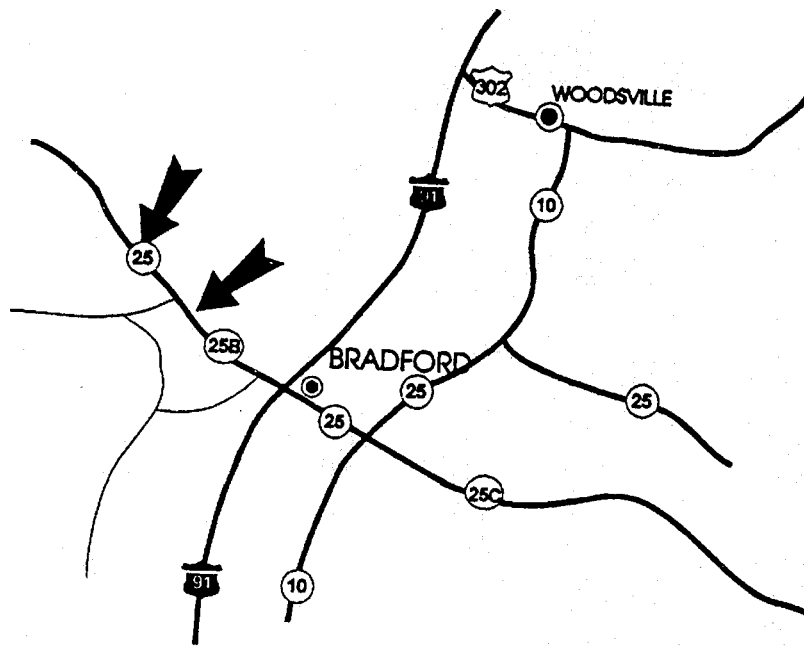
Figure 8. Bradford, Vermont, pothole repair test site.

The weather was wetter than average, which caused the pavement at the test site to deteriorate throughout the monitoring period. This deterioration necessitated the placement of an overlay in the spring of 1993. A total of 105 weeks of performance data were collected at this test site.

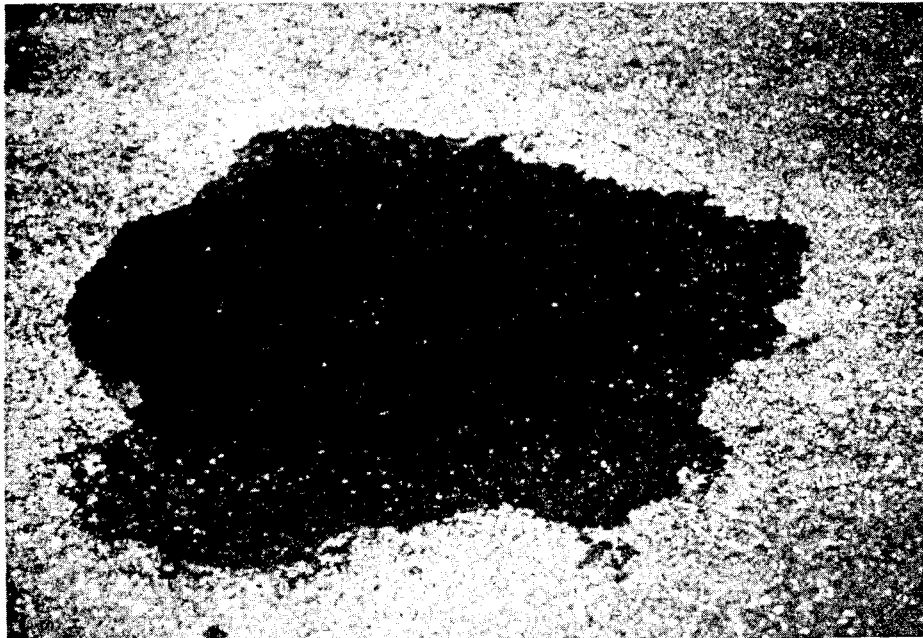
Some of the more significant distresses noted at the test sites were dishing, raveling, and edge disintegration. However, bleeding was prevalent among the PennDOT 486 patches but was not widespread among the other patches placed. Figures 30 through 34 show examples of bleeding, shoving, cracking, raveling, and edge disintegration as they were noted in the field.

Figure 30. Example of bleeding distress.

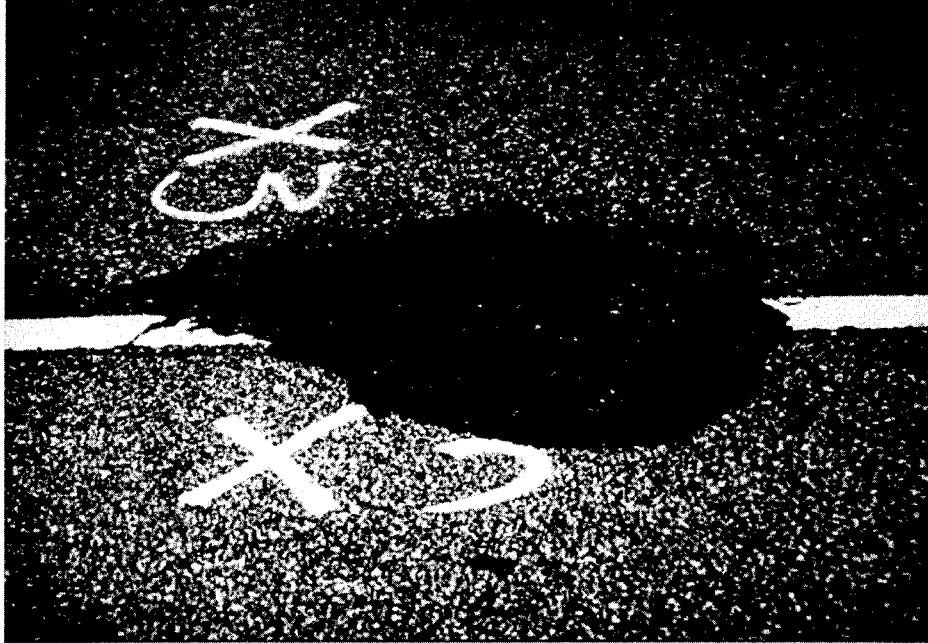
Figure 31. Example of shoving distress.

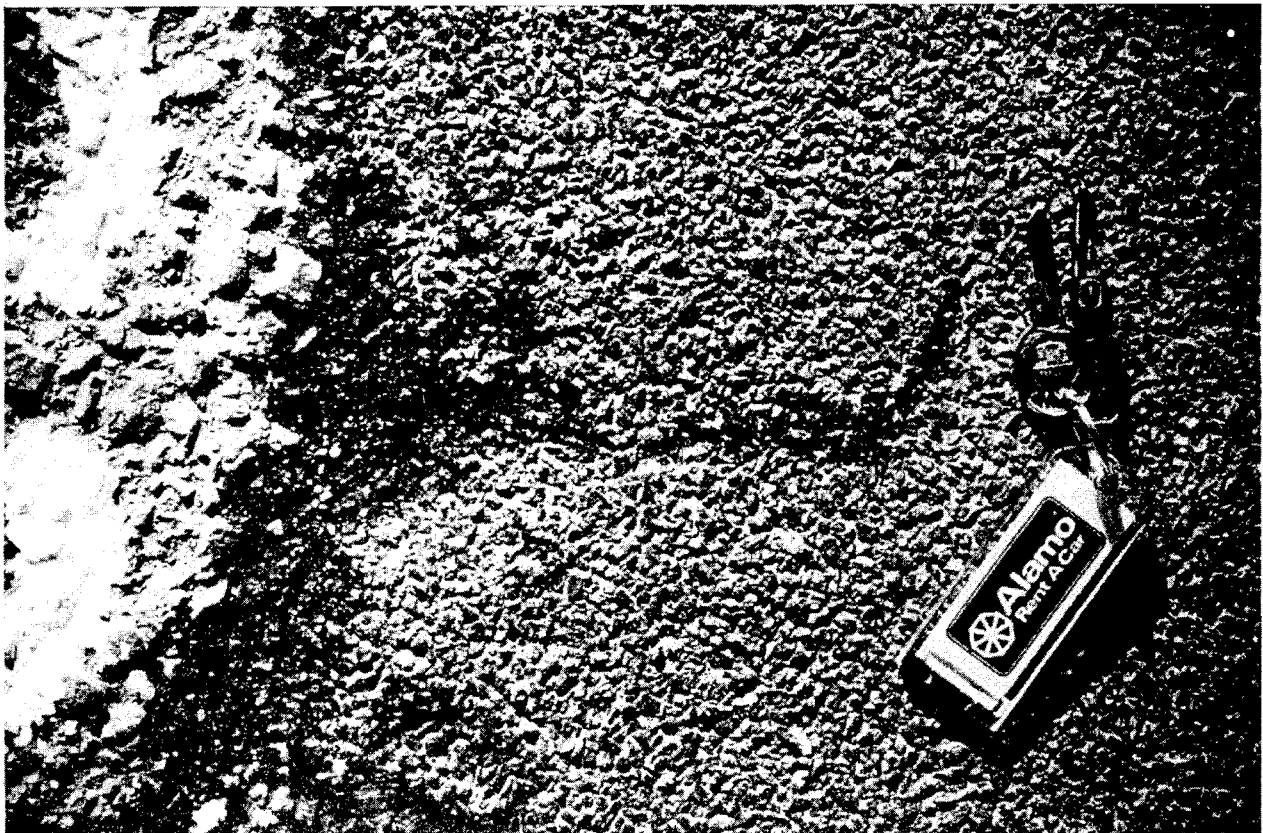
Figure 32. Example of cracking distress.

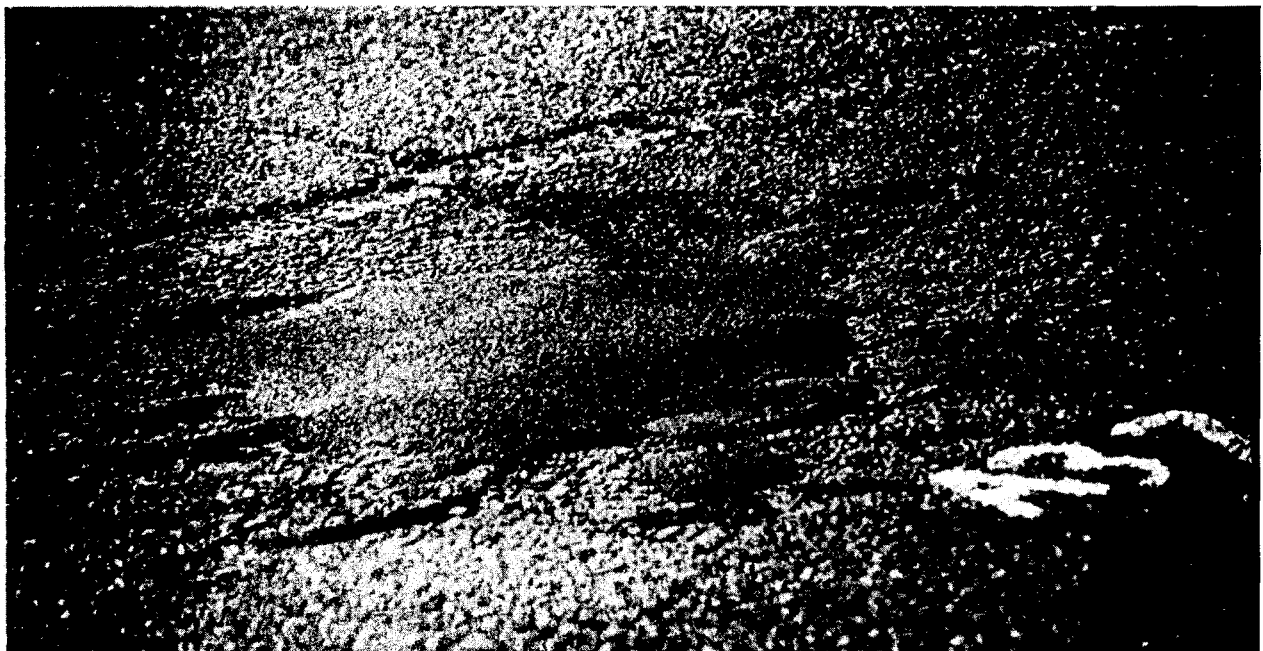
Figure 34. Example of edge disintegration distress.
