# Durability Analysis of Aluminized Type 2 Corrugated Metal Pipe

PUBLICATION NO. FHWA-RD-97-140

JANUARY 2000

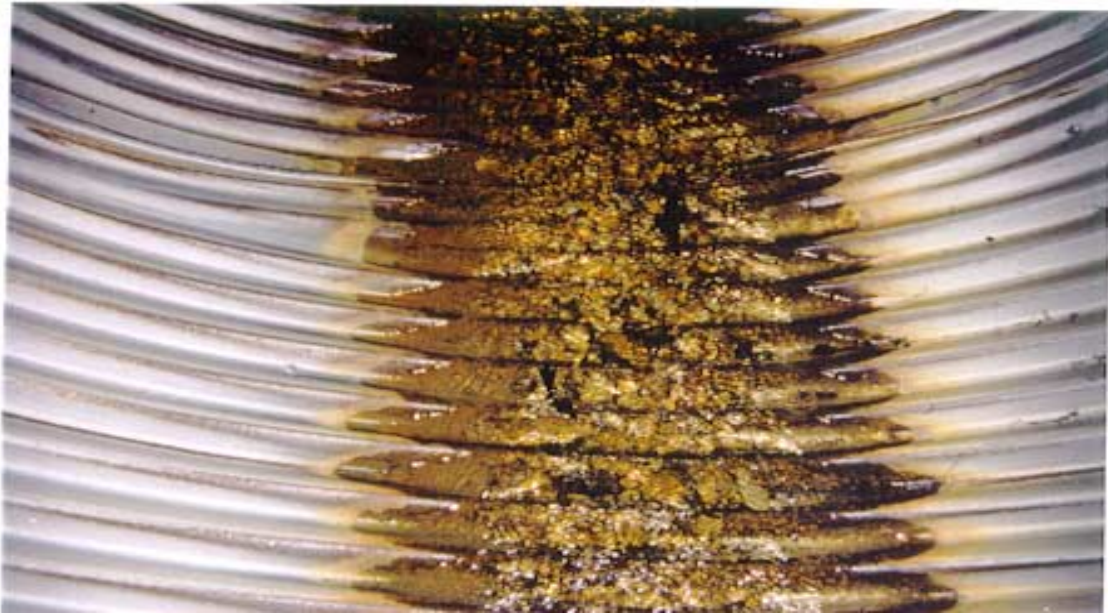
Locations 310.0 and 310.1 were the only two culverts at the Natchez Trace Parkway that were experiencing any kind of flow conditions at the time of the inspection. A possible alternative explanation for the advanced deterioration is a synergistic effect of the potentially corrosive Alabama soils and incidence of abrasion. The wear pattern on these culverts is indicative of the type of deterioration that occurs as a result of abrasive wear. This wear occurs predominantly on the upstream tangents of the corrugations. Figure 4 shows the interior of 310.0. Figure 5 shows a close-up of the invert of this culvert. Notice in both photos that the exposed steel and apparent rusting is more significant on the upstream side of the corrugation. This is consistent with

Figure 4. Culvert at 310.0 (flow is from bottom of photo to the top).

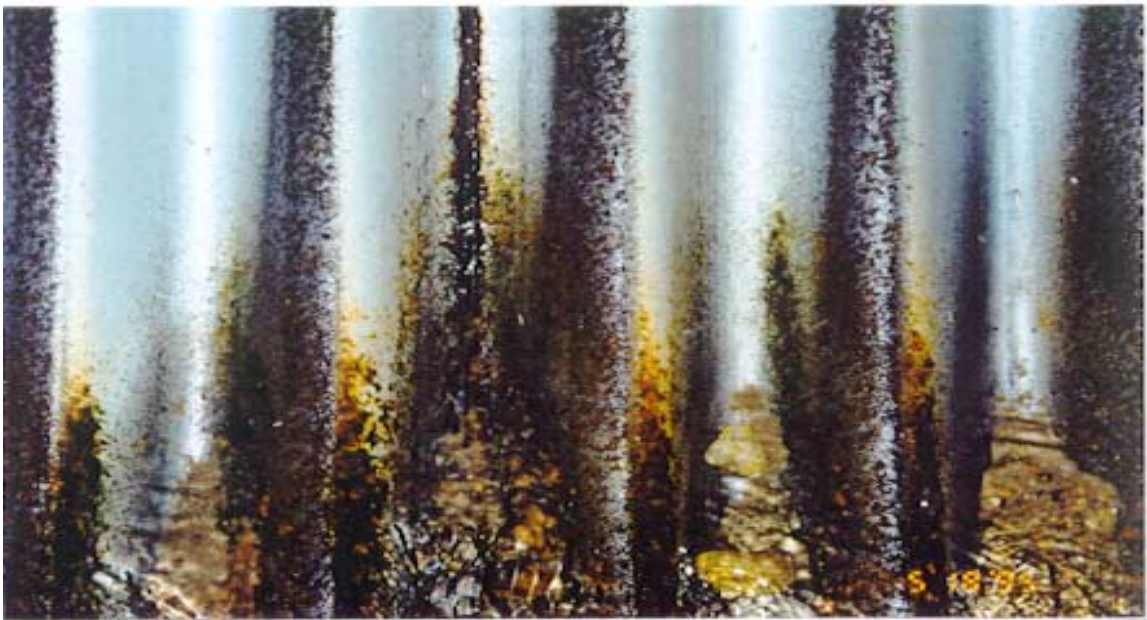
abrasive damage. Chemical attack would be expected to affect both sides equally, as shown in figure 6, which is a photo of an Aluminized Type 2 pipe (not in this study) exposed to an aggressive environment in the absence of abrasion.

Figure 5. Close-up of 310.0 (flow is from left of photo to right).  
Note: Wear and corrosion predominate on upstream side of corrugation.

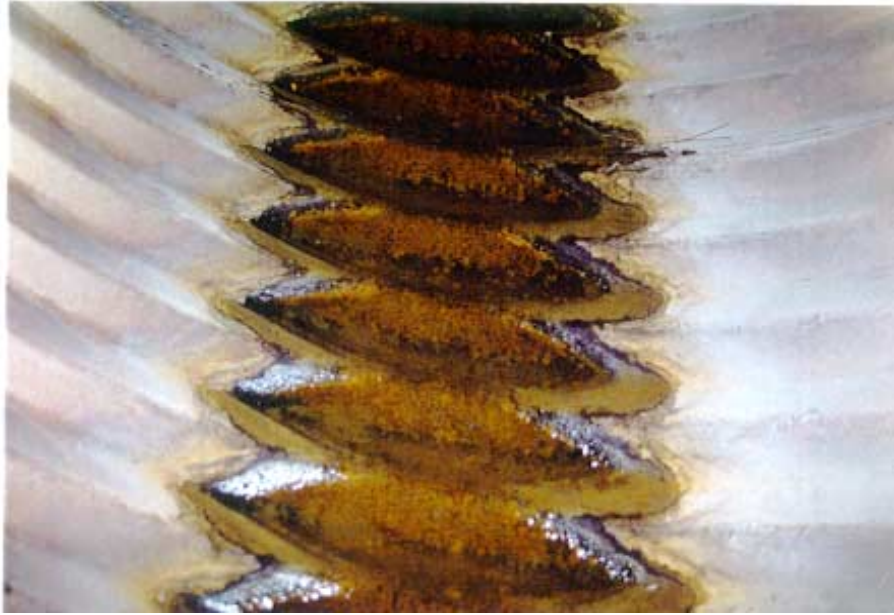
Figure 6. Aluminized Type 2 culvert after 5.5 years exposed to runoff with a pH of 2.5 to 3.5 (not from this study).

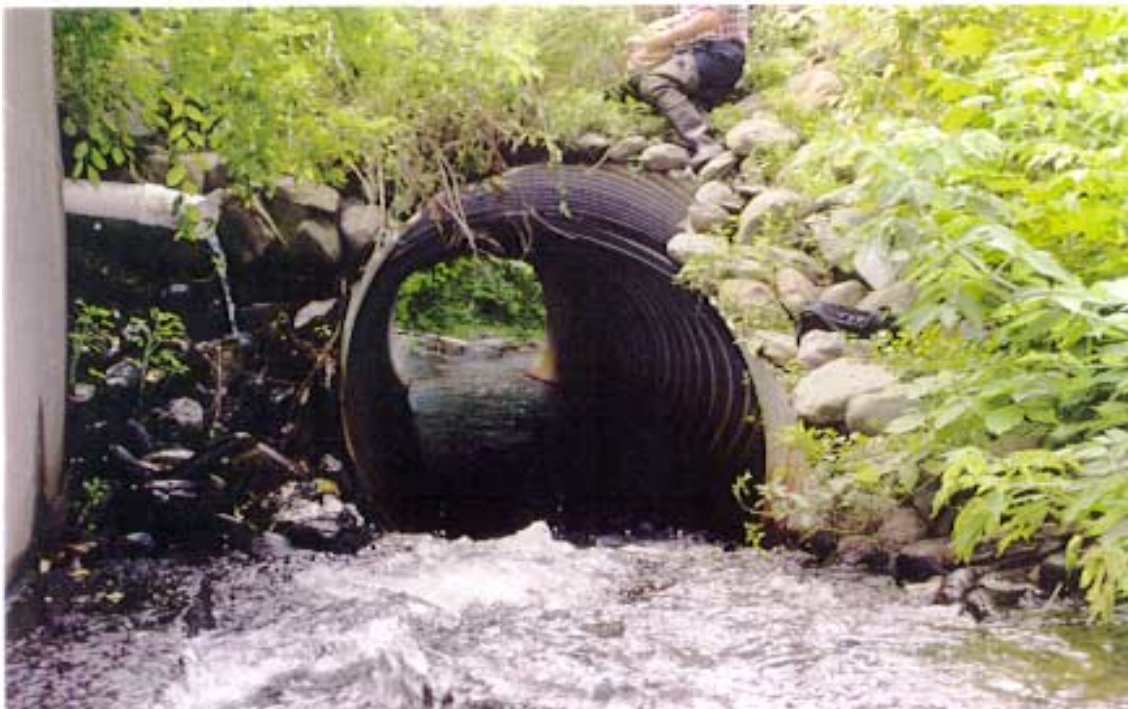
The third data outlier is that from the location in Dexter, Maine. This culvert is experiencing the highest abrasion of any of the Aluminized Type 2 pipes in this investigation. A high-velocity flow passes through this culvert carrying a rock bed load. Figure 7 shows an overview of the Dexter culvert.

Figure 7. Culvert at Dexter, Maine, experiencing high-velocity flow.
