# Shearographic Inspection of a DeHavilland DHC-7

December 1993

DOT/FAA/CT-TN92/39

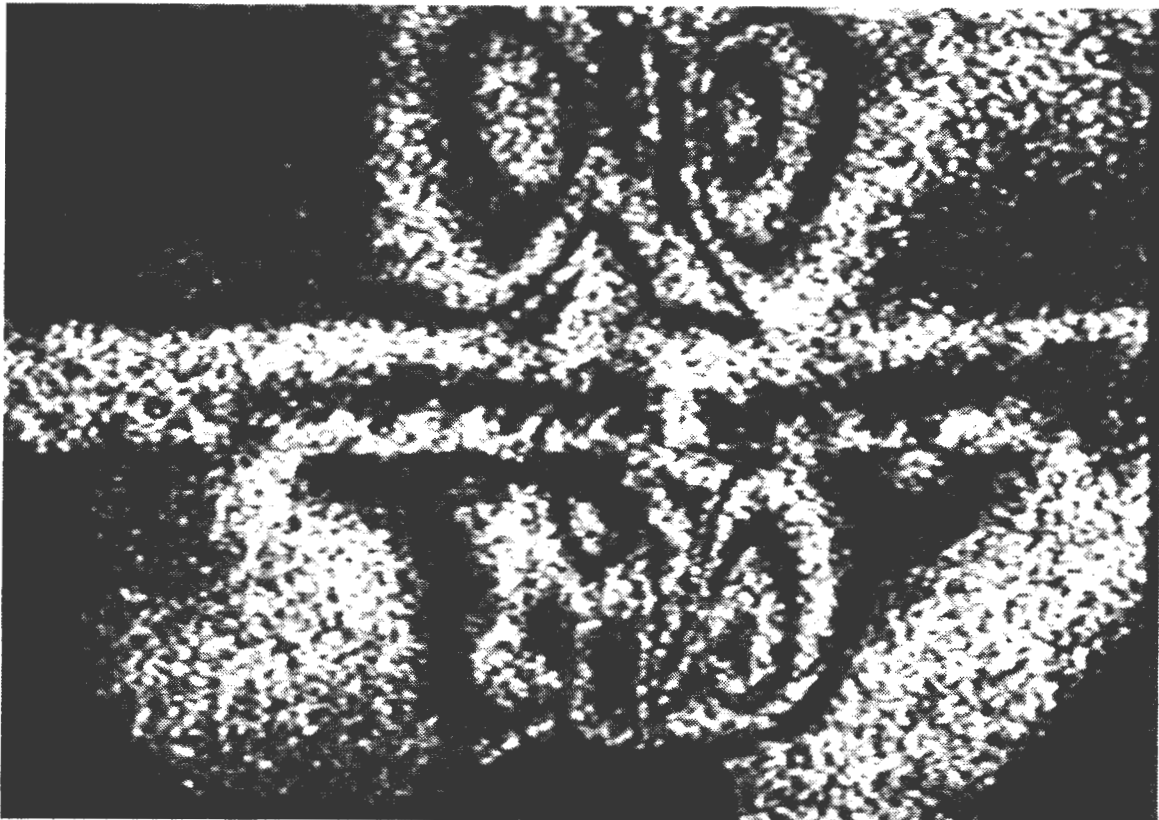
Figure 2. Shearogram of Waffle Doubler using Cabin Pressure Straining.

By comparing the shearograms made using pressurization with those using acoustic stimulus, it is apparent that the latter contain fewer fringe lines and are therefore more readily interpreted.

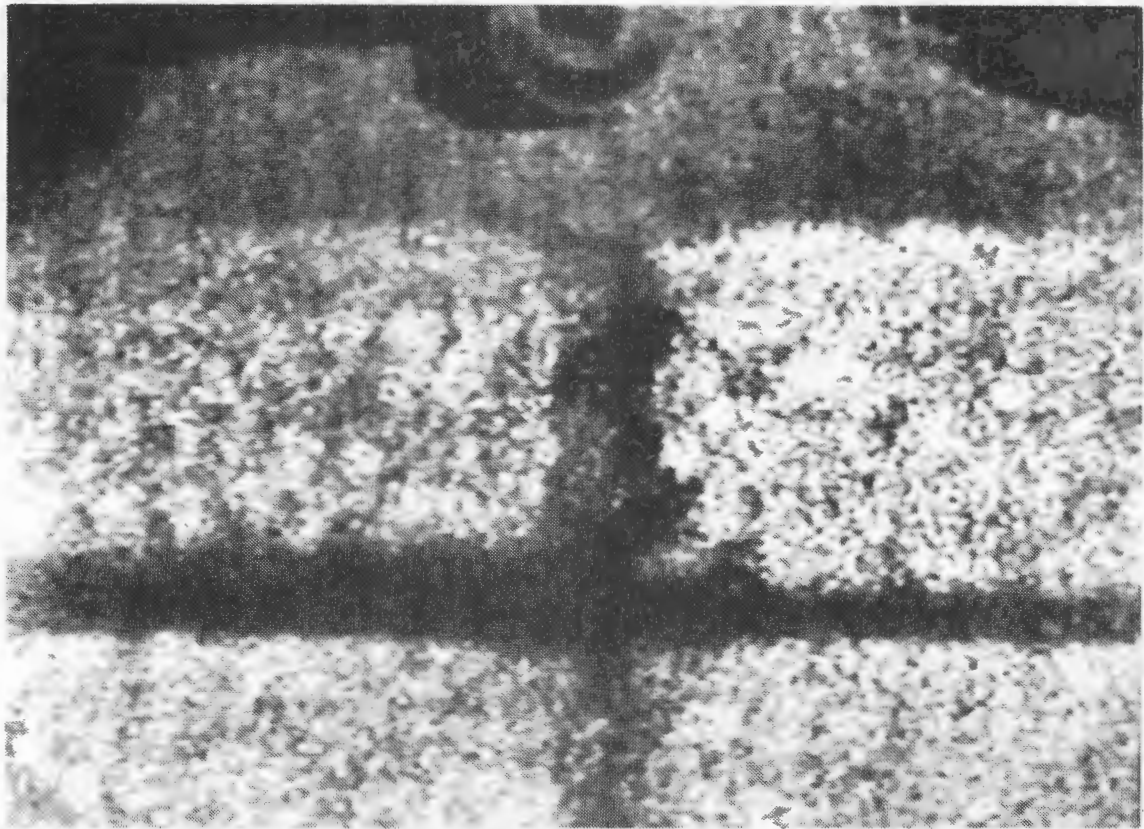
Figure 3. Shearogram of Waffle Doubler using Acoustic Straining.

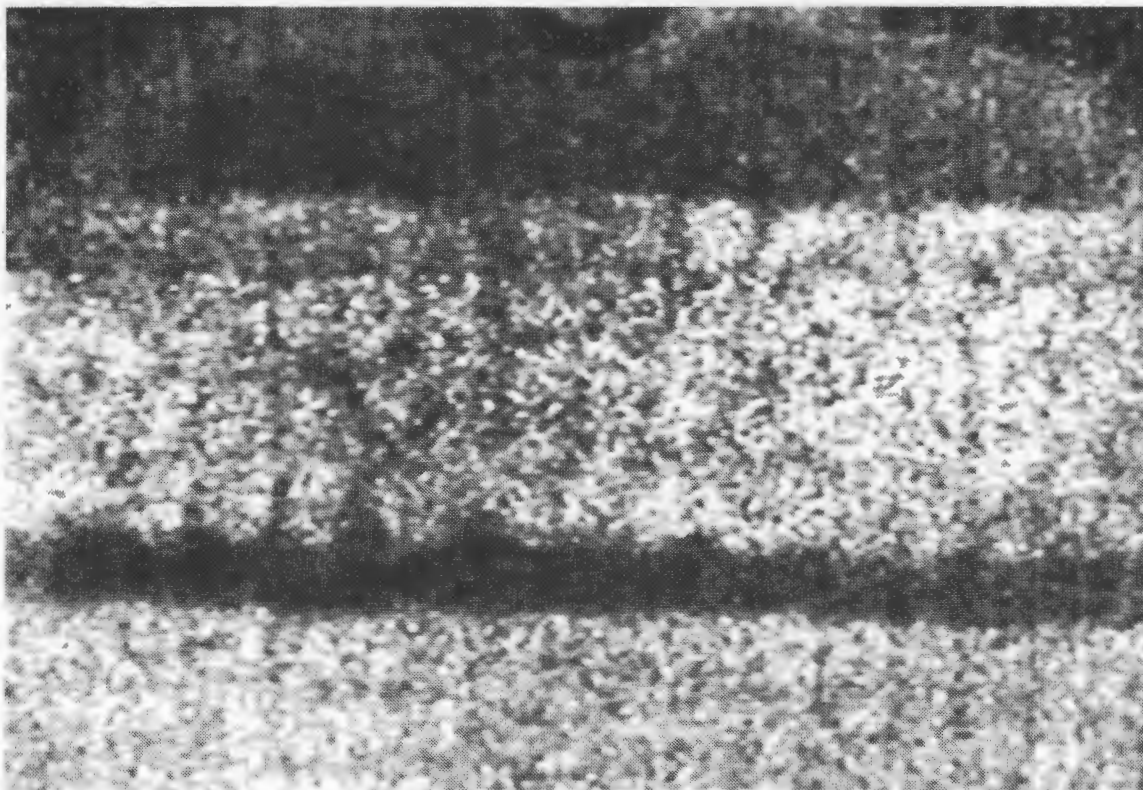
Figure 8. Shearogram of Center of Waffle Doubler.
