Catastrophic Icefall Hazard Assessment, Avoidance Procedures & Mitigations Strategies - Phase II Site-Specific Studies

February 2018

Alaska Department of Transportation & Public Facilities

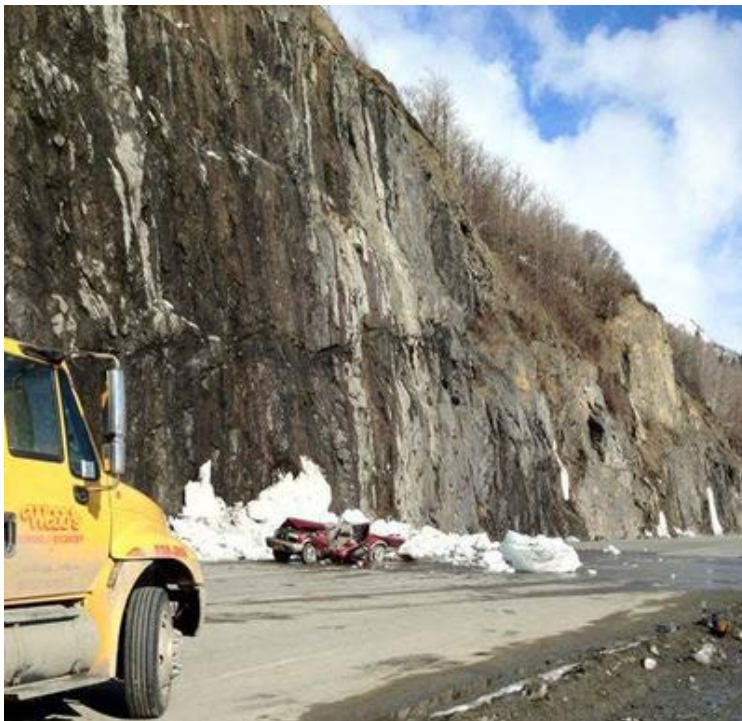
Figure 1 – Post-impact photo from 6 April 2012 icefall event near MP 113.2 NB along the Seward Highway. (Photo adapted for use from KTUU article pub. 6 April 2012)

On the afternoon of 6 April 2012, a large slab of ice fell in the vicinity of Mile Post ("MP") 113.2 of the Seward Highway (Alaska Highway 1), severely injuring a motorist. The slab that fell was estimated to be on the order of 60 to 80 ft. in height by 20 ft. in width (Fig. 1). As a result of this direct icefall impact event, which was rare based on industry reporting of similar incidents, DOT&PF initiated state-specific icefall hazard evaluations in the winter of 2015 in order to better understand the hazard and develop initial strategies for icefall mitigation. The proposed course of work consisted of an initial literature review (Phase No. 1) to be followed by site-specific studies (Phase No. 2), both of which are further described in Section 1.2.

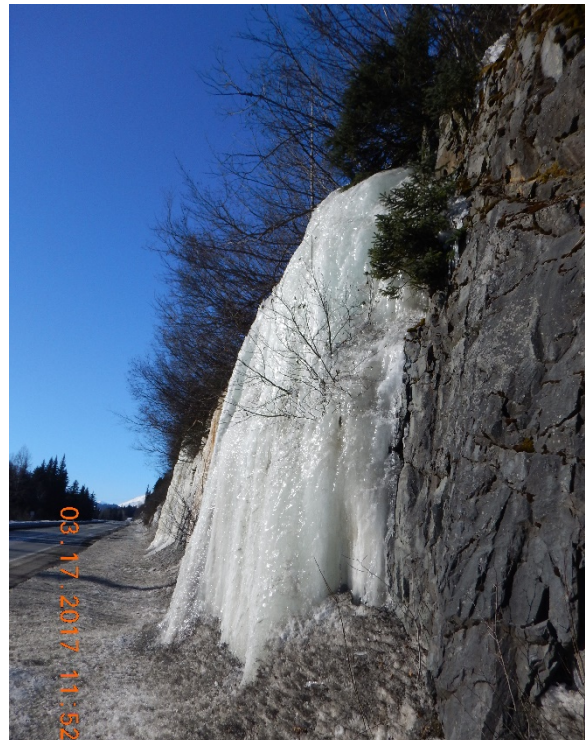
Figure 4 – Stable ice slab feature near MP 74.8 SB on Seward Highway (Photo by Scarptec, Inc.)

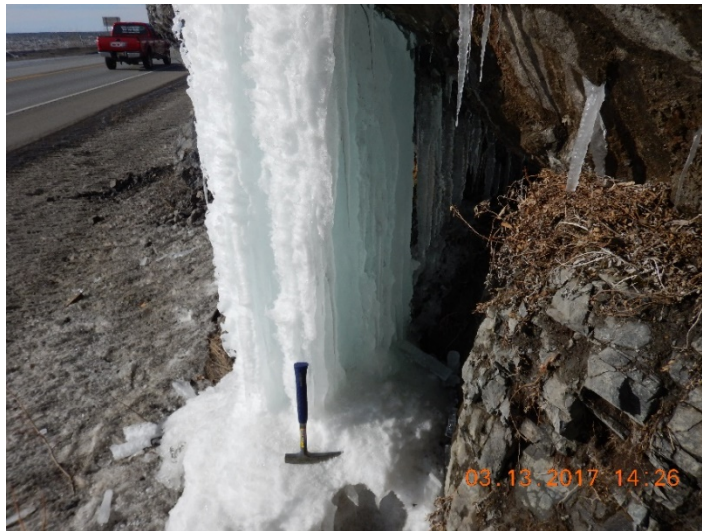
Ice slabs may be locally, partially or temporarily supported on the slope over the residence period. For example, well-developed ice sheeting on near vertical slope faces could be supported at the toe by direct bearing on rock. In similar fashion, a mid-slope bench from previous blasting activities could serve as a local ice slab bearing feature. Ice slab stability is unlikely to be compromised during extended periods of below freezing average daily temperatures due to contact adhesive strengths; however, slab loads will be distributed to contact points as the bond adhesion is lost due to melting.

Figure 5 – Partial ice column direct bearing near MP 113.2 NB on the Seward Highway (Photo by Scarptec, Inc.)

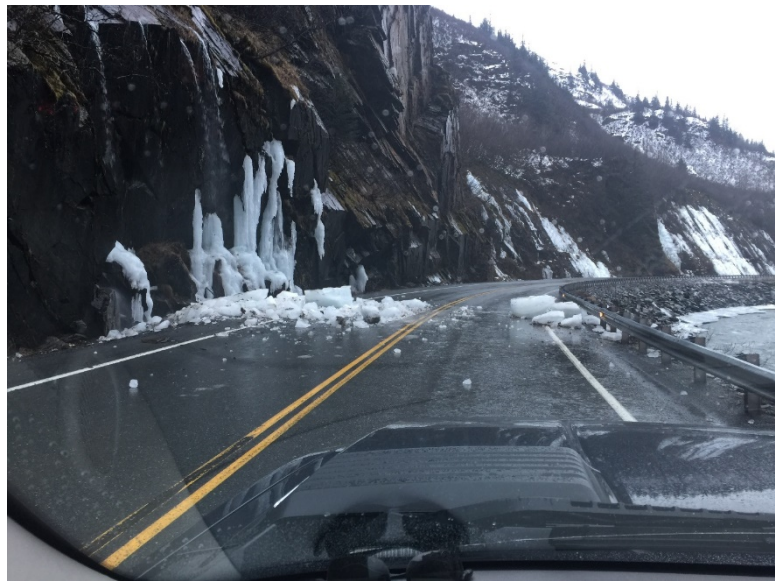
Figure 8 – Direct icefall impact & shatter at MP 13.9 Richardson Highway. Slab partially rotated outward during fall from overhung slope on 13 December 2017. Photo courtesy of AKDOT&PF.

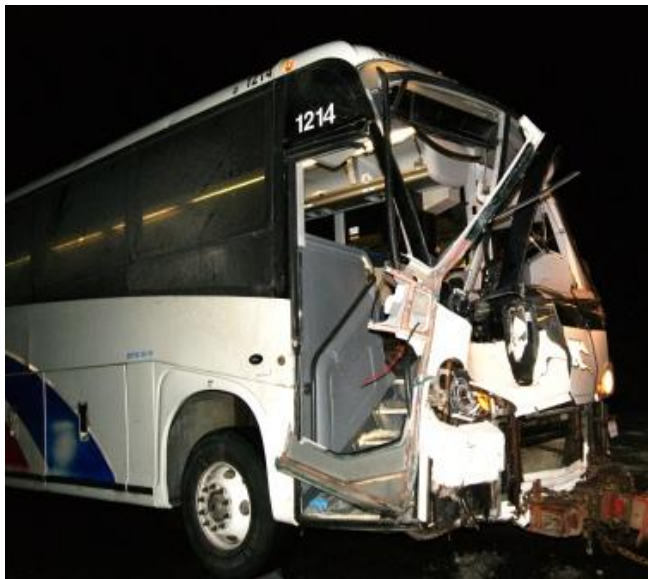
Figure 9 – Direct icefall impact damage to bus near Terrace, British Columbia, courtesy of Terrace Daily Online, February 5, 2011.

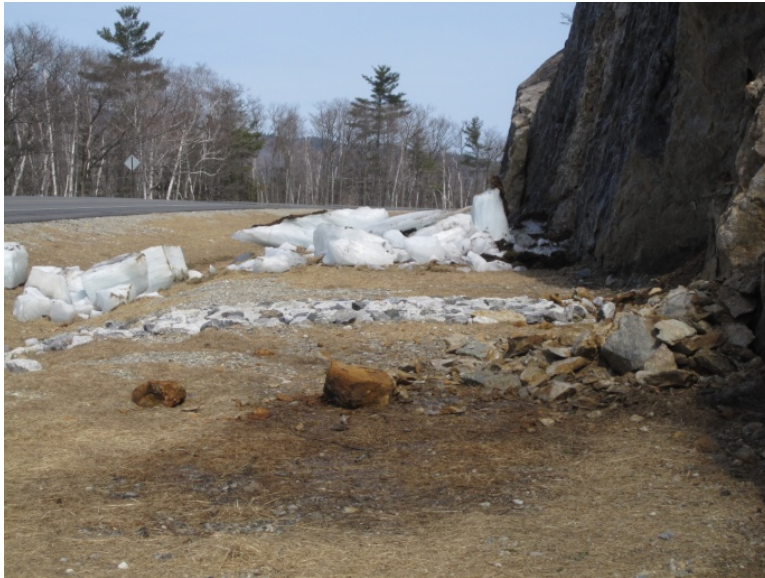
Figure 10 – Impact shatter from a spring icefall event in Gilead, Maine. Photo adapted courtesy of Haley & Aldrich, Inc.

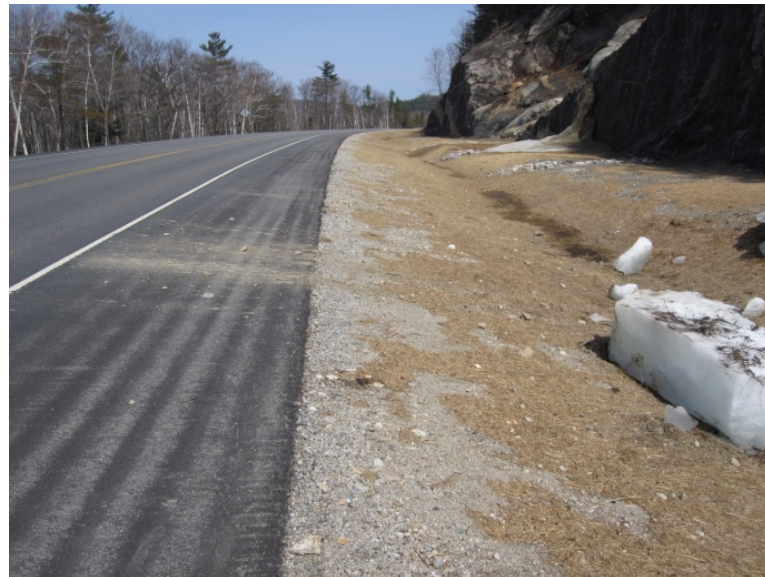
Figure 11 – Impact splatter from icefall impact in Gilead, Maine. Note mud and gravel in road. Photo adapted courtesy of Haley & Aldrich, Inc.

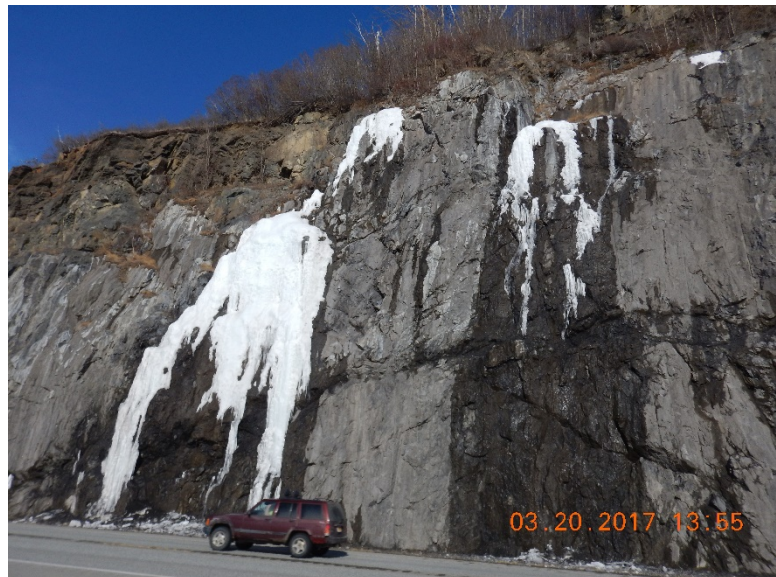
Bedrock surface temperatures will heat up relatively quickly in contrast with adjacent snow and ice due to their intrinsic albedo value, which is primarily based on mineral assemblages within the bedrock crystal fabric. The color of the bedrock and any surface staining will affect the rate of heating. The addition of moisture around the perimeter of the ice slab (e.g.) from slab melting) will aid in “darkening” the rock and will aid in the further lowering of the rock’s albedo, as shown in Fig. 12. In turn, this effect will result in an increase in the rate of rock surface heating. Moistened bedrock surfaces even were found exuding steam on one such day in March of 2017.

Figure 12 – Ice slab melting on dark colored rock near MP 113.2 NB on the Seward Highway (Photo by Scarptec, Inc.)

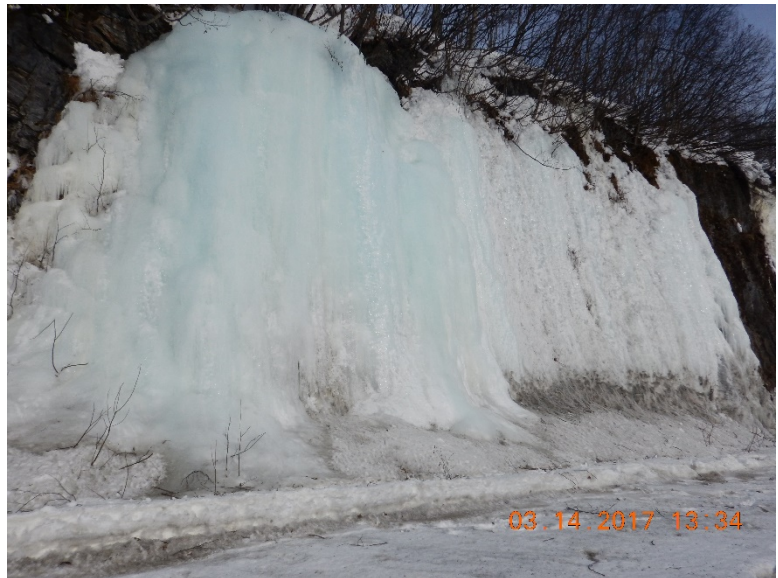
The color of ice can be an important indicator with respect to ice strength, as documented by glacial research. Ice with a clear and or blue hue (Fig. 13) is generally compact, free from air voids and micro-crystalline, all of which is correlated with higher strength. Conversely, white or gray (Fig. 12 and right side of Fig. 13) ice is considered relatively weak due to the presence of entrained air bubbles (porosity) and coarse crystal structure. Color can be used as a proxy for ice strength compressive (crushing) strength, which is temperature dependent. This is important because internal ice weakness can lead to fracturing and separation between individual slabs, which could lead to icefall. At temperatures close to the melting point, ice has a limiting value of crushing strength of approx. 150 to 300 psi.

Figure 13 – Strong blue ice slab with adjacent weak white ice near MP 38.3 SB on Richardson Highway (Photo by Scarptec, Inc.)

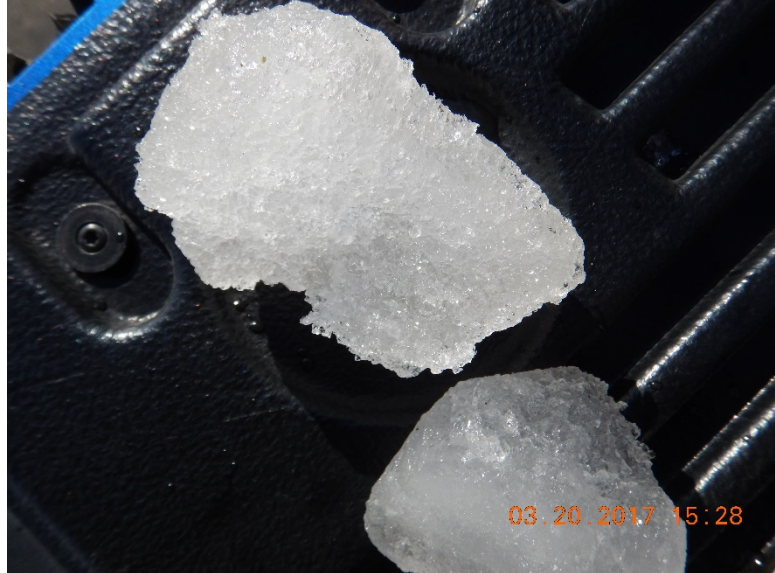
Ice with coarse-grained, randomly-oriented crystals and contains entrained air bubbles is generally significantly weaker than ice with micro-crystalline textures and no visible signs of porosity. A photographic example of weak ice texture is included as Fig. 14. Fallen ice fragments can be inspected for color and texture to make qualitative estimations of ice slab internal strength. White or gray granular textures indicate weak ice, which may indicate candidacy for eventual break-up and subsequent fall from the main ice slab.

Figure 14 – Sample of fallen coarse-grained weak white ice from ditch at MP 113.2 NB on the Seward Highway (Photo by Scarptec, Inc.)

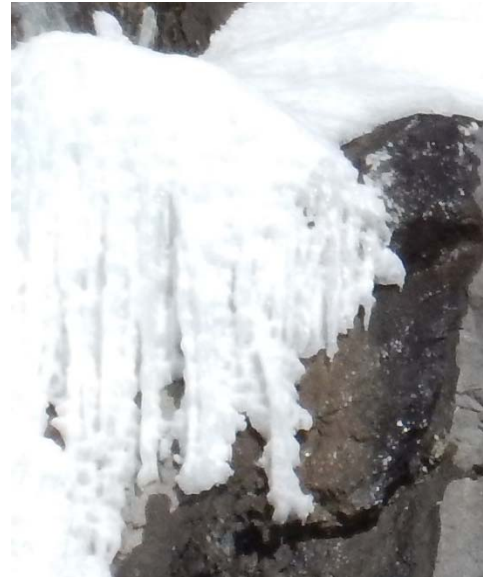
- *Dilation* – Is a subset of translation where the slab “rides over” the top of asperities on the slope surface, showing evidence of lenticular voids between the ice and the bedrock. The contact surface essentially opens-up for a portion of the slab length.

Figure 15 – Interface retraction seen at MP 113.2 NB on the Seward Highway in March 2017 (Photo by Scarptec, Inc.)

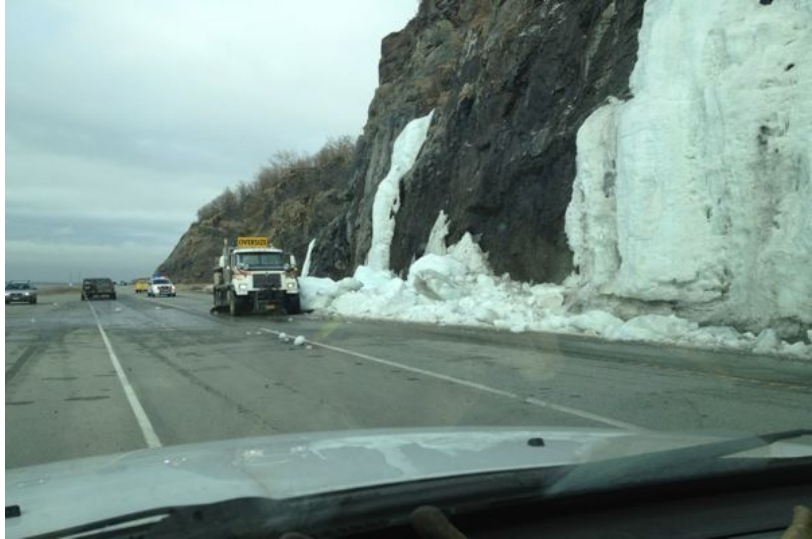
Figure 21 – Clean-up of 6 April 2012 icefall event near MP 113.2 on the Seward Highway (Photo by KTUU)

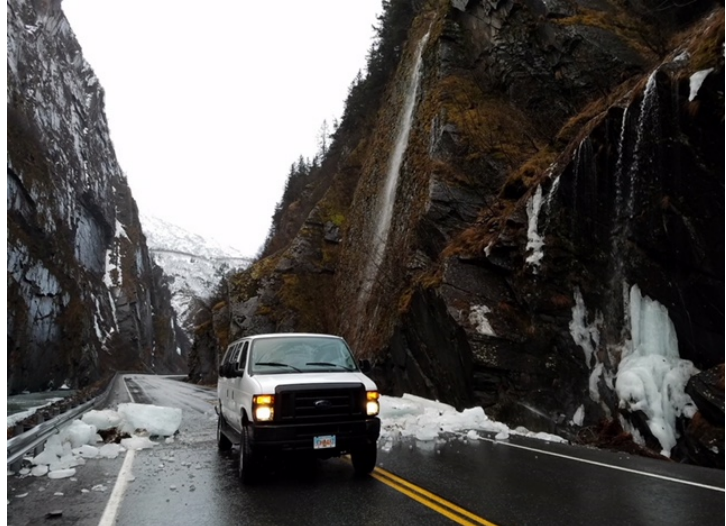
The portion of slope between approx. MP 13.7 and 14.0 southbound (west side of road) in Keystone Canyon has periodically shed small to medium blocks of ice, based on observations provided by DOT&PF Valdez District M&O staff. One specific segment of slope at approx. MP 13.9 is referred to by staff as “Car Wash Rock”, as there is frequently running surface water cascading over the slope face. There was very limited ice development on 15 March 2017 when we visited the site.

Figure 22 – Photo of 13 December 2017 icefall event near MP 13.9 on the Richardson Highway (Photo by Alaska DOT&PF)

The MP 14 site along the Richardson needs a temporary (i.e. short-term) one lane traffic diversion during expected periods of slope warming, when bedrock surface temperatures are expected exceed 32 deg. F for when active ice melting is observed. Given the site’s highway width constraints, a barrier is considered to be one of the only effective long-term (low maintenance) solutions available for icefall hazard mitigation.

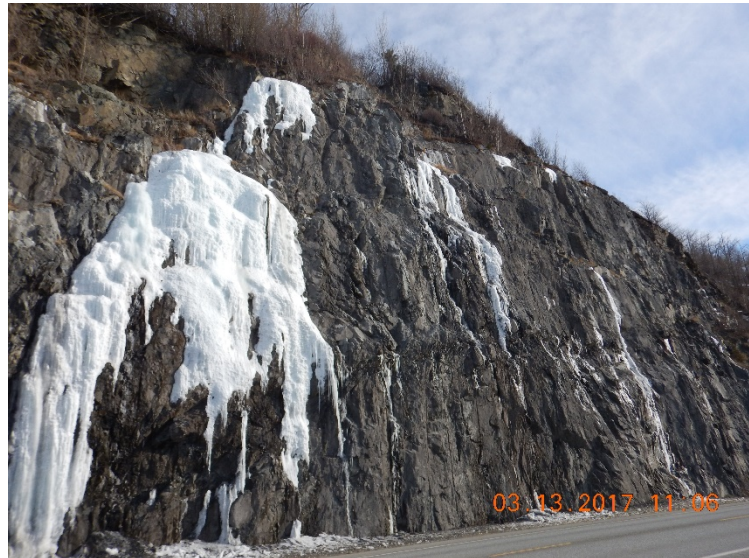
The site is comprised of a steeply cut south-southwest facing rock slope with slope heights ranging between 50 and 140 ft. Existing slope angles range between 70 and 86 deg. based on direct measurements of the slope; however based on available as-built plans, it appears that the slope is generally between 76 deg. (4V:1H) and 82 deg. (8V:1H). The slope appears to have been cut in “lifts”, resulting in small lineations or remnant benches at approx. 30 ft. height intervals. These remnant benches provide efficient ice support ledges where ice can “hang-on” and support overlying upper slabs. Free water in the form of surface and fracture-controlled discharge is abundant at this site due primarily to upslope run-off from snow melt.

Figure 23 – Photo of ice conditions near MP 113.2 on 13 March 2017 (Photo by Scarptec, Inc.)

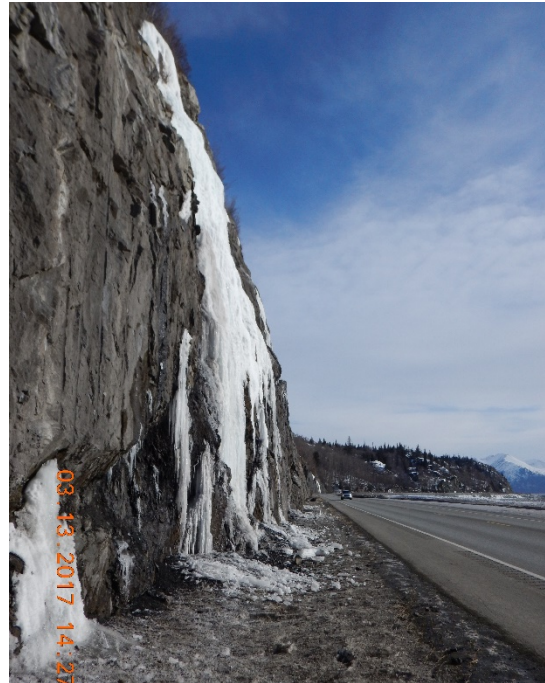
Figure 24 – Ice conditions along ditch near MP 113.2 on 13 March 2017 (Photo by Scarptec, Inc.)

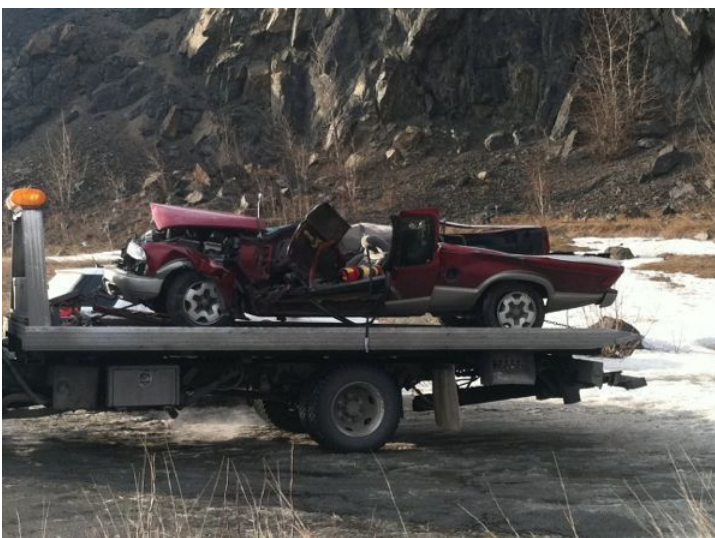
By our estimates based on photos, the falling slab of ice was approx. 60 to 80 ft. high by 20 ft. wide by 4 to 6 ft. thick. It appears that the direct impact zone extended approx. 22 ft. from toe of slope and maximum lateral extent of ice debris field was approx. 35 ft. from the slope toe (Fig. Nos. 1 & 21), just beyond the centerline of the road into southbound lane. It also appears that the this specific ice sheet failed in discrete sections, as there appeared to be other slabs that came down at different times. Based on our site observations, photographic evidence and recorded accounts from that day, we believe that the slab ultimately failed by loss of adhesive shear strength along the rock-ice contact in a period of increased average daily temperatures, resulting in a large cascading mass of falling ice. The failure event was likely a prolonged direct impact event lasting between 3 and 6 seconds as ice fell on itself and was subject to self-crushing at impact. In other words, this was not one discrete block but rather a series of slabs that delaminated vertically up the slope face. This resulted in significant damage to a small sports utility pickup truck (e.g. Ford® Ranger or equivalent), and it appears from photos that the truck was compressed vertically between 2.5 and 3.5 ft., as indicated in Fig. 25 above.

Figure 25 – Damaged vehicle from 6 April 2012 icefall event near MP 113.2 on the Seward Highway (Photo by KTUU)

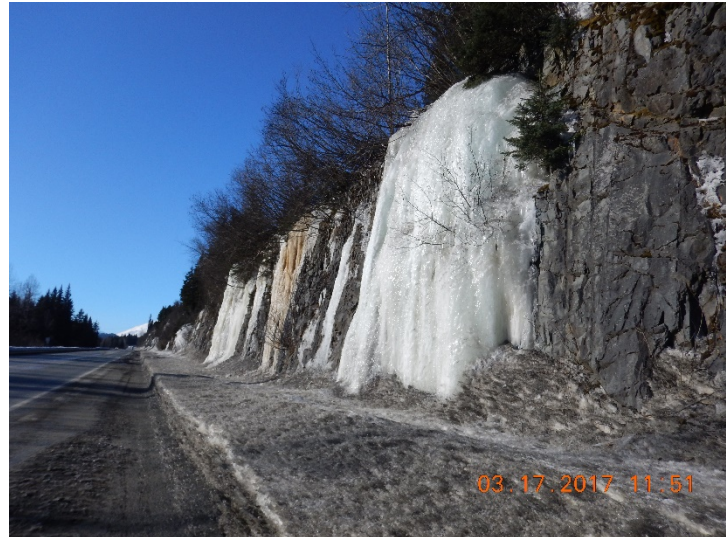
During our 17 March 2017 visit, we observed the presence of three well-developed ice slabs at approx. MP 74.8, one of which appeared to be a “frozen waterfall” type feature (Fig. 4). The dimensions of these ice slabs are indicated in Appendix 2. Based on DOT&PF accounts, this ice feature is frequently observed during the winter season. This frozen waterfall feature was the largest of the three ice areas, encompassing a size of approx. 27 ft. in height by 22 ft. in slope parallel width by between 1 and 9 ft. in thickness. The ice slab thickness of up to 9 ft. points to consistent water seepage and steady outward slab growth. Ice was observed locally on other portions of this slope face; however, these areas of ice were small and localized. Photos of the three primary ice slabs is included above as Fig. 26.

Figure 26 – Ice slab conditions adjacent to MP 74.8 SB along Seward Highway (Photo by Scarptec, Inc.)

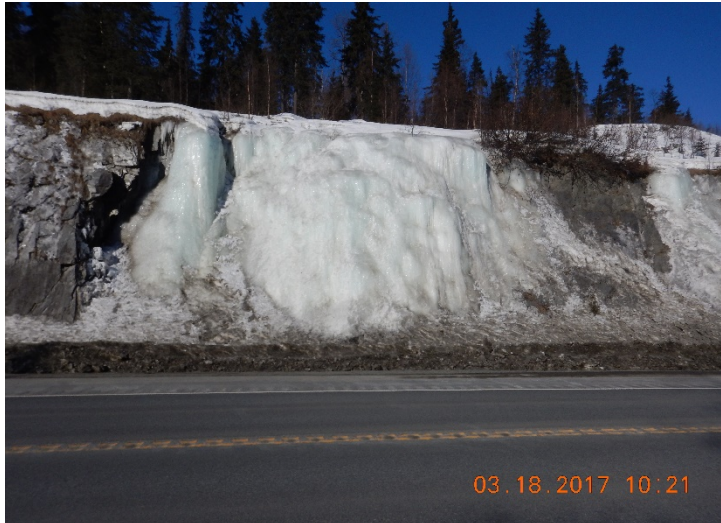
This northeast facing segment of slope consists of 15 to 120 ft. high cut rock slope that is convex inward in overall shape due to horizontal curvature of the two-lane roadway. The cut appears to have been advanced in three main lifts using drill and blast perimeter control methods, which resulted in the presence of two intermediate slope breaks (i.e. short benches). The slope angle appears to be approx. 70 deg. overall, with individual lifts likely cut at closer to 76 deg. (4V:1H). Catchment ditch widths vary between 19 and 26 ft. and ditch depths were observed to be 3 to 3.5 ft.

Figure 27 – Ice slab conditions near MP 57.9 NB along Seward Highway (Photo by Scarptec, Inc.)

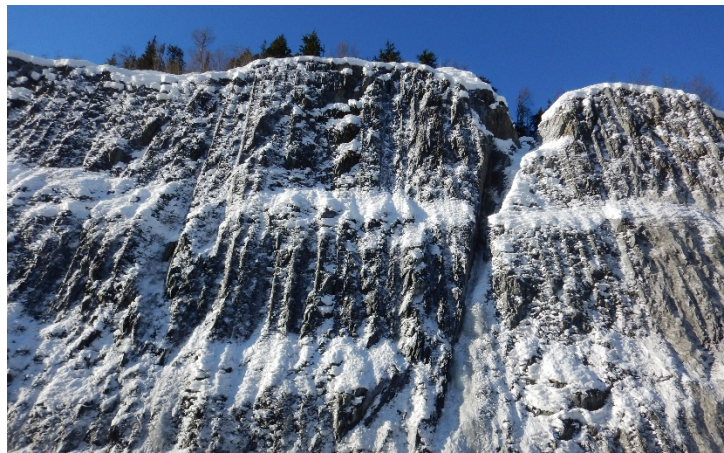
The only area of developed ice on the main cut slope face was observed within a high angle discontinuity as reflected on Fig. 28. It is our opinion that this feature drains water from beyond and up-gradient of the slope and that the water freezes once seepage encounters the slope face; however, the ice within this fracture feature was highly localized and on the order of 1 to 4 ft. wide by 2 to 4 ft. in thickness.

Figure 28 – Minor ice in fracture near MP 58.1 NB along Seward Highway (Photo by Scarptec, Inc.)

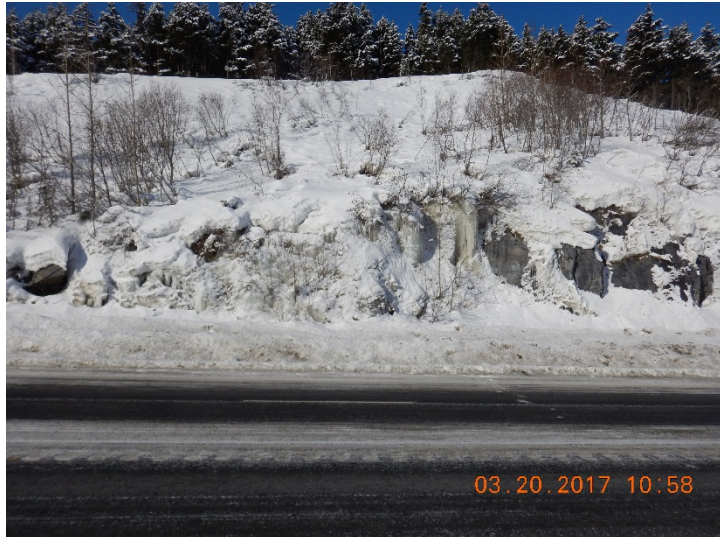
Periodic icefall events have been documented by DOT&PF Silver Tip M&O staff to have entered the roadway section on two occasions, as described above in Sec. 9.2. The exact timing and locations of these events is unknown but based on the occurrence of these two events, ice could again enter the roadway; however, we again note the significance of the southbound sight distance and wide catchment ditches which appears adequate for icefall events emanating from the main slope face. Based on our observations of slope geometry and ice development in the field, it is our opinion that both events where ice impacted the roadway were the result of upslope ice sliding events, originating from back-slope areas above the slope crest.

Figure 29 – Ice development near MP 52.3 SB along Seward Highway (Photo by Scarptec, Inc.)

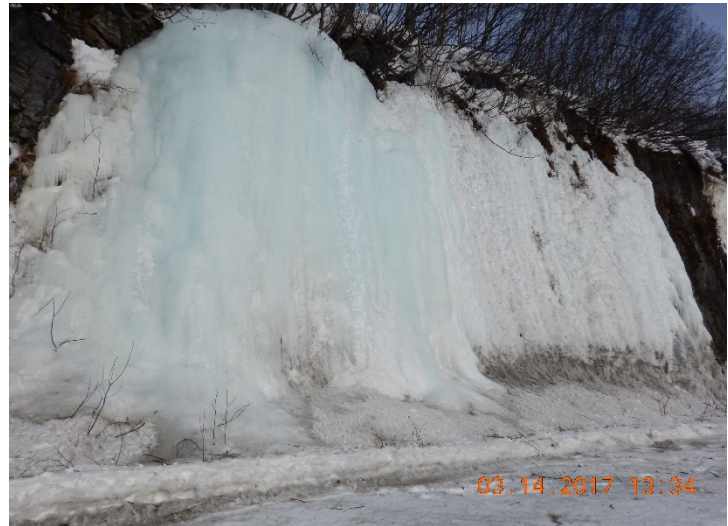
We visited the site on 16 September 2016 and 14 March 2017 to observe late summer and late winter slope conditions, respectively. This segment of highway consists of a south-southwest facing rock slope with total heights ranging between approx. 20 and 73 ft. and slope angles of approx. 65 to 72 deg. An approx. 440-ft. long upper bench feature appears to exist at the northern half of the slope. Available rockfall catchment was measured as a consistent 31 ft. in width, with ditch depths between 4 and 4.5 ft.

Figure 30 – Well-developed ice slab near MP 38.3 SB along Richardson Highway (Photo by Scarptec, Inc.)

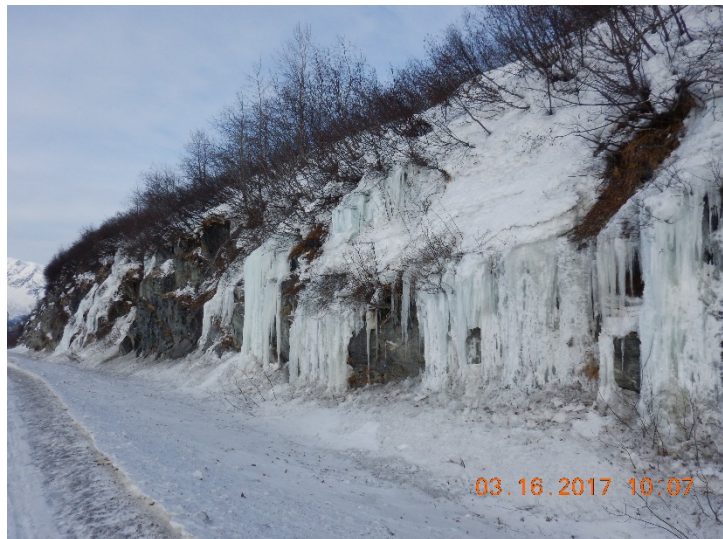
The MP 22.7 to 23.3 segment of highway consists of a three lane section (one southbound lane down-grade and two uphill northbound lanes) of roadway through Thompson Pass toward the City of Valdez. We visited this site on 15 September 2016 and 16 March 2017 to observe late summer and winter slope conditions, respectively. Existing slope heights measured between 35 and 50 ft., and south-southeast facing slope angles were found to range between 70 and 85 deg. Rockfall catchment ditch widths were found to be significant in size, and measured between 35 and 40 ft. in horizontal width by 5 to 6 ft. in depth. Data collected during the September 2016 visit is included as Appendix 1.

Figure 31 – Ice development near MP 22.9 SB along Richardson Highway (Photo by Scarptec, Inc.)

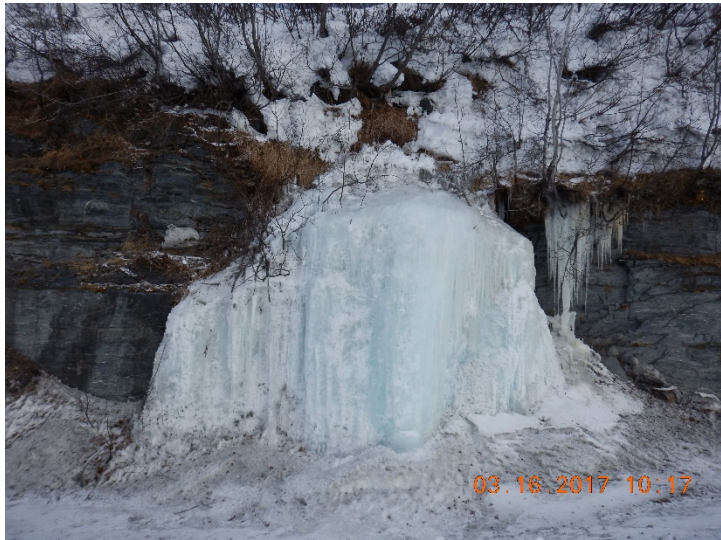
Based on accounts from DOT&PF Valdez District M&O staff, the ice formation thickness can build-out extensively along this section of roadway and icefall shatter fragments have been cast as far as the white painted shoulder fog line (approx. 41 to 46 ft. from slope toe) in previous years; however, no large fragments are known to have impacted the highway, as further described in Sec. 9.2.

Figure 32 – Ice development near MP 23 SB along Richardson Highway (Photo by Scarptec, Inc.)

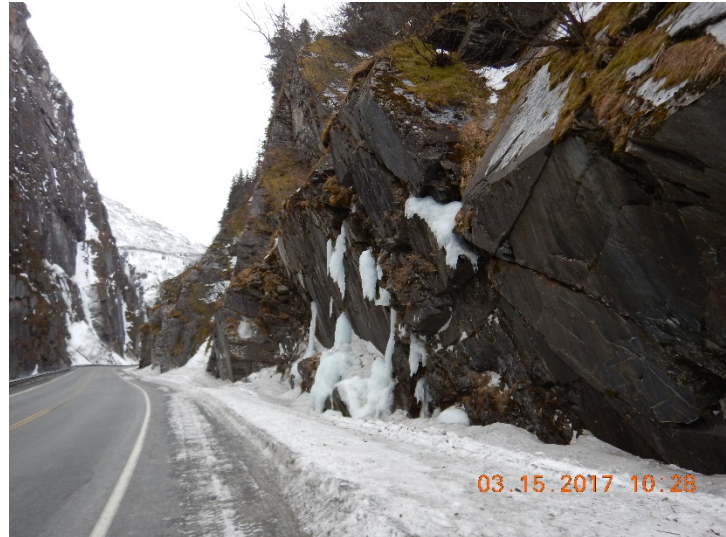
This section of highway represents the southern-most site along the Richardson Highway, and is part of Keystone Canyon as the roadway snakes its way through the mountain pass and into the City of Valdez. The two lane highway is bounded by a rock slope on the southbound side and by the Lowe River along the northbound side. We visited this site on 15 September 2016 and 14 to 15 March 2017 to collect information on slope conditions during winter and summer months. The existing east-northeast facing slope from MP 13.7 to 14.0 southbound is irregular and stair-stepped along its profile, with localized bedrock overhangs. Slope height appeared to range between approx. 102 and 189 ft., with highly irregular overall slope angles estimated to be between 50 deg. and near-vertical depending on position along the highway. Measured rockfall catchment ditch width varied between 14 and 22 ft., with ditch depths of 3 to 5.5 ft.

Figure 33 – Limited ice development near MP 13.9 SB along Richardson Highway on 15 March 2017 (Photo by Scarptec, Inc.)
