Testing and Recommended Practices to Improve Nurse Tank Safety: Phase III

U.S. Department of Transportation
Federal Motor Carrier Safety Administration

July 2018

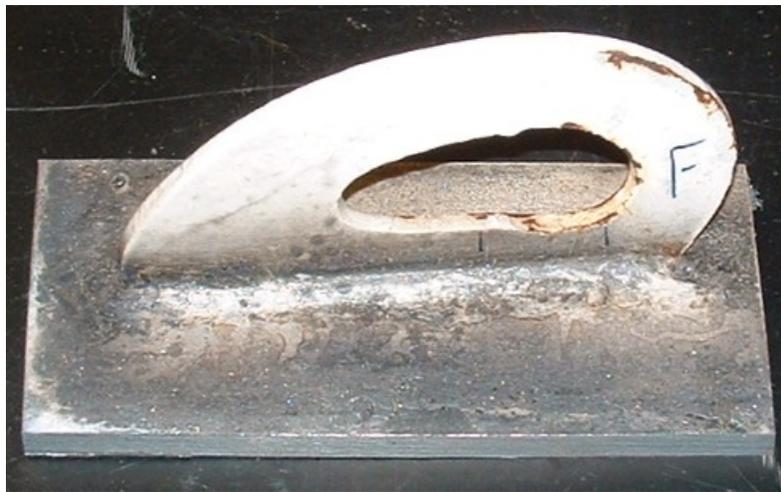
Figure 7. Photograph. Example of one type of tank lifting lug.

Example 1: Cutting a lifting lug from a tank has shown that the regions showing an indication often were caused by voids in the weld between the base of the lifting lug handle steel and the shell. These voids occur because the tank lifting lug handles are T welds that are fillet welded on each side. Figure 7 shows one of these tank lifting lug handles. If complete penetration underneath the T lug is achieved, the welds from either side of the handle meet and no void in the weld under the lifting lug results. However, as shown in Figure 8, if penetration of the welds from each side is incomplete, a gap can exist underneath the lifting lug between the T of the handle and the base metal of the tank shell. These lifting lug gaps may appear to be flaws, since complete weld penetration was not achieved; however, this type of weld does meet ASME Boiler and Pressure Vessel Code because the welds are at least 6.4 mm thick.

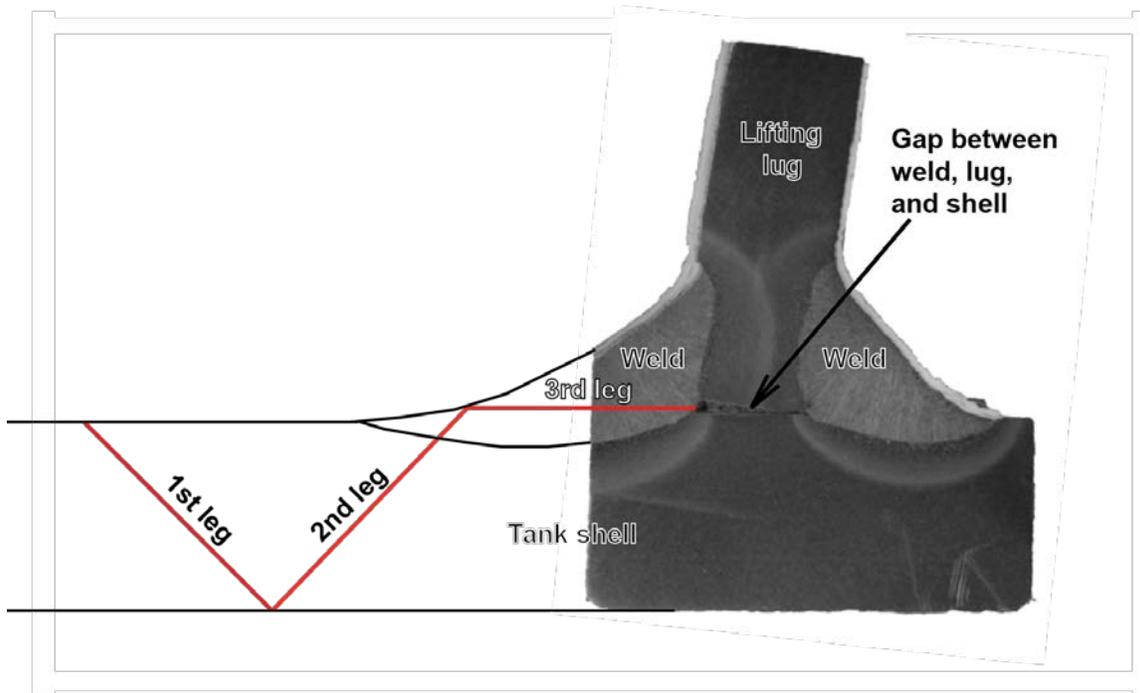
Figure 8. Diagram. Schematic showing how a third ‘leg’ response in the ultrasound acoustic signal can be caused by a gap between the lug and the base metal, resulting in an indication.

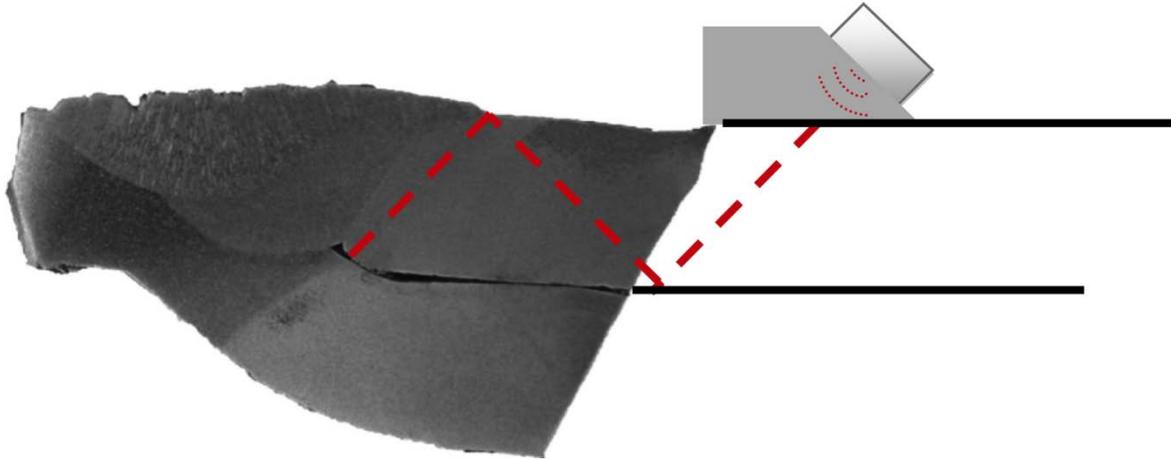
Example 2: Many indications found were at lap welds, such as the head-to-shell weld. The representative for one manufacturer refers to these as joggles (see Figure 9 and Figure 10). These were recorded separately as indications “in the weld” and were classified differently than those from the HAZ. One such tank containing such lap/joggle indications was acquired for structural analysis in the Phase II study. That was done by cutting a section out of the tank to enable direct observation of the weld. Photographs of polished cross sections taken from regions of that tank which had such “in the weld” indications showed that such readings can occur because of the nature of the joint between the two welded sections (see Figure 10).

Figure 9. Photograph. A cross section of a lap/joggle joint with a schematic showing why a signal is generated at a weld containing a “blind corner.”

These “in the weld” indications were seen in the majority of tanks. Figure 9 illustrates why “in the weld” indications were detectable from only one side of a girth weld, and often more than 50 percent of the length of the circumferential welds were suspected of containing a “blind corner” region. Figure 10 shows a cross section from a full penetration weld with little to no geometric distortion, which yields a greatly reduced chance of causing a “false-call” ultrasonic indication.

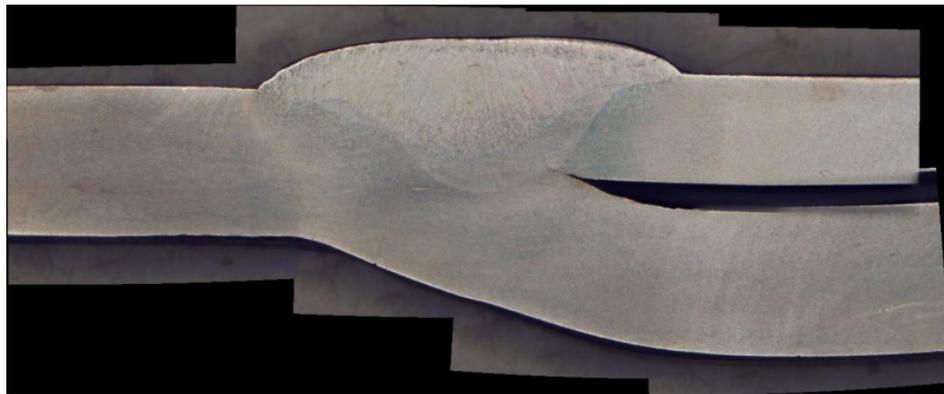
Other extracted tank sections were cut from a series of tanks that had been removed from service by the tank owners and donated to the Phase I study. In these regions of the tank, the weld bead does not penetrate to include the curved surface of the overlapping plate. This produces a “corner trap” (shown in Figure 9) where the acoustic signal can be reflected, producing an indication from the un-welded corner, which is not a SCC. For comparison, Figure 10 shows an example of a weld where complete penetration has been achieved.

Figure 10. Photograph. A cross-section of a lap/joggle joint showing full penetration of the weld bead. This section of weld did not have indications “in the weld.”

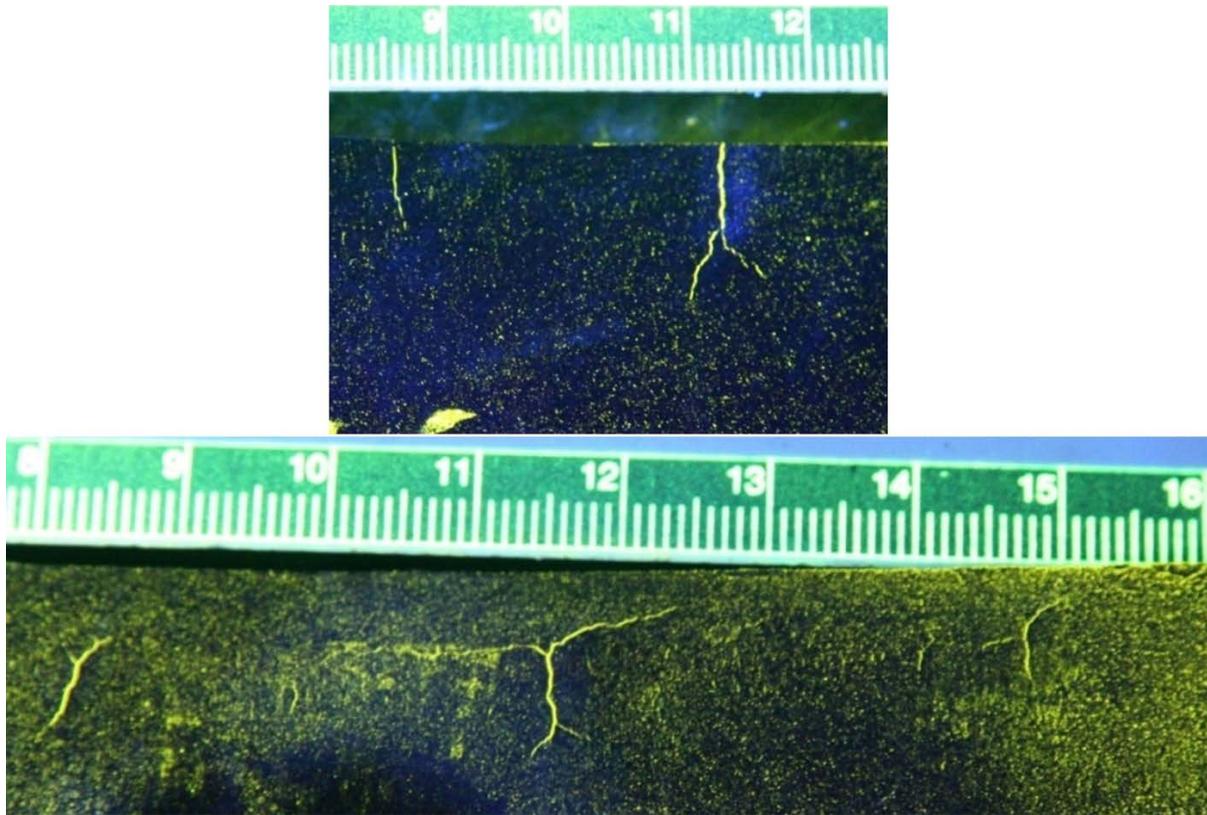
Classification of these indications is complicated by the fact that some cracks are present in branched networks (Figure 13). Where gently curving indications were detected, the lengths of branched indications were classified as being aligned with whatever direction comprised the largest portion of the indication complex.

Figure 13. Photograph. Magnetic particle-highlighted examples of crack branching in nurse tank SCCs. Finest divisions on the scales shown are millimeters.
