# Dissecting Coating Disbondments

Pipeline and Hazardous Materials Safety Administration  
U.S. Department of Transportation

Report No./DNV Reg No.: ENAUS 811 Brossia (101131)  
Rev 1

**Summary:**  
 A study was conducted to evaluate the main factors that lead to pipeline coating disbondment. This study compared laboratory and field observations to help ensure the validity of the findings.

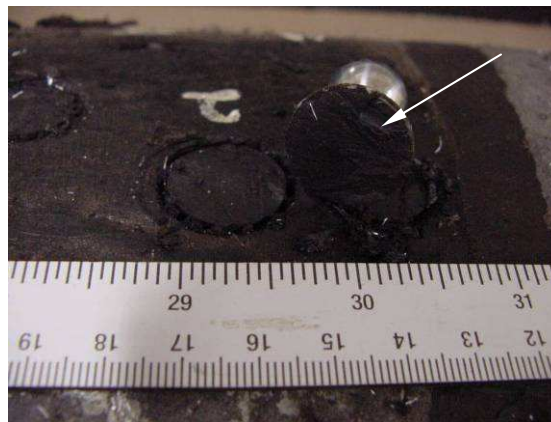
In contrast, all the tests performed on CTE and RCTE coatings showed cohesive failure with a maximum strength that varied from about 200 psi to 600 psi. A typical cohesive failure is shown in Figure 10. Because most of the available FBE sections did not show any signs of deterioration, as evidenced by the extremely high adhesion strength values, it was decided to intentionally damage the coatings to assess the conditions leading to such superior adhesion (Figure 11). FBE coated sections were heated with a methane torch for a few minutes until blistering was observed on the surface of the pipe. Dollies were attached on areas showing evident signs of blistering. The entire standardized procedure was then followed. Typical results are summarized below.

**Figure 10.** Typical appearance of coal tar coating showing cohesive failure.

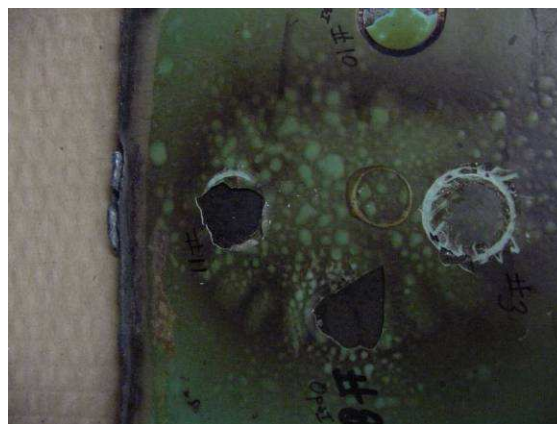
**Figure 11.** Typical appearance of an intentionally blistered FBE coated pipe.

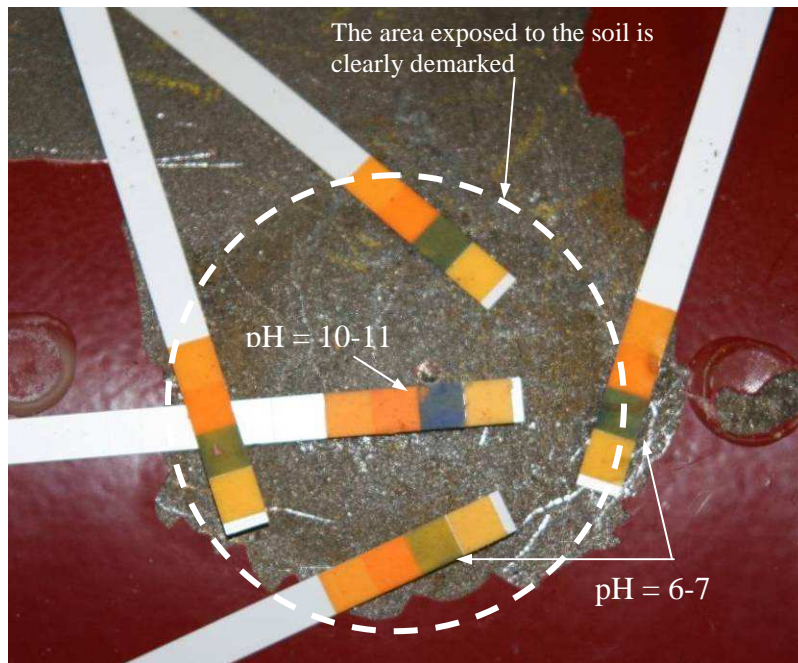
To determine the actual extent of the damage, the coating was gently scraped off using a utility knife. All the coating that was easily peeled with the knife was removed. The surface pH was measured at the defect and, at least, at four other locations to determine if a possible gradient in pH along the failed surface existed. Results are shown in Figure 26. As seen in Figure 26, the pH was approximately 10-11 in the region surrounding the defect; but was nearly neutral everywhere else. Figure 27 shows the results of a control test performed on the same pipe away from the affected area. The test was conducted to determine whether the large extent of coating failure was somehow related to defective or poor coating application. As seen in Figure 27, peeling of the coating was difficult and confined to the area near the CDT exposure area. Although a defective coating due to application errors should not be completely ruled out, these results seem to confirm that the disbonded region extending outside the area exposed to the CDT was likely caused by the CDT experiment itself. Possible explanations for this observation will be discussed later.

**Figure 26.** Extent of the attack and pH indication after test on as-received section B

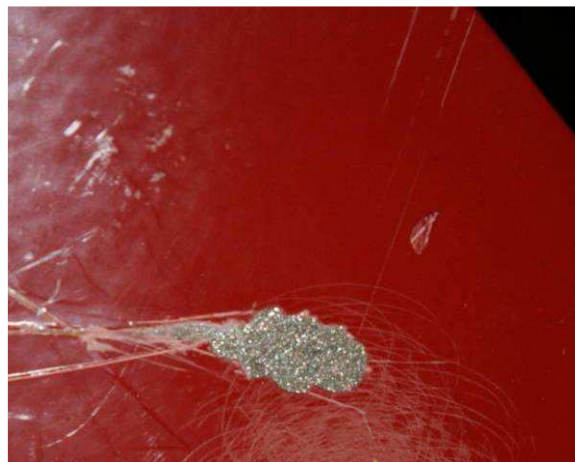
**Figure 27.** Control test showing that away from the damaged area peeling of the coating was not possible, indicating good adhesion.

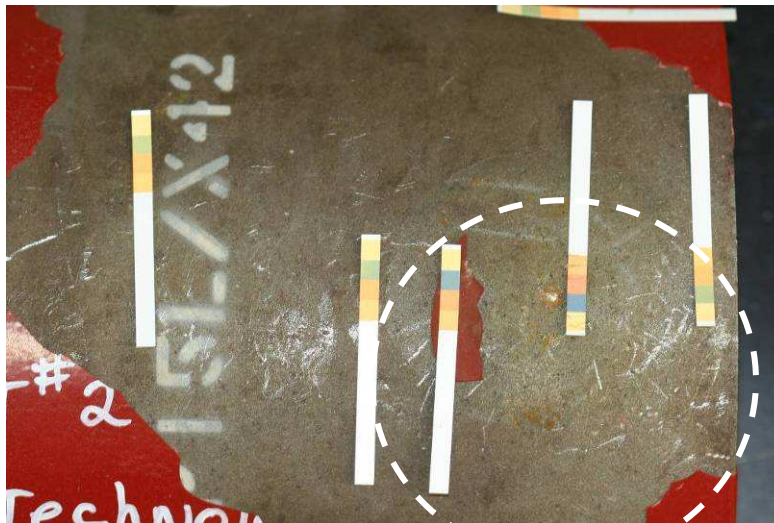
measured before CDT testing. The objective of the chloride pre-treatment was to evaluate how the presence of chloride affects ionic migration. The surface pH was 6-7 everywhere but at the proximities of the defect, where the pH reached 10-11. The back side of the failed coating near the defect also showed a pH of 10-11.

**Figure 28.** Extent of the attack and pH indication after test on chloride pre-treated pipe.

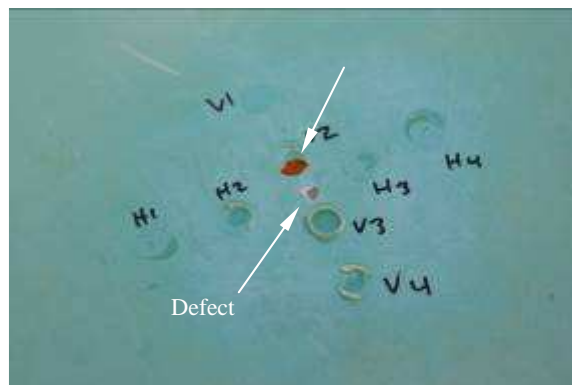
Results obtained for aged FBE in both 0.5 M NaCl and soil environments were in line with the results obtained for new FBE coatings. Adhesion strength before testing always surpassed the strength of the adhesives used to attach the dollies. No failure of the FBE coating occurred before the CDT. After testing, however, failures were observed at locations near the defect from where hydrogen evolution was readily visible, Figure 31. Adhesion strength on failed spots varied from 362 to about 1600 psi. The surface pH was always near neutral and the chloride content below 31 ppm. IEC analysis (Table 21) confirmed the surface chemistry measured using the Bresle patches.

**Figure 31.** Pull-off adhesion measurements showing a failed spot near the defect.

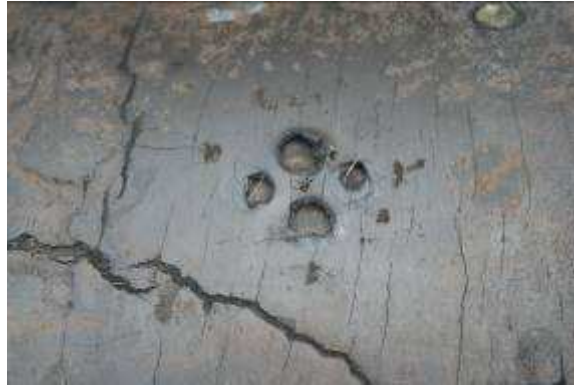
However, the overall response of the RCT was better than that of CTE coatings as the main failure mode was cohesive. The pH on the failed areas was nearly neutral and the chloride content below 31 ppm. IEC analysis confirmed the chloride contents measured with the Bresle patches. Only two locations showed elevated chloride contents of 14 and 93 ppm compared to all other locations that were less than 5.4 ppm.

**Figure 32.** Pull-off adhesion measurements showing a failed spot near the defect.

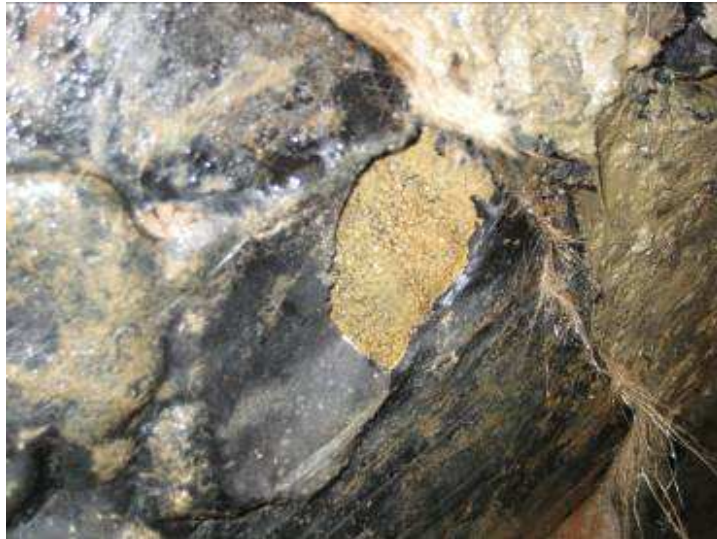
**Figure 49.** Signs of coating damaged were found at different locations.

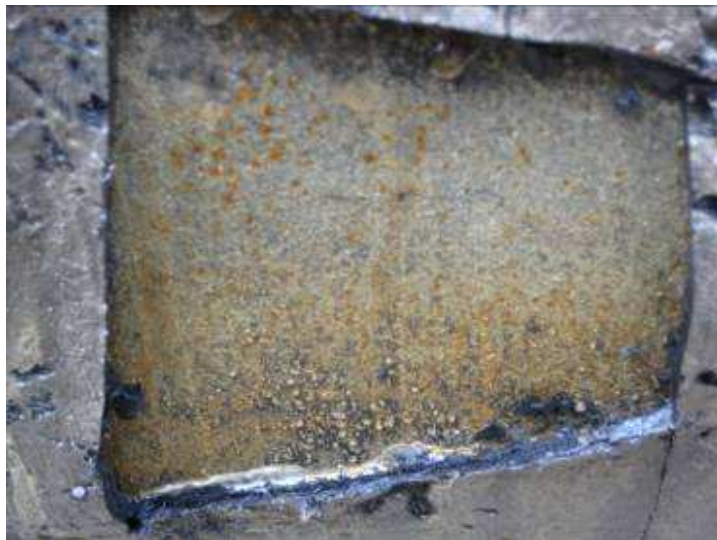
**Figure 50.** Removal of damaged coal tar coating prior to analysis on the areas adjacent to the defects.

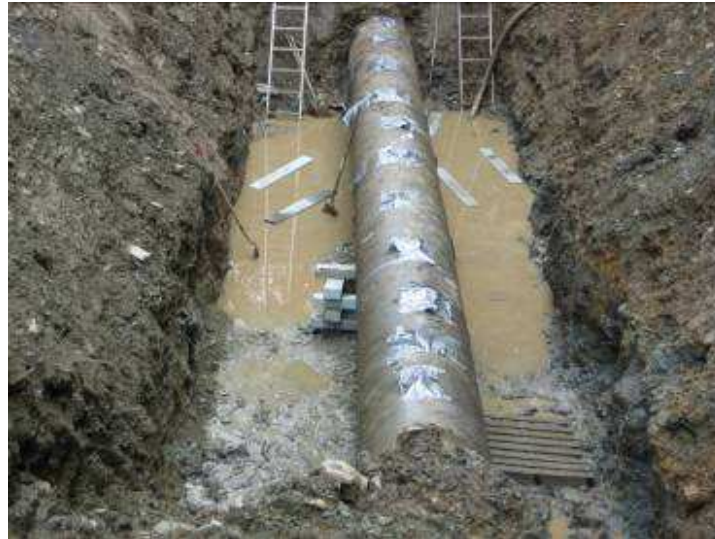
Figure 51. Water flooded the ditch, removing some of the dollies located at the 6 o'clock position.
