U.S. Department  
of Transportation  
**Federal Railroad  
Administration**

RR 11-10 | May 2011

## HEAVY AXLE LOAD REVENUE SERVICE MUD-FOULED BALLAST INVESTIGATION

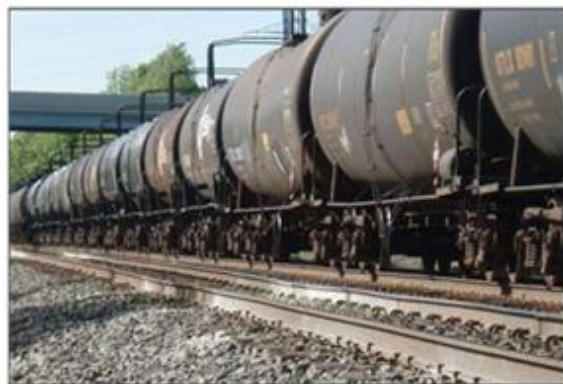
Figure 1. Muddy Ballast Site with Degraded Track Geometry

Transportation Technology Center, Inc., investigated the track substructure at three Norfolk Southern mainline sites to determine the root causes of localized mud-fouled ballast deterioration and associated track roughness, as Figure 1 shows.

The inspections were carried out by digging cross trenches in the tie cribs to a depth of 3–4 feet below the ties. The trenches revealed that water trapped in the fouled ballast layer was the main cause of the geometry deterioration at all sites. Although well-defined ditches were located next to and below the elevation of the ballast layer, the very low permeability of the fouled ballast shoulder and clay subgrade effectively blocked lateral drainage from the ballast section to the ditch. As a result, the top ballast layer was fouled with mud slurry that, in some cases, was being pumped up around the sides and ends of the ties.

Maintenance activities such as cribbing to remove fouled ballast between ties, surfacing, and ballast undercutting/cleaning to depths of 12 inches (in) or less are commonly used to deal with muddy ballast conditions. However, these methods do not necessarily restore adequate permeability of the ballast layer. Installing cross drains or ballast renewals that are deeper than 12 in below the ties may be required to restore the lateral drainage path.

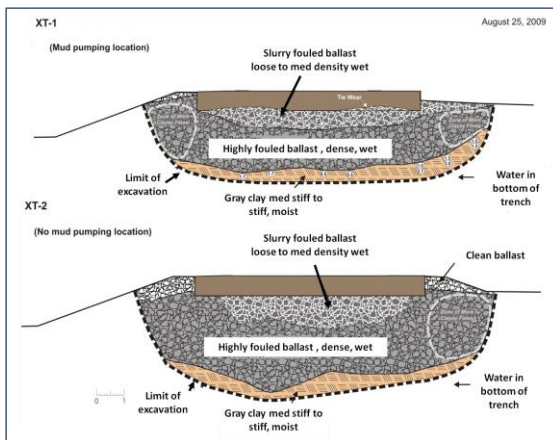
Figure 2. Similarity of XT-1 and XT-2 Cross Sections

- A top granular layer consisting of loose to medium-dense aggregate that was wet and fouled primarily with mud slurry.
- A second granular layer, denser than the top layer, very wet and fouled, but without the mud slurry.
- Subgrade of moist plastic clay, gray in appearance and moderately stiff at the surface, becoming increasingly stiff a few inches below the subgrade surface.

The only difference in the appearance of the three trenches was that the mud slurry in the top layer had pumped through the shoulder ballast at XT-1 to form a mud spot (Figure 2).

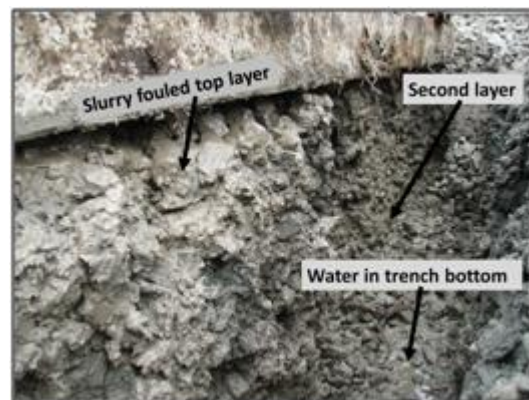
Figure 3. Ballast Condition at XT-5 Cross Trench

Two cross trenches were dug at the RD 83.0 site: one at a mud spot labeled XT-5 and the other at a non-mud spot labeled XT-4. The conditions at these trenches were somewhat similar to PC 59.1, as Figure 3 shows, and are described

- The mud spot had a top layer less than 12 inches deep that was wet and fouled with mud slurry material.
- It had a second layer, denser than the top layer, also wet and fouled, but without the slurry. Water also collected at the bottom of the trench as at PC 59.1.
- The hardpan layer, consisting of cemented limestone and slag, was located between the second granular layer and the subgrade. The subgrade that was visible at the edge of the hardpan was moist clay.

Plans are in place to install a mud spot remediation test at the site near Ravenna, OH. The approach will be to install an impermeable layer between the top and bottom ballast layers to facilitate drainage and isolate the fouled bottom ballast from the clean top ballast.

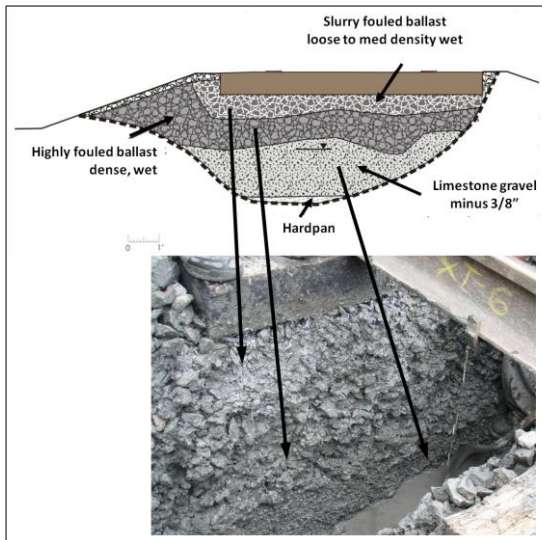
Figure 4. Ballast Layers at the CNO&TP 75.5 Site

Two cross trenches were dug at the CNO&TP 75.5 site labeled XT-6 and XT-7. As with the other sites, the granular layers were very wet with water collecting in the bottom of the trench, along with slurry-fouled top layer and a denser, highly fouled second layer. However, there was a third layer of medium-dense granular limestone gravel subballast sitting on a hardpan layer (Figure 4). This site was slightly different from the other two in that there was more water present, and the slurry tended to pump through the ballast

shoulder near the toe, rather than pumping up around the ties.
