# **Valve Integrated Pressure Regulator Examination (DOT DUNS #079807449)**

Report Number:  
**R-WHA-15113-0-A-EX1**

**Mark Toughiry  
Pipeline and Hazardous Materials Safety Administration  
1200 New Jersey Avenue, SE  
East Building, 2nd Floor, Room E21-338  
Washington, DC 20590**

**WHA International, Inc.**

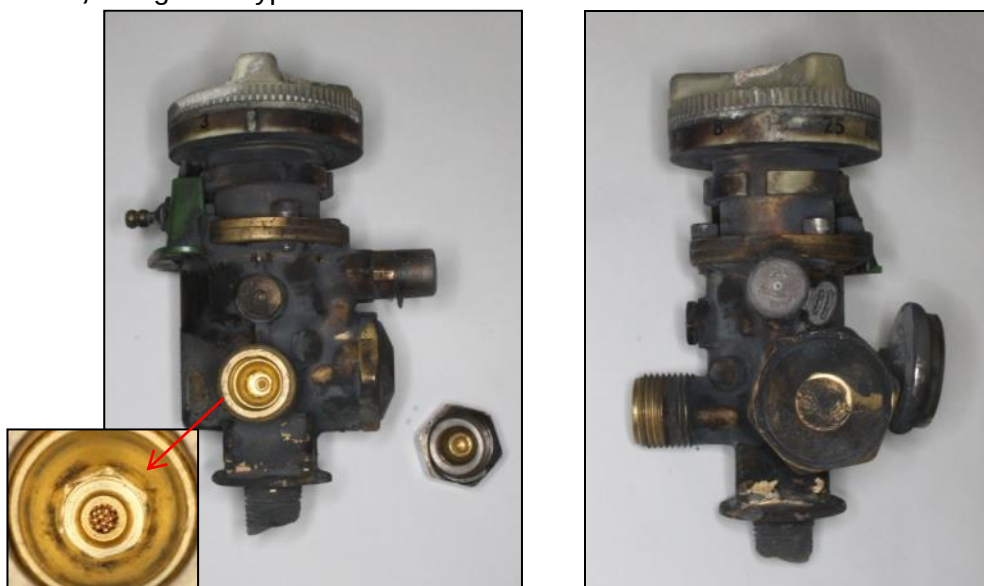
**Figure 5 – Views of VIPR (Rotated Clockwise)**

**Figure 6** – Views of VIPR (Rotated Clockwise) and Flange Close-up

**Figure 5** and **Figure 6** provide various views of the incident VIPR from four different sides. Figure 5a (top-left) shows an external view of the VIPR with the fill-port cap removed to expose the fill port assembly and filter. This port, like other ports, was visually undamaged, relatively clean, and intact. The fill-port filter was visually undamaged. Other views in this figure also show the external condition of the VIPR from various sides. The VIPR externally was covered with combustion residue, largely consistent with greyish aluminum-oxide (visually) but did not exhibit inside-to-outside evidence of burn-through. It was noteworthy, however, that the pressure gauge was bent consistent with an impact loading. It was also noteworthy that the flange on the VIPR, at the cylinder-to-VIPR interface, was bent on one side, consistent with an impact or bending moment applied to the body of the VIPR (**Figure 6**). The bend and deformation of the flange was approximately opposite the side of the VIPR threads that exhibited the heaviest melt/consumption of brass.

The VIPR exhibited combustion and slag deposits on the majority of its external components and external surfaces. However, external fire damage to the VIPR was generally limited to the cylinder-to-VIPR thread connection. Fire damage to the thread connection was also heaviest on the lower 12 o'clock region of the threads away from the flange and flange O-ring seal. VIPR damage to the cylinder thread post is shown in **Figure 20**. Noteworthy bending, consistent with impact, was also observed on the flange and the pressure gauge at 6 o'clock (**Figure 6**).

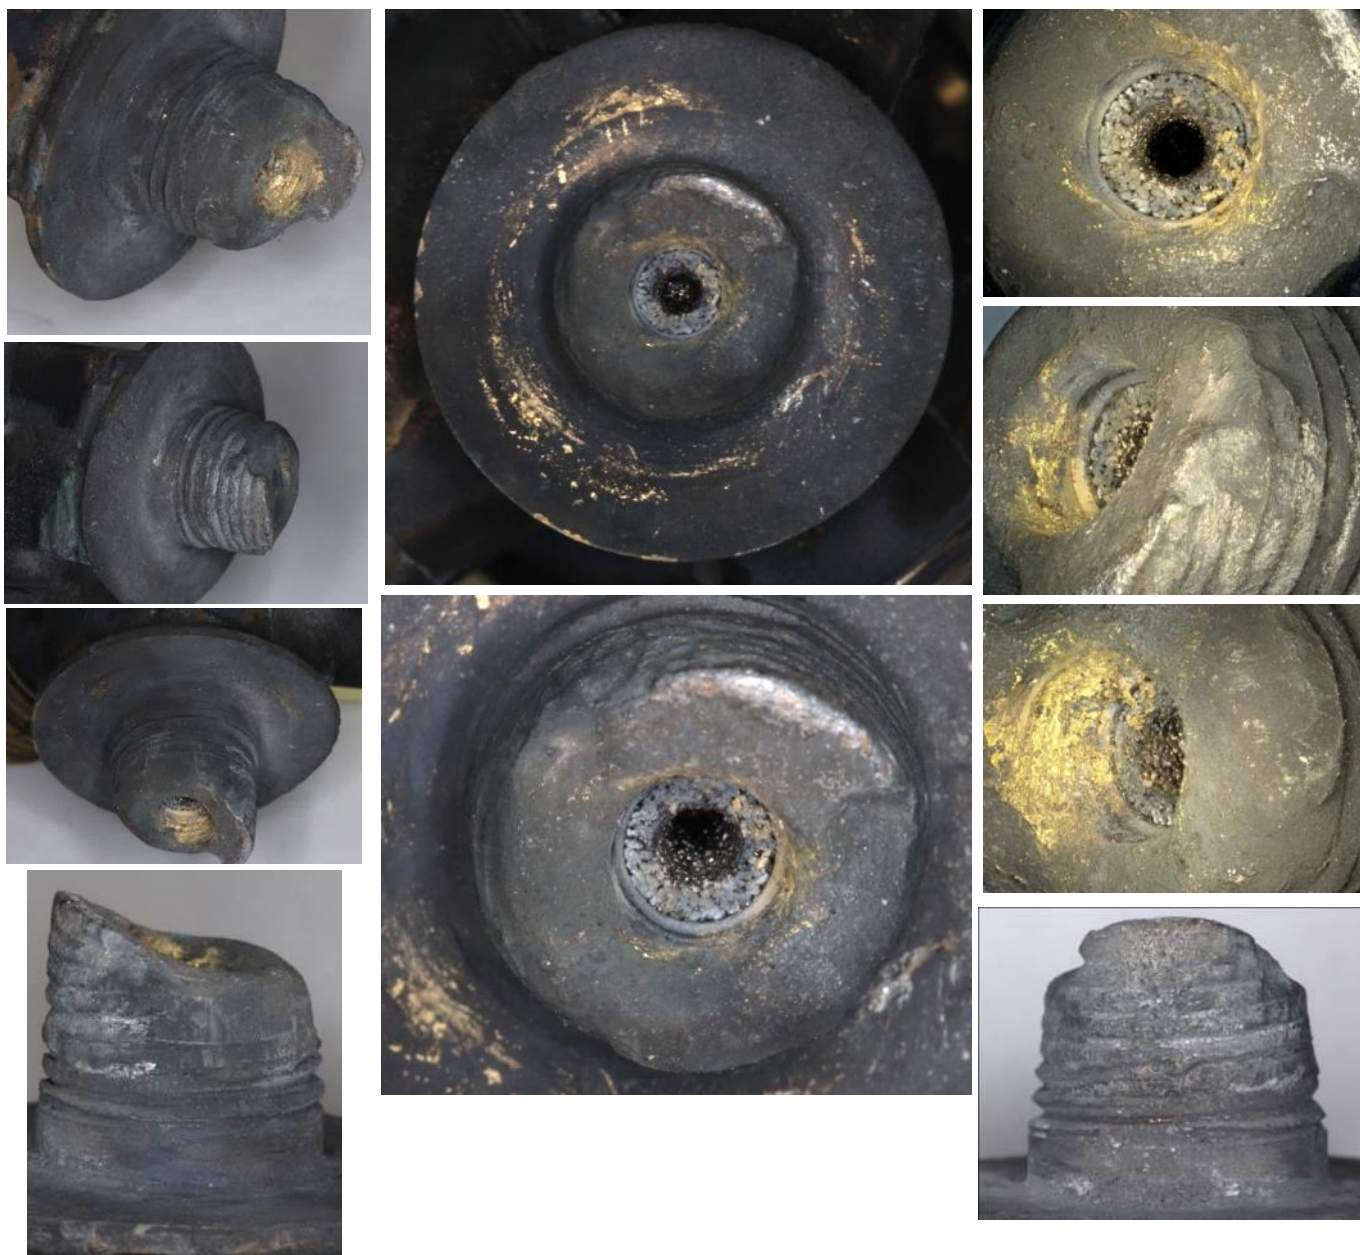
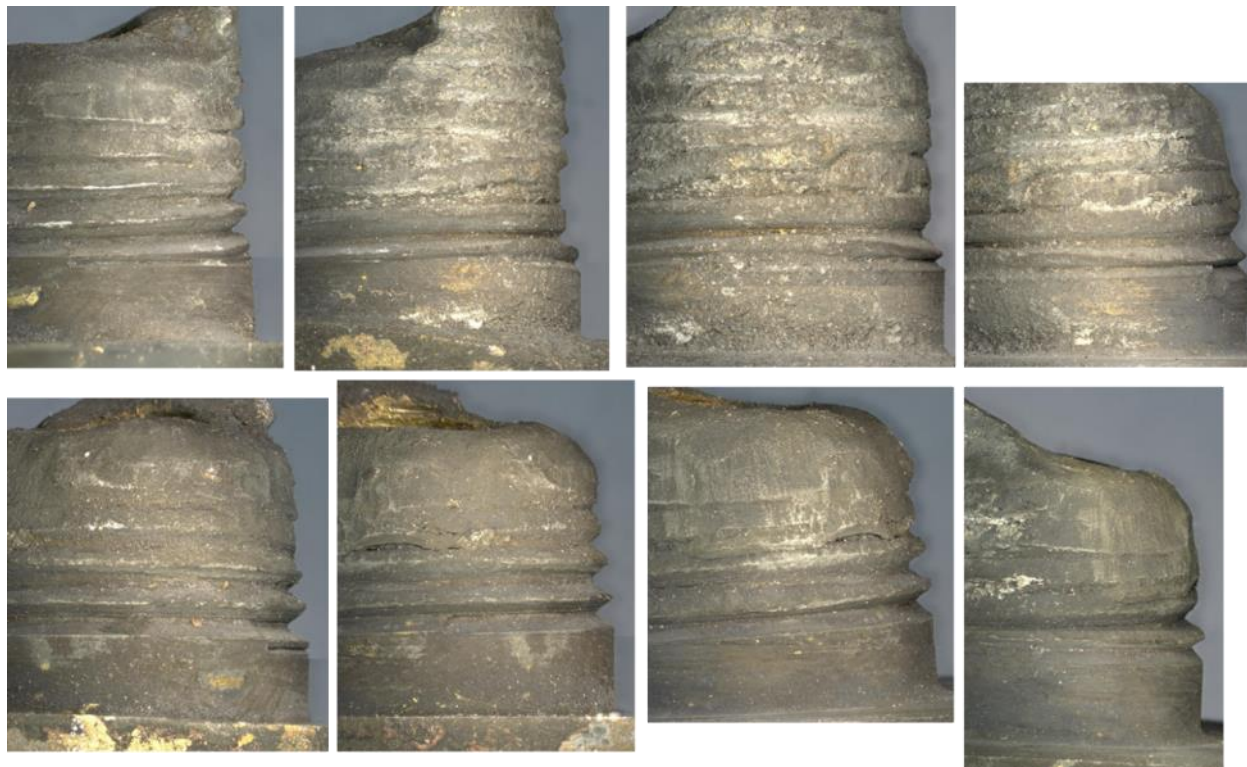
**Figure 8** – Magnified Images of the VIPR Thread Damage

**Figure 8** depicts magnified images of the flange of the VIPR and the fire-damaged threads. **Figure 9** provides more detailed images of the VIPR thread damage. These images show that the surfaces proximate to the VIPR threads were covered with combustion residue and were primarily comprised of aluminum combustion products (see also EDS summary in **Appendix D**, discussed later). The threads also exhibited melting and/or consumption with a geometric preference for material loss on one side of the threads. The filter was covered with combustion residue but was intact and did not exhibit evidence of compromise or burn-through. The filter's threaded retainer element was missing.

**Figure 9 – Magnified Images of the VIPR Threads (Clockwise Rotation)**

**Figure 8** and **Figure 9** depict various views of the VIPR threads, VIPR flange region proximate to what would have been the cylinder and cylinder O-ring gland. These figures depict the very heavy melting and melt-flow associated with the lower segments of the VIPR threads. The SEM/EDS analysis was consistent with evidence of heavy aluminum combustion products deposited on the VIPR threads and suggested that aluminum combustion had developed initially in the lower segment of the threads proximate to the 12 o'clock region<sup>8</sup>.

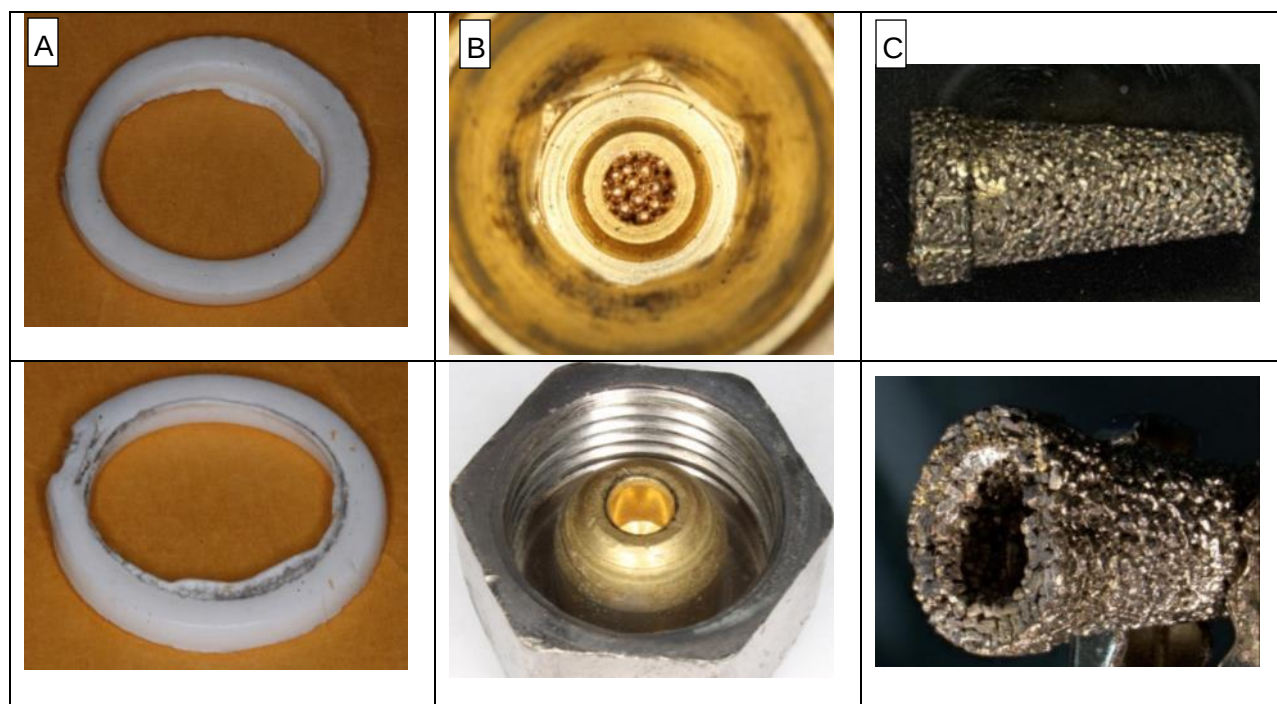
**Figure 12** – Photographs of the Cylinder O-ring seal (A), Inlet Fill Port Filter and Cap (B), and Cylinder-to-VIPR Filter (C)

**Figure 12** depicts the condition of what was provided to WHA as the cylinder O-ring (determined by FTIR to be PTFE) and two of the VIPR filters. The inlet fill port filter and protective cap are also shown in this figure. These components were visually clean but solvent rinses of the filter indicated detectable levels of a hydrocarbon contaminant. The cylinder-to-VIPR filter is also depicted and after careful removal from the VIPR threads, was observed to exhibit an intact and largely clean appearance. However, detectable levels of hydrocarbon were also observed on this filter for both careful solvent rinsing of the interior conical bore and solvent rinsing of the external conical structure. During these solvent rinses the filter was positioned so that careful solvent rinses would drain from the filter in such a manner that the interior and exterior would not be cross-exposed.

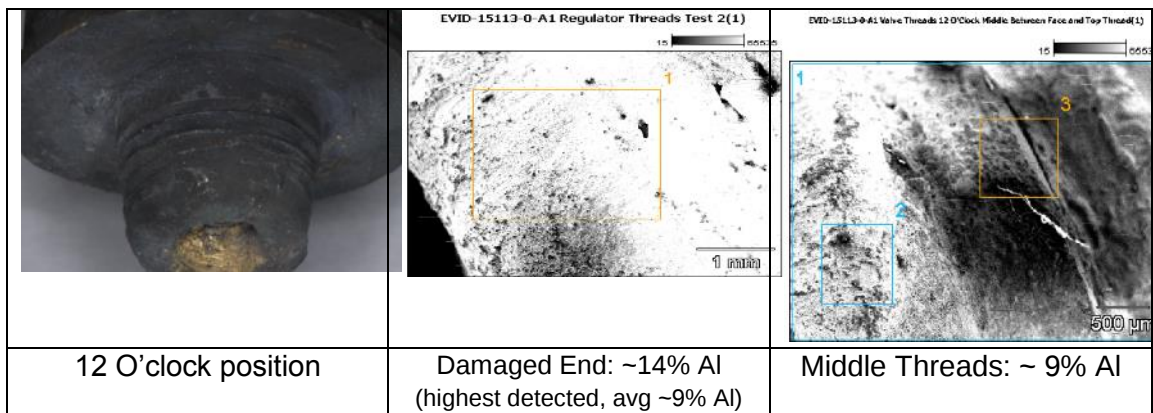
**Figure 18 – 12 O'clock Position SEM Images**

- 12 o'clock position: Al content (~10%) generally consistent throughout thread position from damaged end to flange. This was the approximate position observed to exhibit the heaviest brass consumption and/or melt/flow and exhibited the heaviest thread distortion.

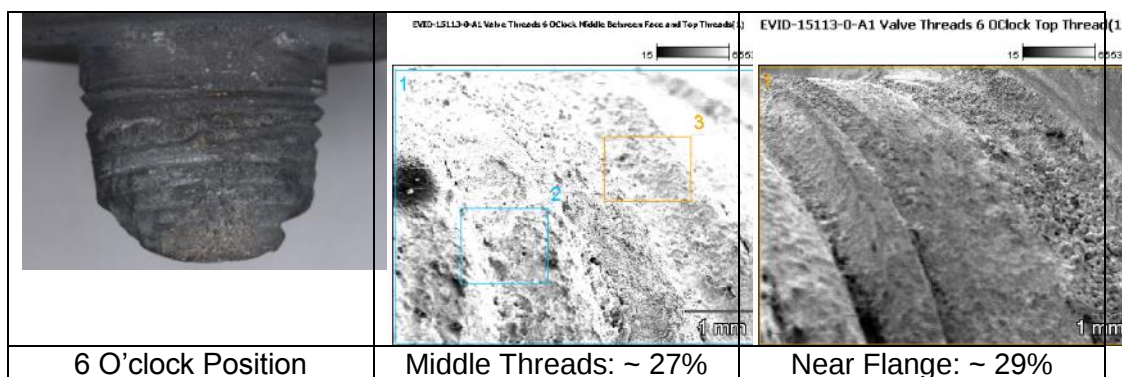
**Figure 19** – 6 O'clock Position SEM Images

- 3 o'clock position: Al content generally higher on damaged end (~12%) than flanged end (~6%)
- 9 o'clock position: Al content (~12%) consistent throughout thread region from damaged end to flange, highest amount of Al (~18%) on thread in one location near the flange; however, overall, the Al concentration was reasonably consistent along this position.
- 6 o'clock position: Al content generally increasing from damaged end (~18%) to flanged end (~30%). This position exhibited heavy aluminum and aluminum combustion products clinging to the threads, probably having been less effected by aluminum combustion before the VIPR was ejected from the cylinder.
