Preventive Maintenance Study - Final Report

WA-RD 871.2

Preventive Maintenance Study

Washington State – Statewide Locations

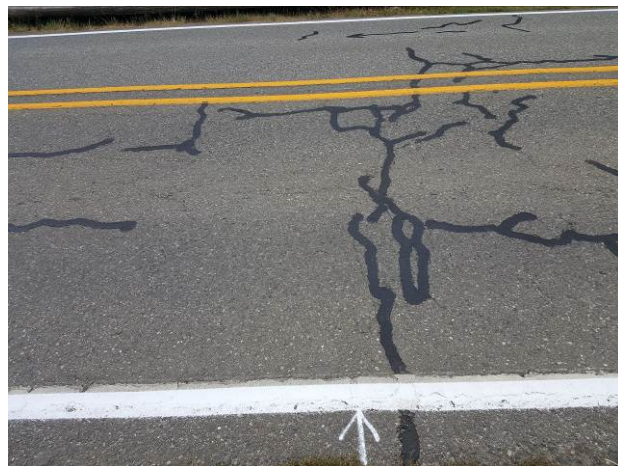
Figure 13. OR34, SR302, Good, age 15 months.

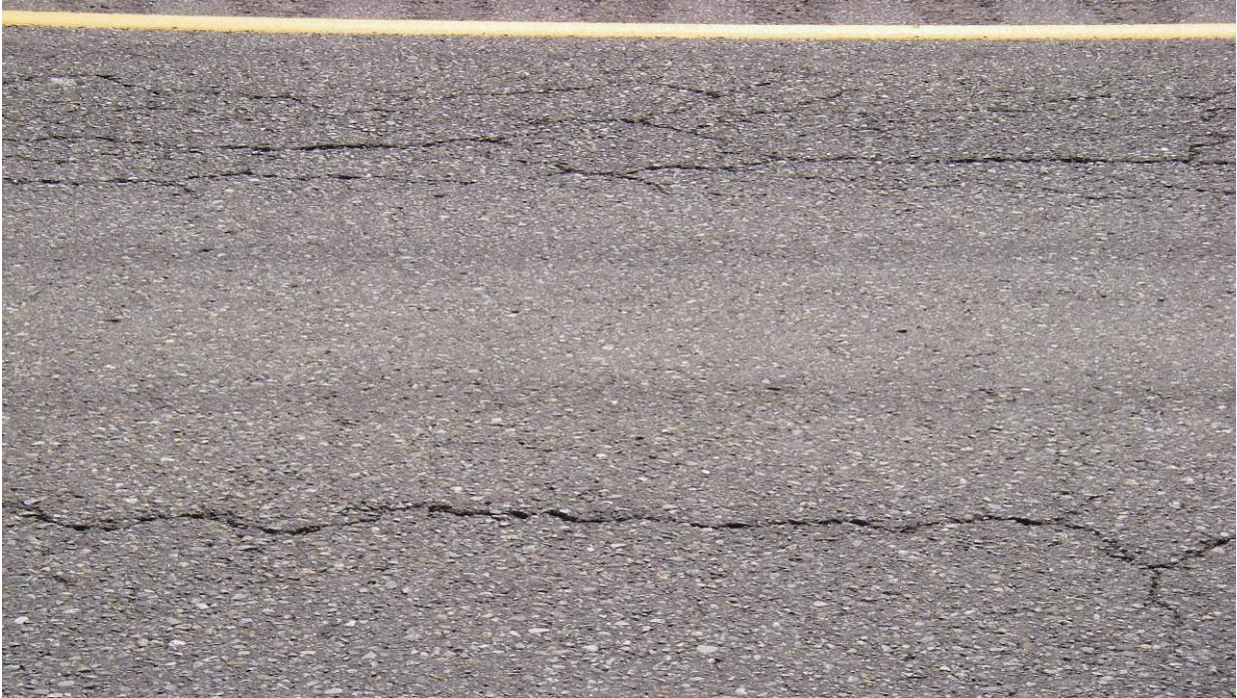
Figure 14. OR1, SR101, prior to treatment. Cracks exceed 1/4 inch in width in places.

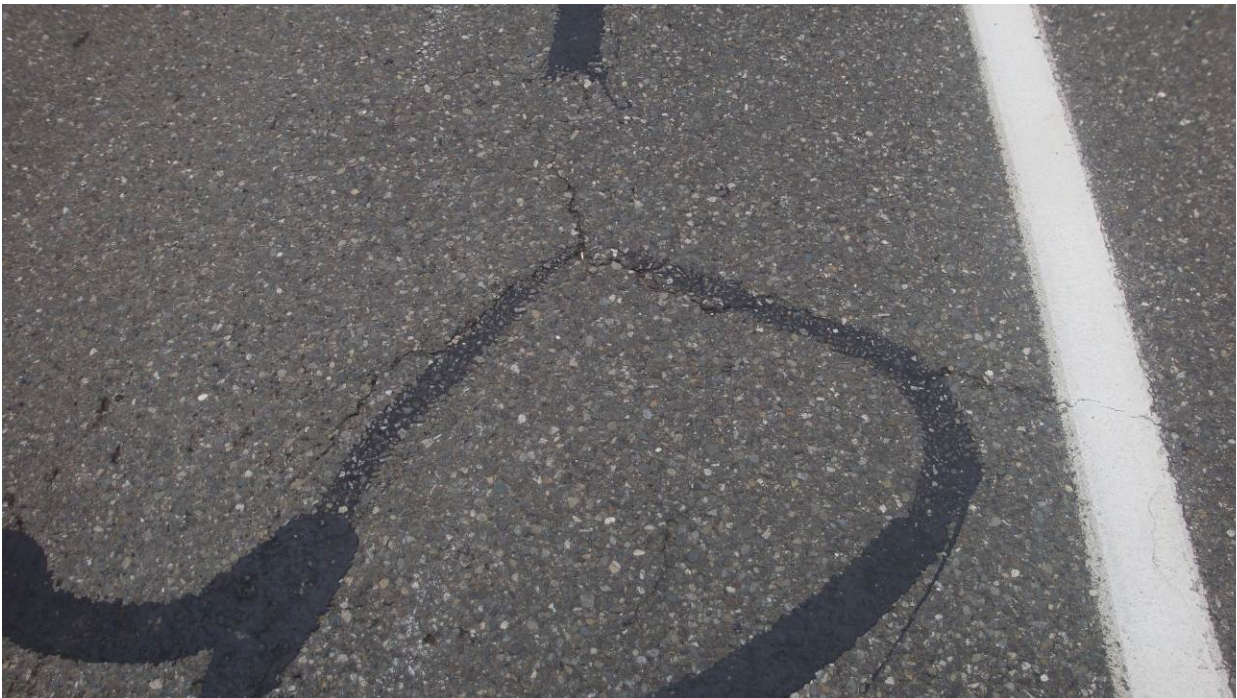
Figure 15. OR1, SR101, one year after installation. Slight wear of sealant over banding.

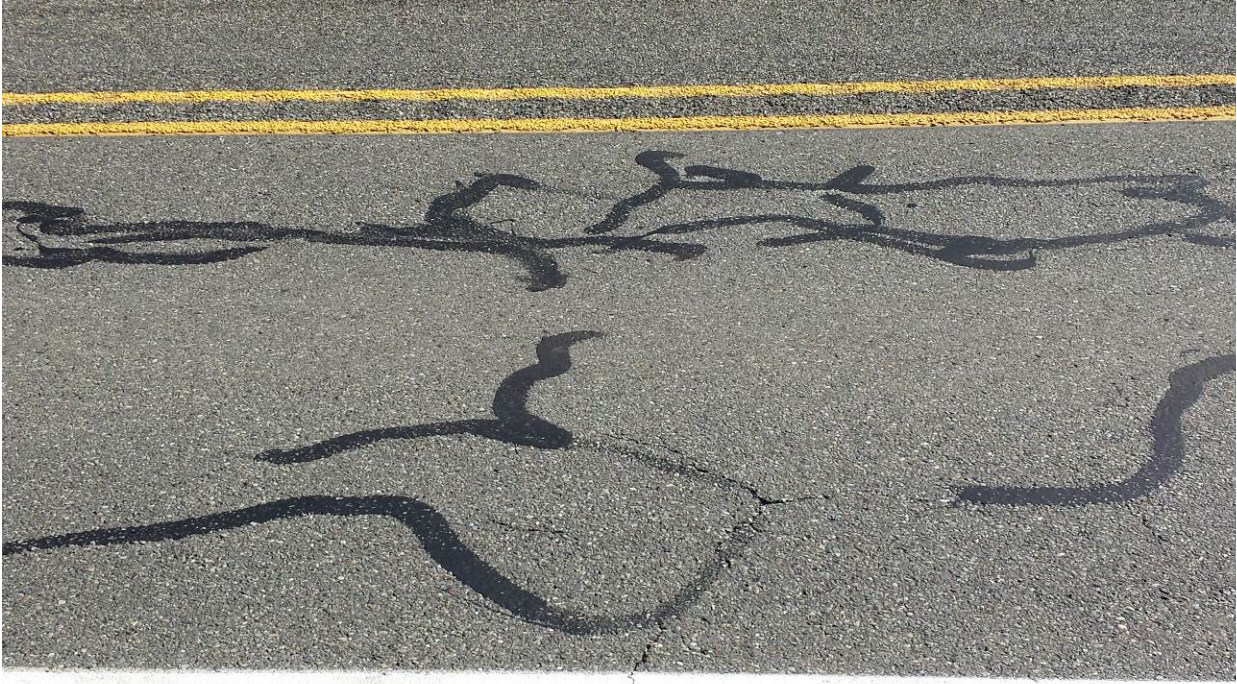
Figure 16. OR1, SR101, two years after installation. There is not much change from year one.

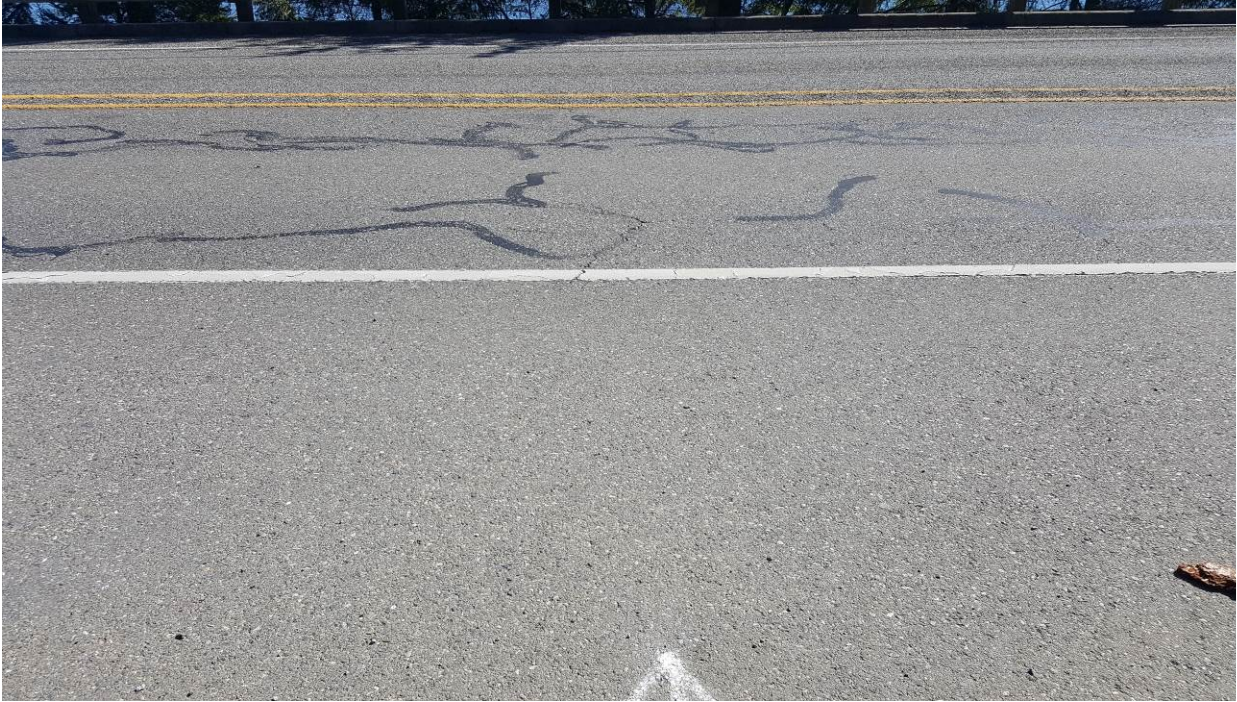
Figure 18. OR1, SR101, four years after installation. There has not been much change in the condition of the crack sealant since year one.

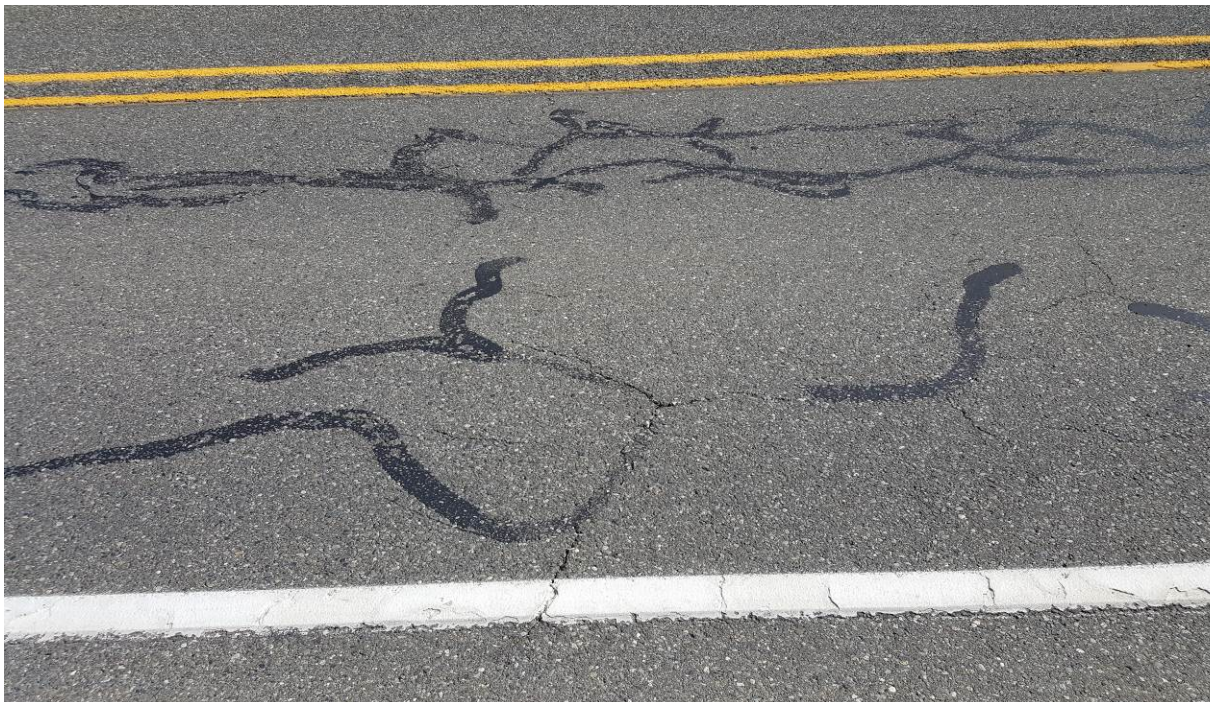
Figure 19. OR1, SR101, five years after installation. The cracks are beginning to appear through the sealant where the original sealant was minimal.

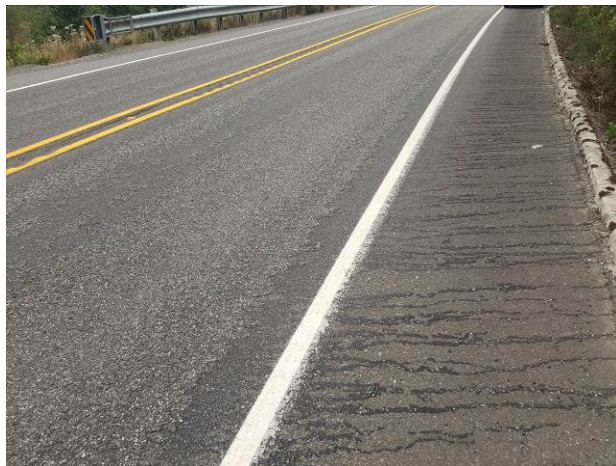
Figure 23. OR22, SR101, Good, age 26 months. Loss of aggregate at bottom of super elevation.

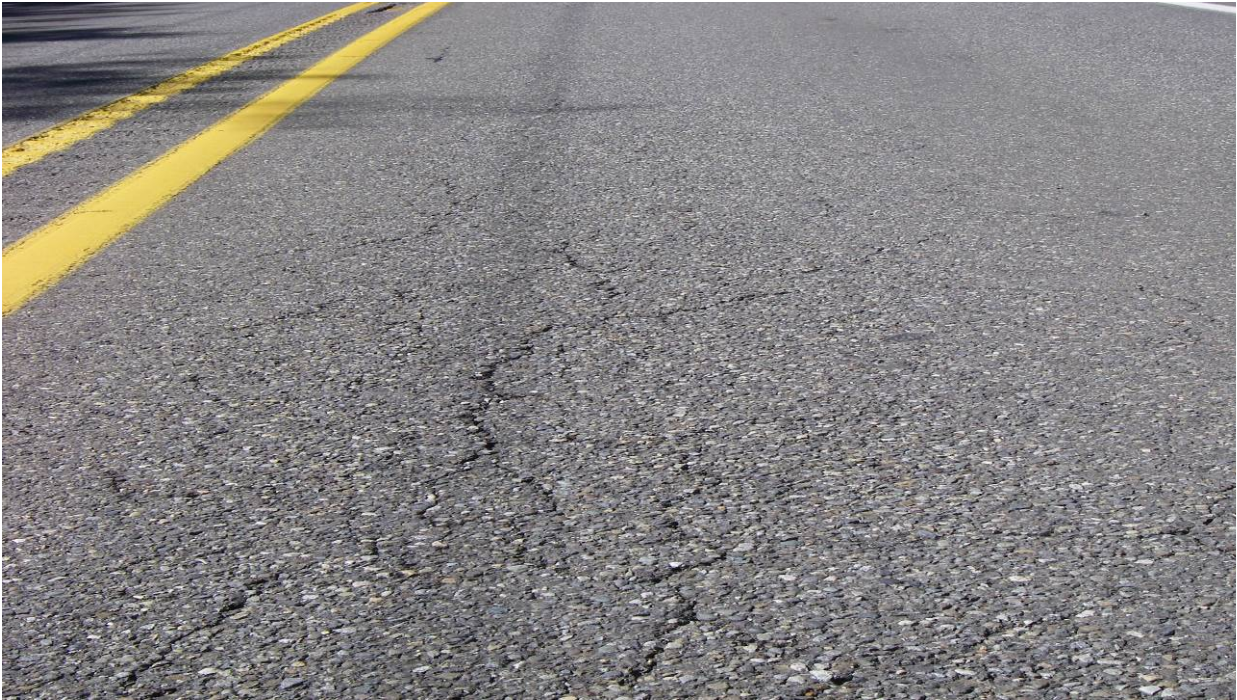
Figure 24. OR1b, SR101, prior to treatment. Alligator cracking was noted over the entire lane, but especially severe in the wheel paths.

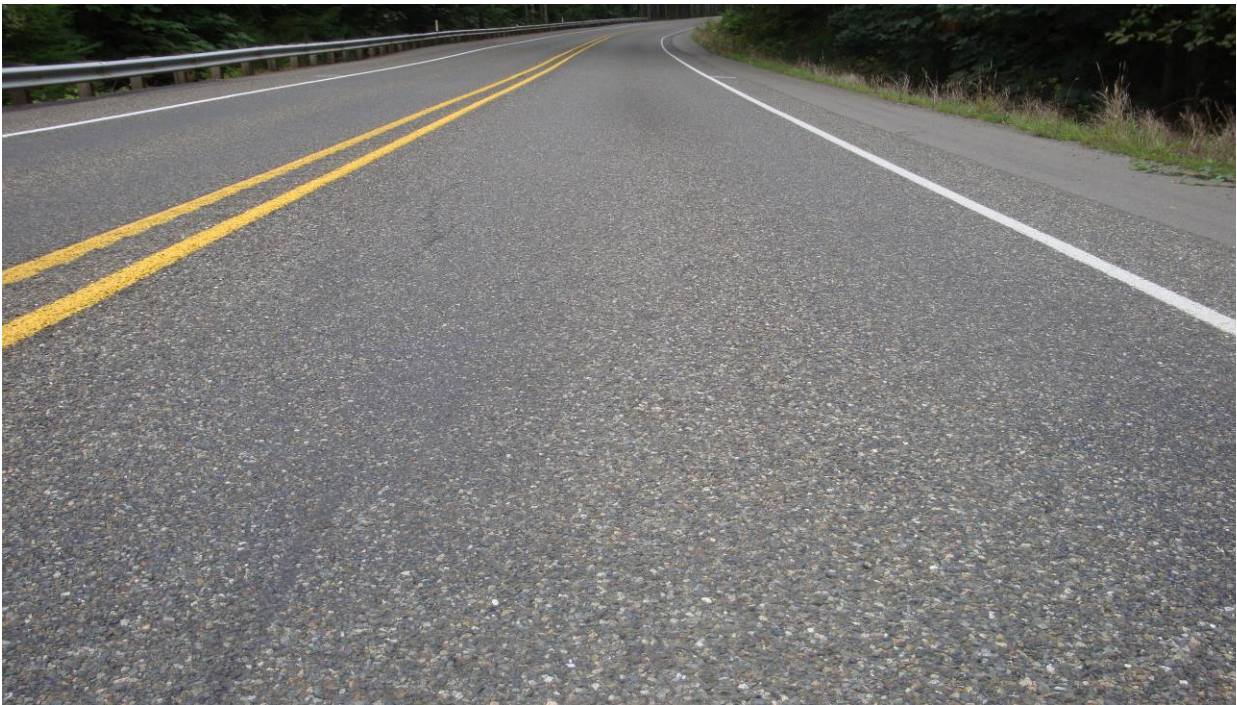
Figure 25. OR1b, SR101, one year after installation. Slight flushing in the wheel paths, one longitudinal crack in the left wheel path.

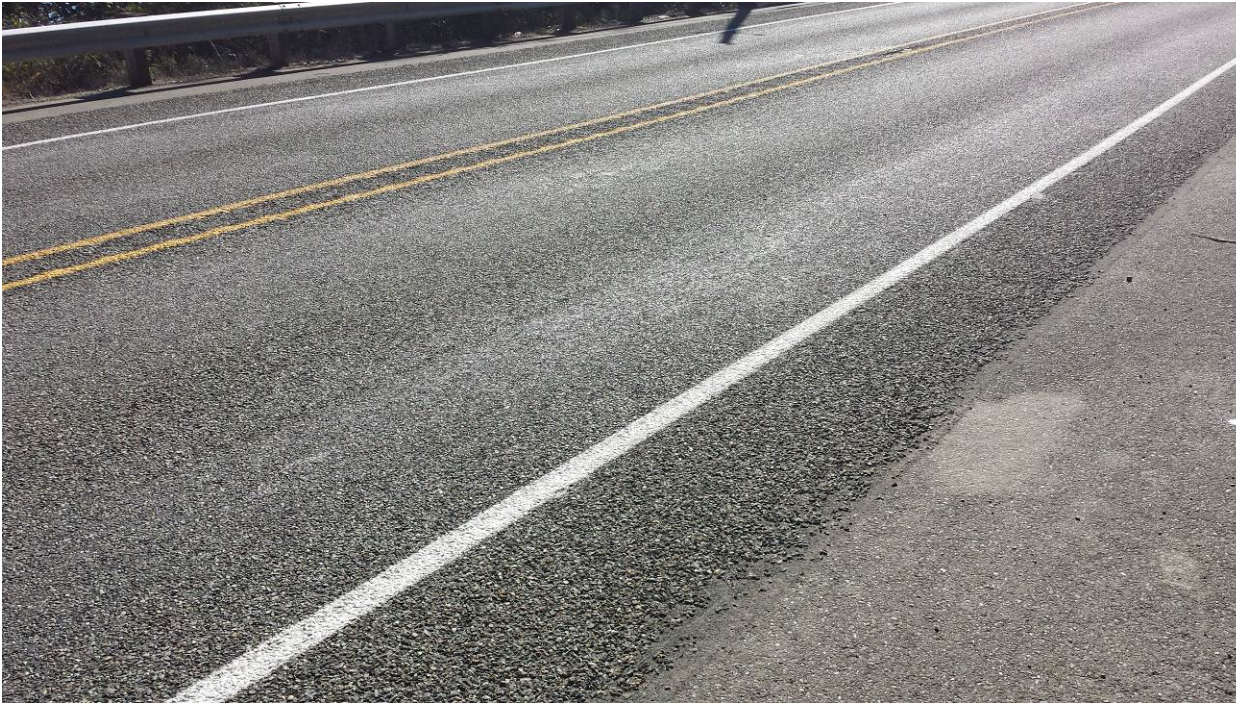
Figure 26. OR1b, SR101, two years after installation. Longitudinal crack appears to have “healed”. Slight flushing in the wheel paths.

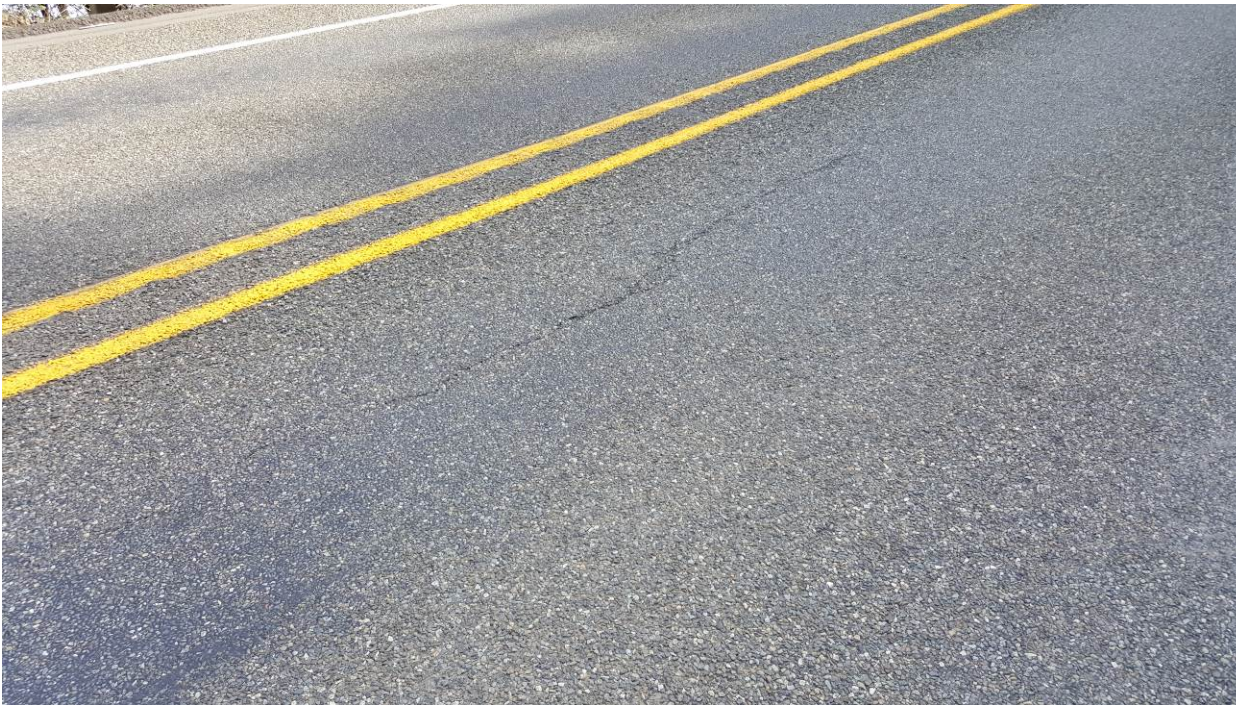
Figure 27. OR1b, SR101, three years after installation. Longitudinal crack is getting longer and wider. Flushing in the wheel paths is about the same.

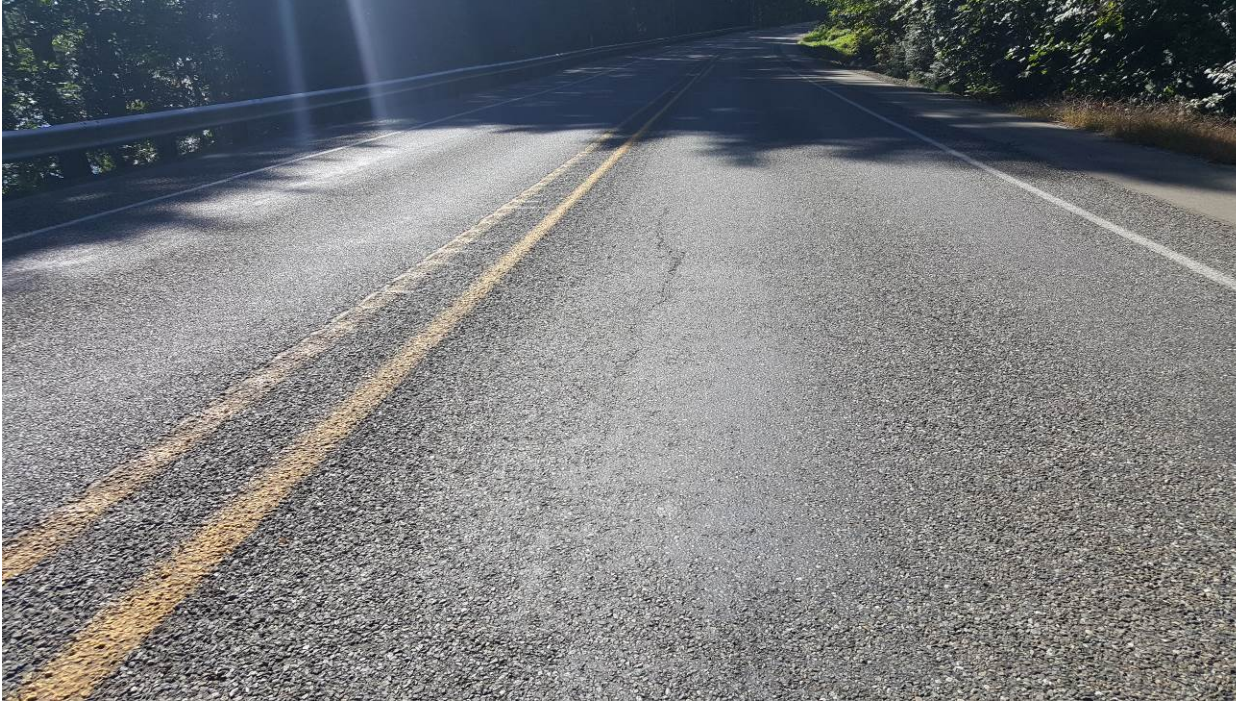
Figure 28. OR1b, SR101, four years after installation. Longitudinal crack condition is about the same, slight rutting and flushing in the wheel paths.

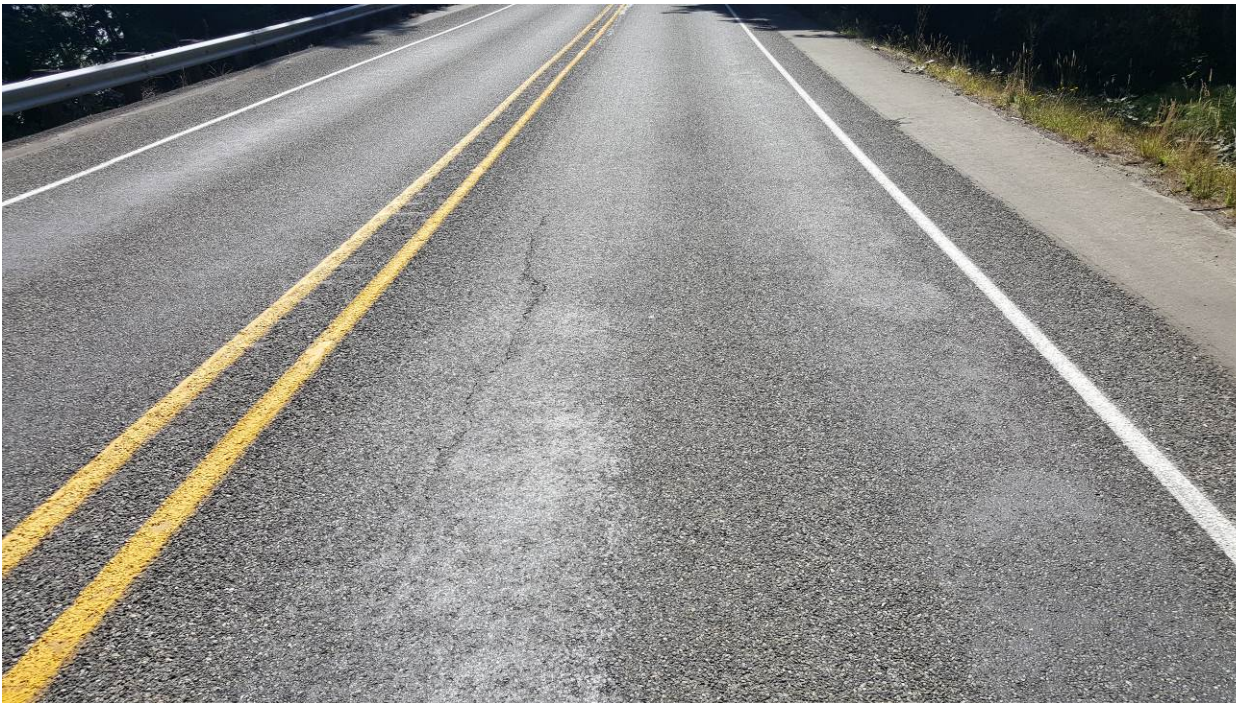
Figure 29. OR1b, SR101, five years after installation. Longitudinal crack condition is about the same, slight rutting and flushing in the wheel paths.

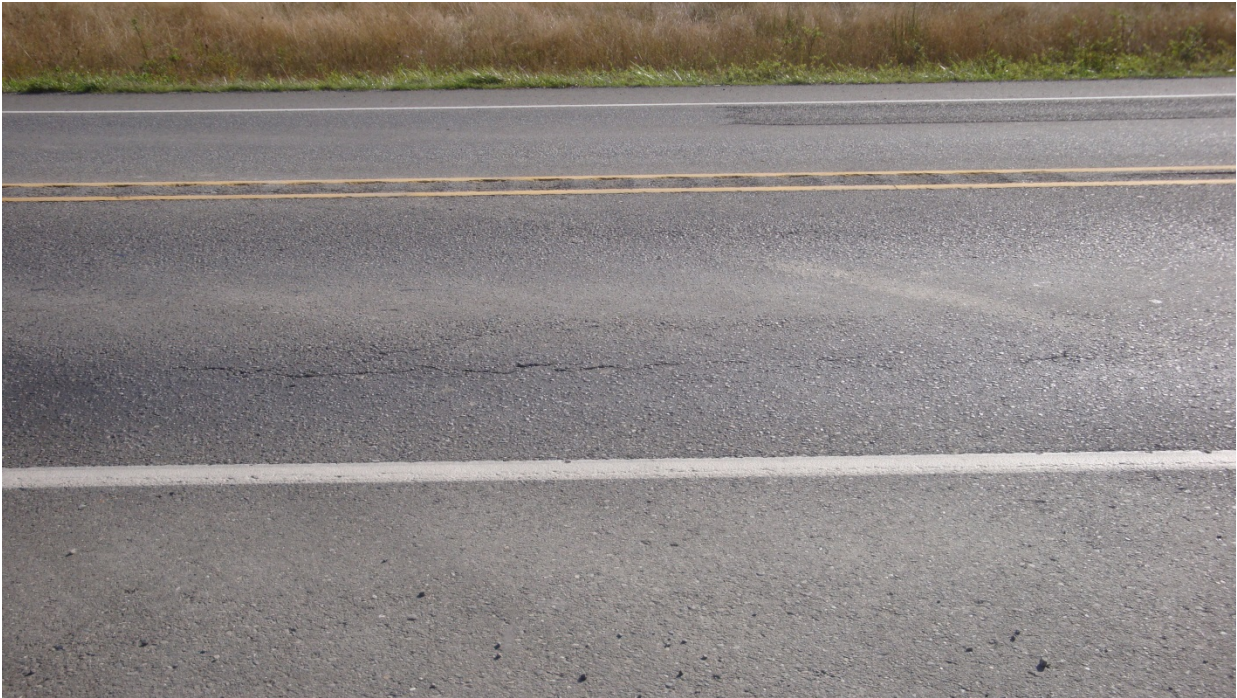
Figure 32. OR12, SR20, prior to treatment. Longitudinal and alligator cracking present in the wheel paths.

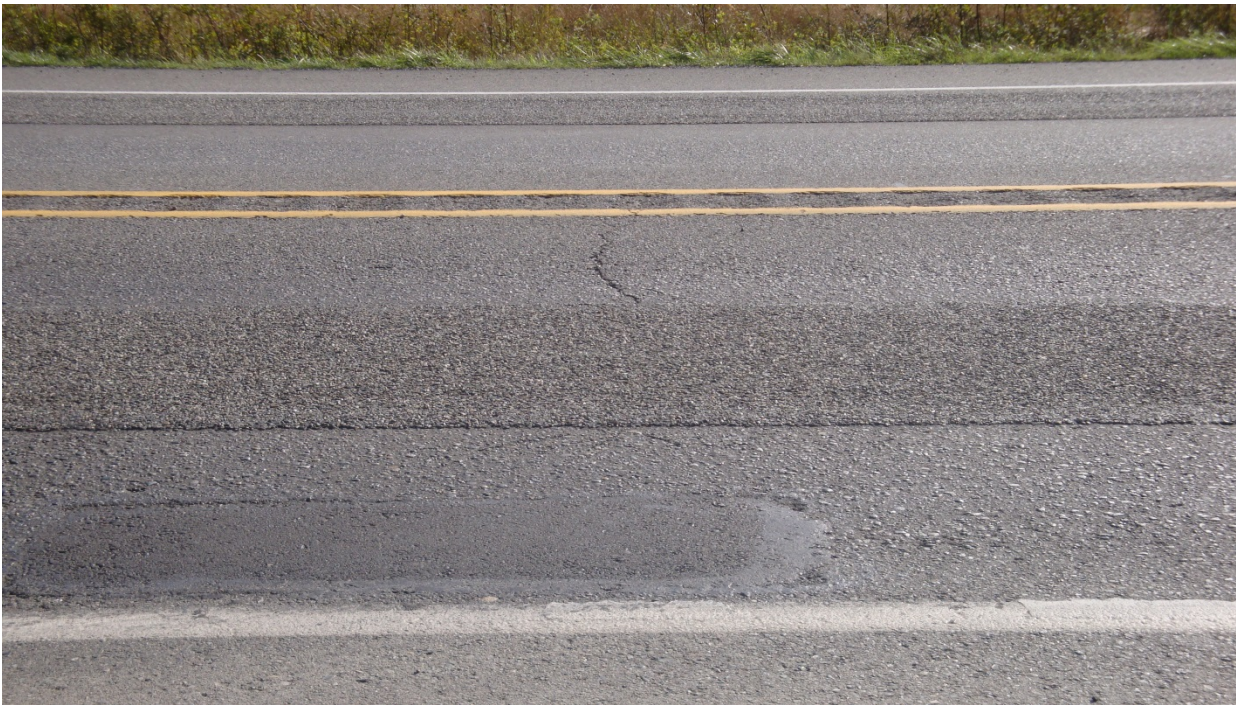
Figure 33. OR12, SR20, immediately after installation. Wheel path chip seal patching was well constructed.

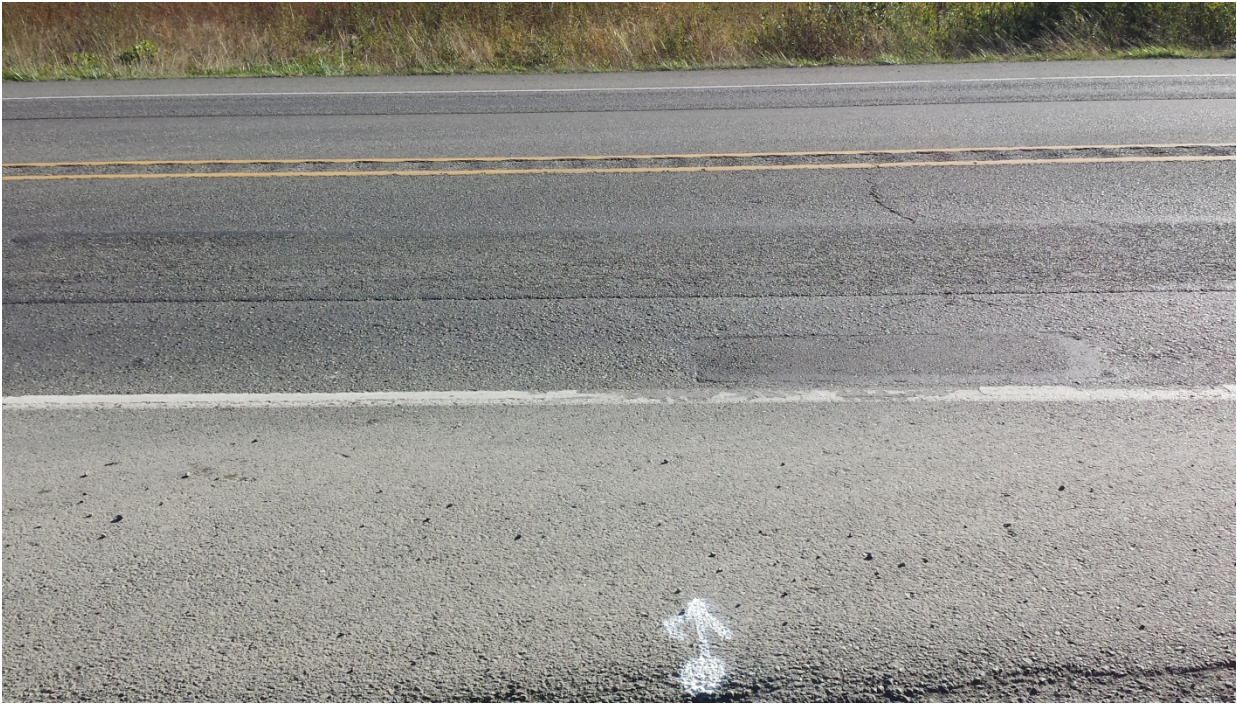
Figure 34. OR12, SR20, one year after installation. No change in the condition of the wheel path chip sealing.

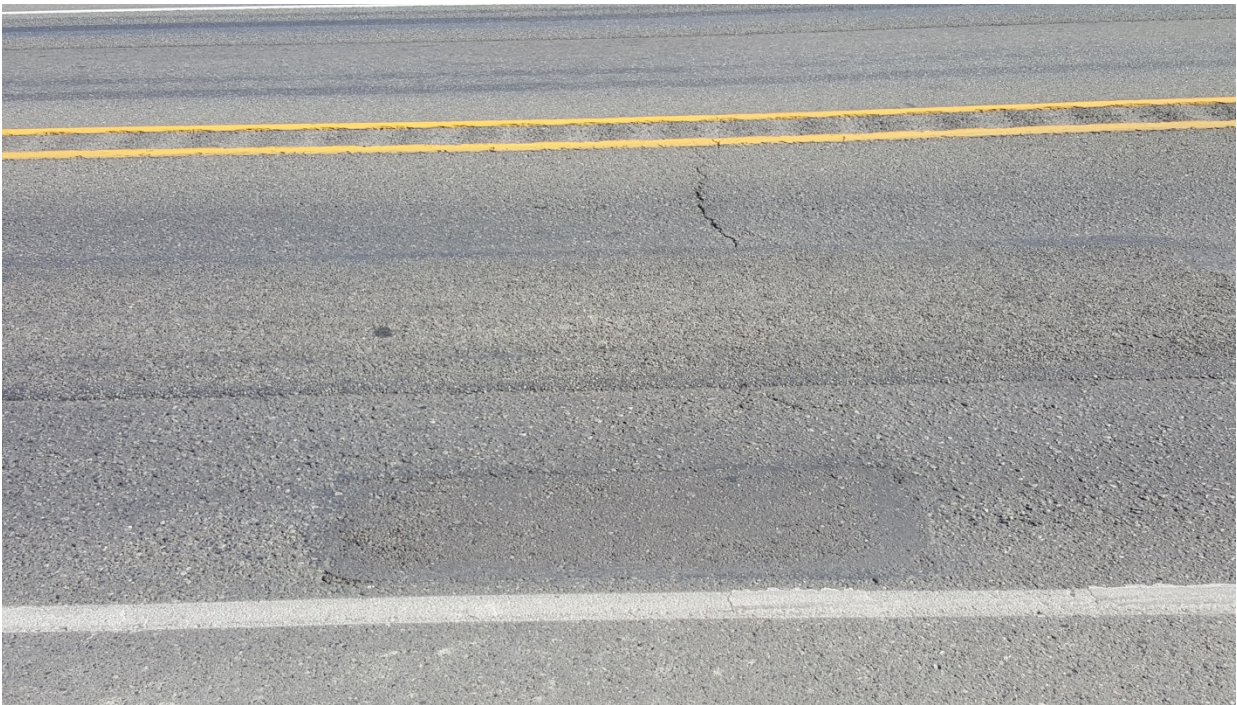
Figure 35. OR12, SR20, two years after installation. Some loss of aggregate but no reflection cracking.

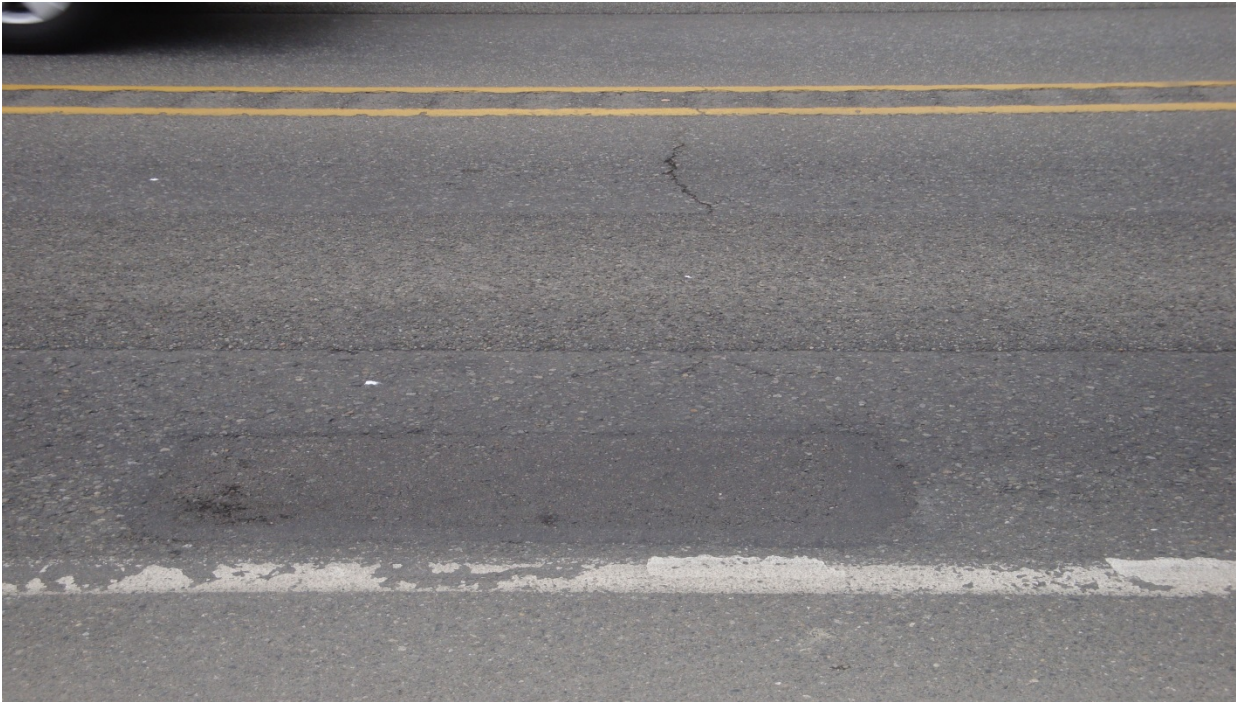
Figure 36. OR12, SR20, three years after installation. Some loss of aggregate but no reflection cracking.

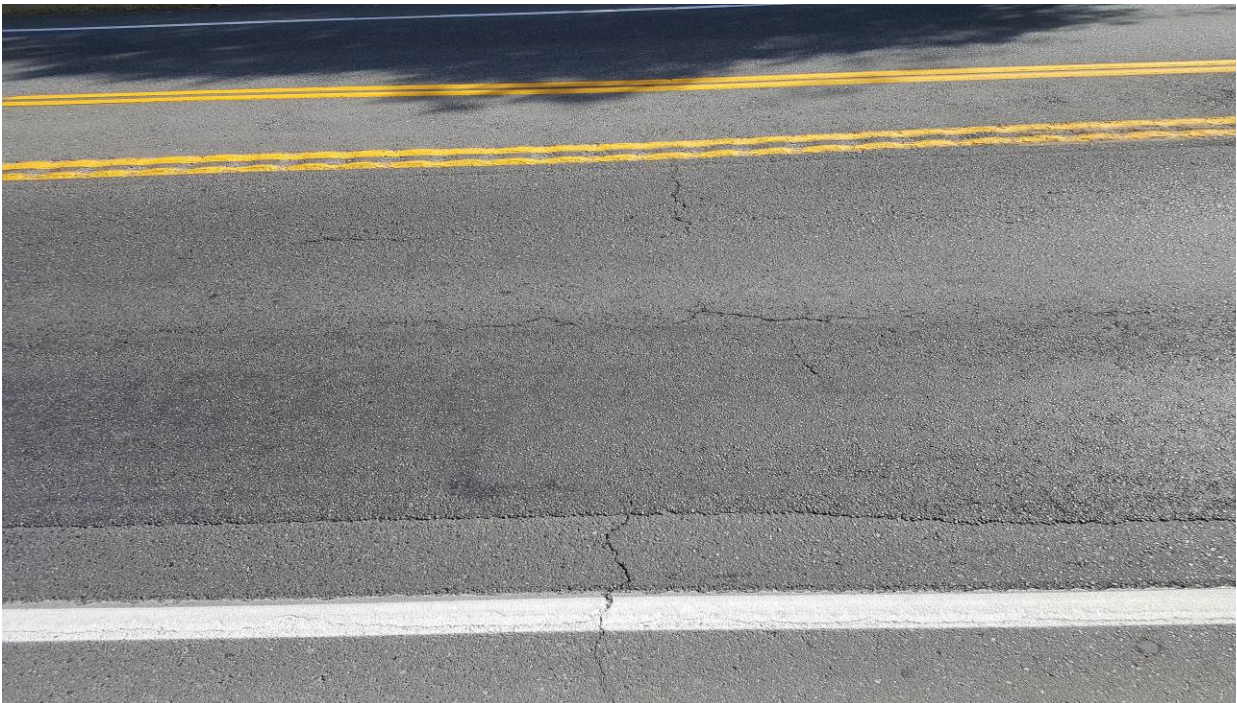
Figure 37. OR12, SR20, four years after installation. Some loss of aggregate and lots of reflection cracking through the wheel path chip seal.

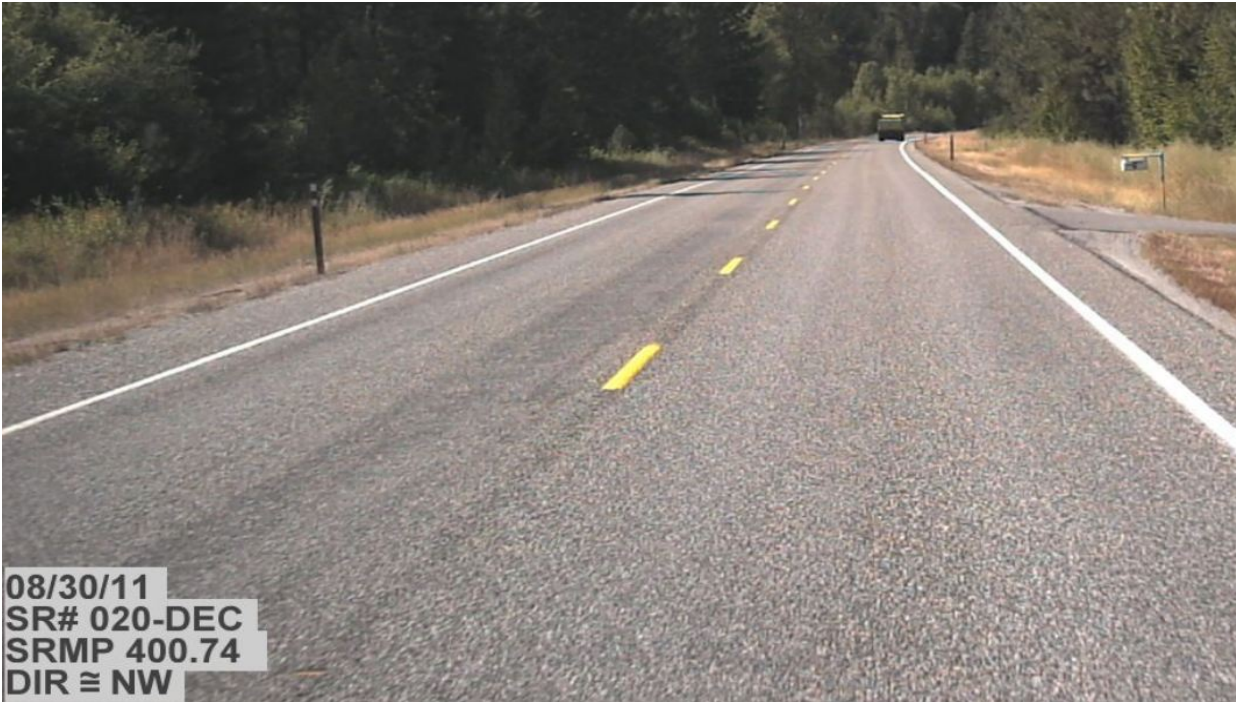
Figure 43. ER7, SR20, prior to treatment. Rutting is visible in the wheel paths.

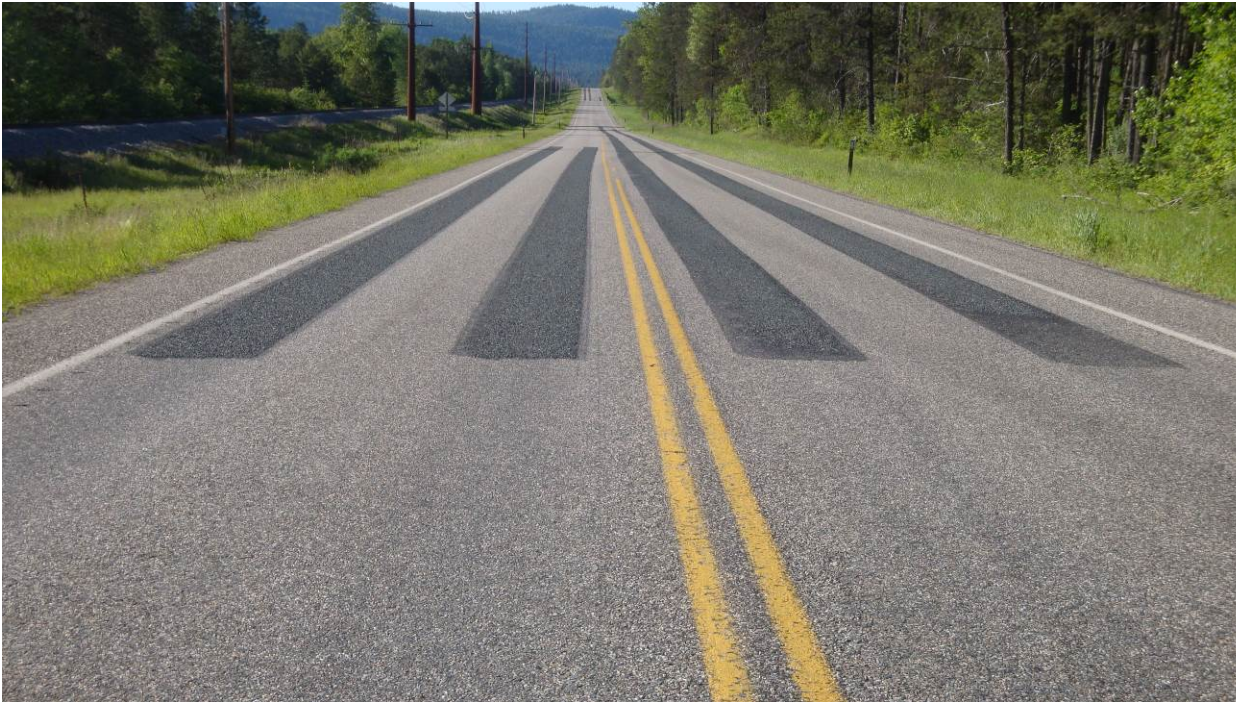
Figure 45. ER7, SR20, one year after installation. Wheel path chip seal rut fills are in excellent condition.

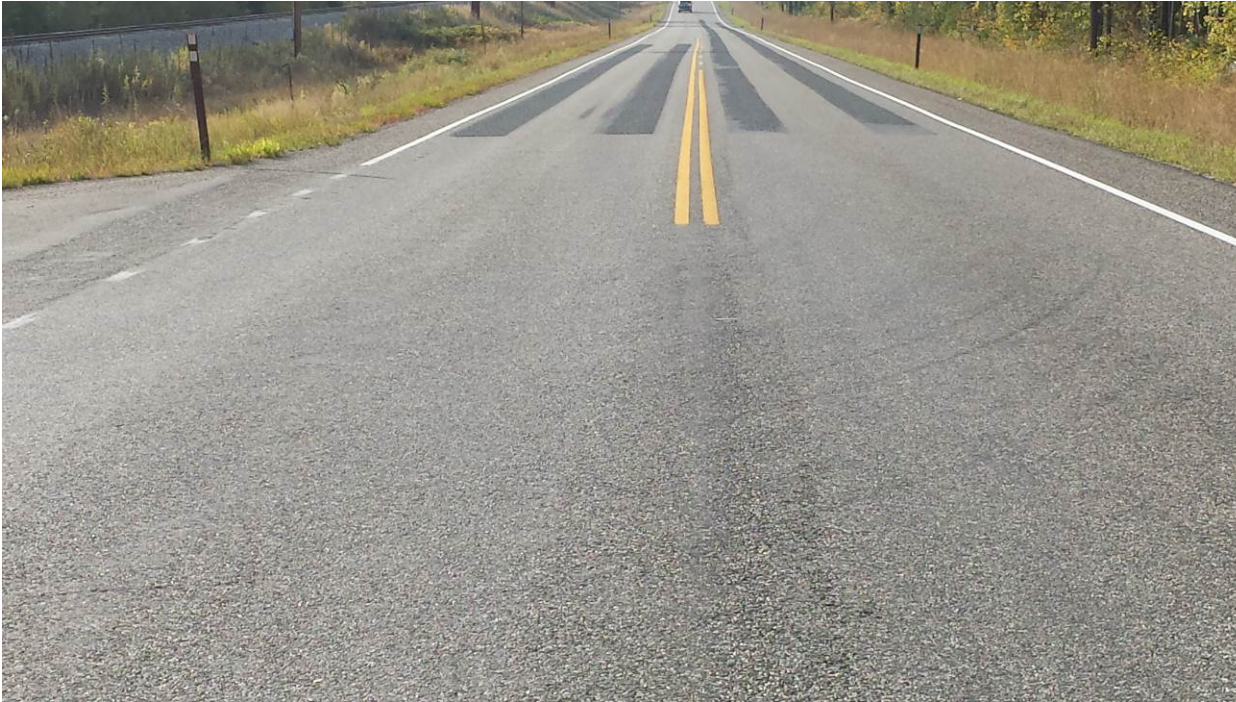
Figure 46. ER7, SR20, two years after installation. No change in chip seal.

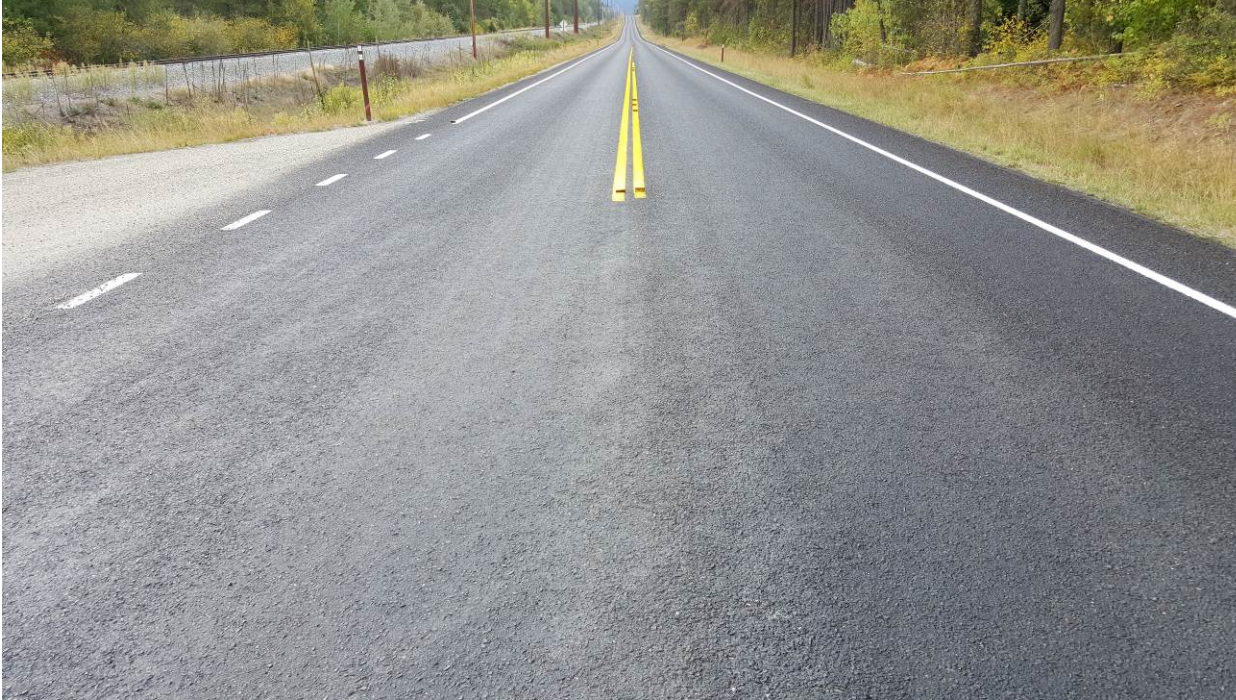
Figure 47. ER7, SR20, three years after installation. Full lane chip seal installed under Contract 8728, US 2 ET AL 2015 Eastern Region Chip Seal.

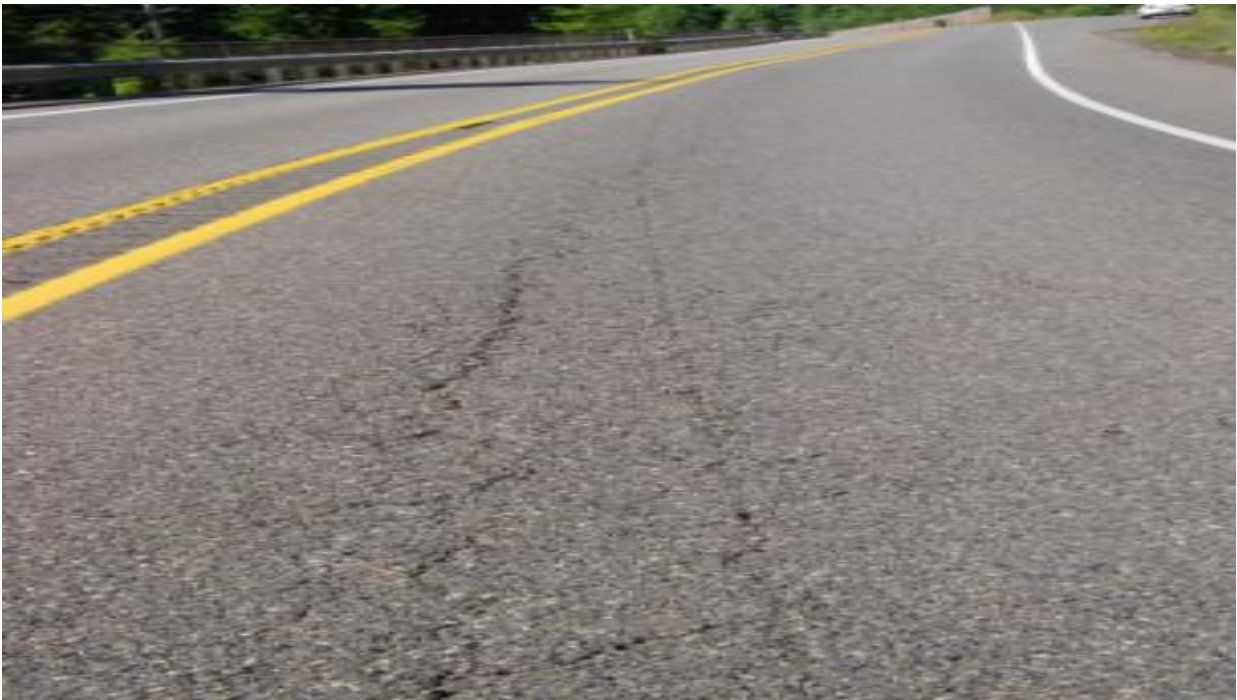
Figure 50. OR1a, SR101, prior to treatment. Alligator and longitudinal cracking noted.

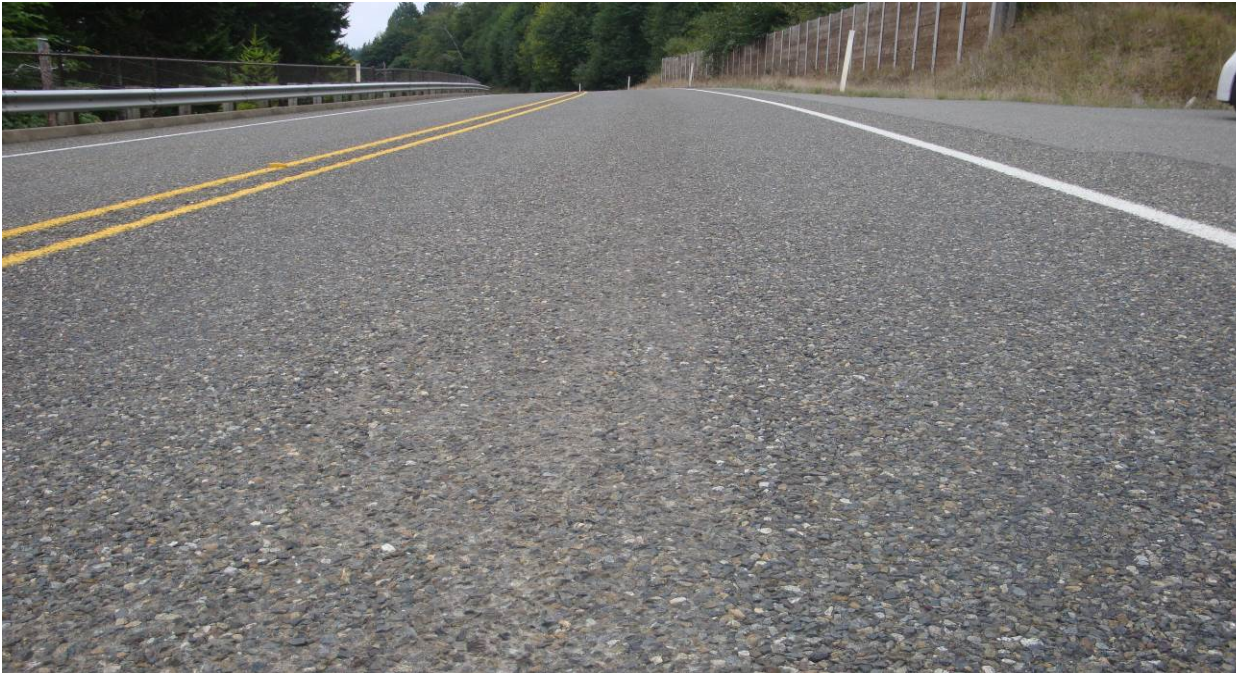
Figure 51. OR1a, SR101, one year after installation. Chip seal looks excellent.

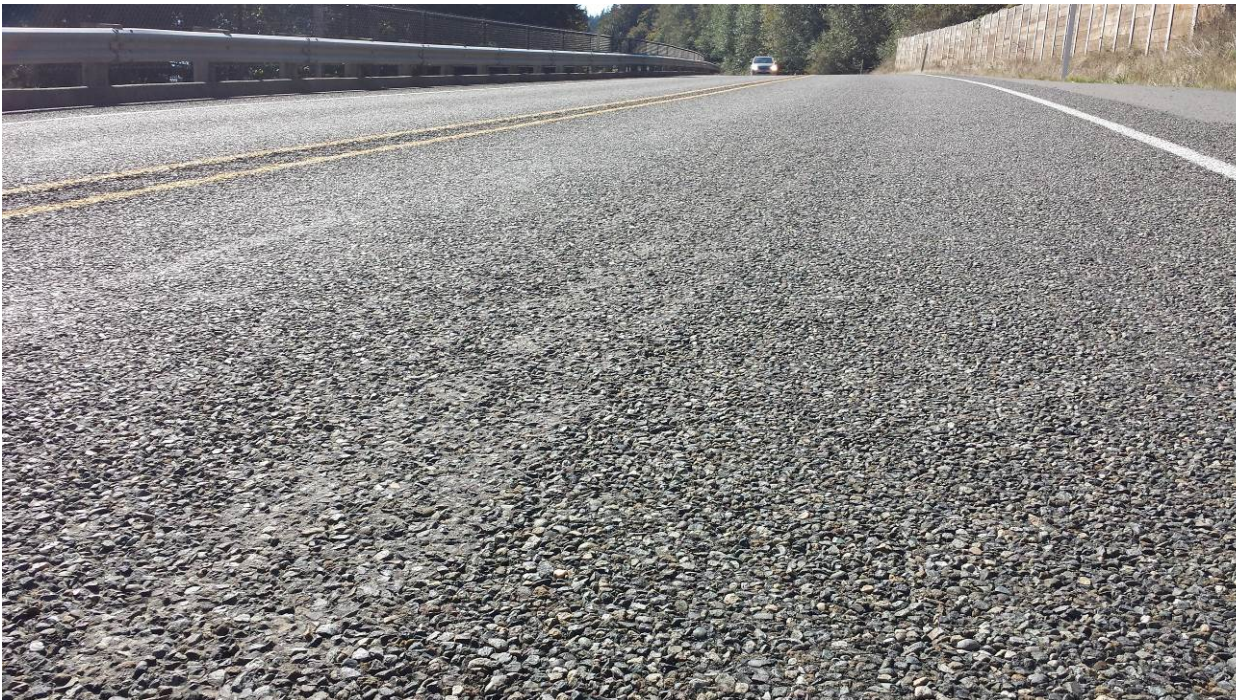
Figure 52. OR1a, SR101, two years after installation. Shadowing of the sealed cracks visible.

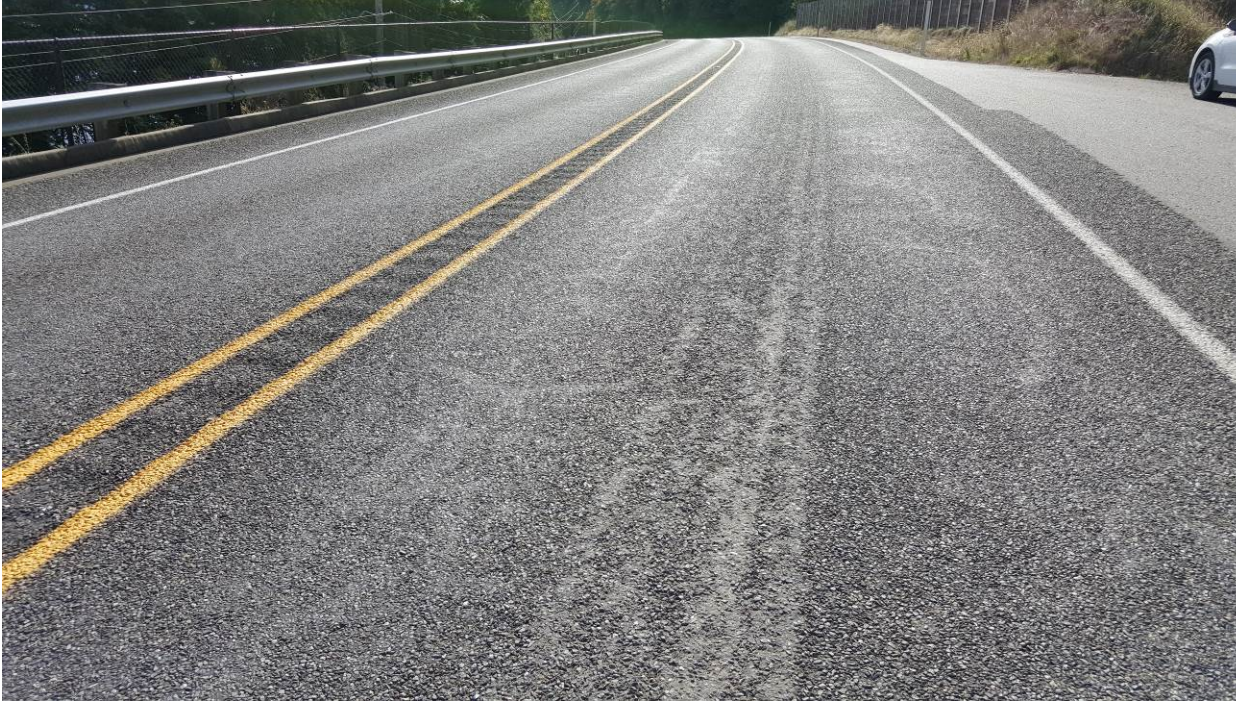
Figure 53. OR1a, SR101, three years after installation. Very slight flushing and shadowing of the sealed cracks.
