Preventive Maintenance Study - Final Report

WA-RD 871.2

Preventive Maintenance Study

Washington State – Statewide Locations

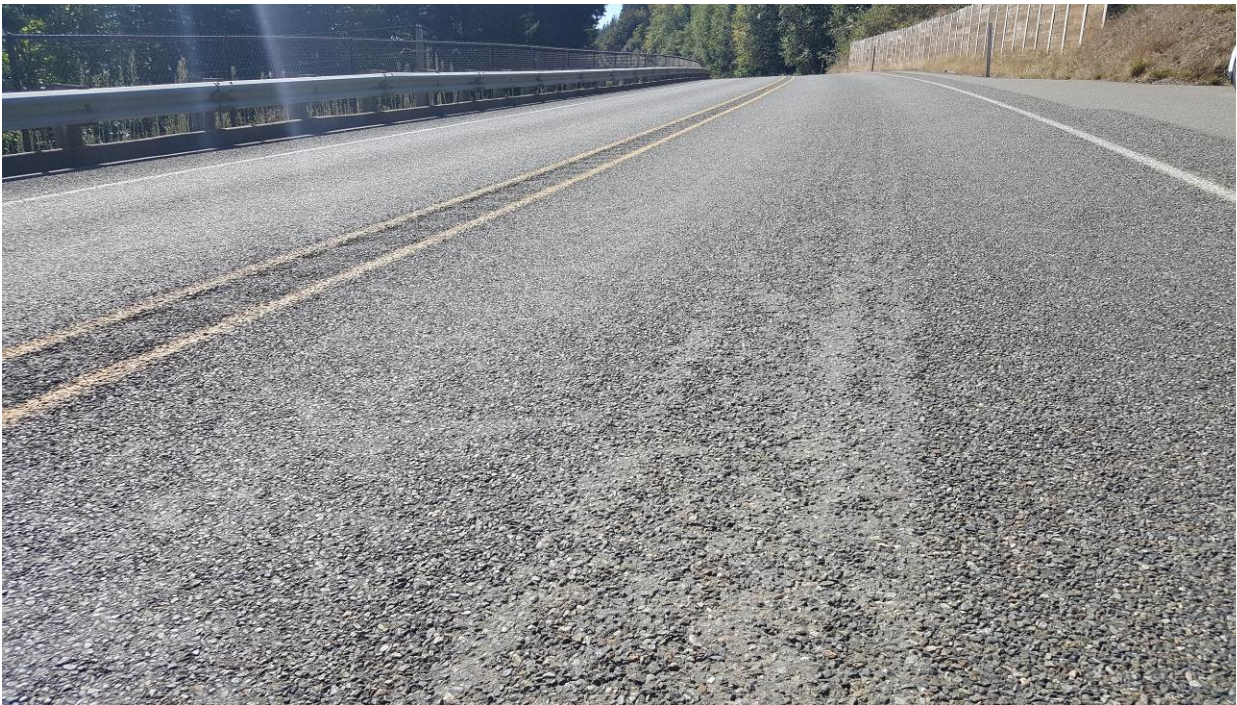
Figure 54. OR1a, SR101, four years after installation. Slight amount of rutting beginning to appear. Flushing does not seem to be a big issue.

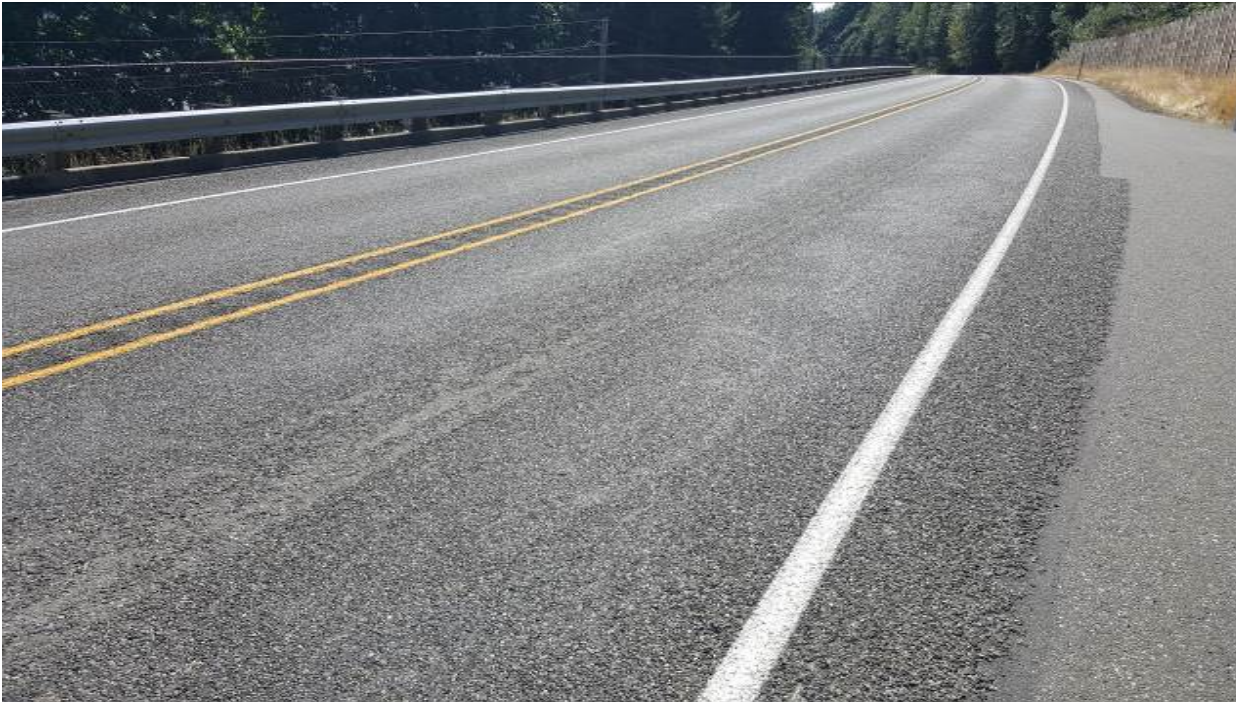
Figure 55. OR1a, SR101, five years after installation. Slight amount of rutting beginning to appear. Flushing not an issue. Shadowing of underlying crack sealant.

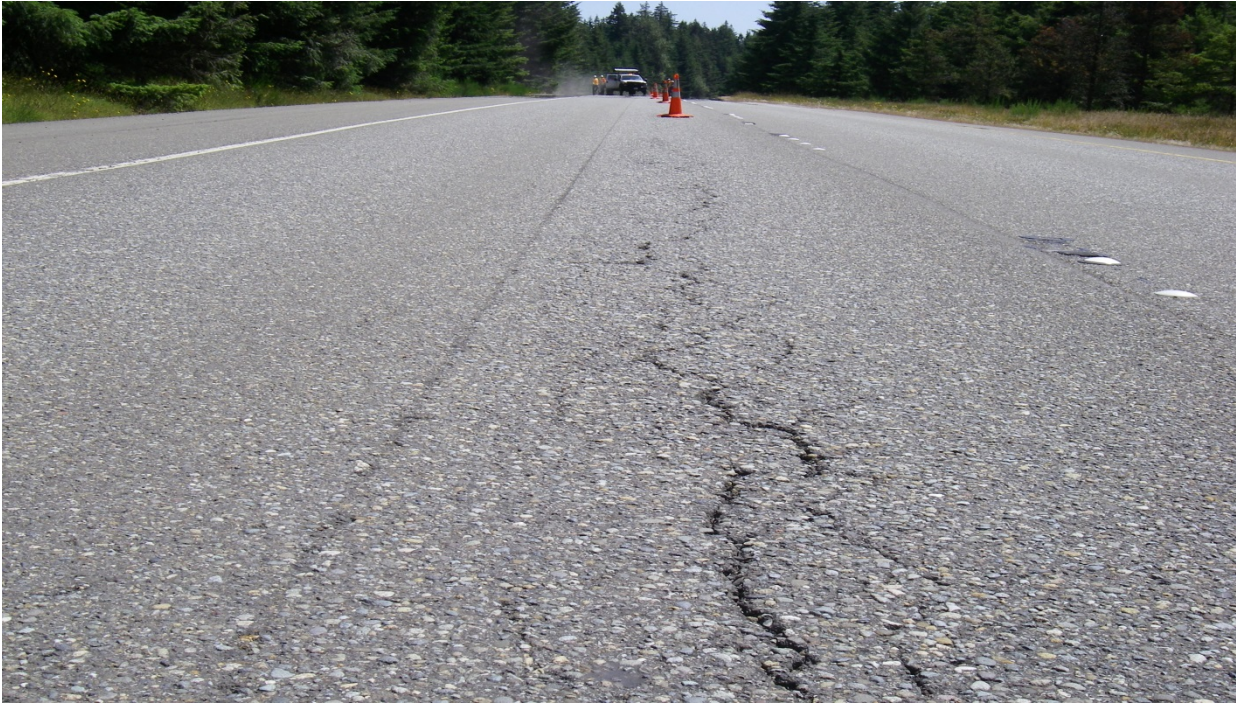
Figure 78. OR2, SR8, prior to treatment. Alligator cracking in the left wheel path. This is not the same location as the following photos which had alligator cracking in both wheel paths.

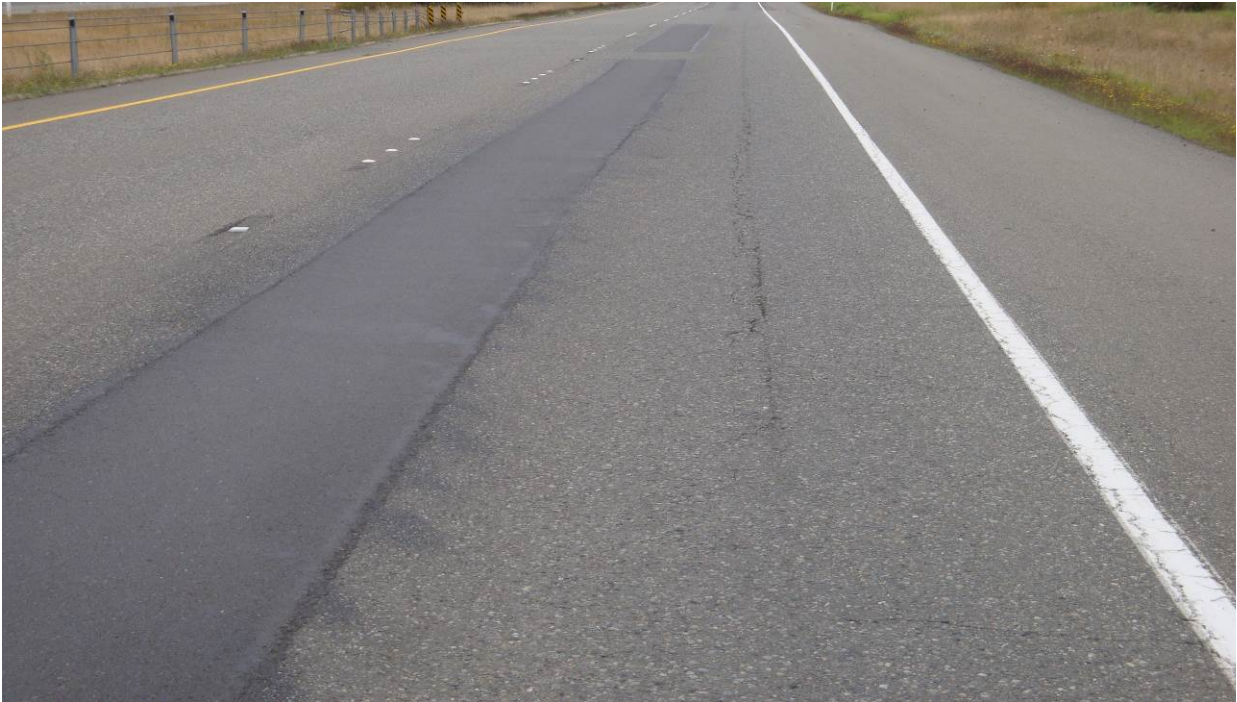
Figure 79. OR2, SR8, one year after installation. Dig out patch looks excellent.

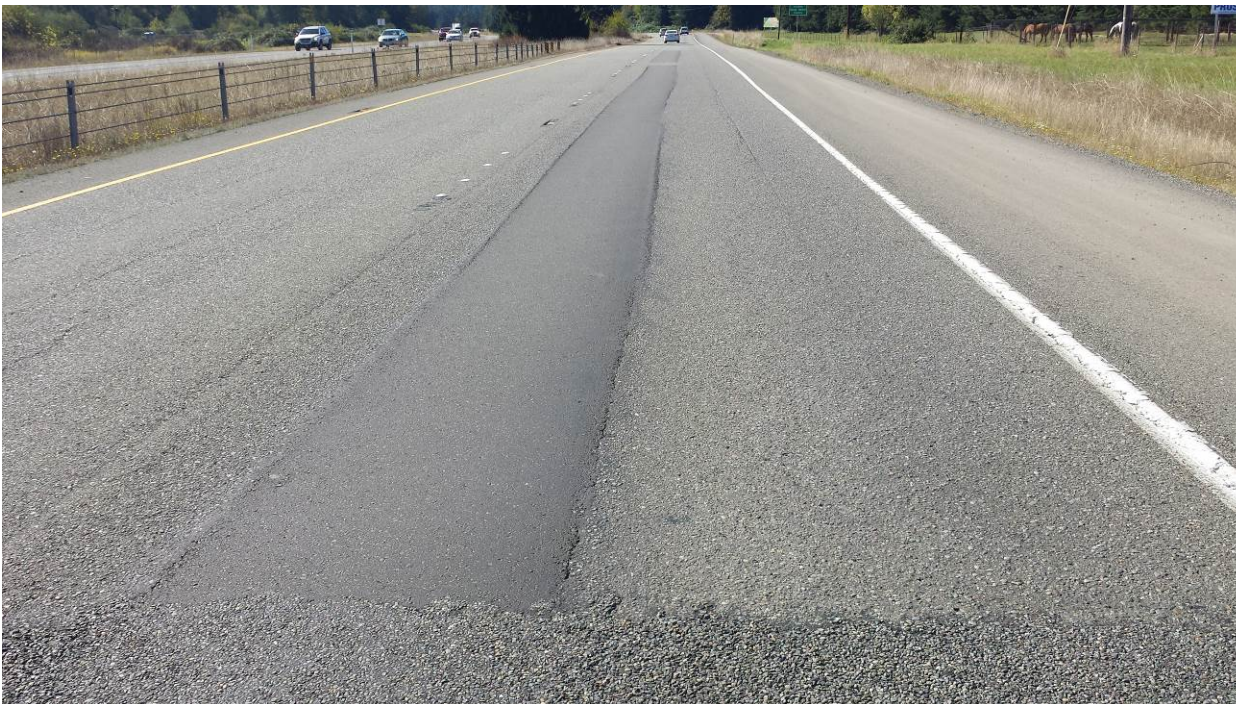
Figure 80. OR2, SR8, two years after installation. No change in condition of patch.

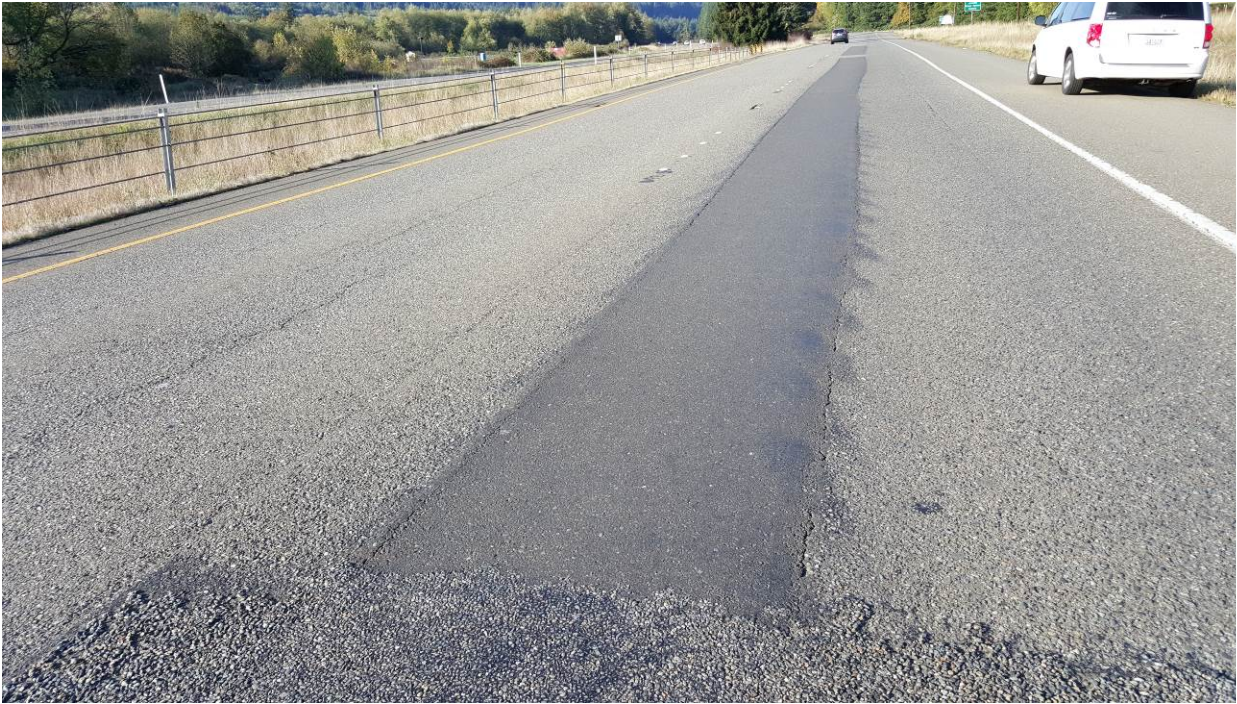
Figure 81. OR2, SR8 three years after installation. Slight rutting in the patch.

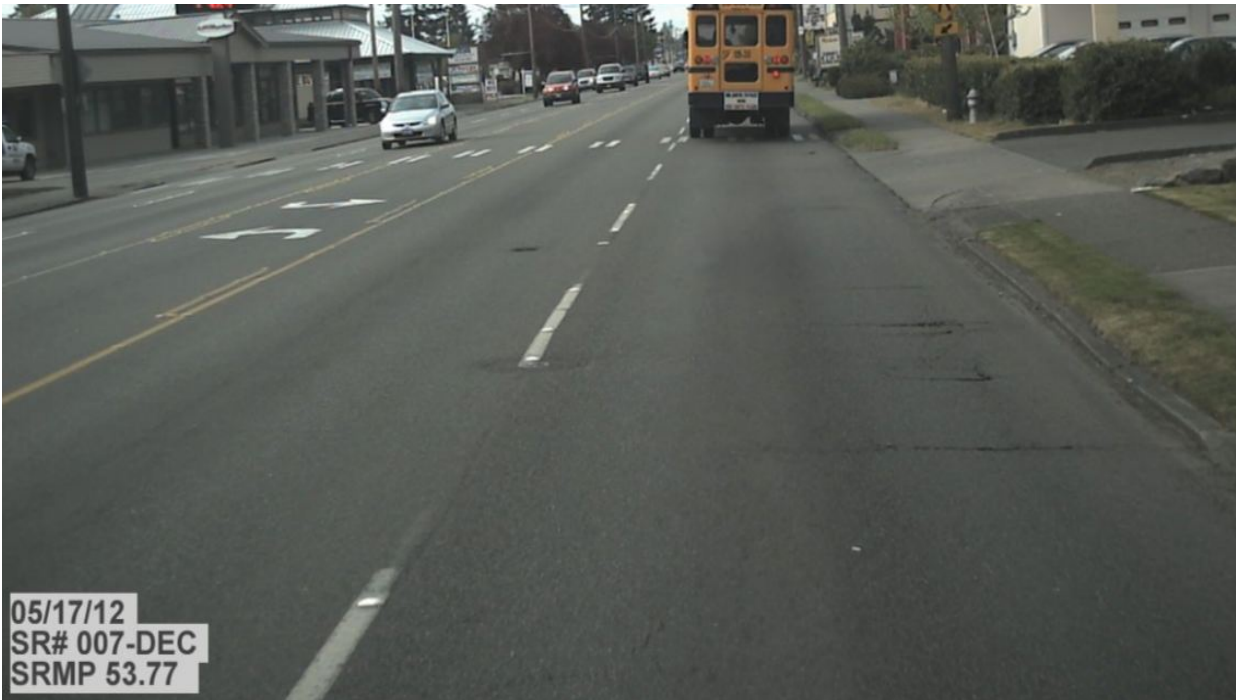
Figure 84. OR5, SR7, prior to treatment. Not at same location as following photos.

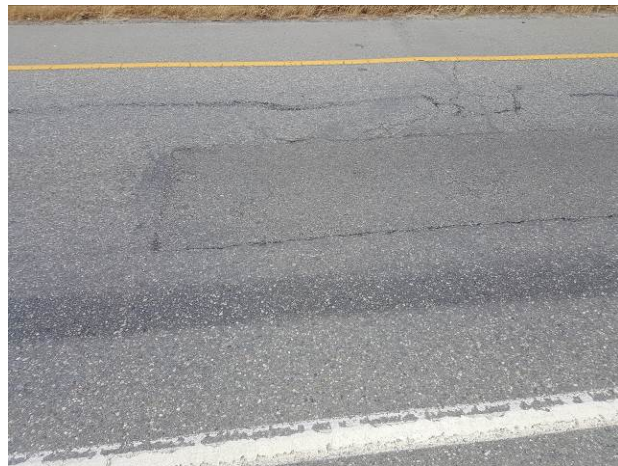
Figure 91. OR4, SR3, Good, age 50 months. Dig out patches and crack sealing in excellent condition.

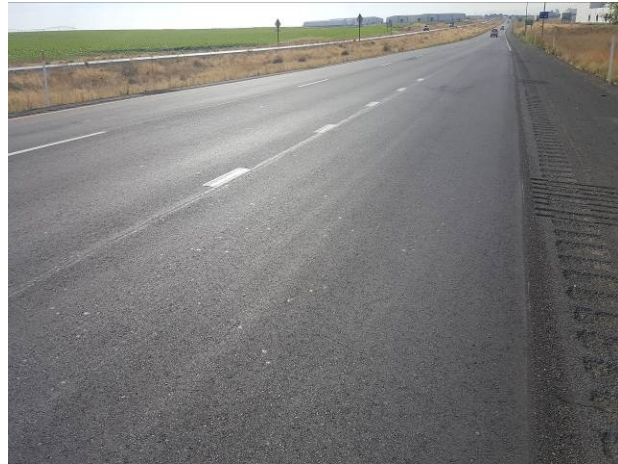
Figure 93. SC4, SR395, Good to Poor, age 26 months. HMA grind/inlay in 2017, C9052.

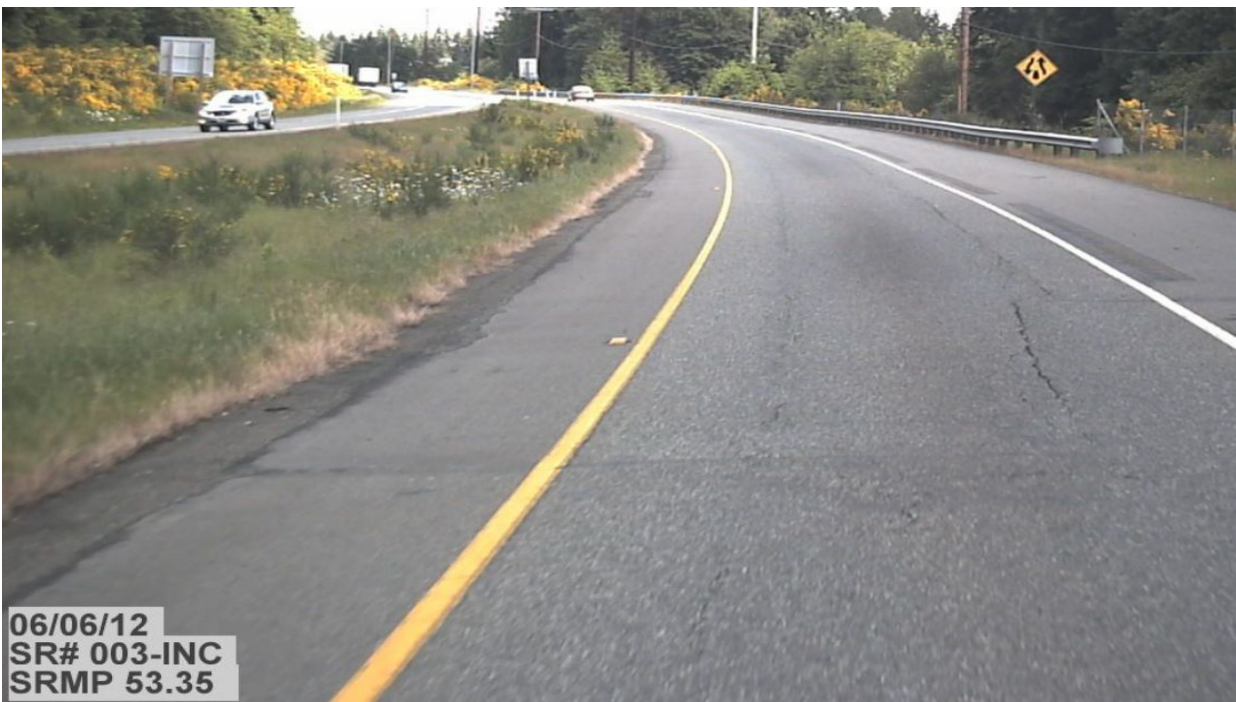
Figure 94. OR4, SR3, prior to treatment. Longitudinal, transverse and alligator cracking.

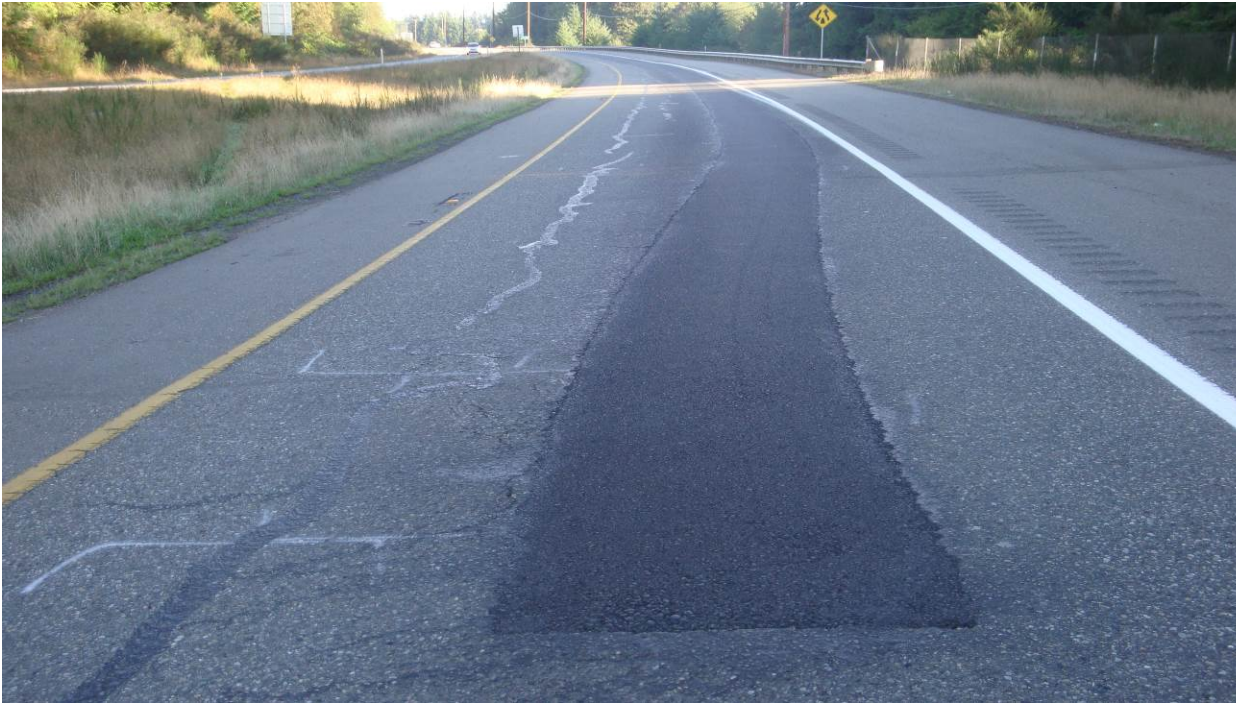
Figure 95. OR4, SR3, a few months after installation. Crack sealing looks good, dig out patches appear under filled in spots.

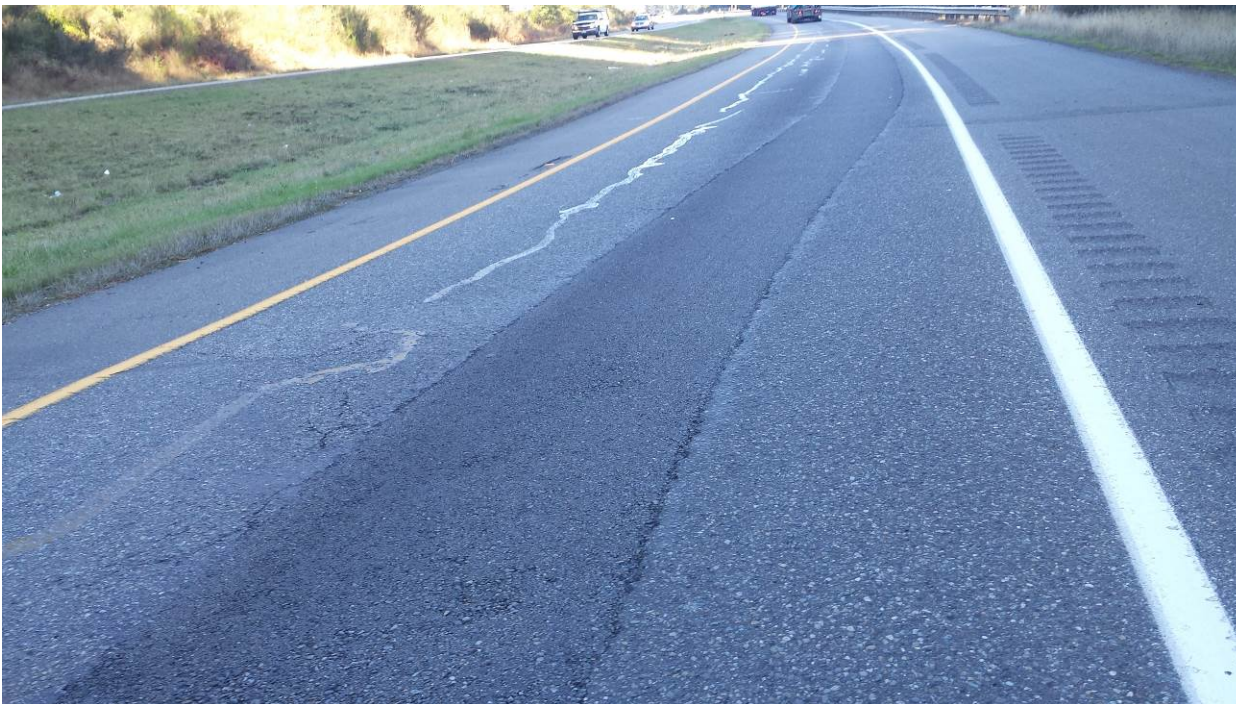
Figure 96. OR4, SR3, one year after installation. Dig out patch and crack sealing look unchanged.

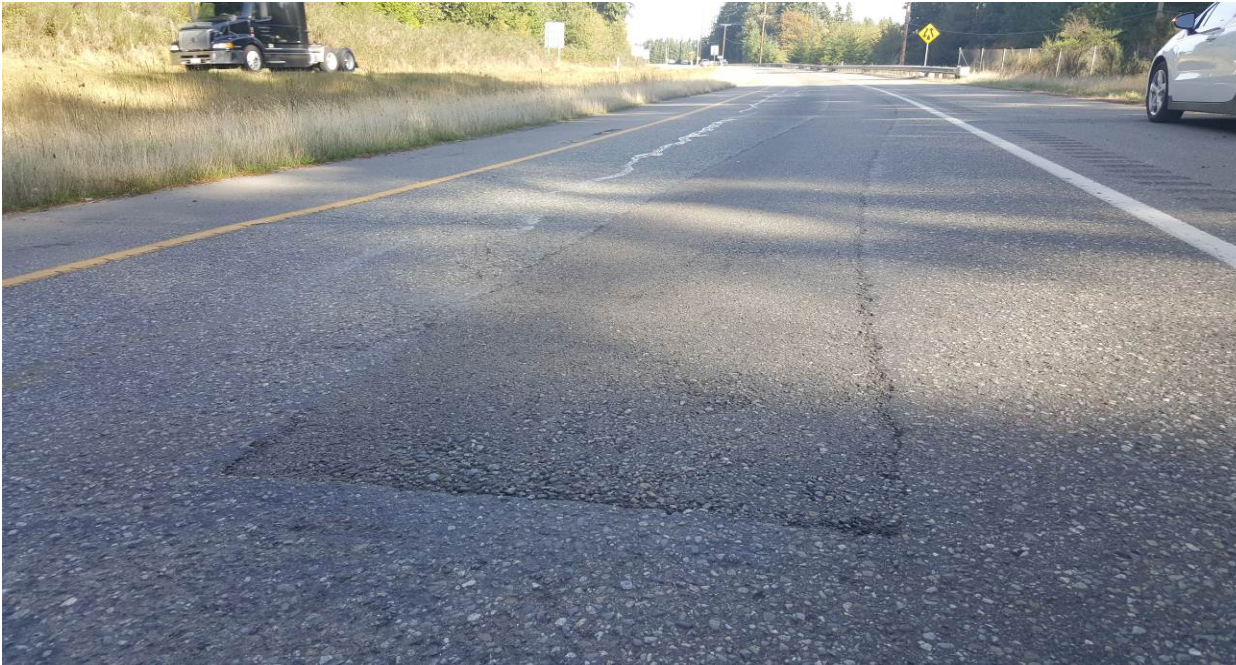
Figure 97. OR4, SR3, two years after installation. No change in dig out patch or crack sealing.

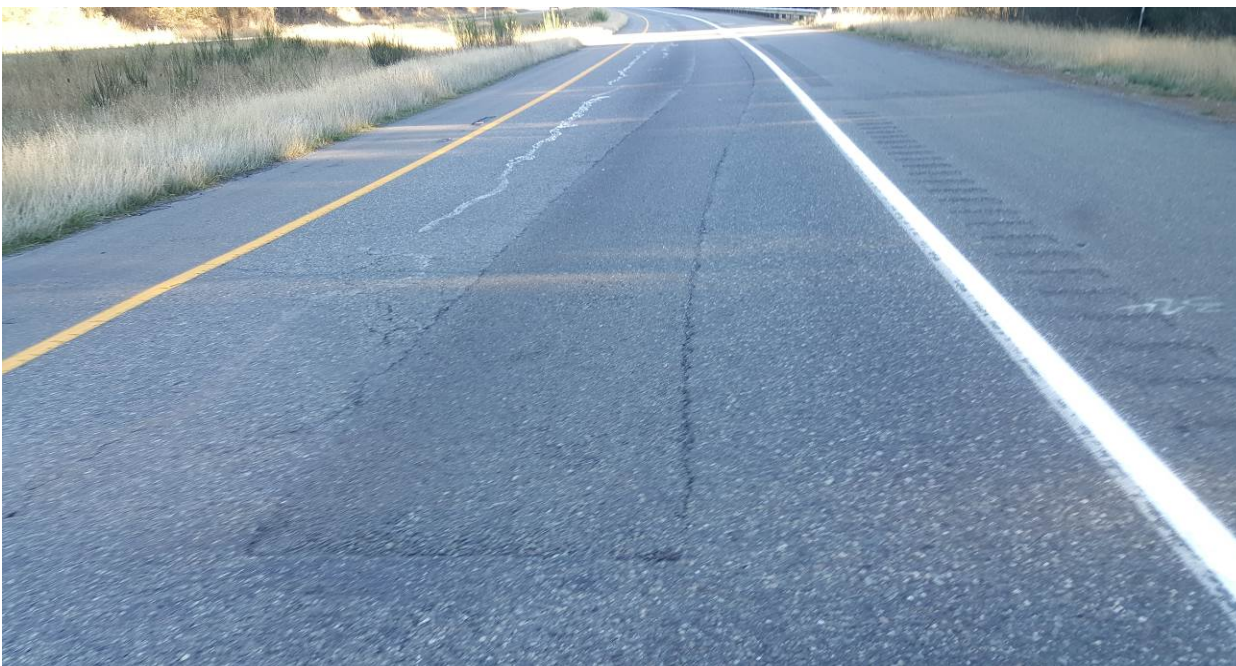
Figure 98. OR4, SR3, three years after installation. No change in dig out patch or crack sealing.

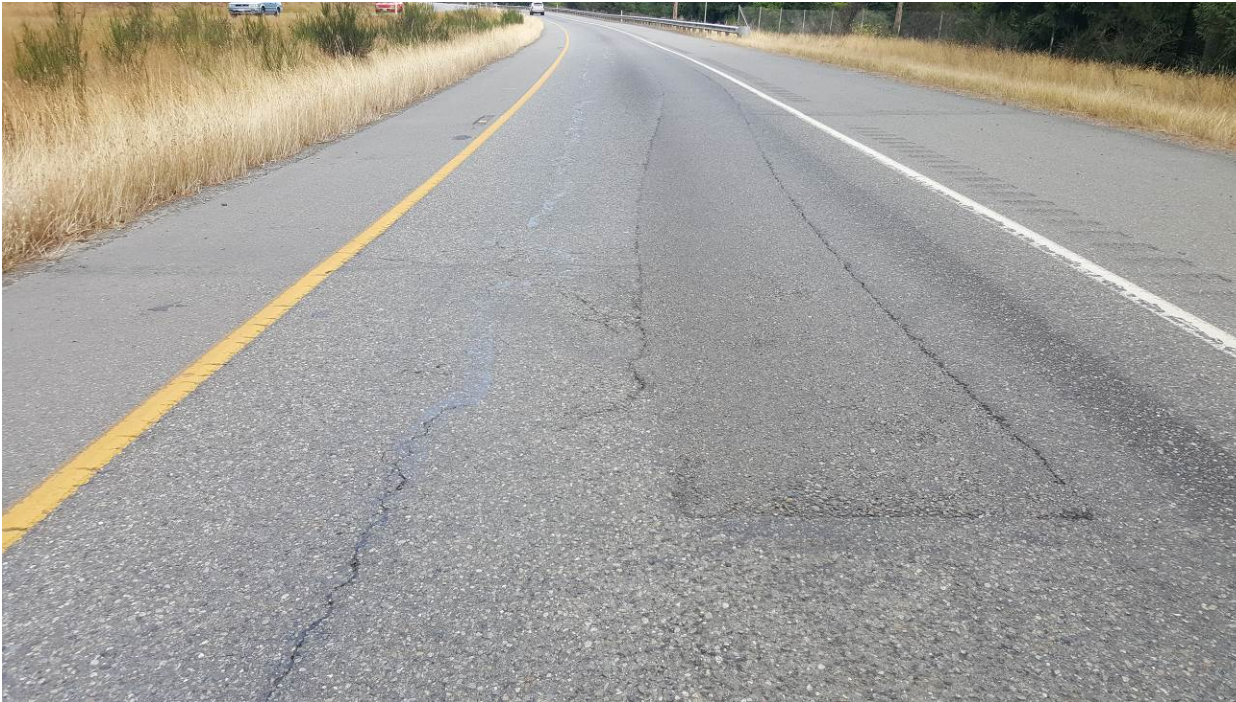
Figure 99. OR4, SR3, four years after installation. No change in dig out patch or crack sealing.

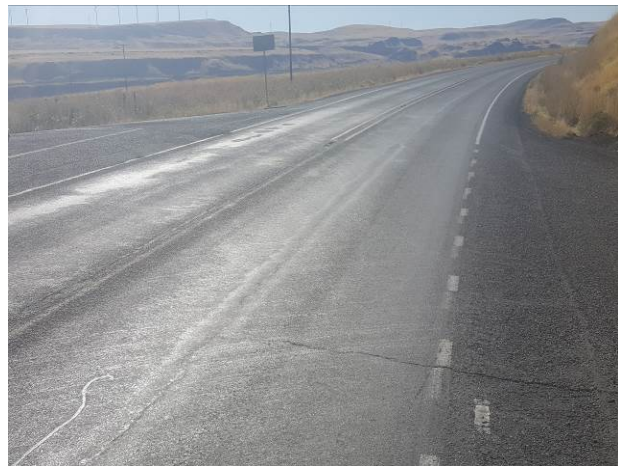
Figure 103. SW1a, SR14, Poor, age 62 months. Transverse and longitudinal reflection cracking and flushing noted at 12 months after installation. Potholes developed at 50 months.

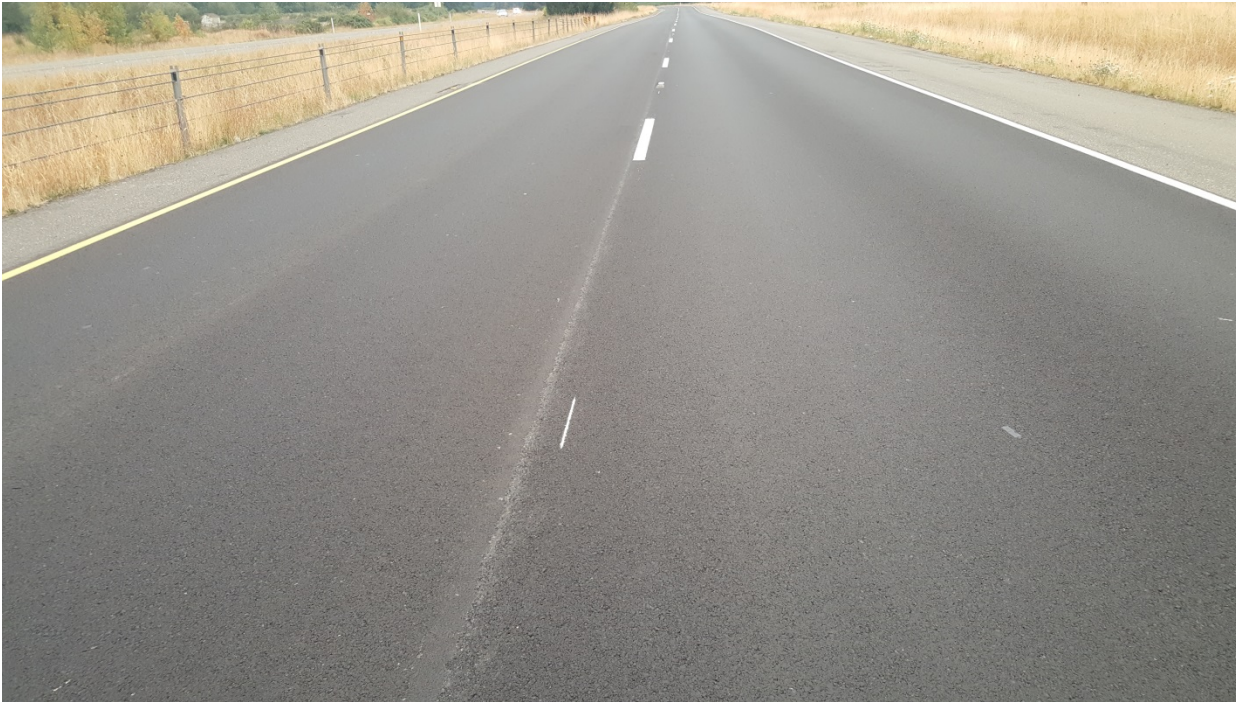
Figure 111. OR2a, SR8, the site received an HMA grind/inlay in 2017, C9001, five years after installation.

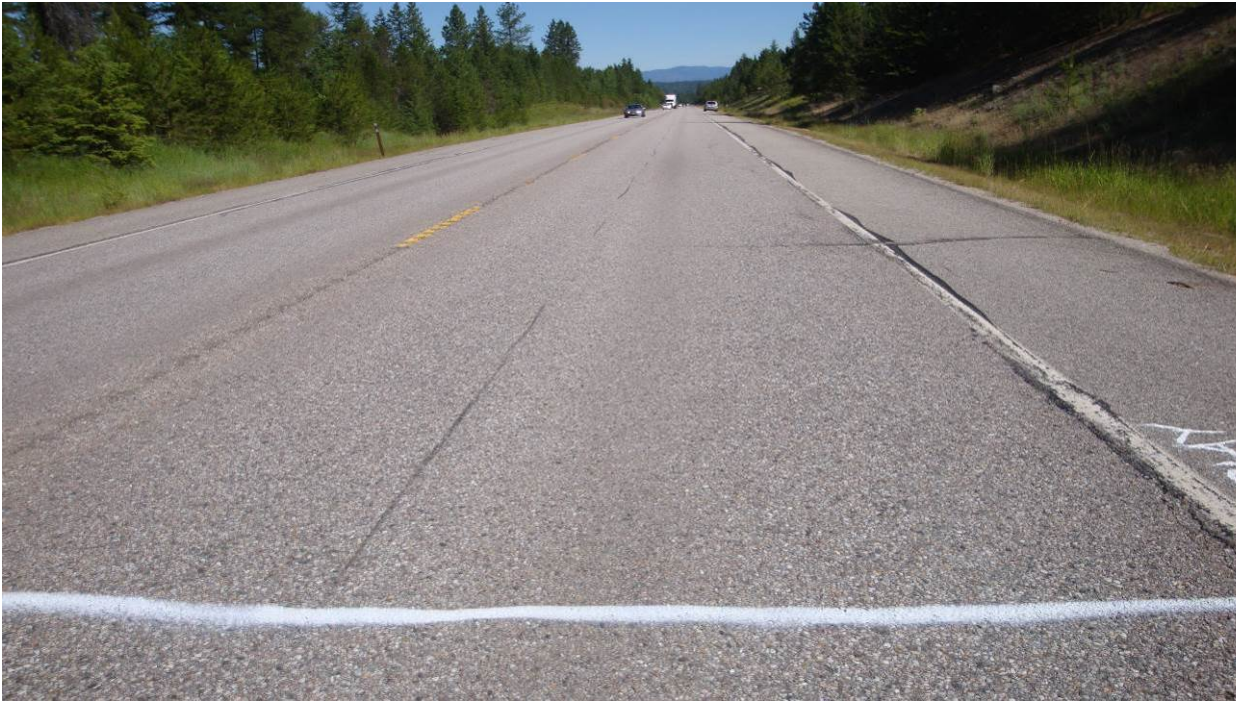
Figure 120. ER9a, SR395, prior to treatment. Longitudinal, transverse and alligator cracking.

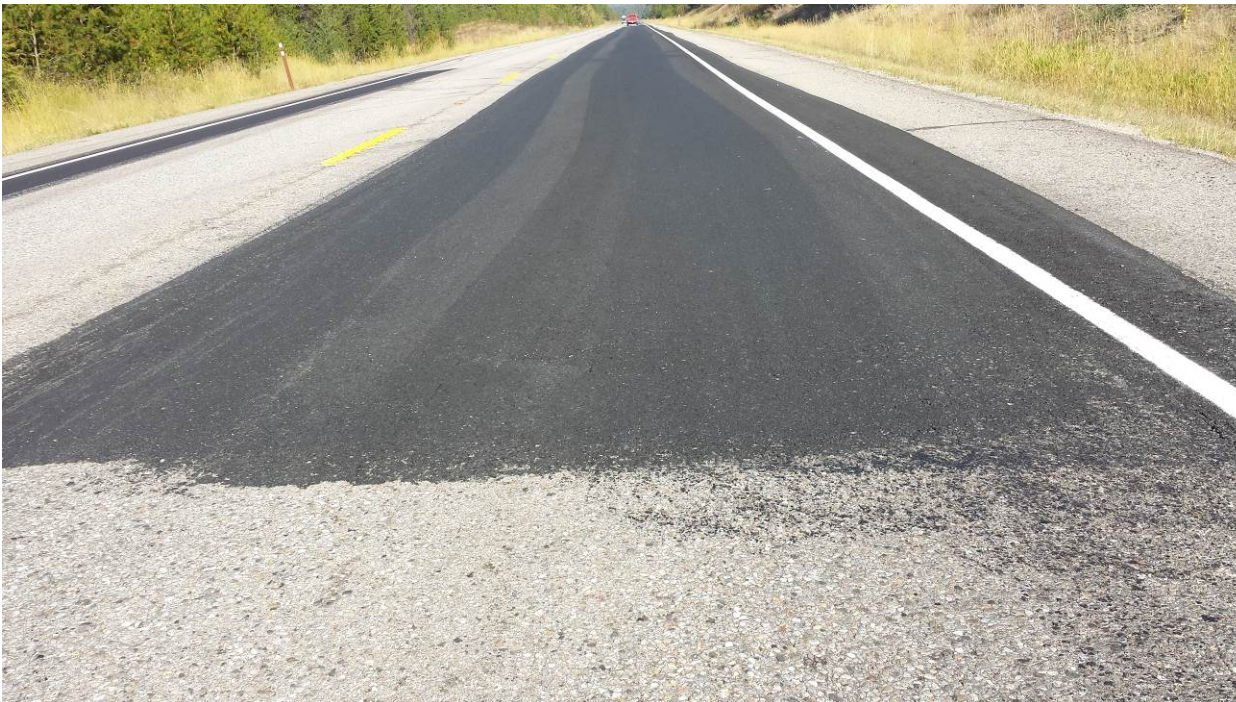
Figure 121. ER9a, SR395, a few months after installation. Blade patch looks excellent.

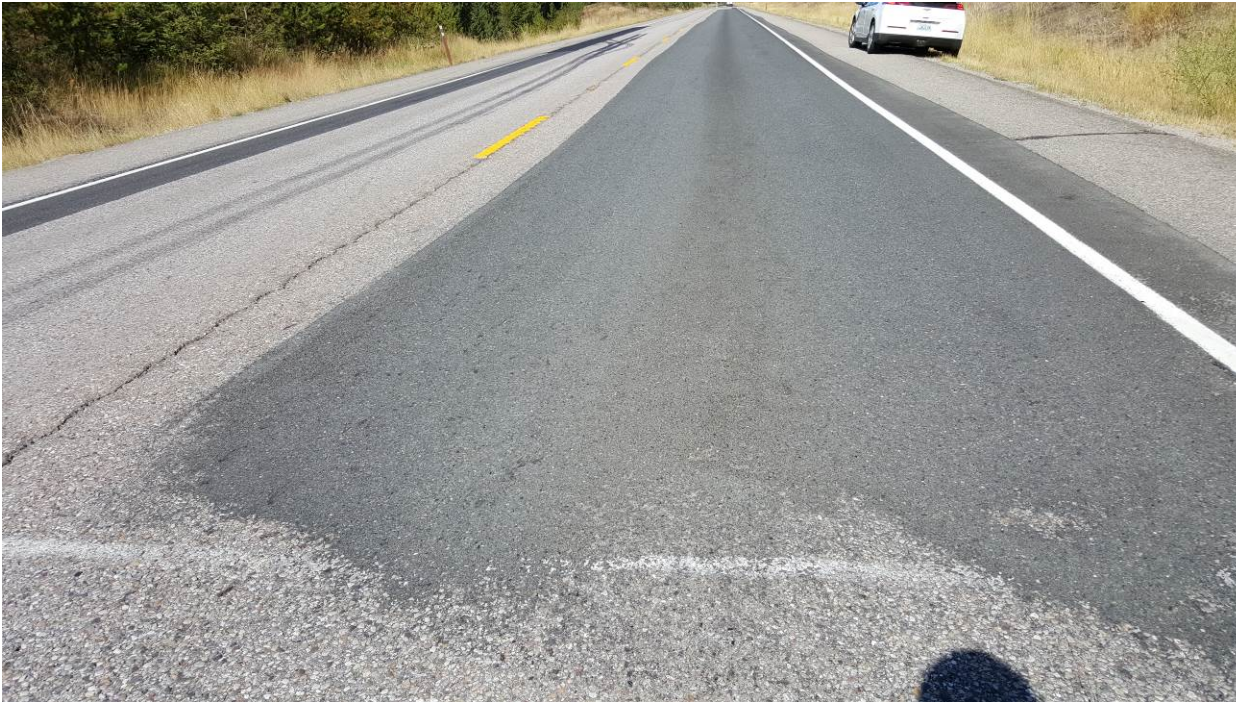
Figure 122. ER9a, SR395, one year after installation in 2014. Some wear of the blade patch at each end. Transverse cracks reflected through the blade patch after only one year.

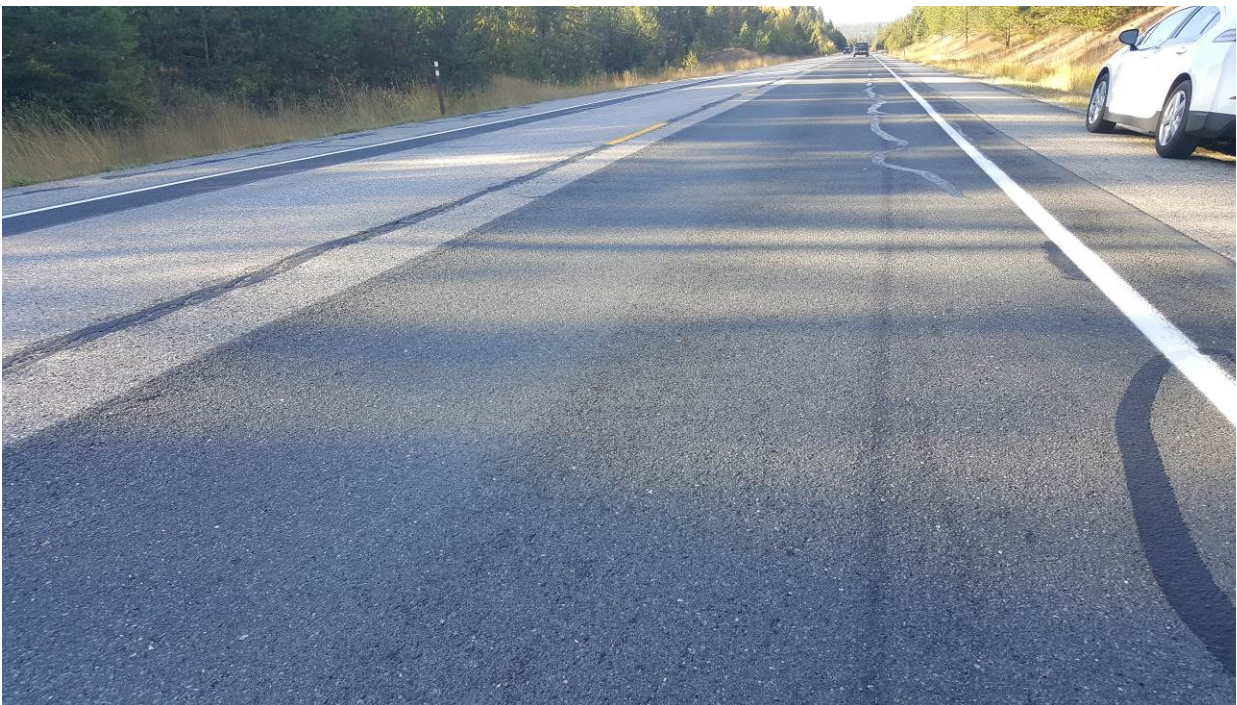
Figure 123. ER9a, SR395, two years after installation. Longitudinal reflection cracking has been sealed. Note slight flushing in the left wheel path.

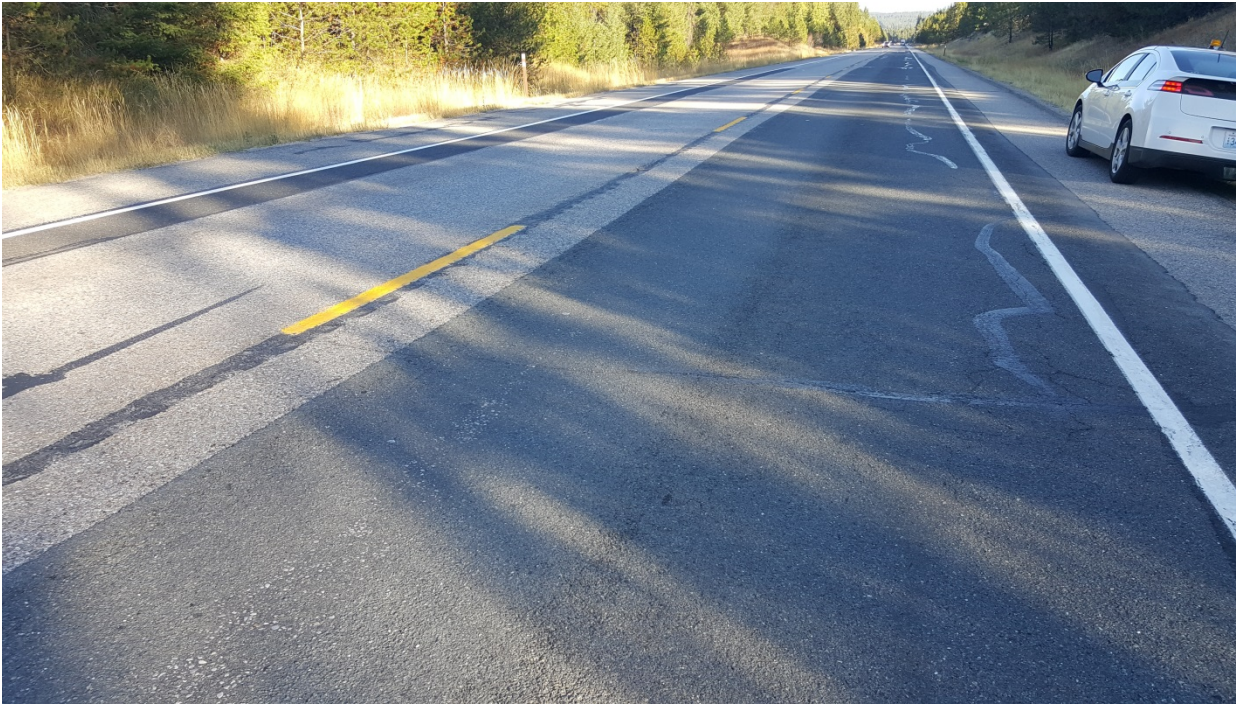
Figure 124. ER9a, SR395, three years after installation. Longitudinal reflection cracking has been sealed. Note slight flushing in the left wheel path.

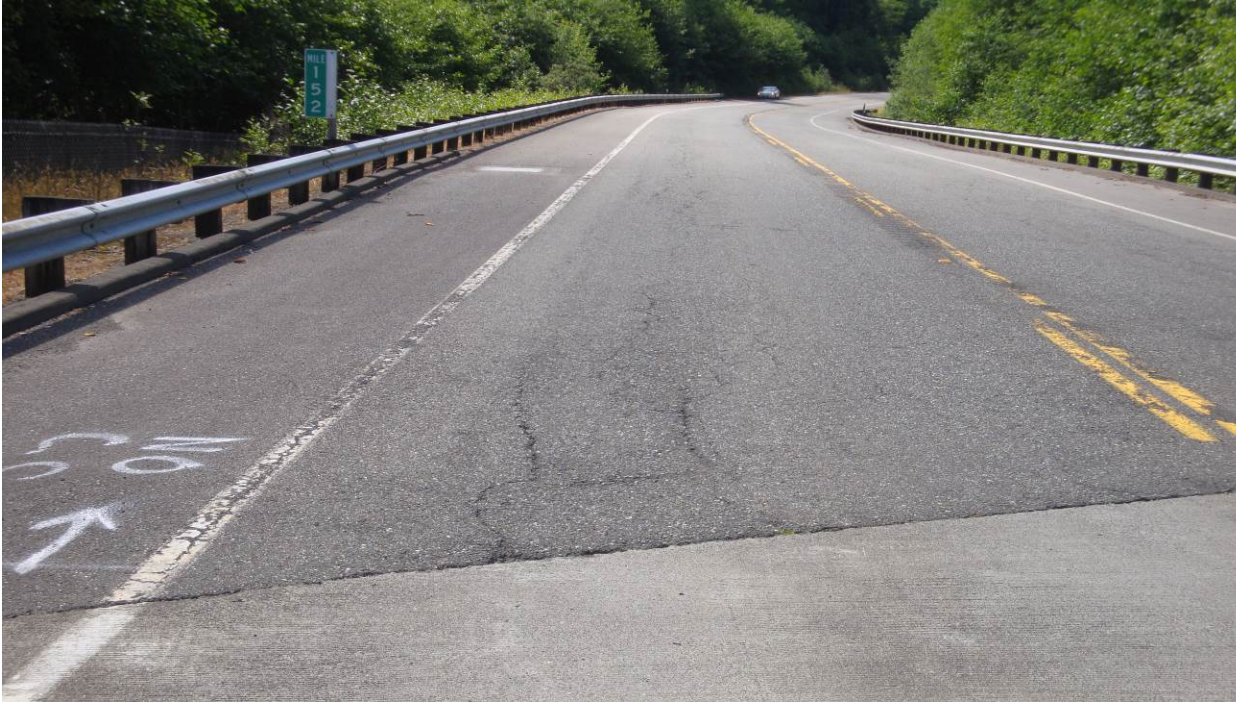
Figure 129. OR3a, SR101, condition in 2012, the year that the other sections were treated.

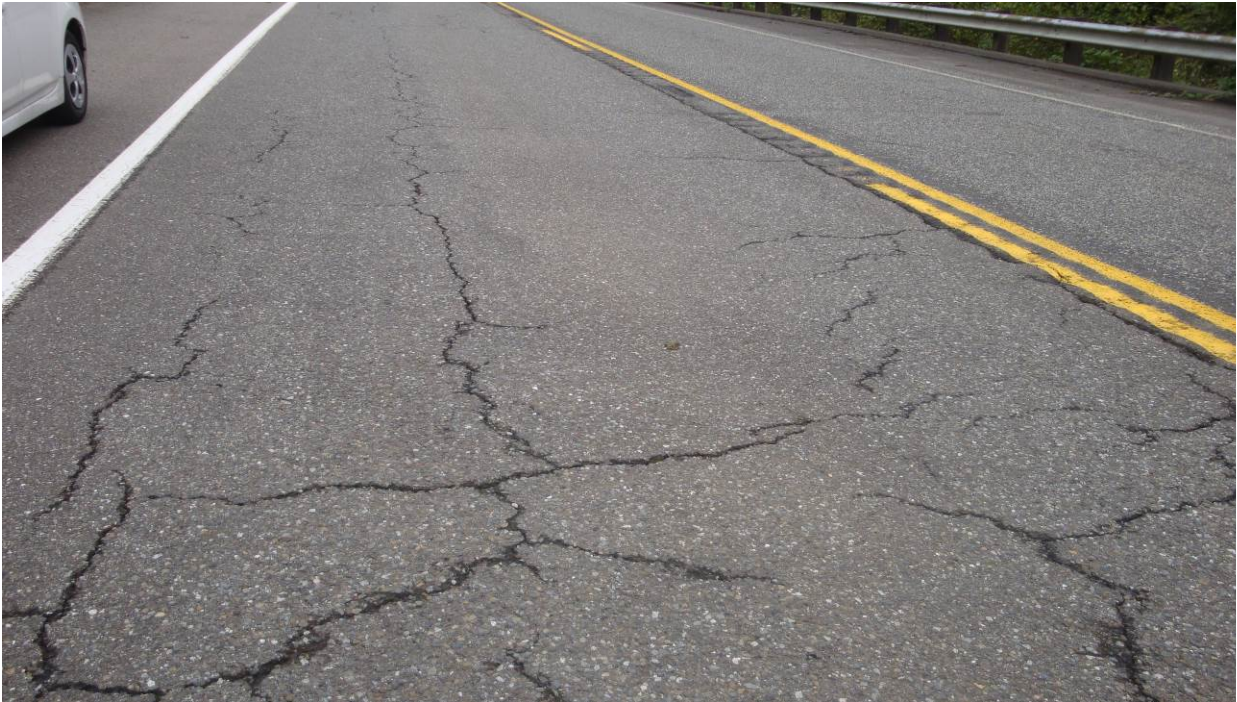
Figure 130. OR3a, SR101, one year after the other sections were treated. Cracking looks severe due to moisture in the cracks.

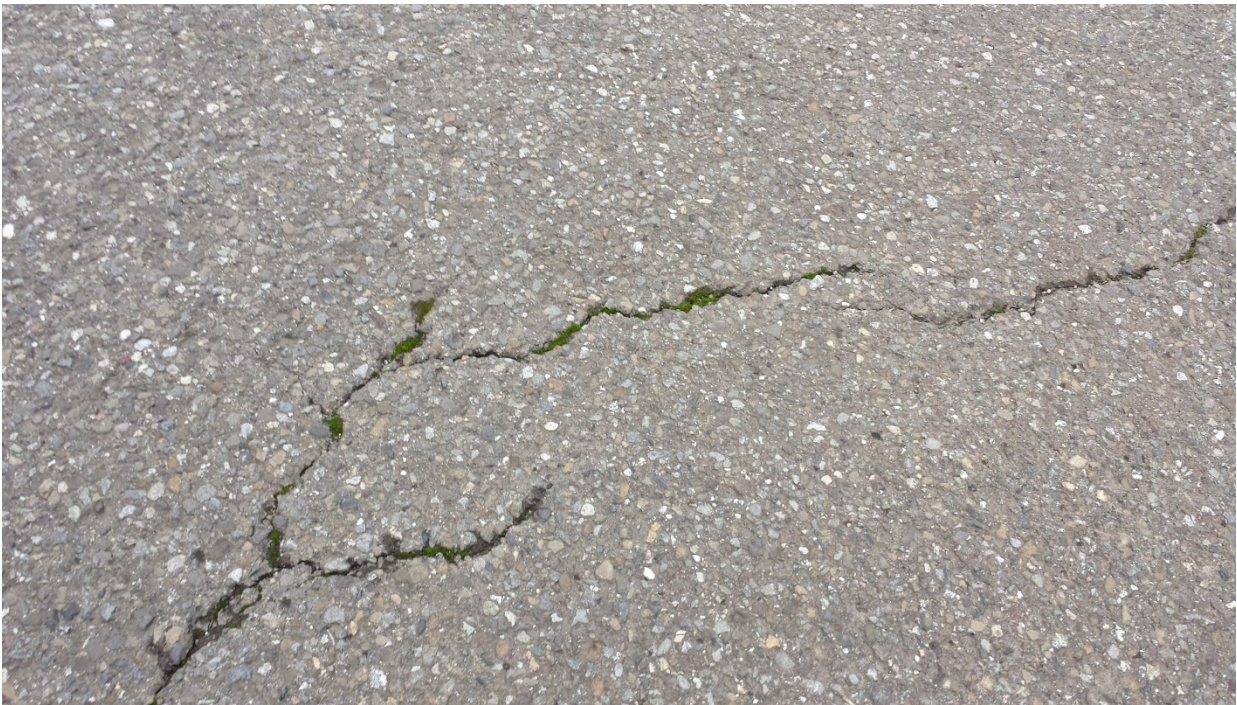
Figure 131. OR3a, SR101, two years after the other sections were treated. Vegetation growing in the wider cracks.

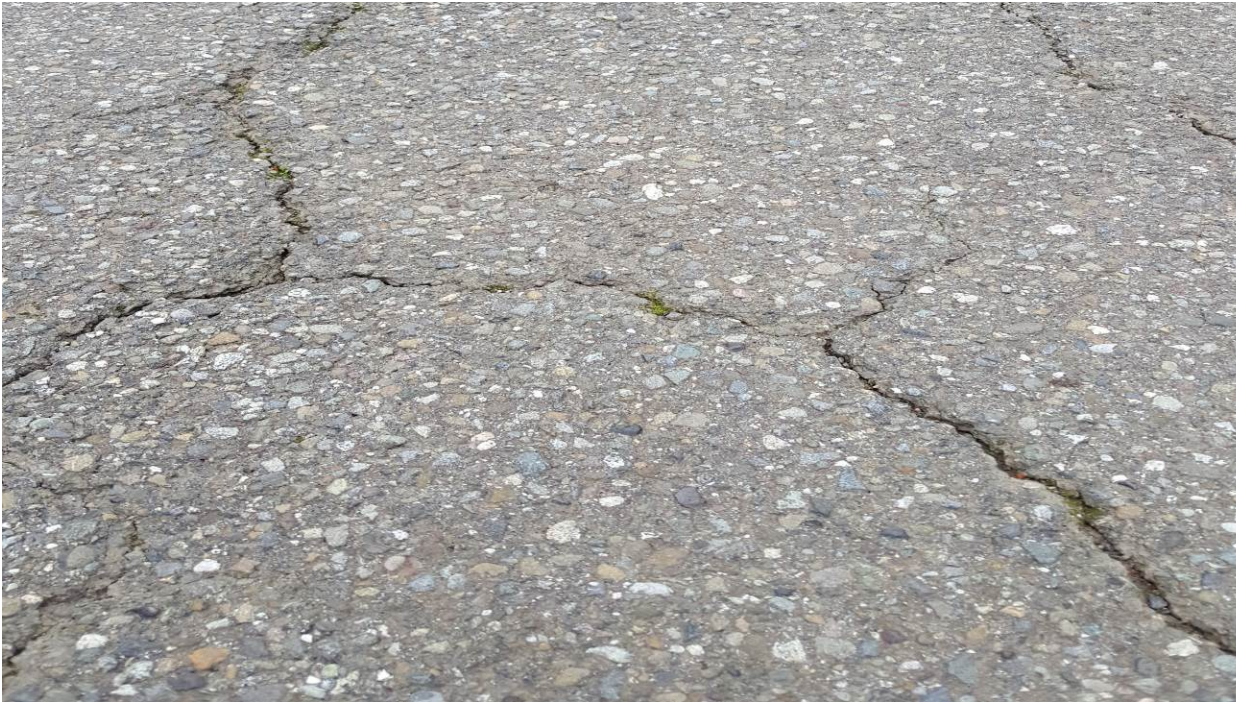
Figure 132. OR3a, SR101, three years after the other section were treated. Cracks are wide but not spalling.

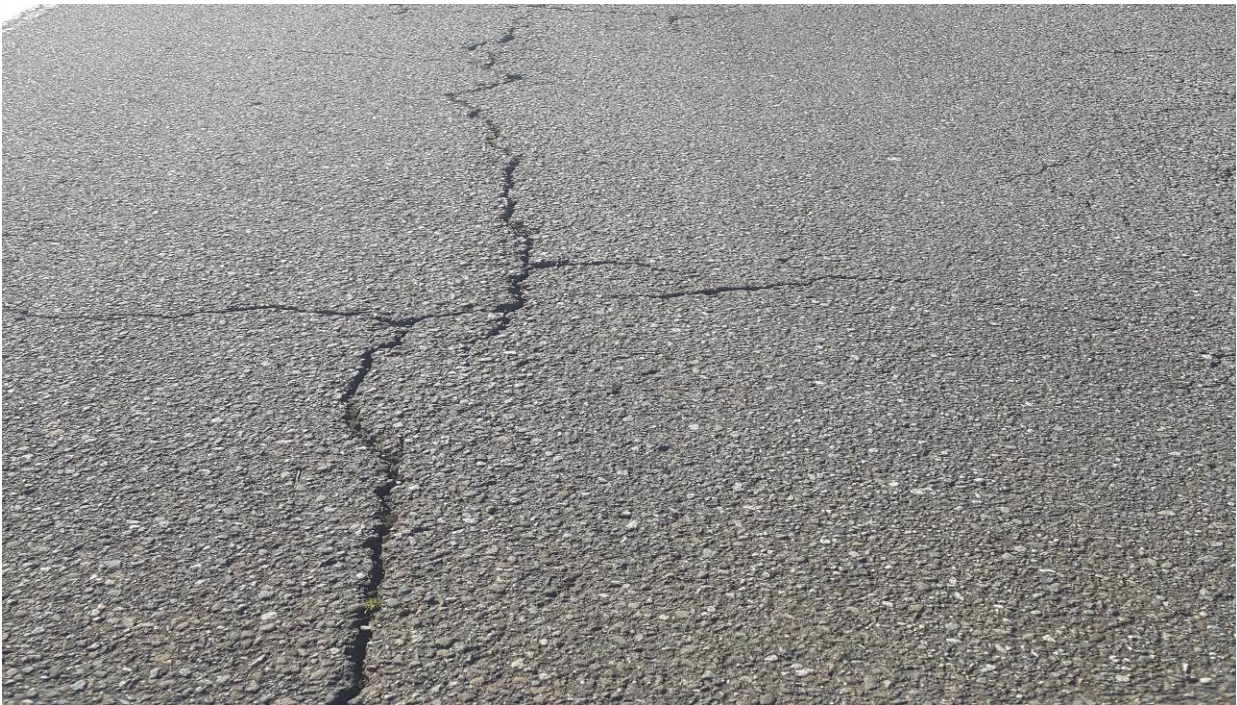
Figure 133. OR3a, SR101, four years after the other sections were treated. Cracks are wide and beginning to spall.
