Preventive Maintenance Study - Final Report

WA-RD 871.2

Preventive Maintenance Study

Washington State – Statewide Locations

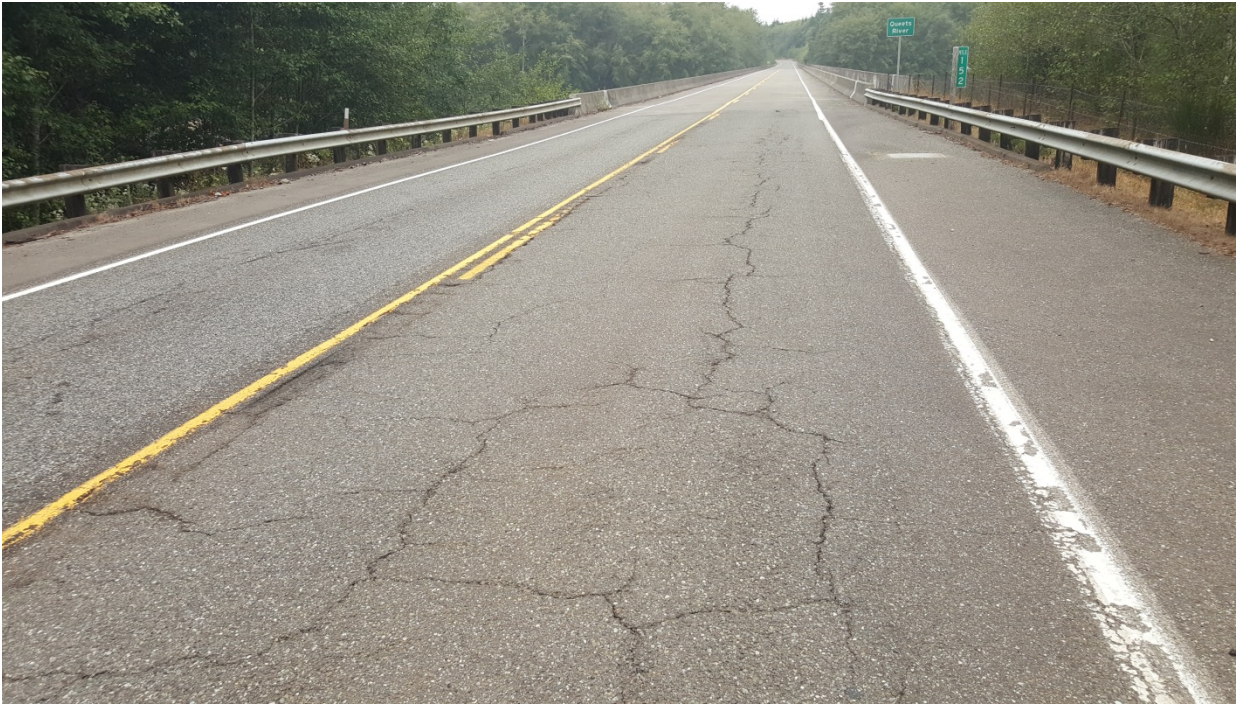
Figure 134. OR3a, SR101, five years after the other sections were treated. Cracks are wide and beginning to spall.

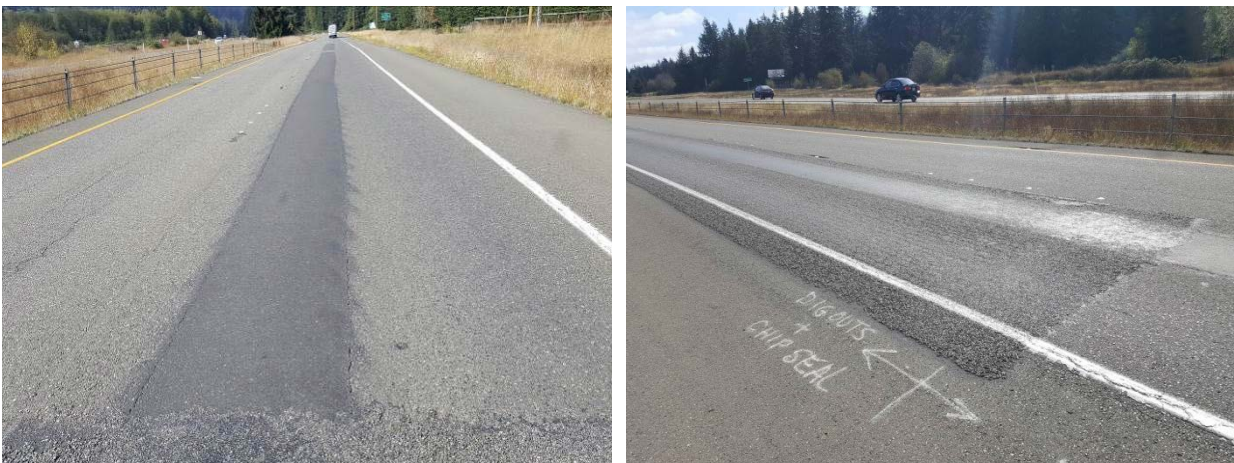
Figure 136. OR2 and OR2a on SR8. OR2 received dig outs and OR2a received dig outs and a chip seal. Photos are from 2016, both sections were milled and filled with HMA in 2017

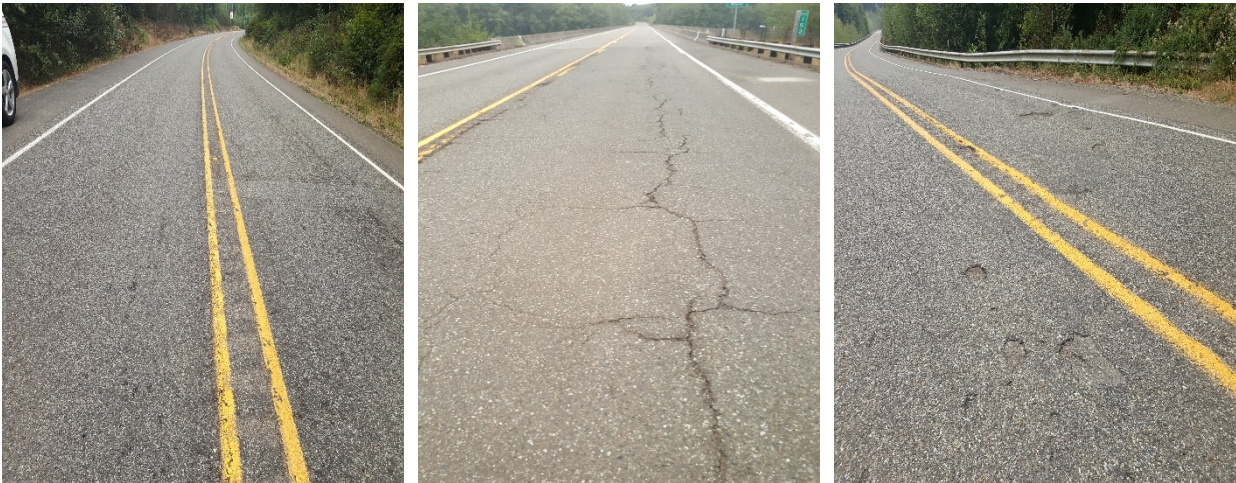
Figure 137. OR3, OR3a and OR3b on SR101. OR3 received dig outs and a chip seal, OR3a no treatment and OR3b a chip seal with no dig outs. Photos from 2017.

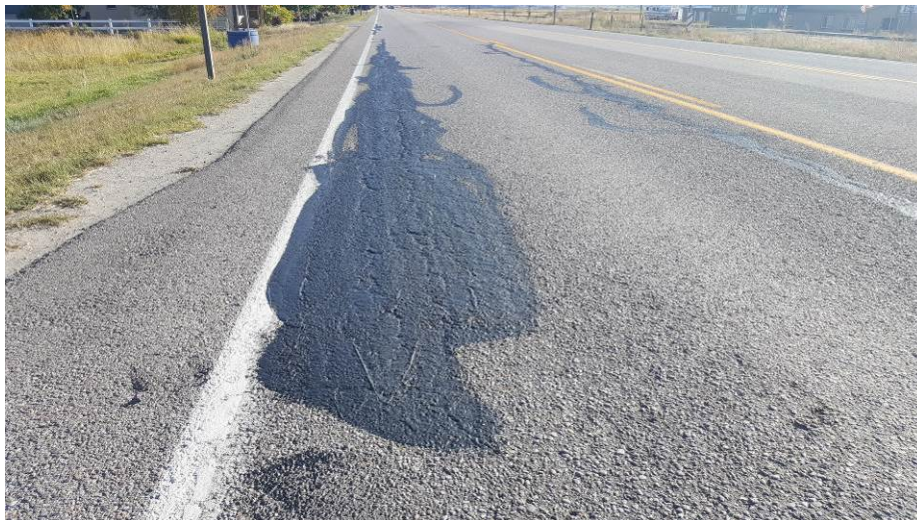
Crack sealing could be the best choice for a pavement with longitudinal and transverse cracking or block cracking that exceeds 1/4 inch in width. It would not be the best choice for alligator cracking because it is impossible to fill all of the cracks and a massive use of sealant could result in a slippery pavement (Figure 139). Crack sealing was used effectively on some sites with alligator cracking because filling the larger cracks prevented spalling of the pavement and the formation of potholes.

Figure 139. Excessive crack sealant used on alligator cracking on SR 20. (November 2016)
