Unmanned Aerial Vehicle Augmented Bridge Inspection Feasibility Study

FINAL REPORT
2017

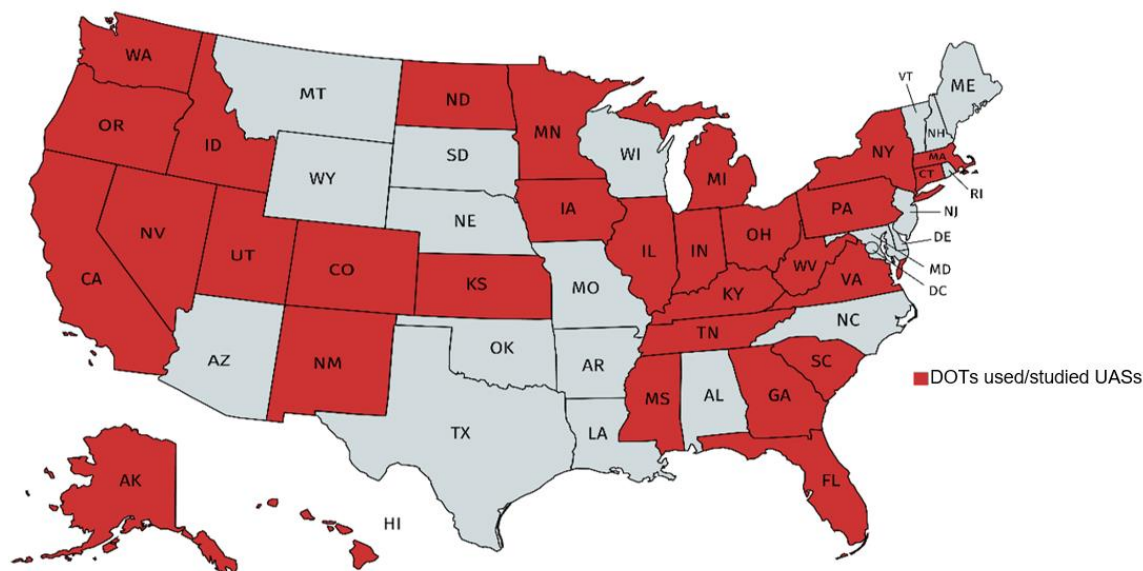
Figure 2.1 Map of State DOTs that have documented Past or Current Study of UASs

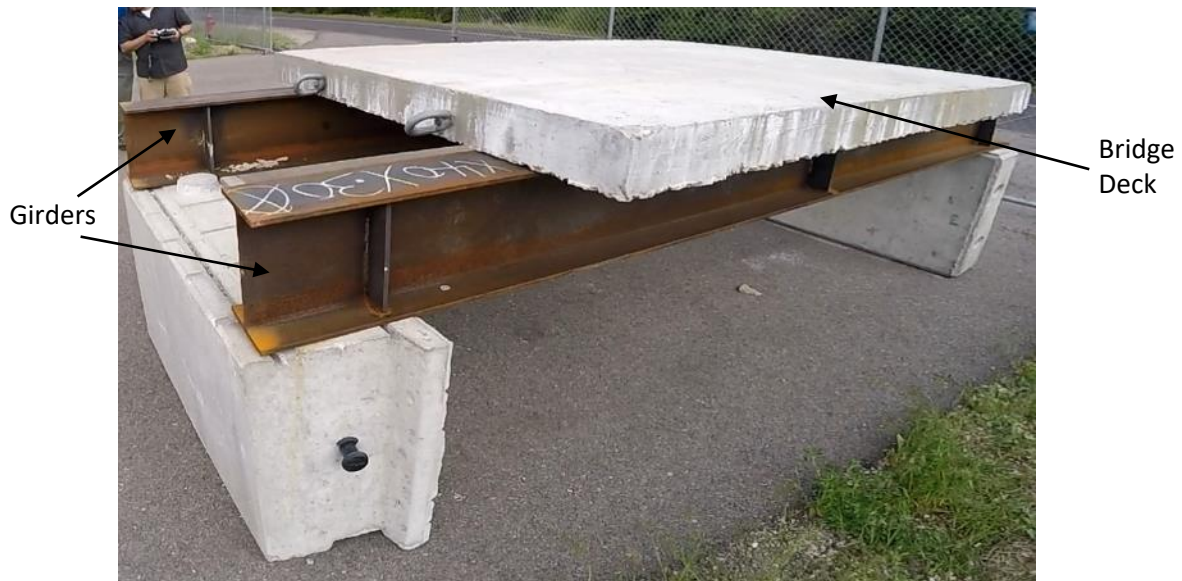
Figure 3.1 Small Bridge at the SMASH Lab

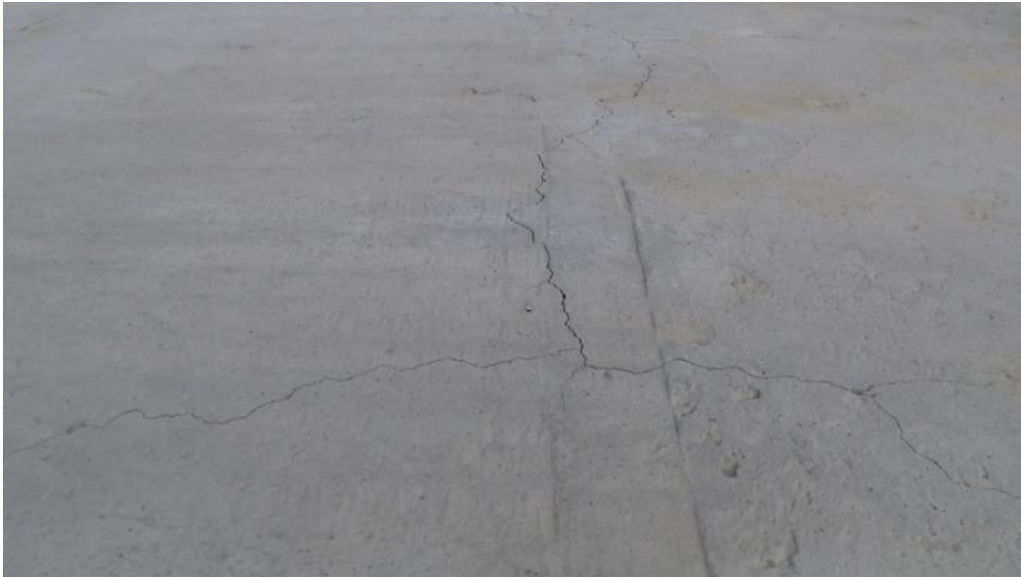
Figure 3.2 Example of Top Cracks in the Color Image Acquired by the UAS, E001

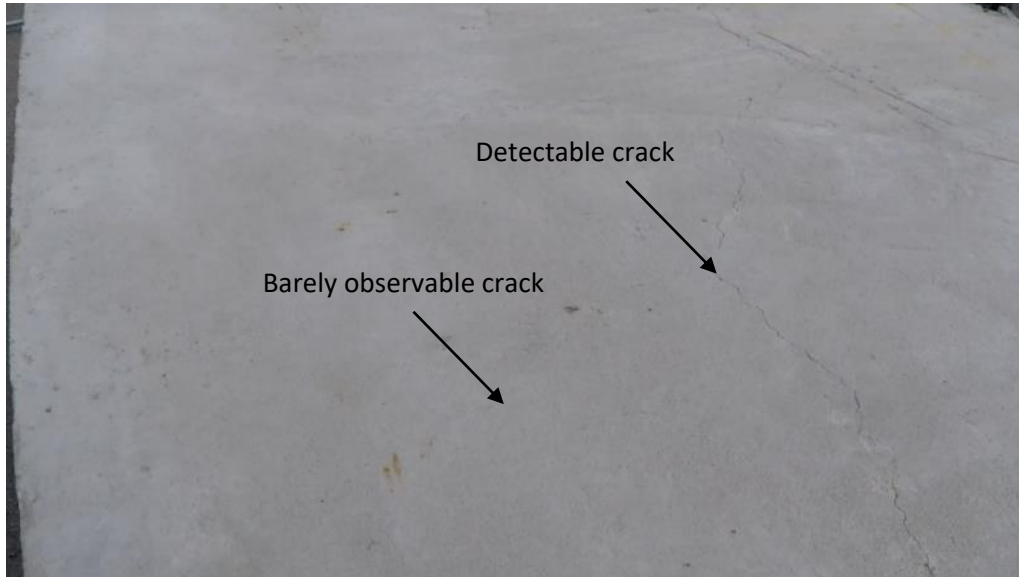
Figure 3.3 Variety of cracks' Dimensions on the Bridge Deck, E001

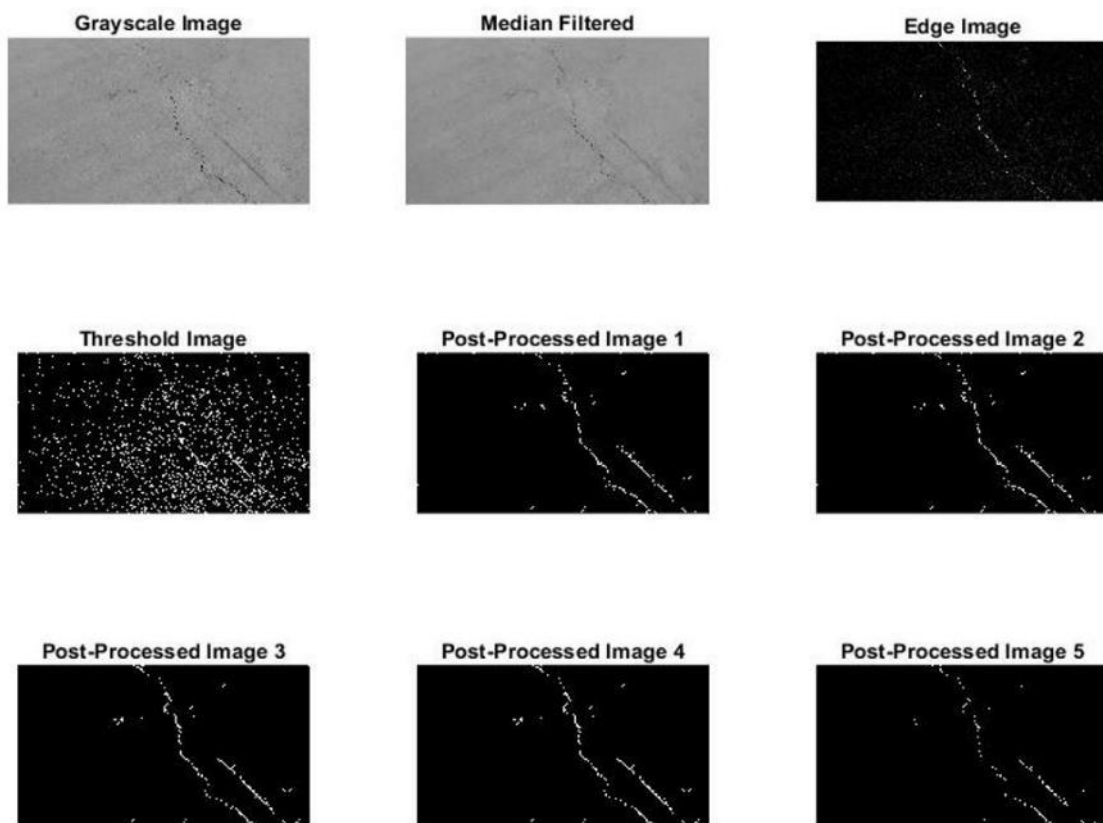
Figure 3.4 Automatic Crack Detection Based on UAS Images, E002

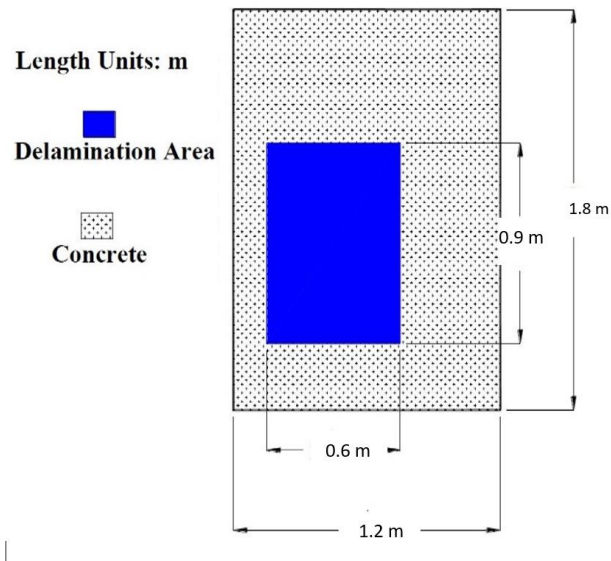
Figure 3.5 The Plan and Elevation View of the Deck and its Delamination, (E003)

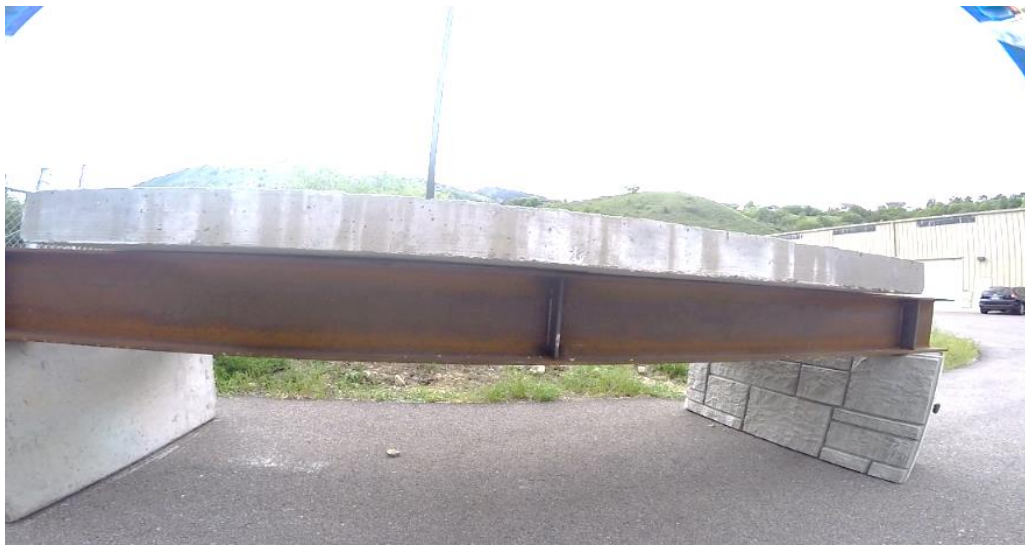
Figure 3.7 Steel Girder Surface Corrosion and Rust in the Image Acquired by UAS, E004

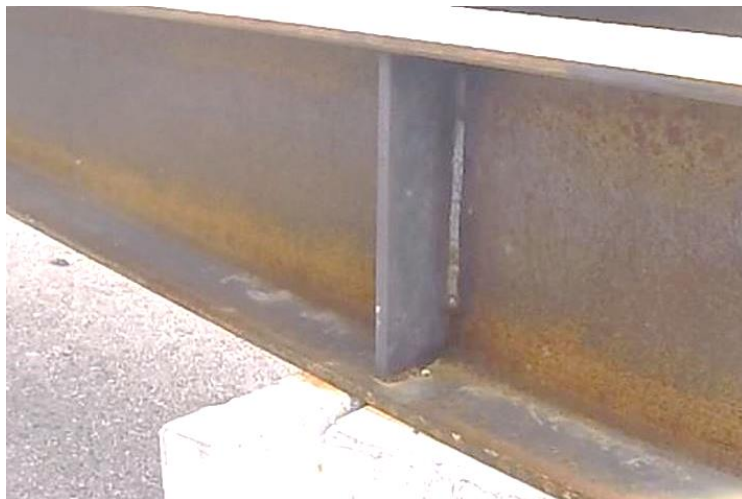
Figure 3.8 Visual Weld Inspection on the Small Bridge, E004

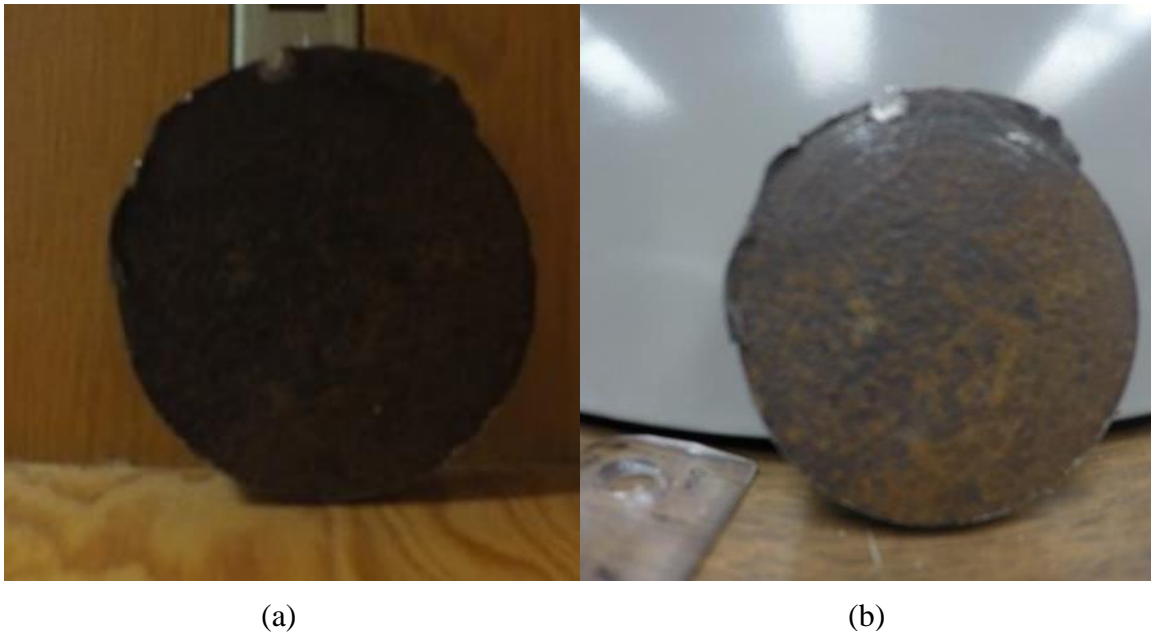
Figure 4.1 (a) Dark Condition, 10 cm (4 inches), GoPro (b) Normal Condition, 5 cm (2 inches), GoPro, E006

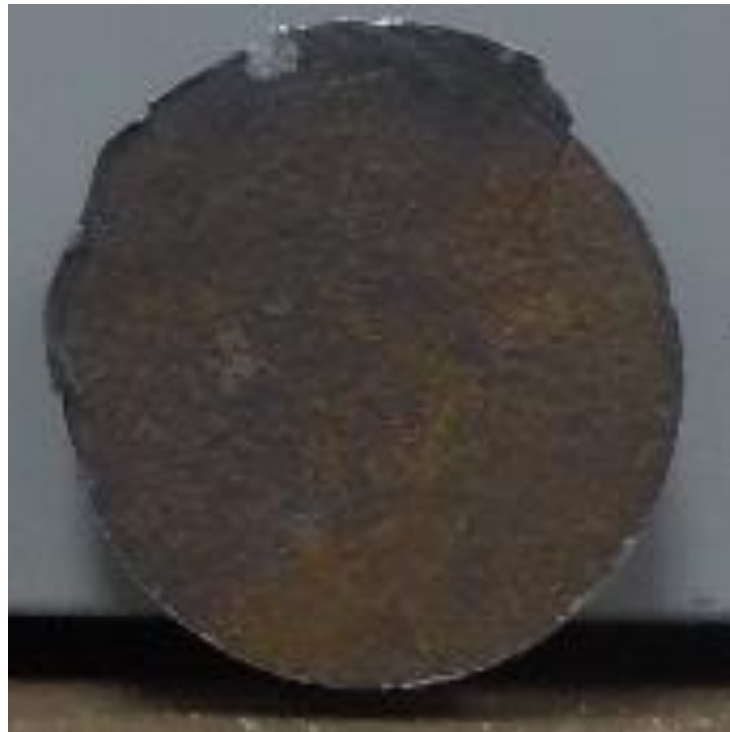
Figure 4.2 Normal Condition, 20 cm (8 inches), GoPro, Fatigue Crack Visible

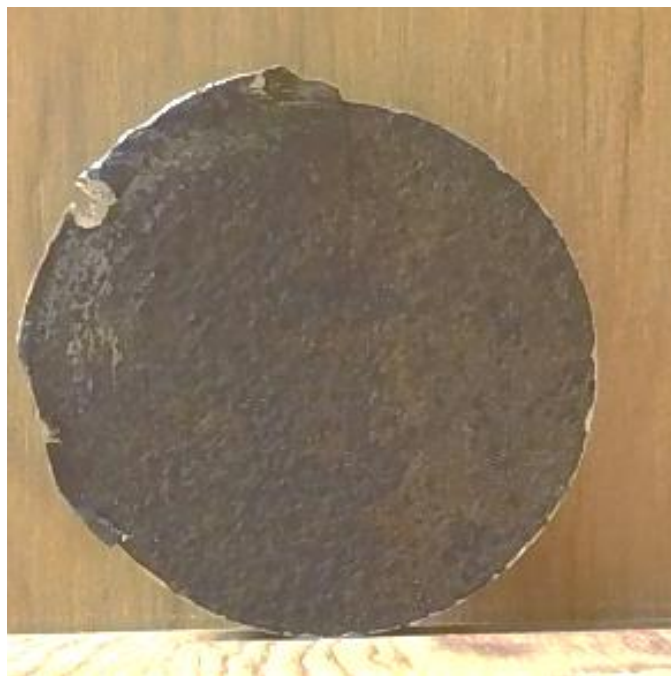
Figure 4.3 Dark Condition, 15 cm (6 inches), DJI Mavic, E007

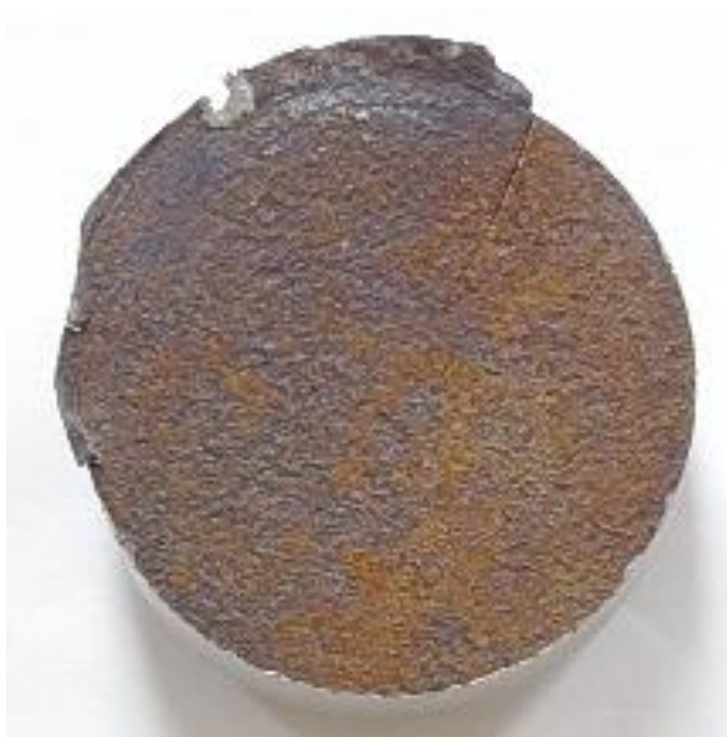
Figure 4.4 Bright Condition, 25 cm (10 inches), DJI Mavic, E007

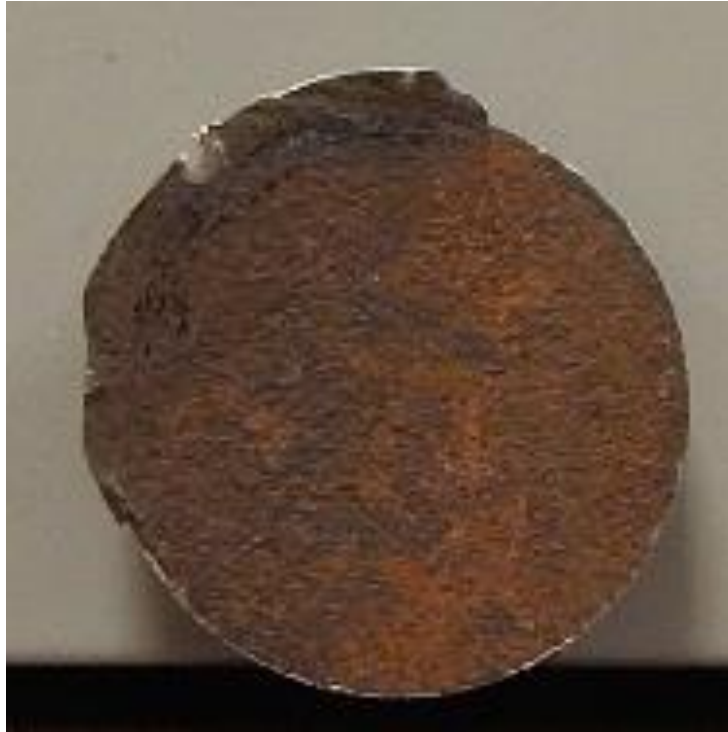
Figure 4.5 Normal Condition, 30 cm (12 inches), Nikon, E008

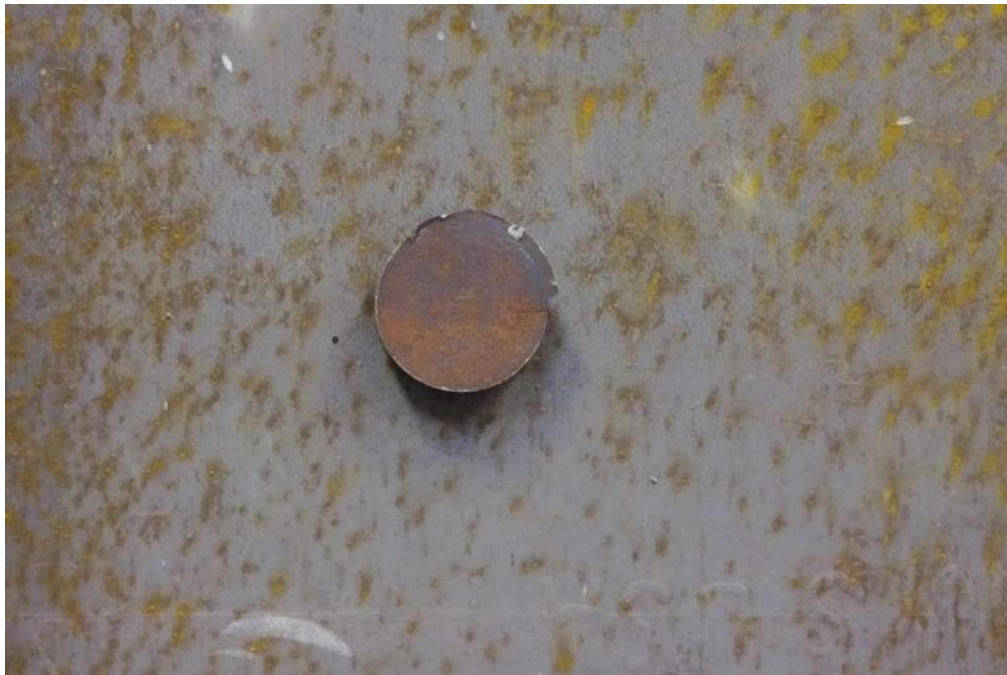
Figure 4.7 Photo of the Test-Piece Taken by DJI Mavic in the SMASH Lab, Normal Condition, E010

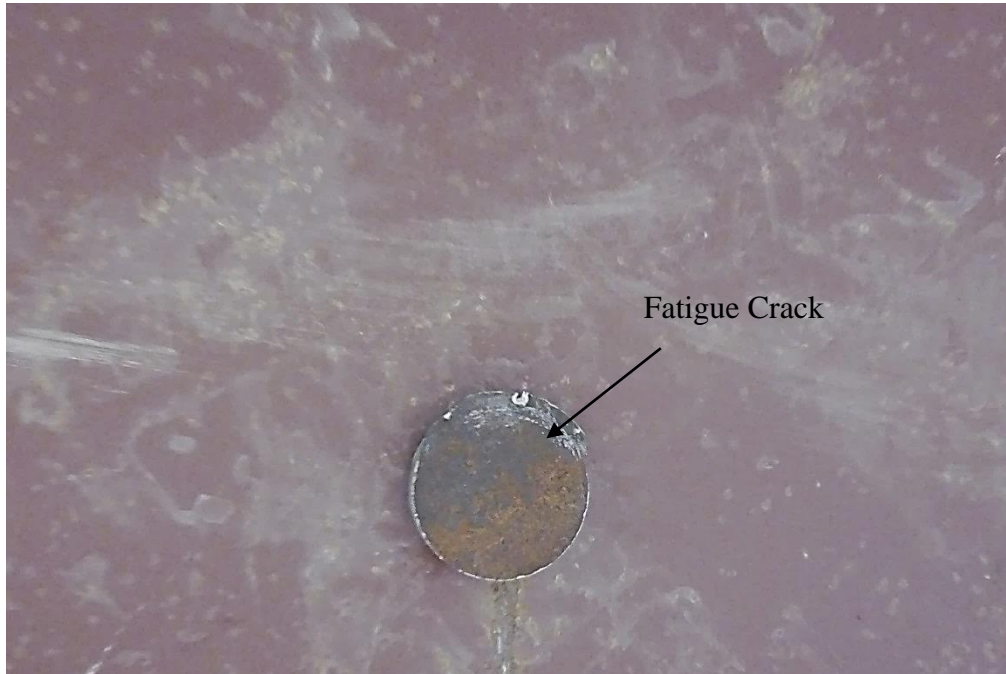
Figure 4.8 Photo of the Test-Piece Taken by DJI Mavic in the SMASH Lab, Dark Condition, E010

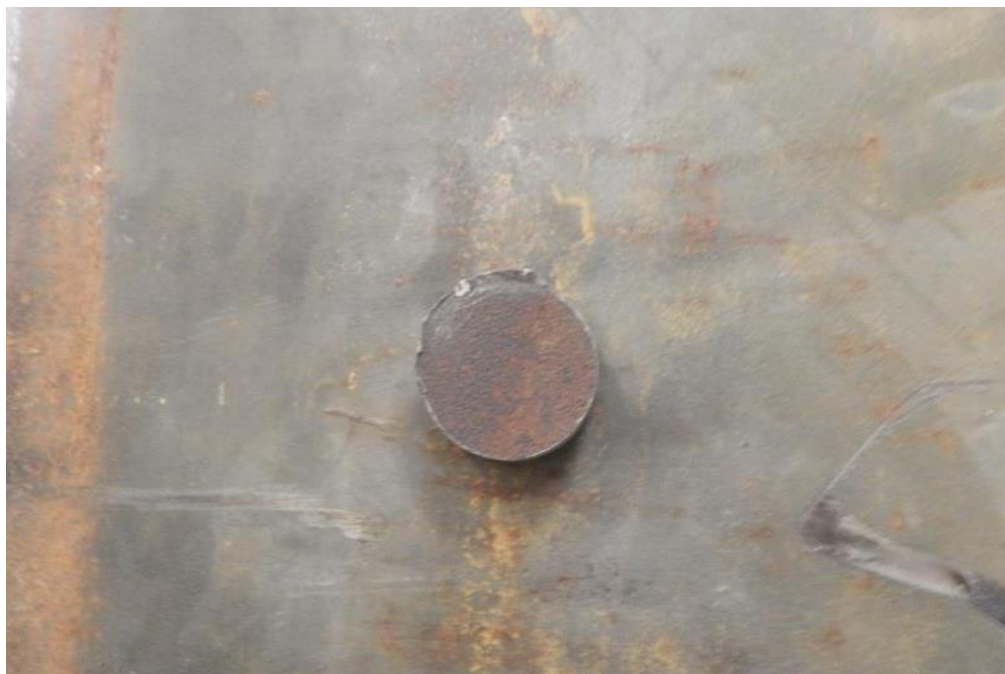
Figure 4.9 Photo of the Test-Piece Taken by the Goose in the SMASH lab, Normal Condition, E011

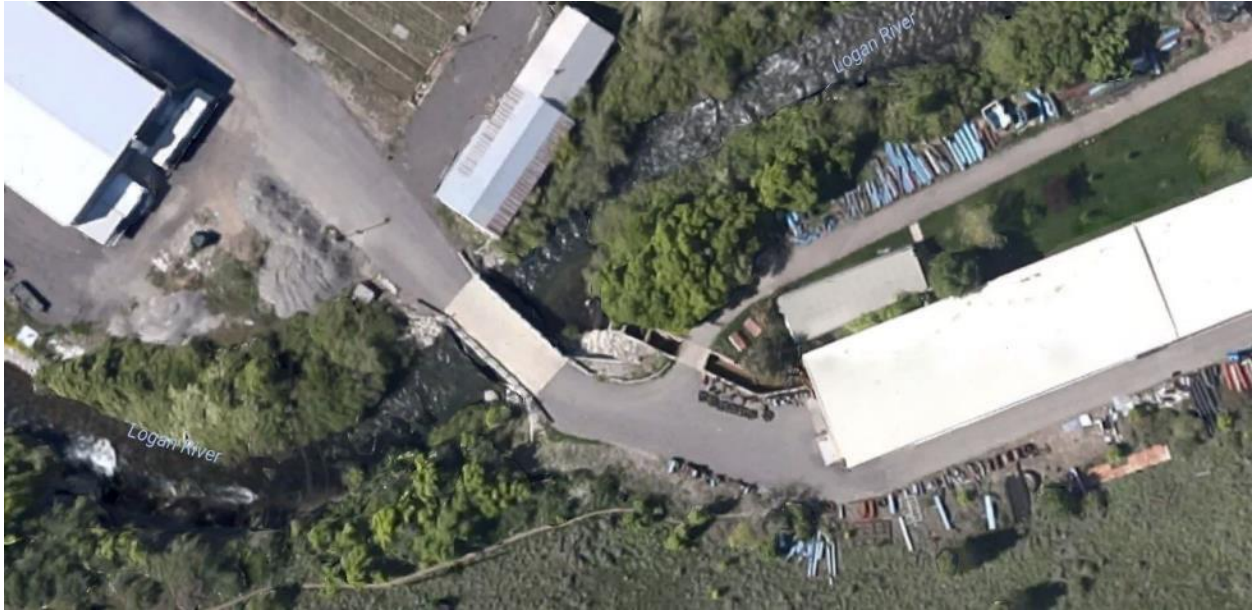
Figure 4.10 The UWRL Bridge

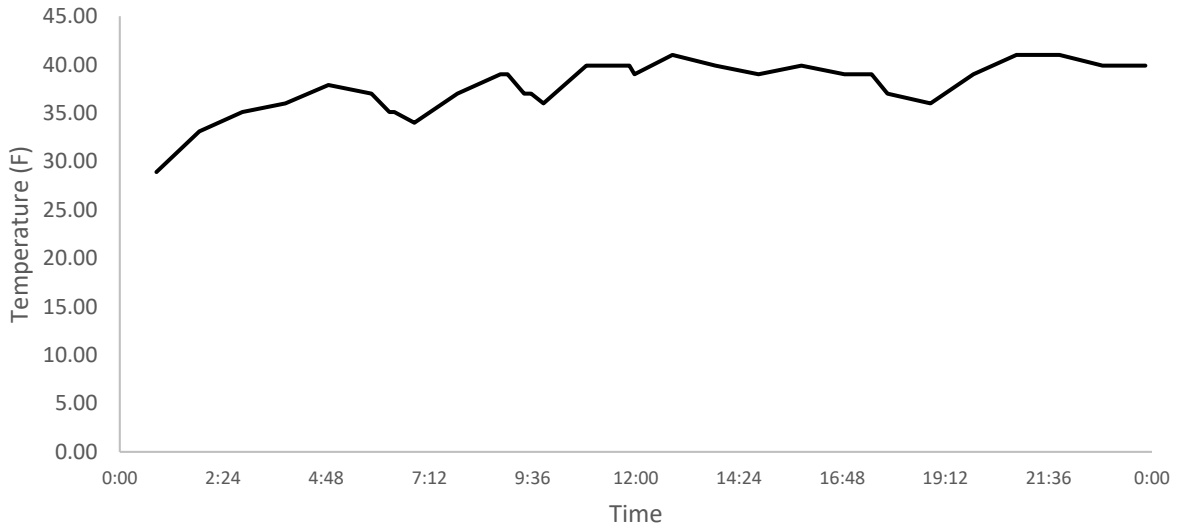
Figure 4.11 Daily Temperature from January 10, 2017 at the UWRL Bridge from KUTLOGAN25 Station (Weather History for Logan 2017)

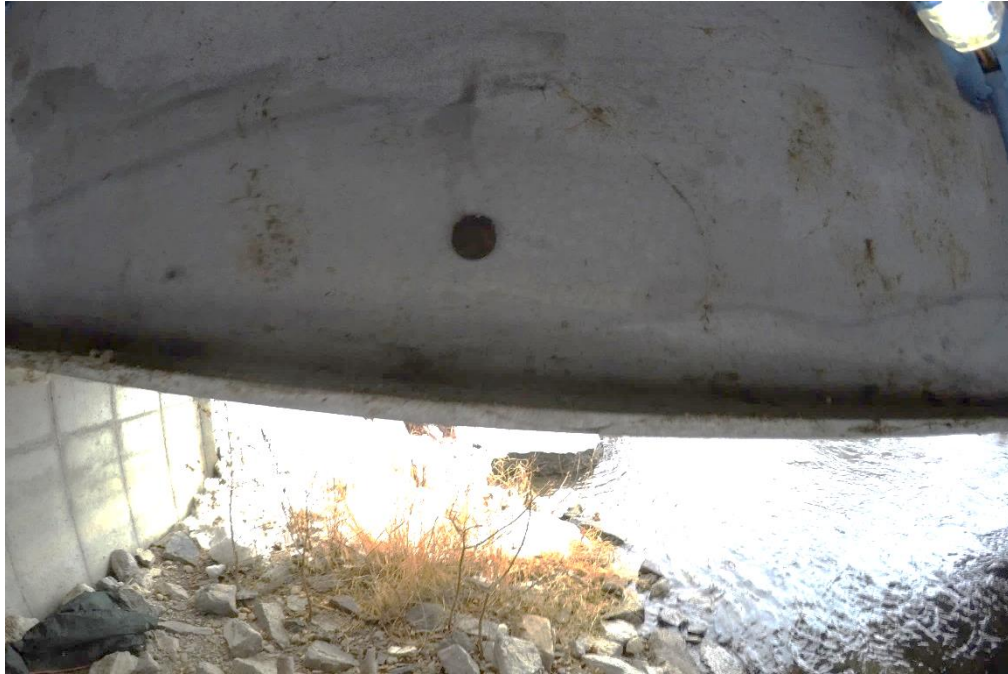
Figure 4.14 Photo of the Test-Piece Taken by 3DR Iris, UWRL Bridge, Normal Condition, E012

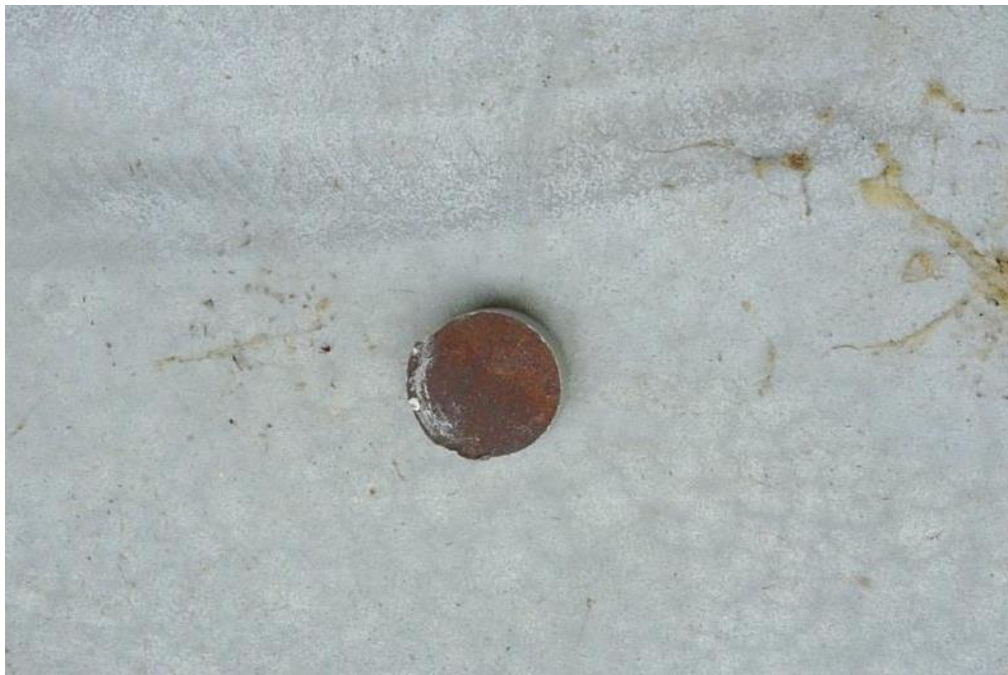
Figure 4.15 Photo of the Test-Piece Taken by DJI Mavic, UWRL Bridge, Normal Condition, Normal Camera Angle, E012

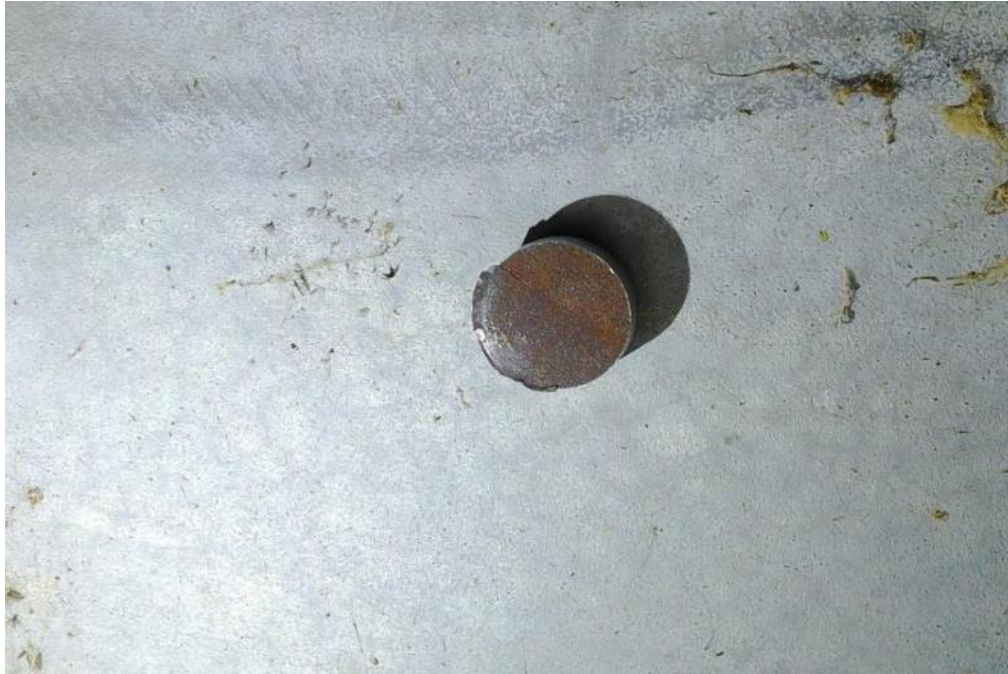
Figure 4.16 Photo of the Test-Piece Taken by DJI Mavic, UWRL Bridge, Bright Condition, Normal Camera Angle, E012

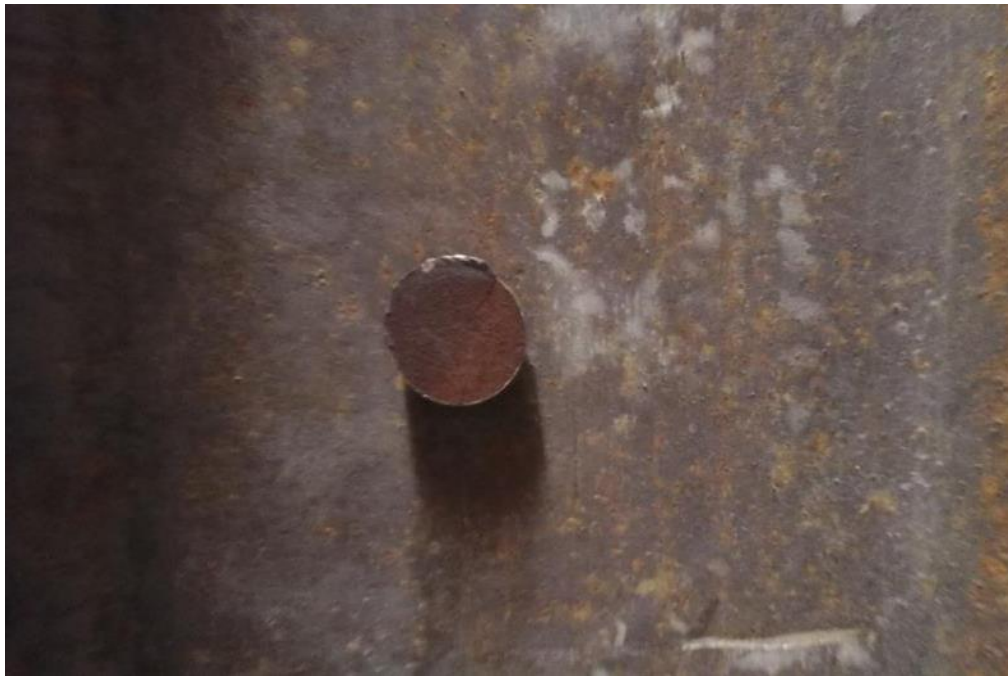
Figure 4.17 Photo of the Test-Piece Taken by DJI Mavic, UWRL Bridge, Dark Condition, Normal Camera Angle, E012

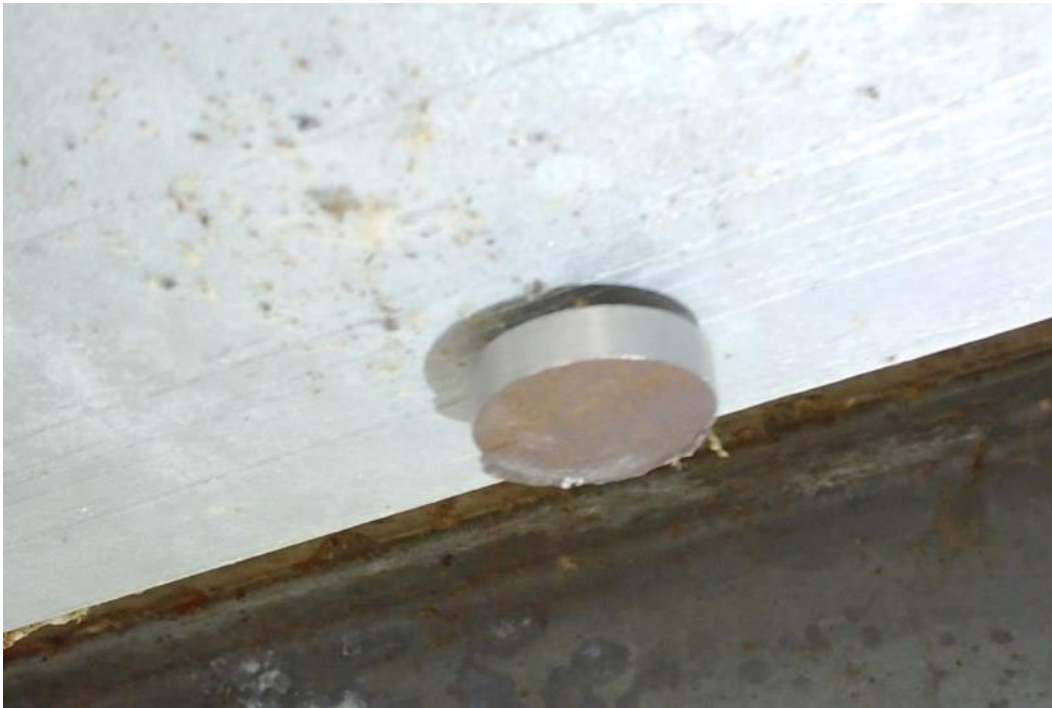
Figure 4.18 Photo of the Test-Piece Taken by DJI Mavic, UWRL Bridge, Bright Condition, Oblique Camera Angle, E012

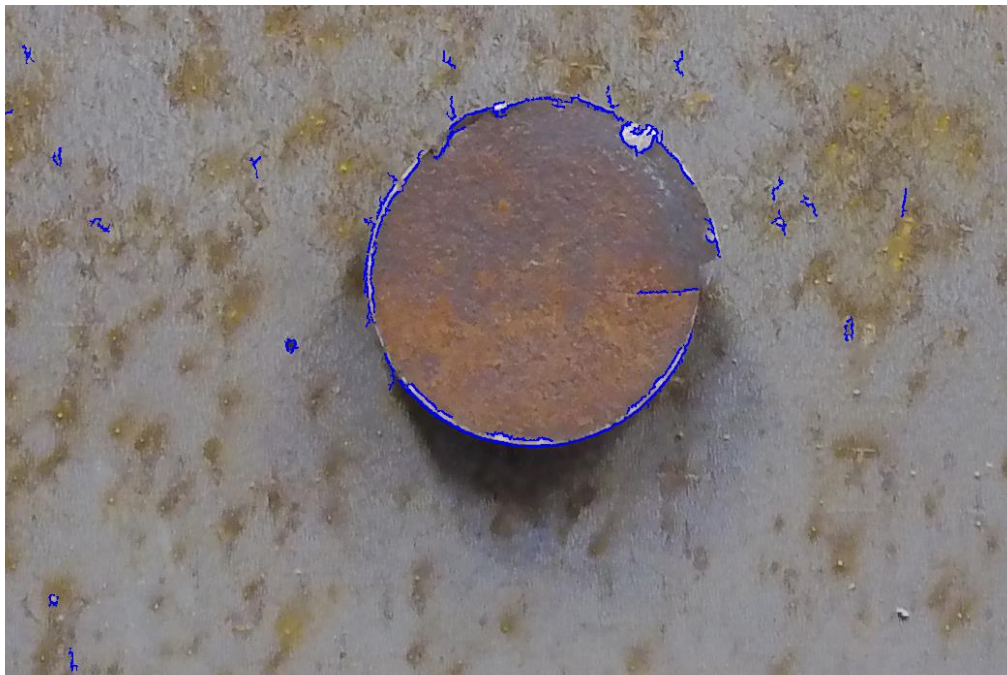
Figure 4.19 The Detected Crack Using Image Processing Techniques on the SMASH Lab Images (Laplacian of Gaussian), E014

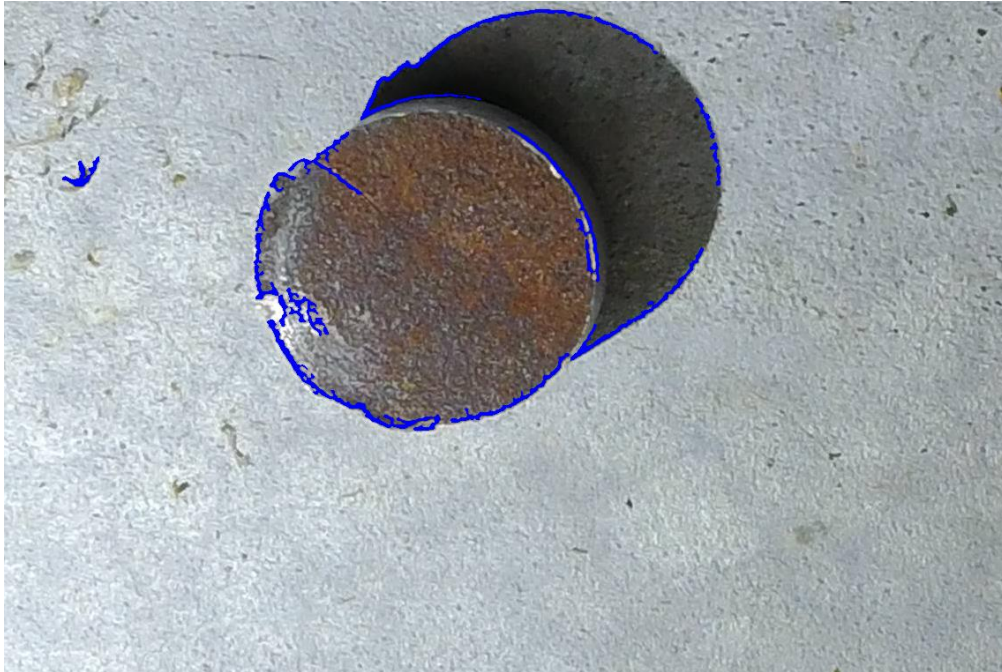
Figure 4.20 The Detected Crack Using Image Processing Techniques on the UWRL Image (Laplacian of Gaussian), E014

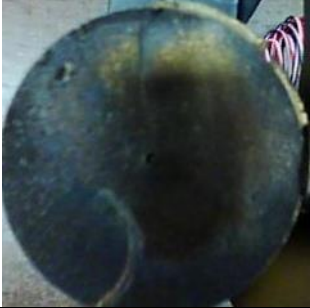
Specimen	Side A	Side B
S02

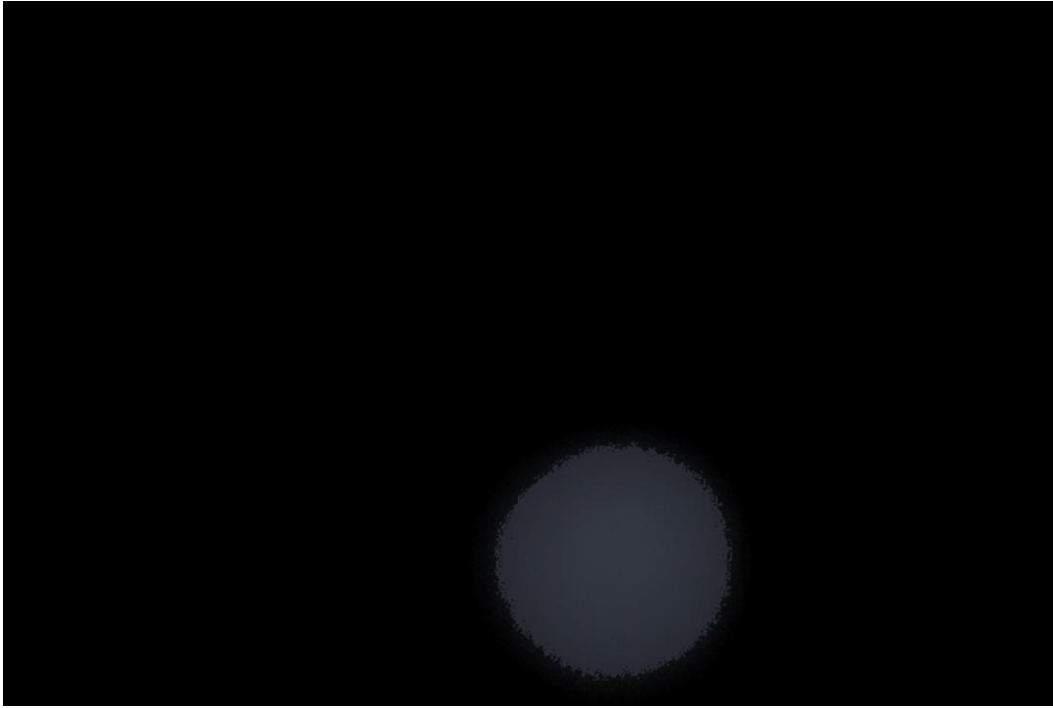
Figure 4.22 Thermal Image from the Second Test-Piece, Passive, E016

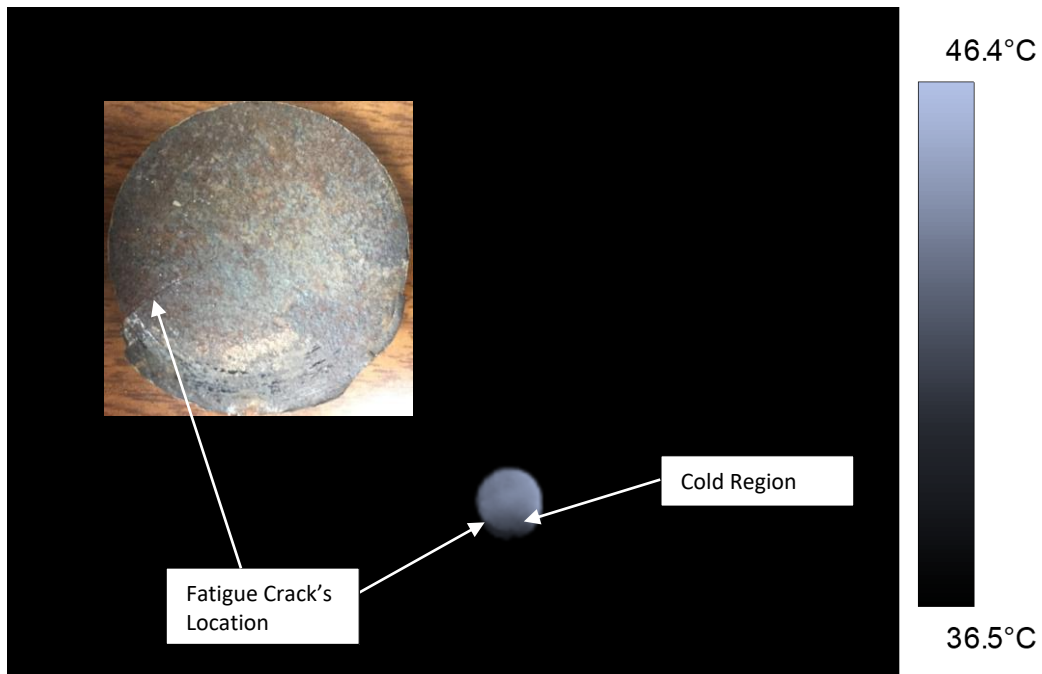
Figure 4.23 Thermal Image of the Side A of Test-Piece 1, 75 cm (30 in) Camera Distance, E017

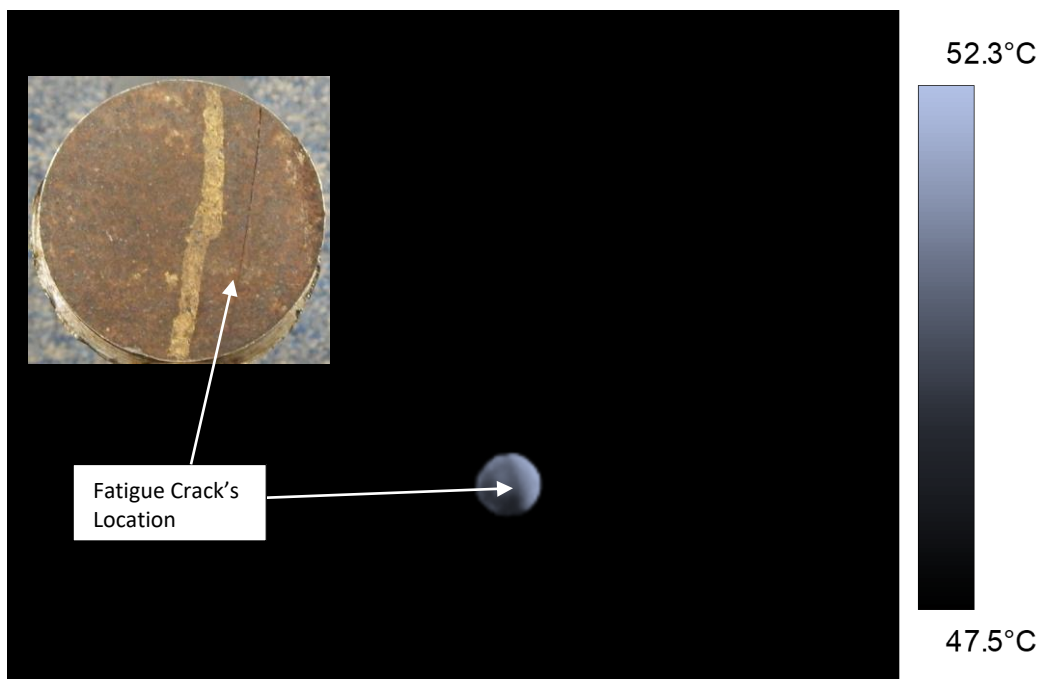
Figure 4.24 Thermal Image of the Side A of Test-Piece 2, 75 cm (30 in) Camera Distance, E018

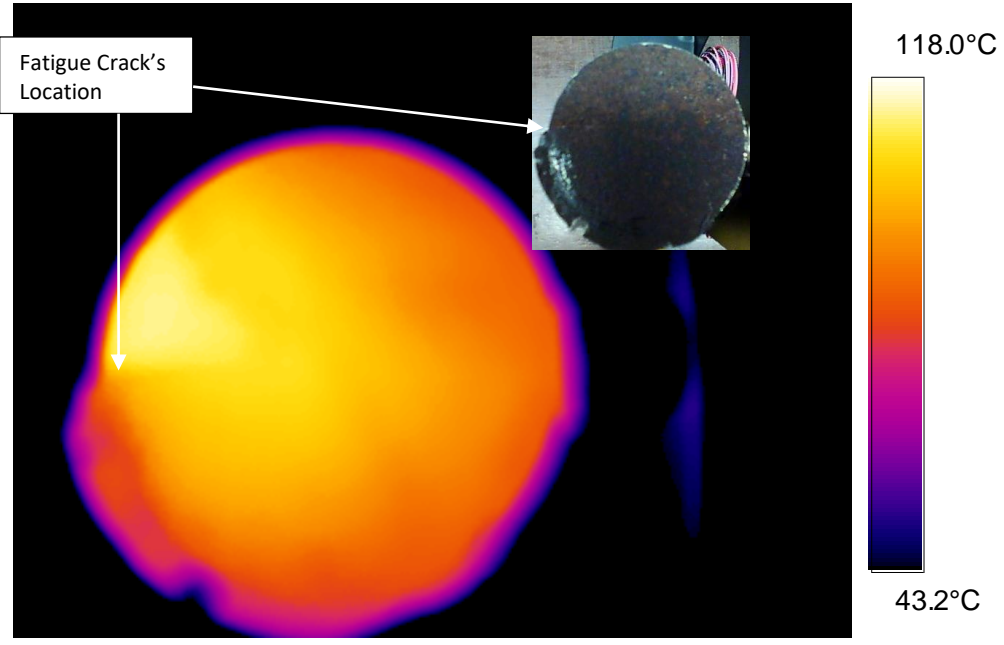
Figure 4.25 Thermal Image of the Side A of Test-Piece 1, 5 cm (2 in) Camera Distance, E019

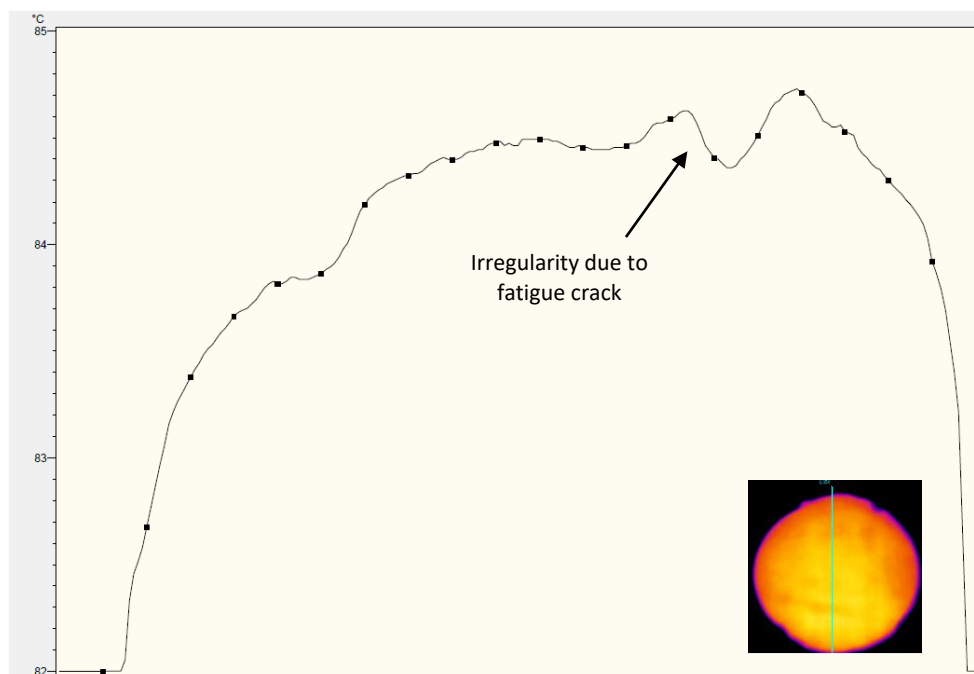
Figure 4.32 Temperature Along the Profile Line for the Side B of Test-Piece 2, 5 cm (2 in) Camera Distance, E020

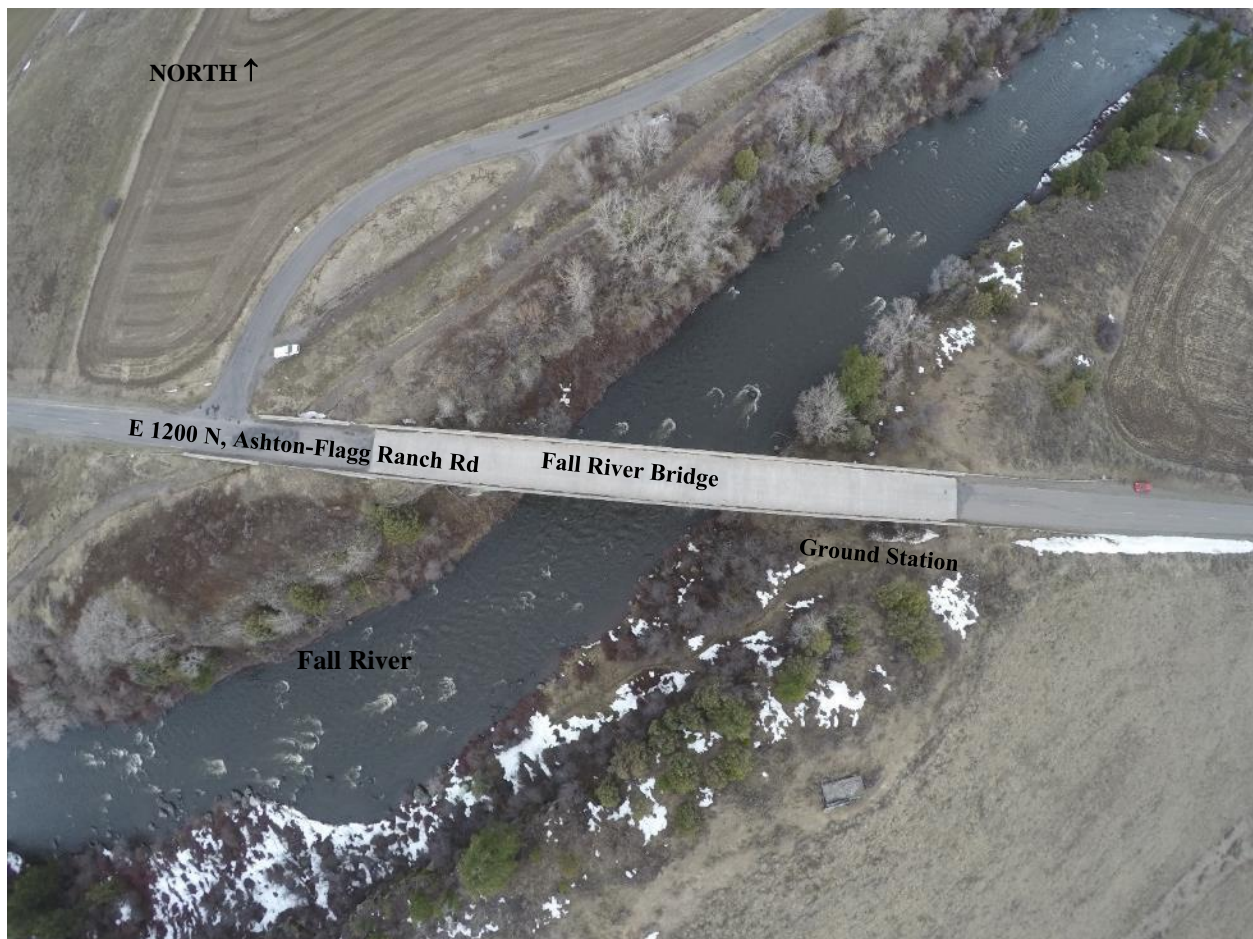
Figure 5.1 Aerial Image Captured by 3DR Solo (Courtesy of Dan Robinson)

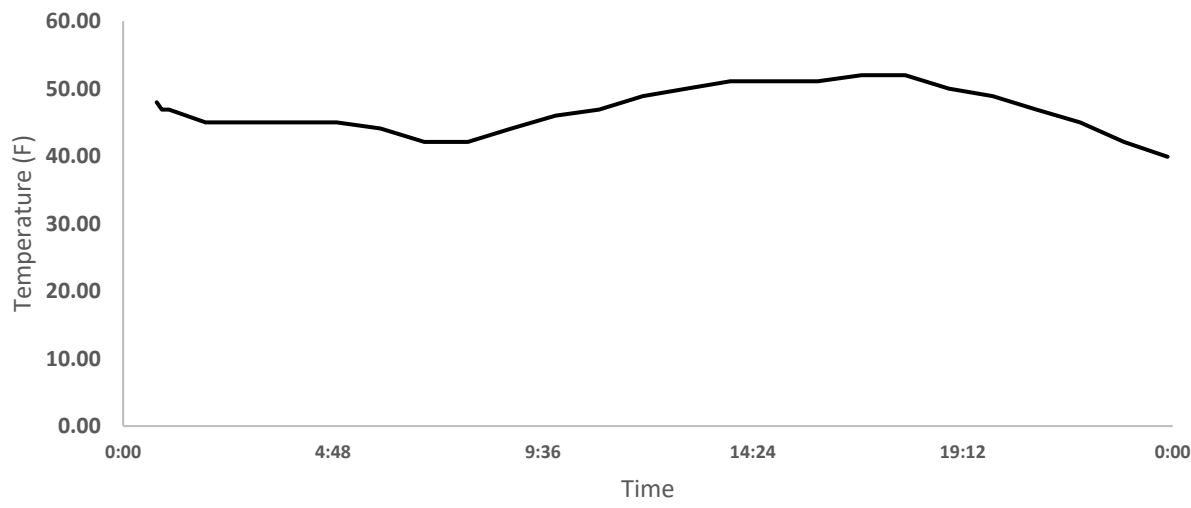
Figure 5.2 Daily Temperature from March 22, 2017 in Ashton from KIDASHO8 Station (Weather History for Ashton 2017)

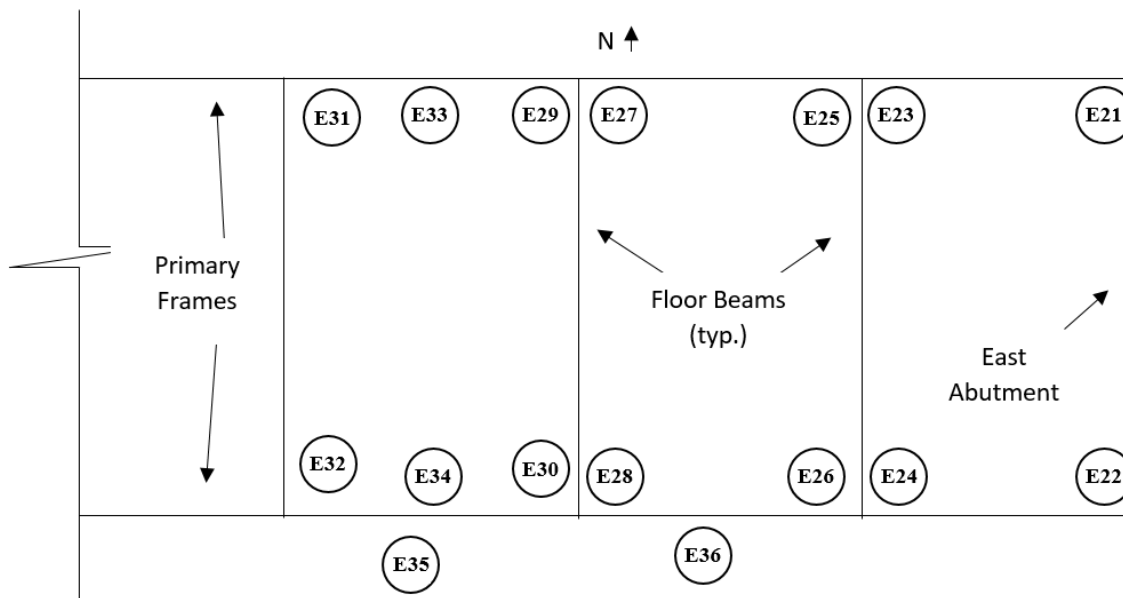
Figure 5.8 Plan View Drawing of the Bridge and Experiment Numbers of Inspection Locations.

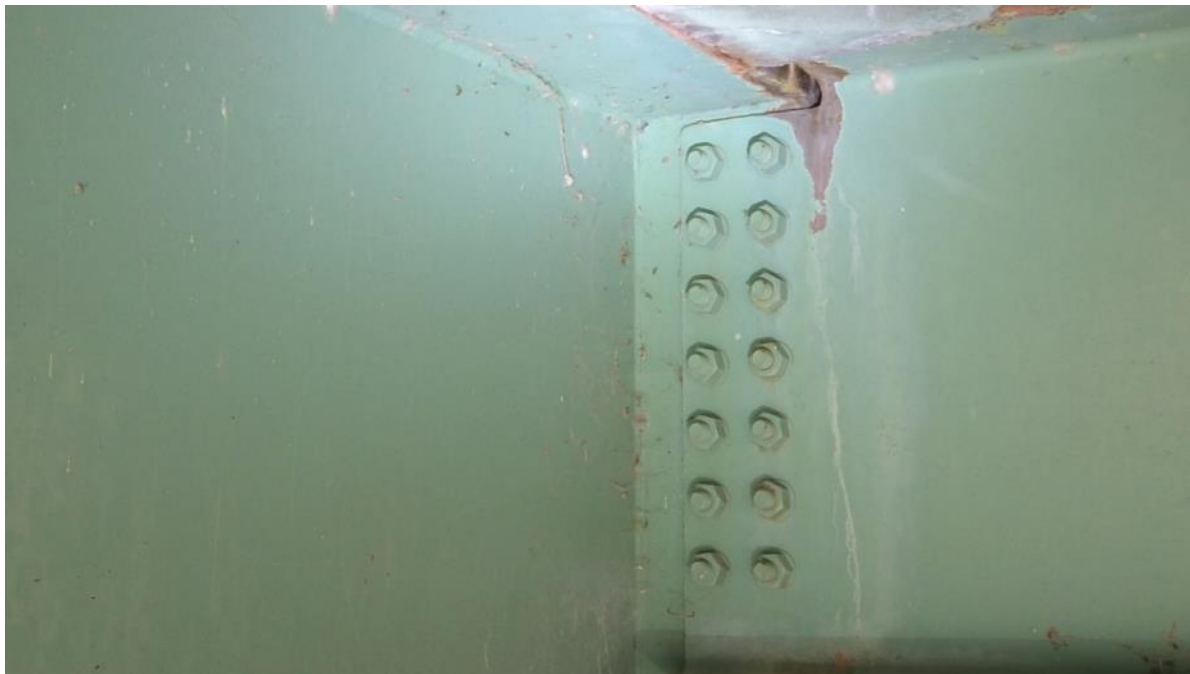
Figure 5.9 First Floor Beam on East, Northern Corner, No Noticeable Crack, E021
