Unmanned Aerial Vehicle Augmented Bridge Inspection Feasibility Study

FINAL REPORT
2017

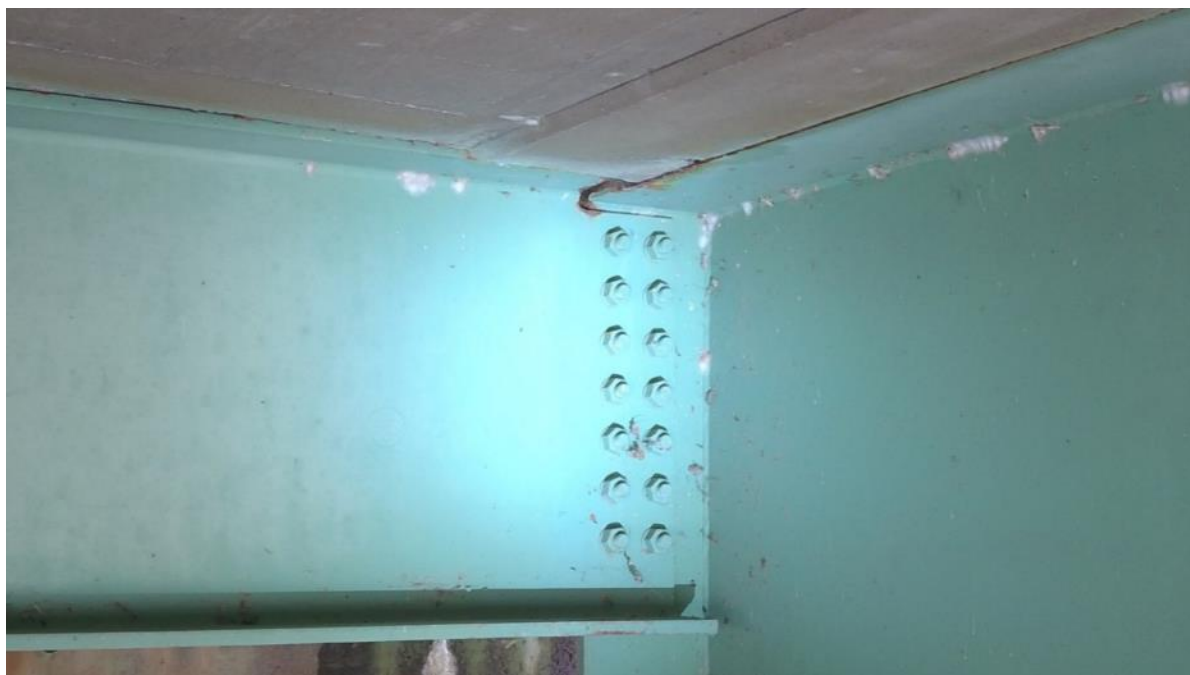
Figure 5.10 First Floor Beam on East, Southern Corner, Debris on the Weld, E022

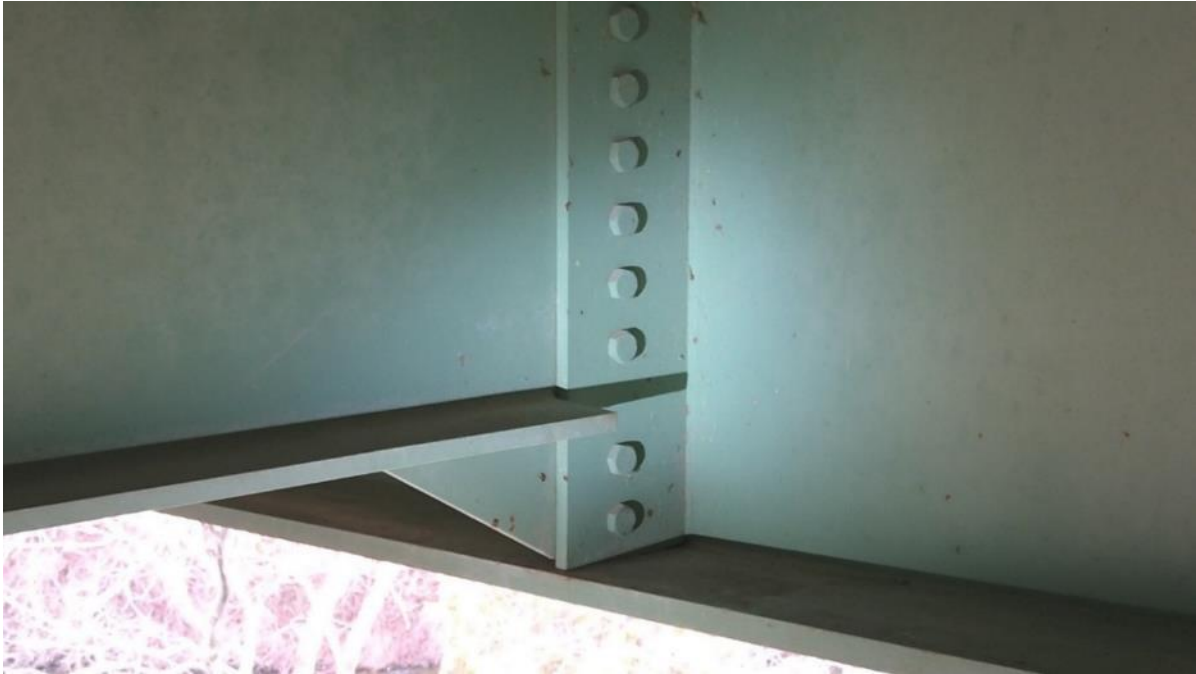
Figure 5.11 No Cracks on Second Floor Beam on East, Southern Corner, E023

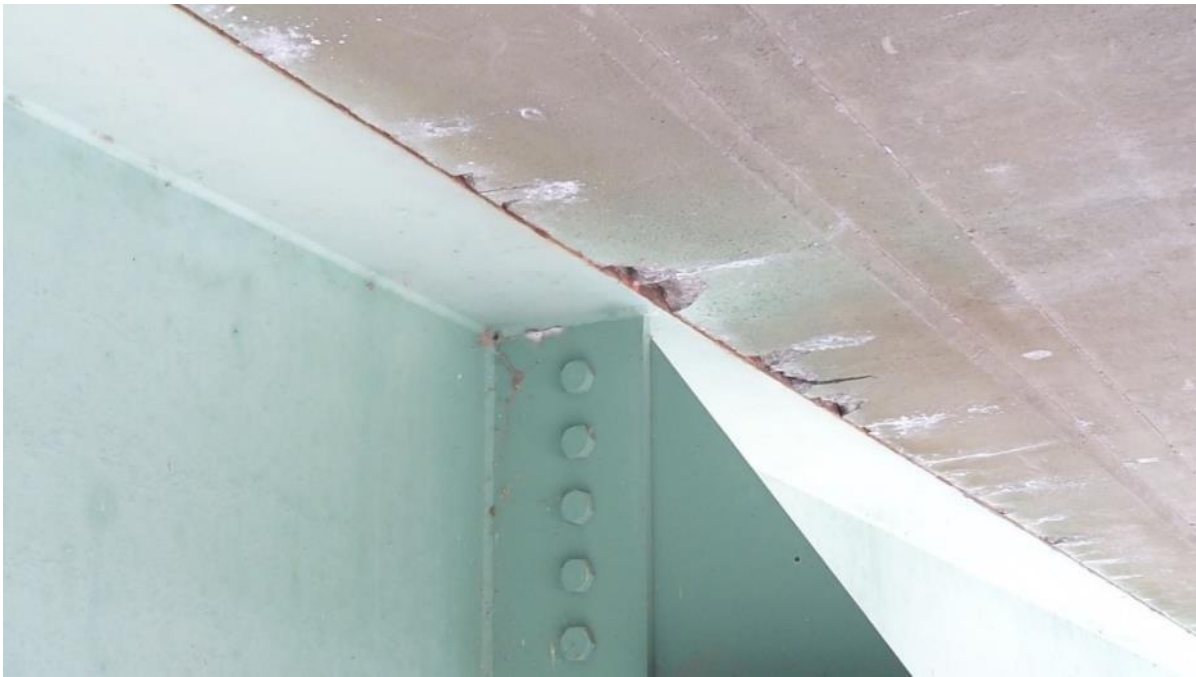
Figure 5.12 No Cracks on Second Floor Beam on East, Southern Corner, Minor Deck Spalling, E024

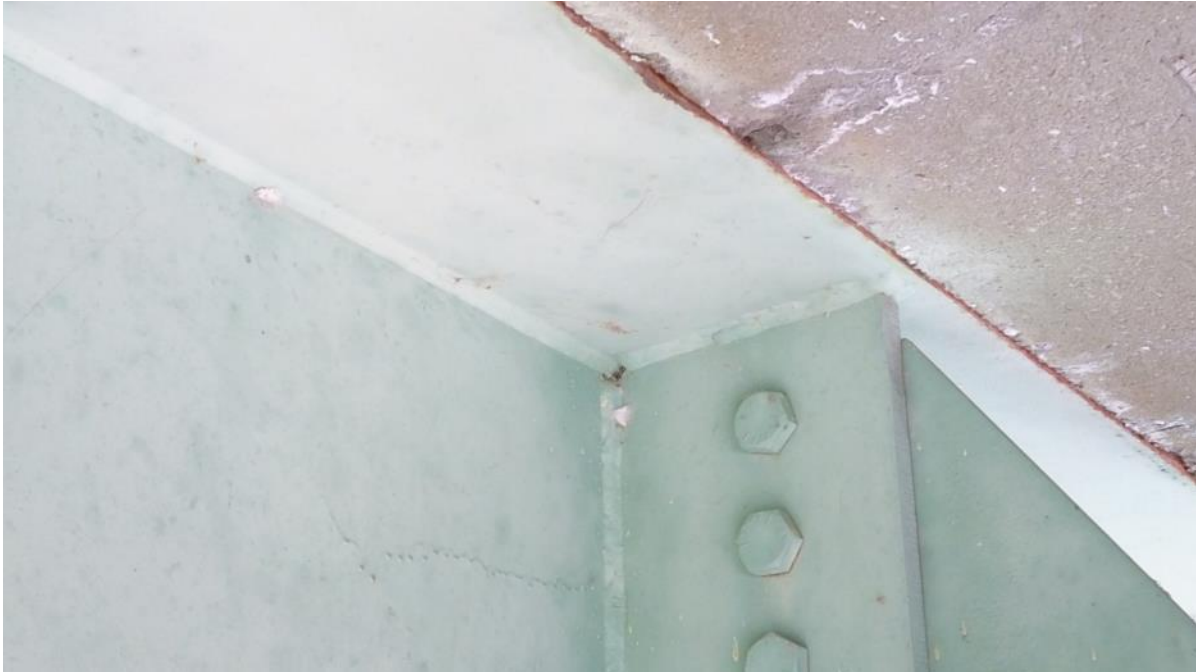
Figure 5.13 Third Floor Beam on East, Mild Rust, Northern Corner, E027

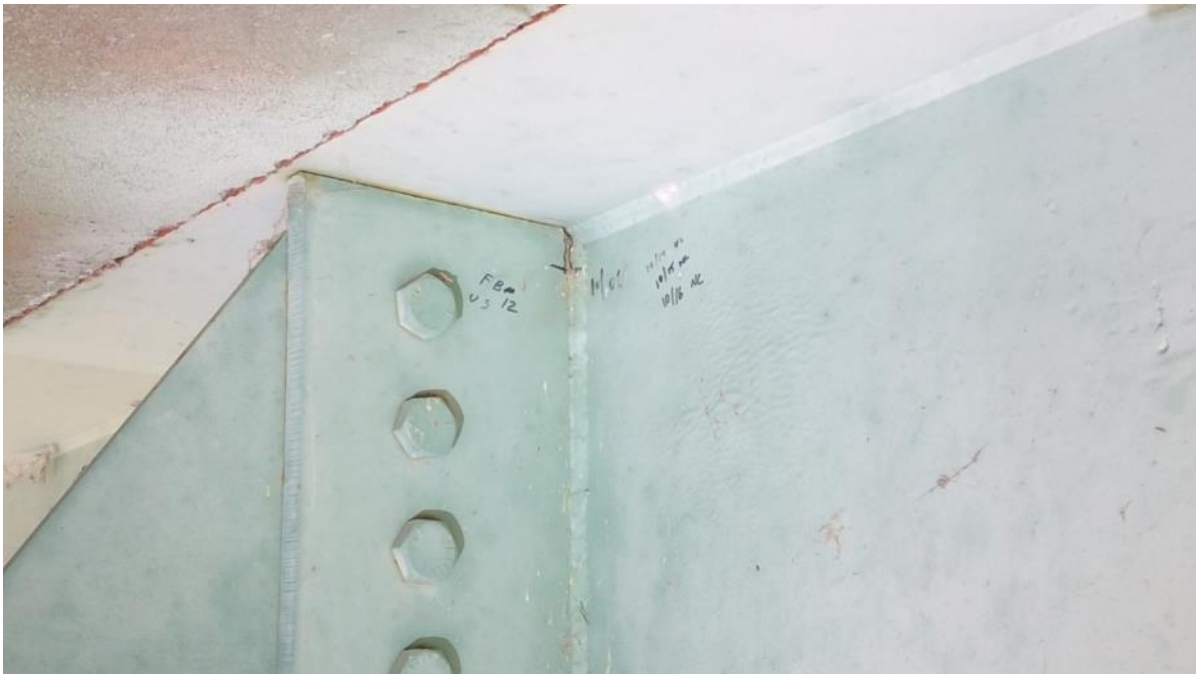
Figure 5.14 Defect (Crack) on the Fourth Floor Beam, E031

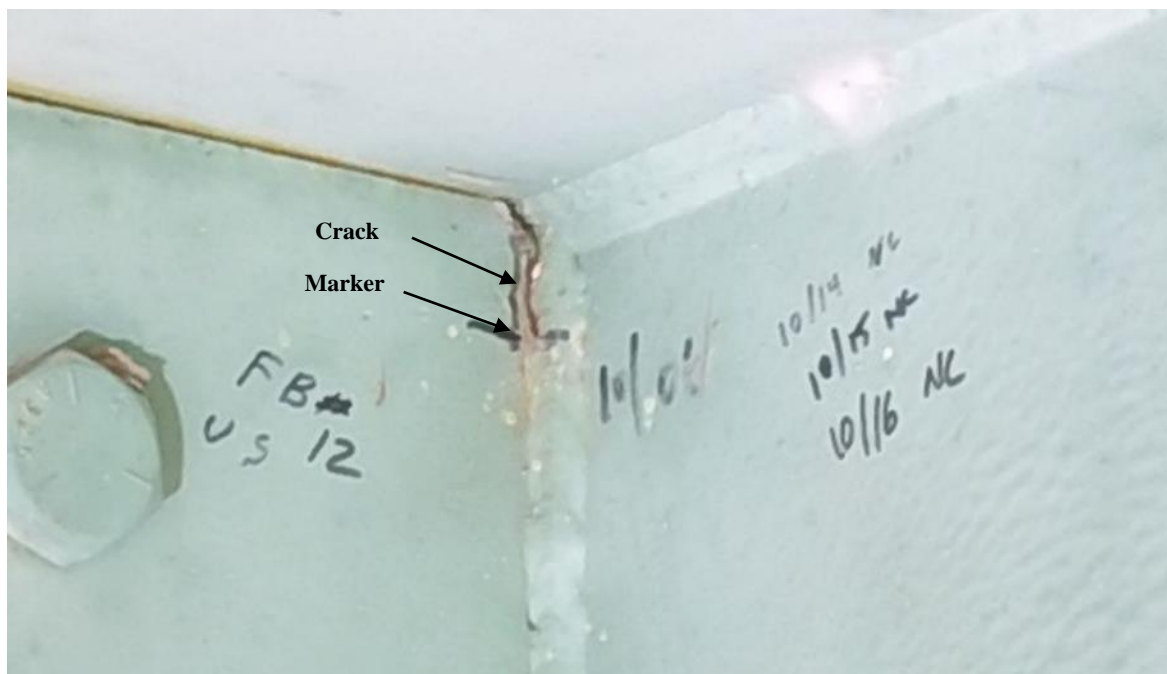
Figure 5.15 Zoomed Image from the Fatigue Crack, E031

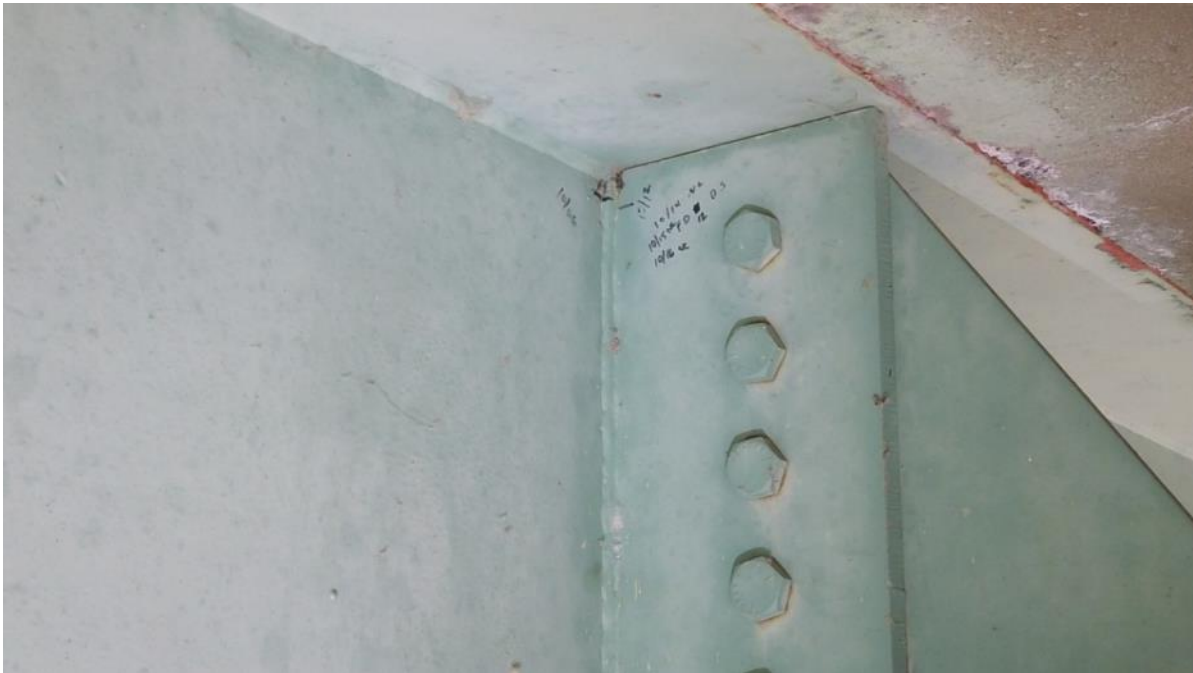
Figure 5.16 Defect (Crack) on the Fourth Floor Beam, Southern Corner, E032

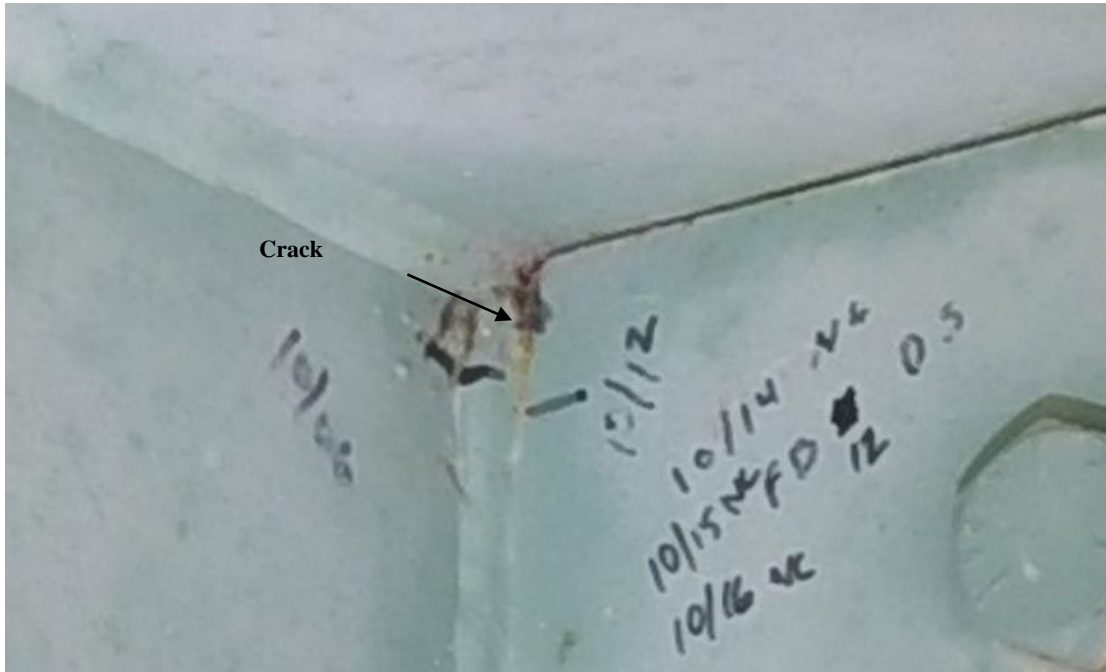
Figure 5.17 Zoomed Image from the Fatigue Crack on the Fourth Floor Beam, Southern Corner, E032

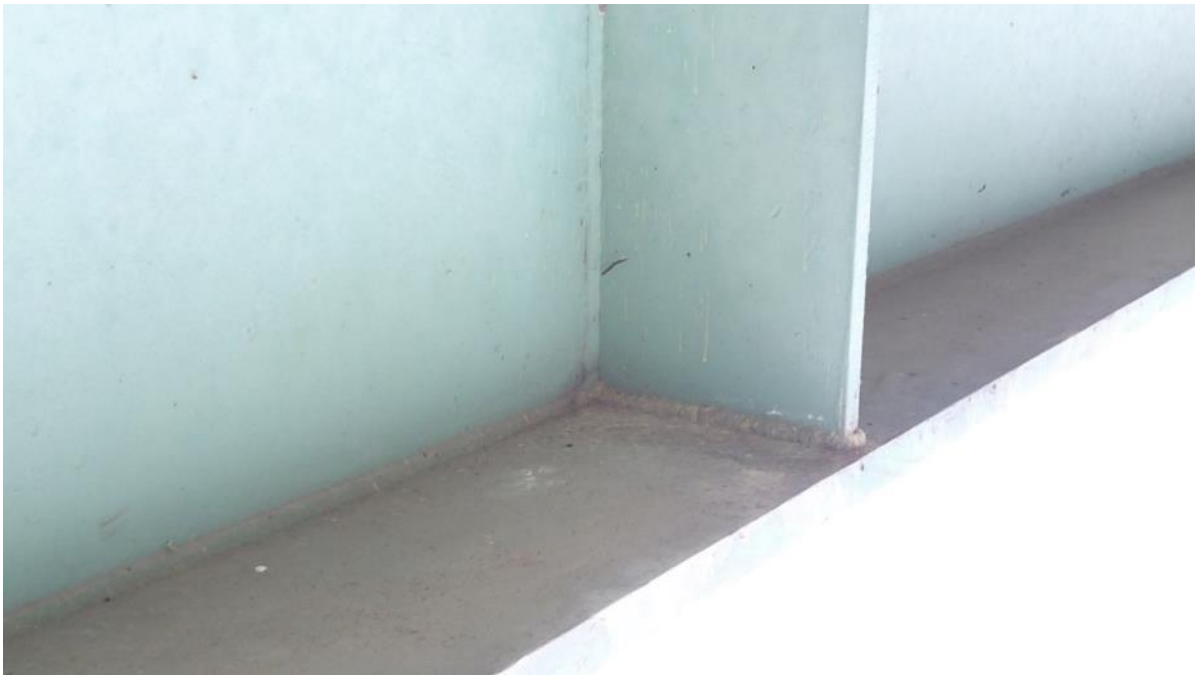
Figure 5.18 No Defects (Crack) on the Fourth Floor Beam, Southern Corner, Bottom Flange Weld, E032

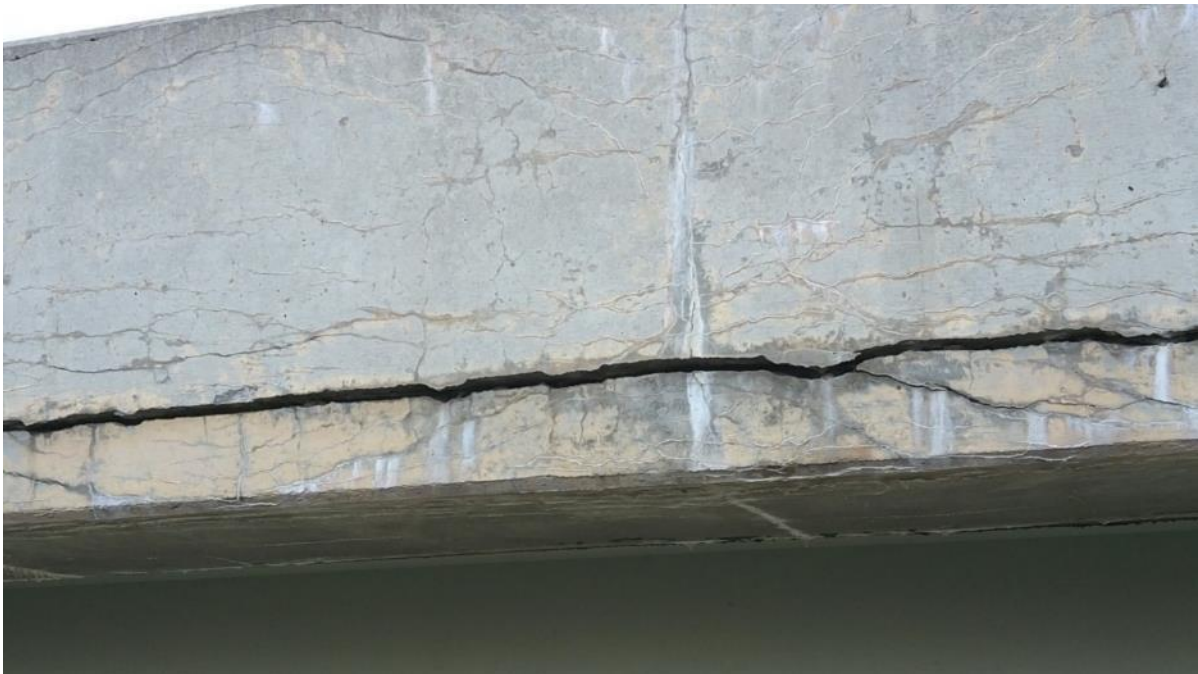
Figure 5.22 Cracks and Possible Delamination on the Southern Barrier, E036

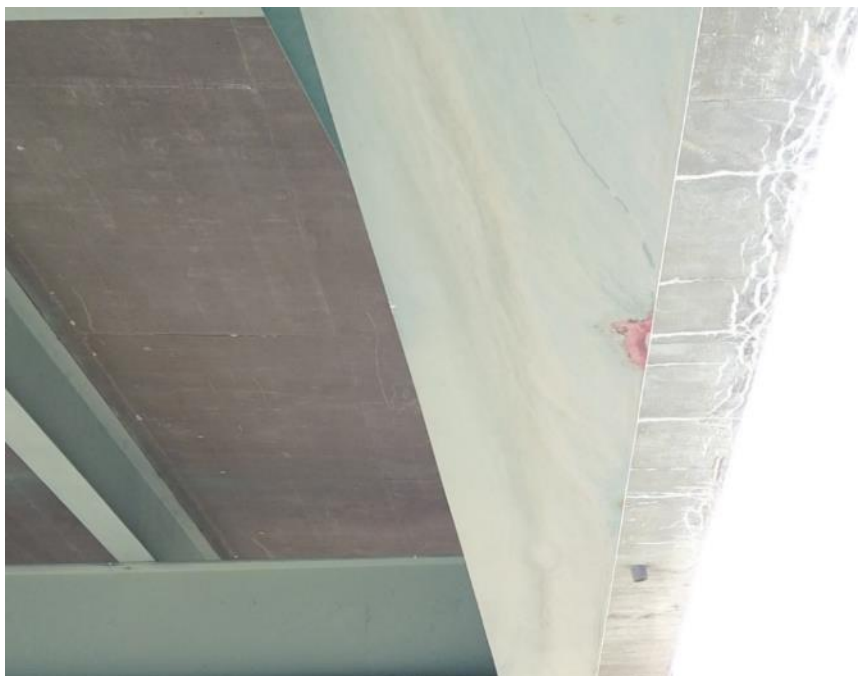
Figure 5.23 Minor Corrosion on Bottom Flange of the Southern Girder, E035 and E036

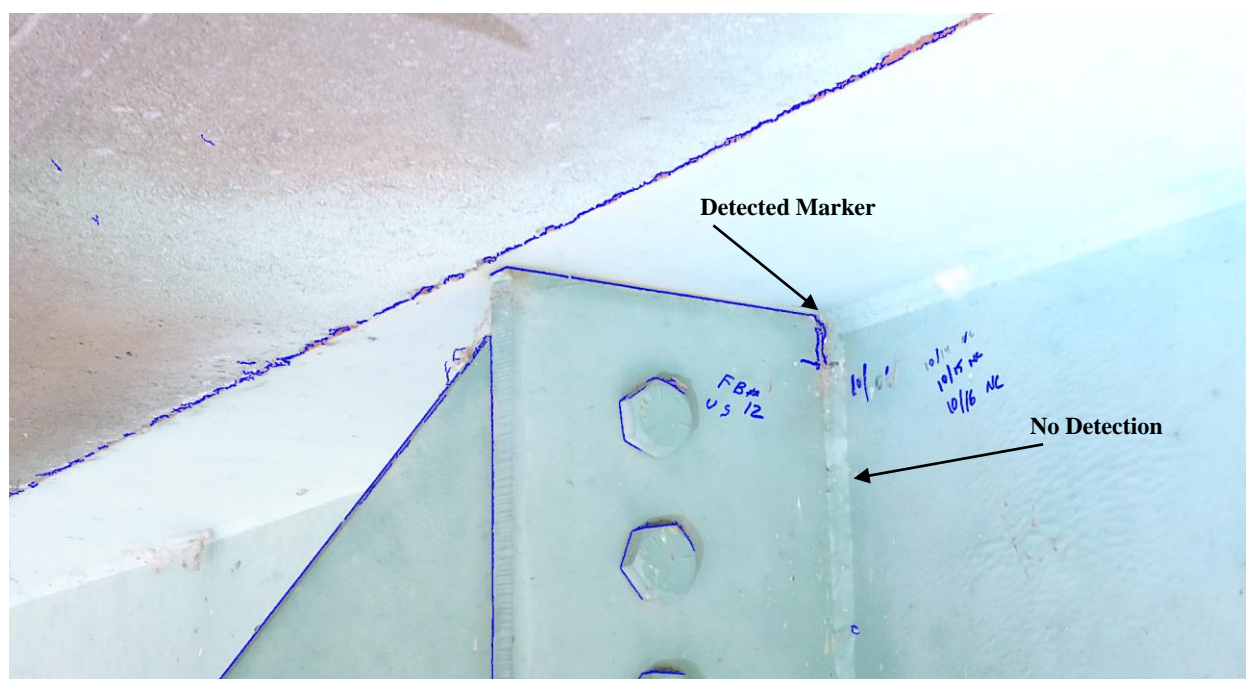
Figure 5.24 Image Processing on Captured Image with Crack, E037

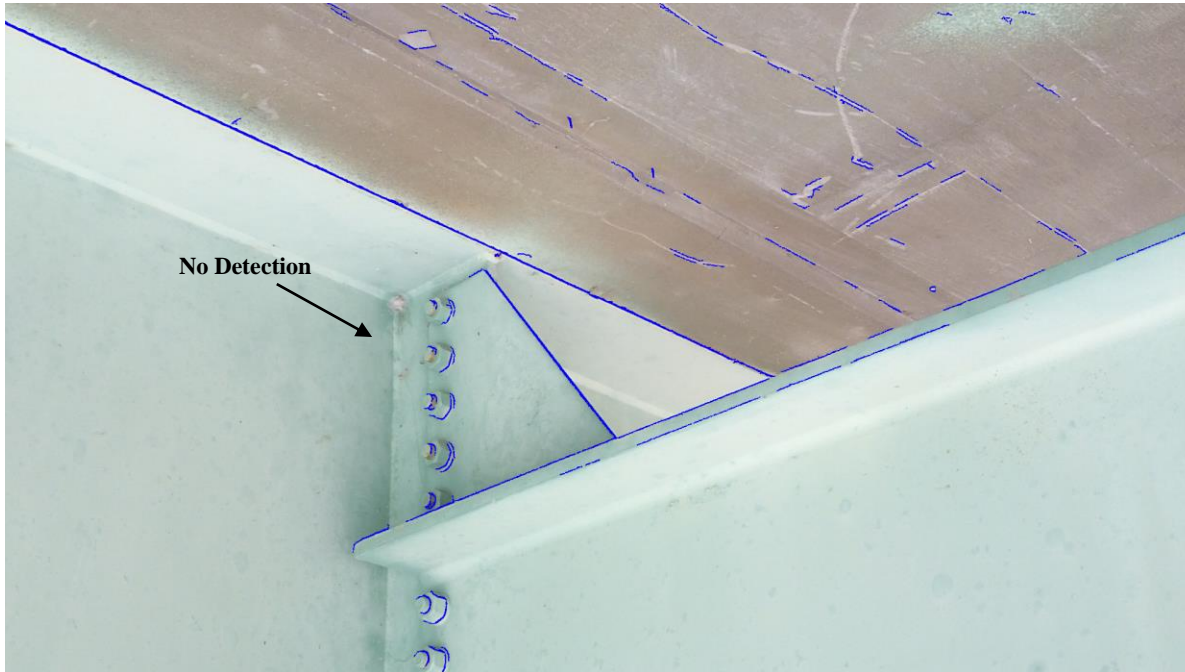
Figure 5.25 Image Processing on Captured Image without Crack, E037

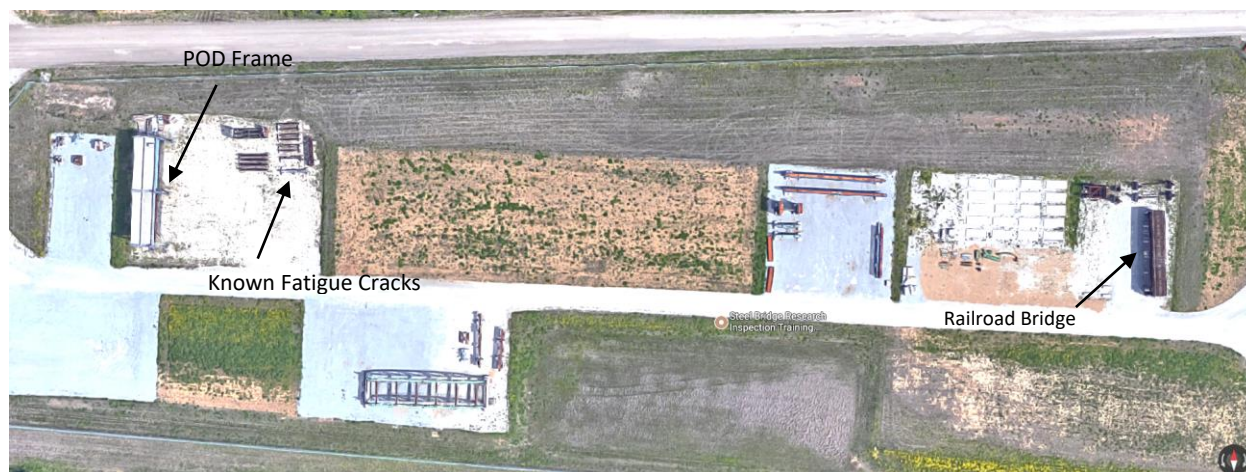
Figure 6.1 The CAI aerial image

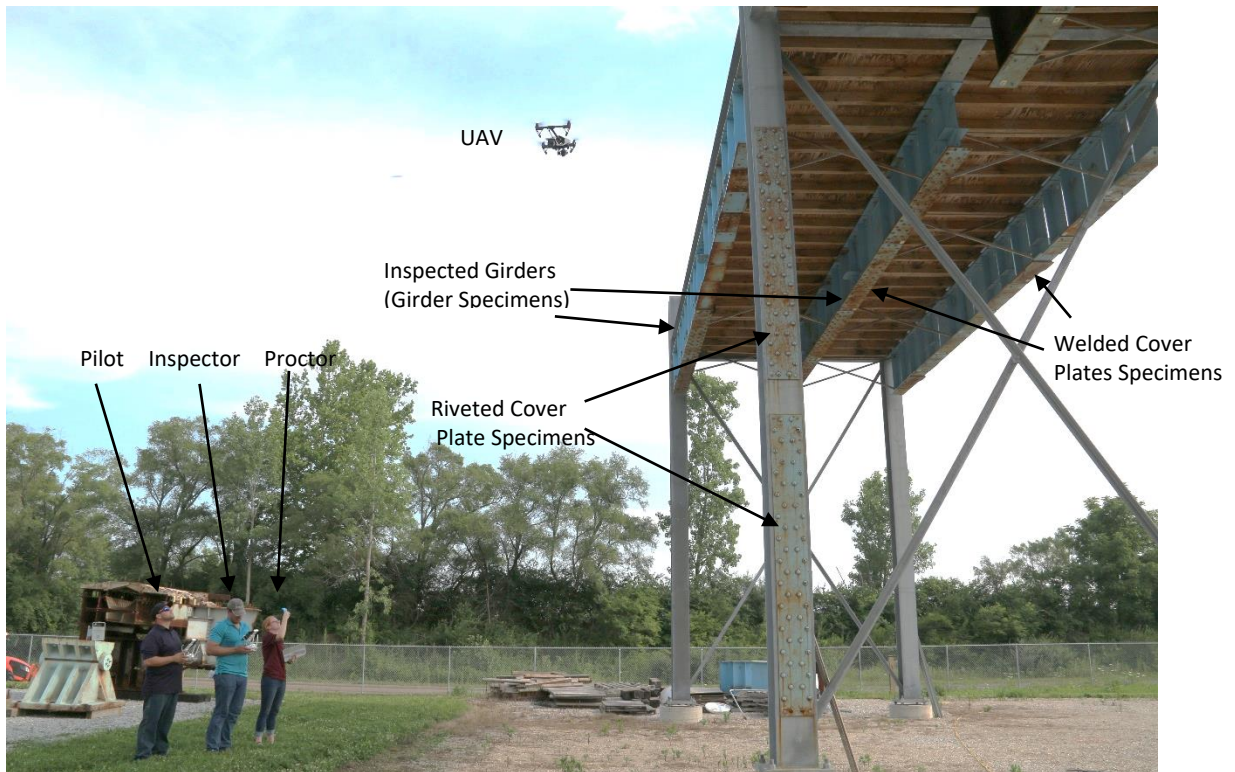
Figure 6.2 POD frame and UAV inspection

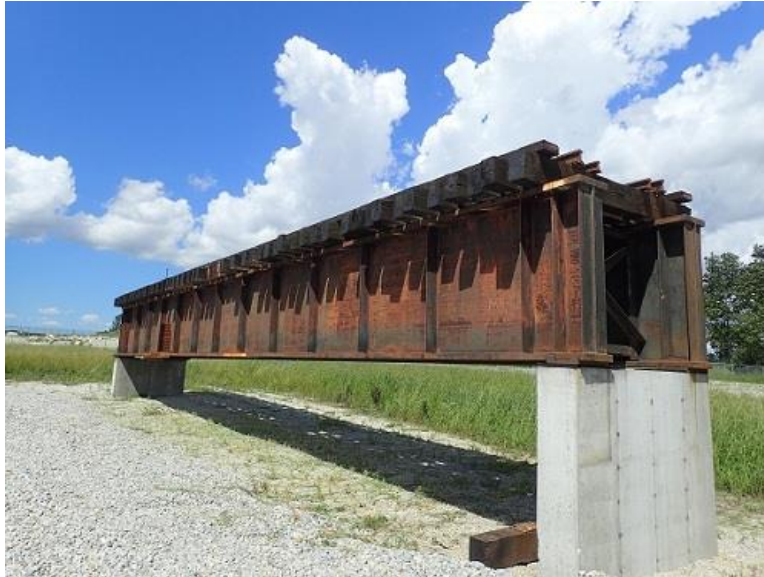
Figure 6.3 Railroad bridge with known fatigue cracks

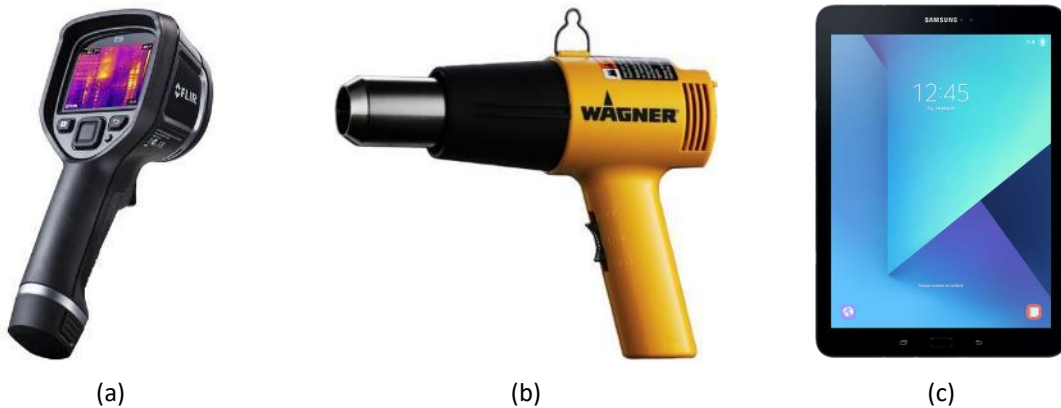
Figure 6.5 (a) Thermal camera FLIR E8, (b) Wagner heat gun, and (c) Samsung tablet

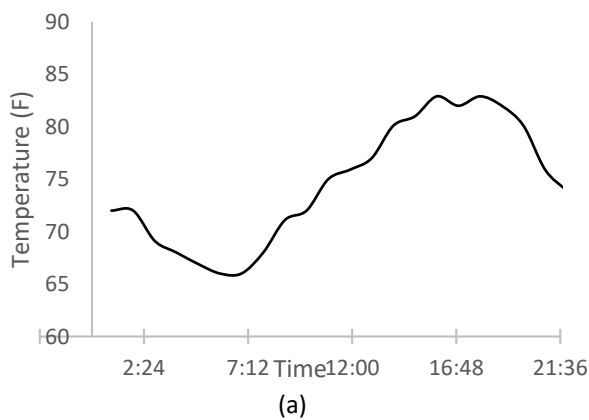
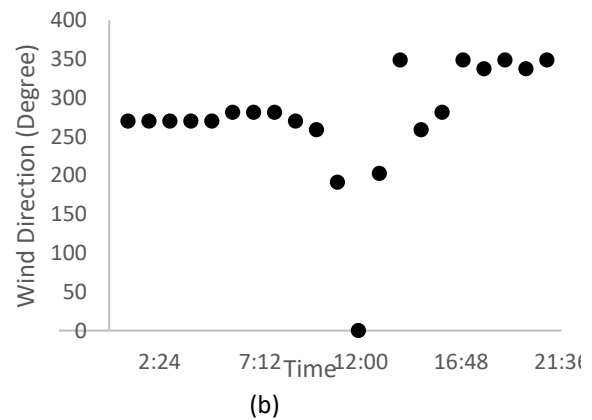
The inspection began around 10:00 am on July 5, 2017 and it continued until 8:30 pm. The average temperature was 75°F (24°C), and the maximum wind speed was 10 mph (16 km/h). Figure 6.6 shows the weather information, including the hourly temperature, wind direction, and wind speed on the first inspection day (adopted from the KLAF weather station on weatherunderground.com). The wind direction during the inspection was mostly to the south. The majority of the inspection took place in an almost wind-free situation.

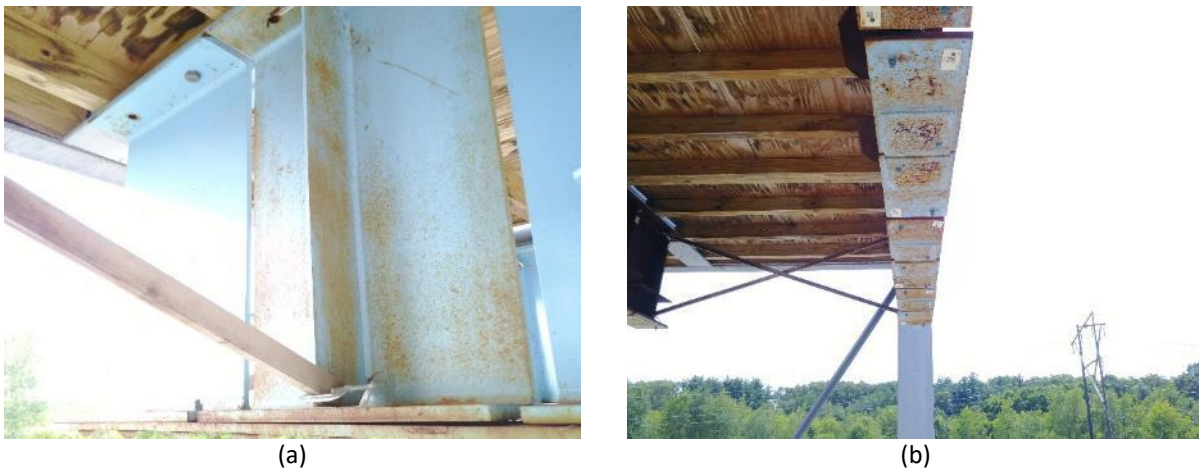
Figure 6.8 DJI Mavic images: (a) a girder in the POD frame with possible fatigue crack and (b) bottom flange cover plates

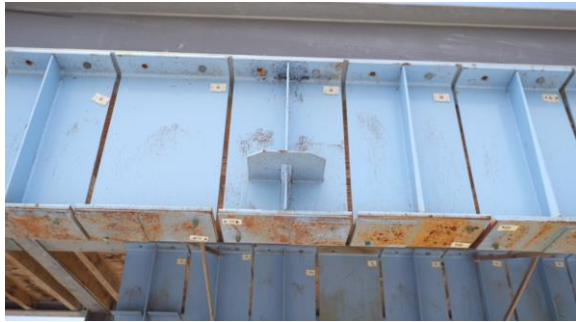
Figure 6.9a shows the cover plates on the bottom flange of one of the POD frames taken by the DJI Inspire, while Figure 6.9b shows one of the DJI Phantom pictures with the riveted cover plates in the POD columns.

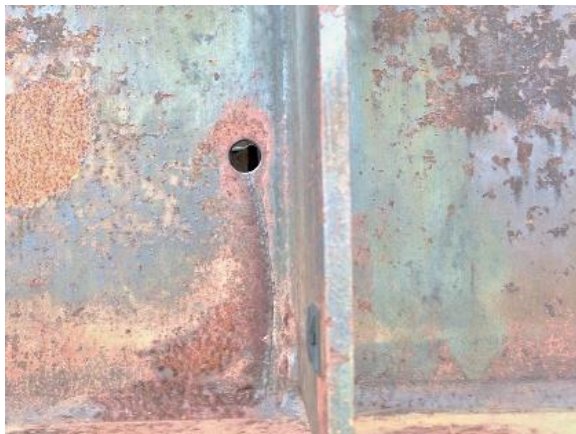
Figure 6.10a and 6.10b show pictures of identical fatigue cracks on the railroad bridge using the DJI Mavic and the Samsung tablet, respectively. The hole at the end of the fatigue crack stops the crack's propagation by reducing the stress concentration. Figure 6.10c and 6.10d show the visual and thermal pictures of the same crack taken by the FLIR E8 thermal camera, respectively. The method used to take these pictures was passive thermography.

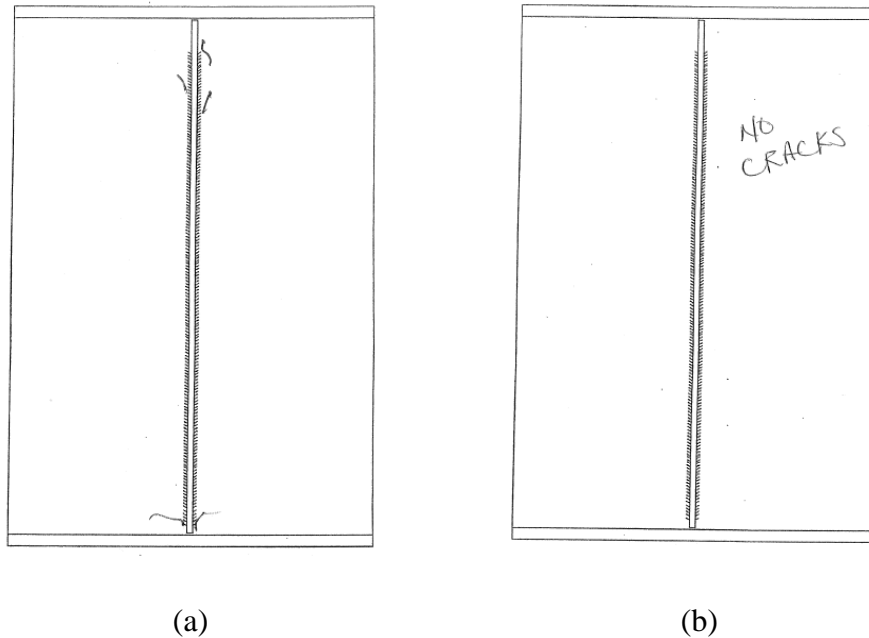
Figure 6.11 Realtime inspection results in the girders of the POD frame: (a) specimen with reported fatigue cracks (b) specimen with no reported fatigue cracks

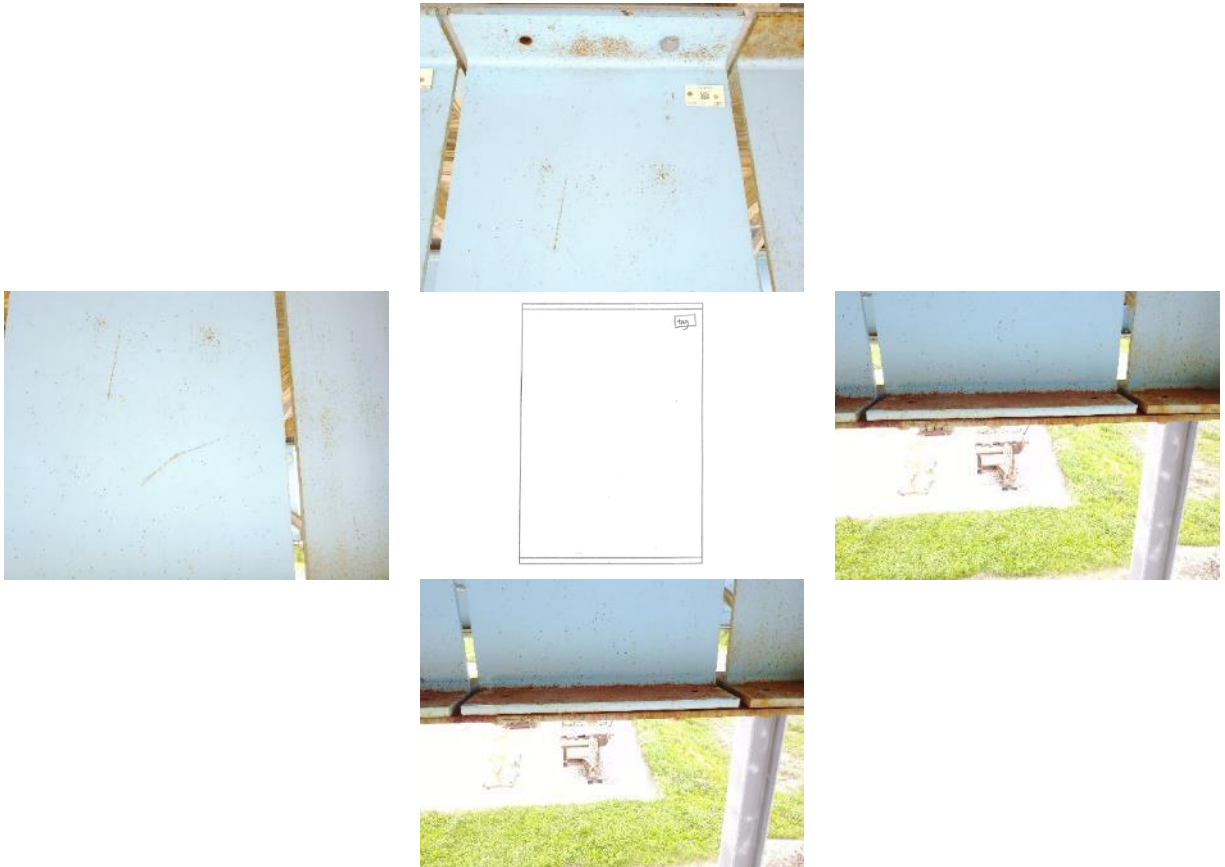
Figure 6.12 Postmortem result and inspection pictures of crack-free specimen

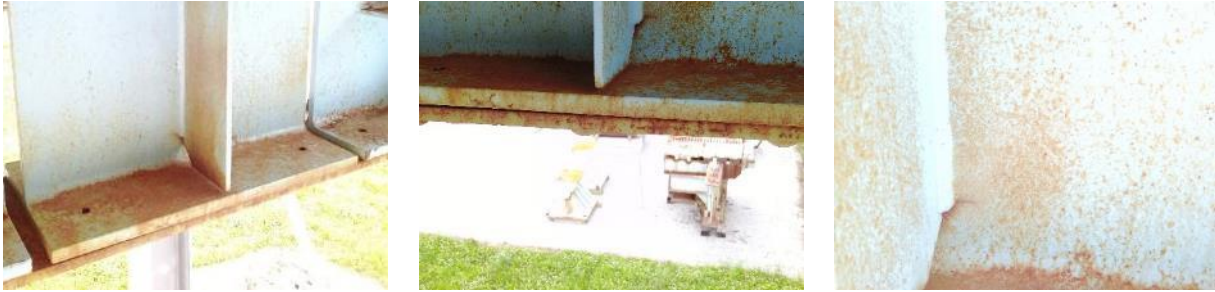
Figure 6.13 Postmortem result and inspection pictures of a specimen with two reported fatigue cracks on the bottom

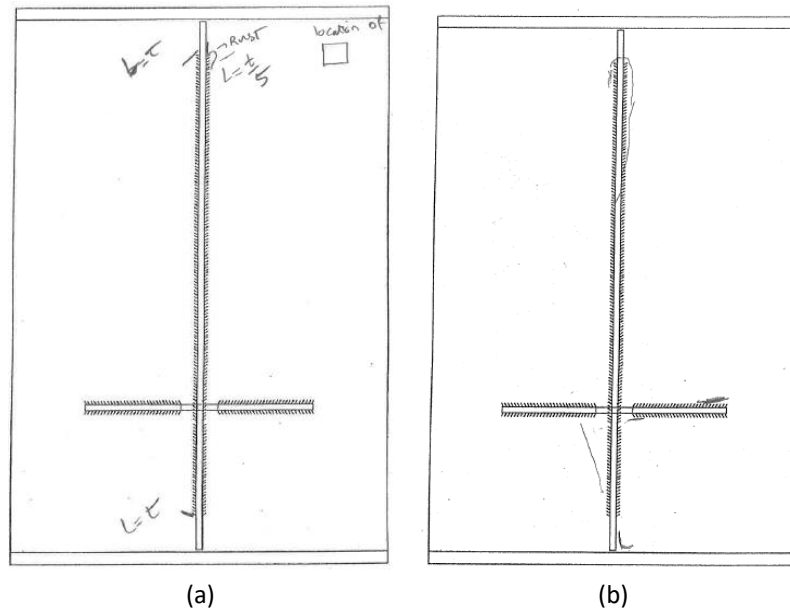
Figure 6.14 A girder specimen inspection using DJI Mavic images: (a) postmortem report and (b) realtime report

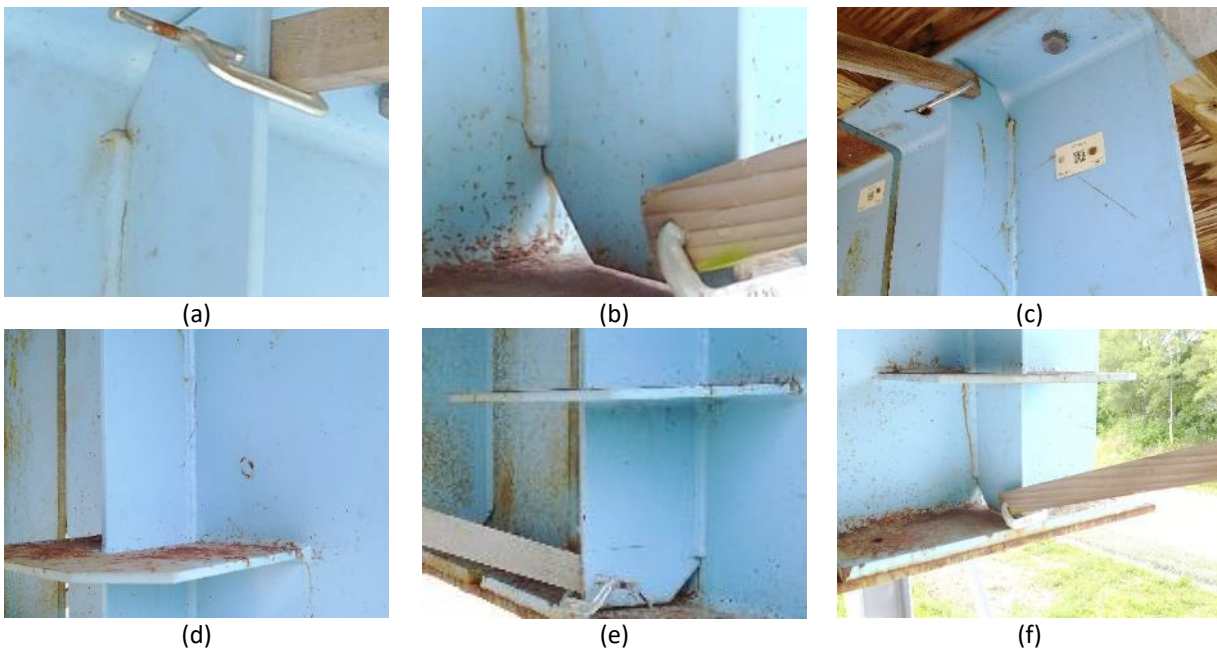
Figure 6.15 DJI Mavic inspection images of a girder specimen : (a) top-left fatigue crack, (b) bottom-left fatigue crack, (c) scratch on top-right, (d) rust on top-right side of the horizontal stiffener, (e) rust and weld notch on bottom-right, (f) scratch on bottom-left

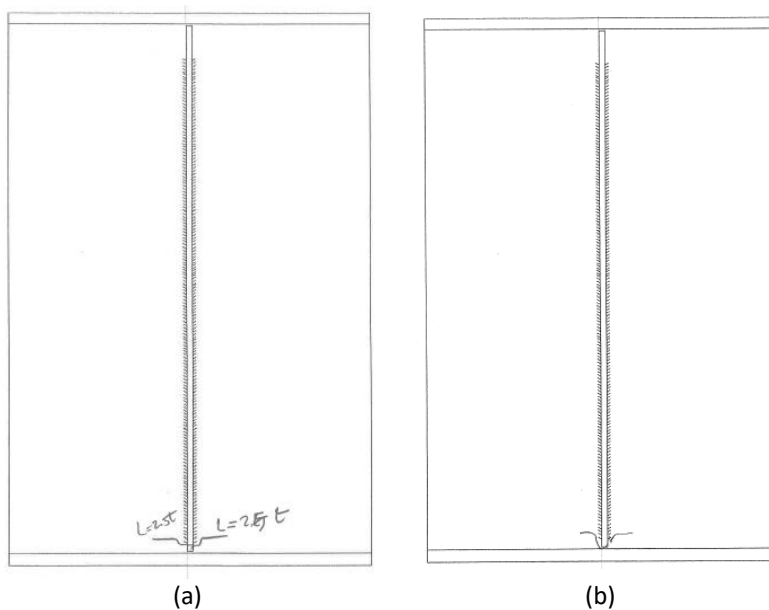
Figure 6.16 Reports on a girder specimen based on the DJI Mavic image: (a) postmortem report and (b) realtime report

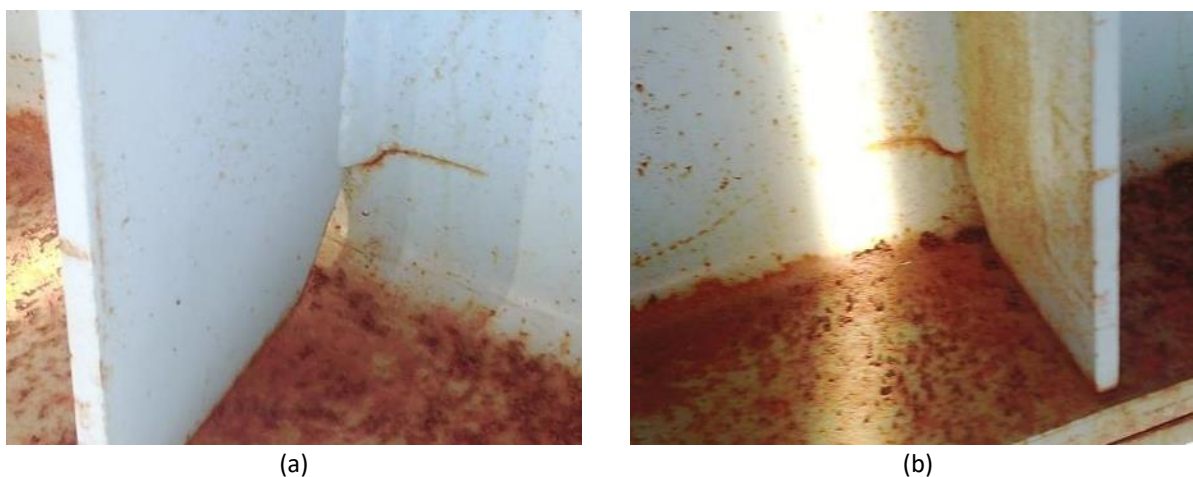
Figure 6.17 DJI Mavic images of fatigue cracks in a girder specimen: (a) crack on bottom-right and (b) crack on bottom left

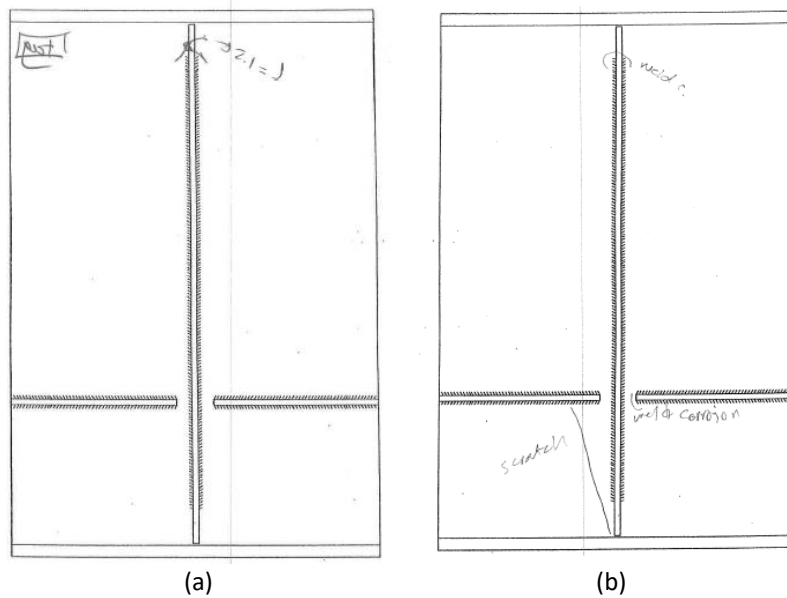
Figure 6.18 A girder specimen inspection using the DJI Mavic images: (a) postmortem report and (b) realtime report

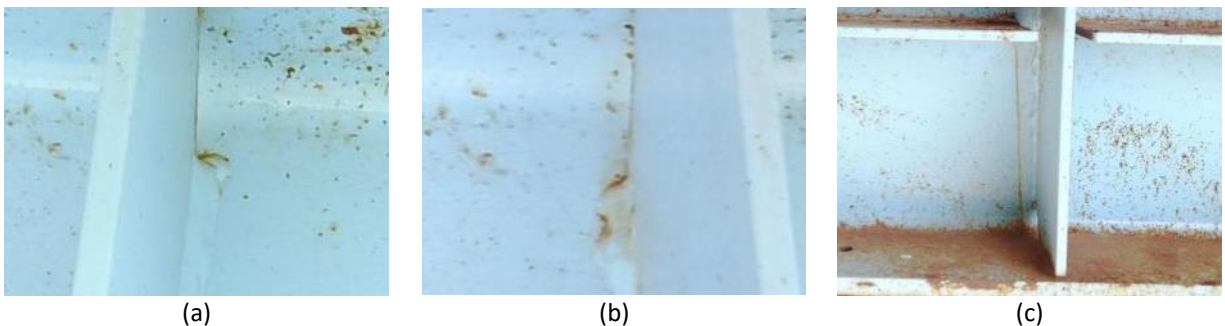
Figure 6.19 Inspection images taken by the DJI Mavic of a girder specimen: (a) top-right fatigue cracks, (b) top-left fatigue crack, and (c) scratch on bottom-left

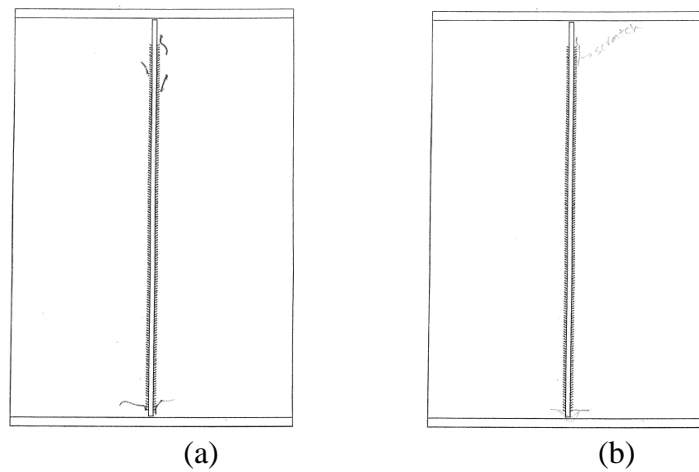
Figure 6.20 Realtime inspection results for a specimen with different number of reported cracks-B according to images from (a) the DJI Mavic and (b) the DJI Inspire

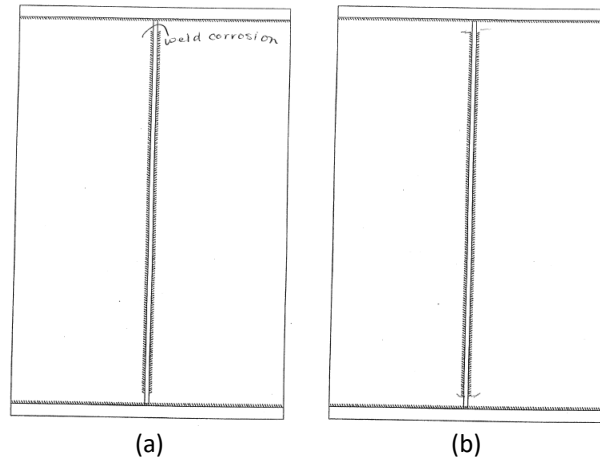
Figure 6.21 Realtime inspection results for a specimen with different number of reported cracks (a) the DJI Mavic and (b) the DJI Inspire

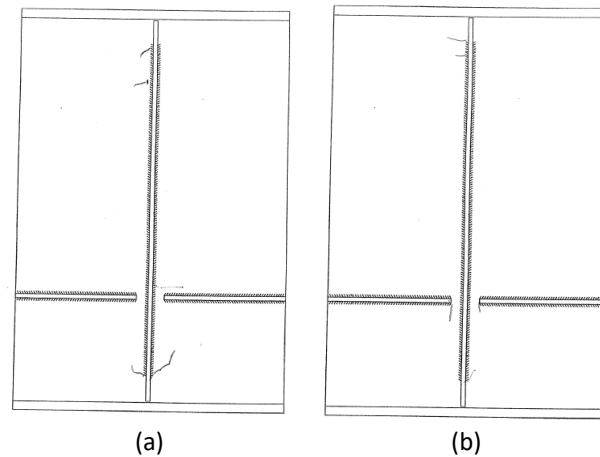
Figure 6.22 Realtime inspection results for a specimen according to images from (a) the DJI Mavic and (b) the DJI Inspire

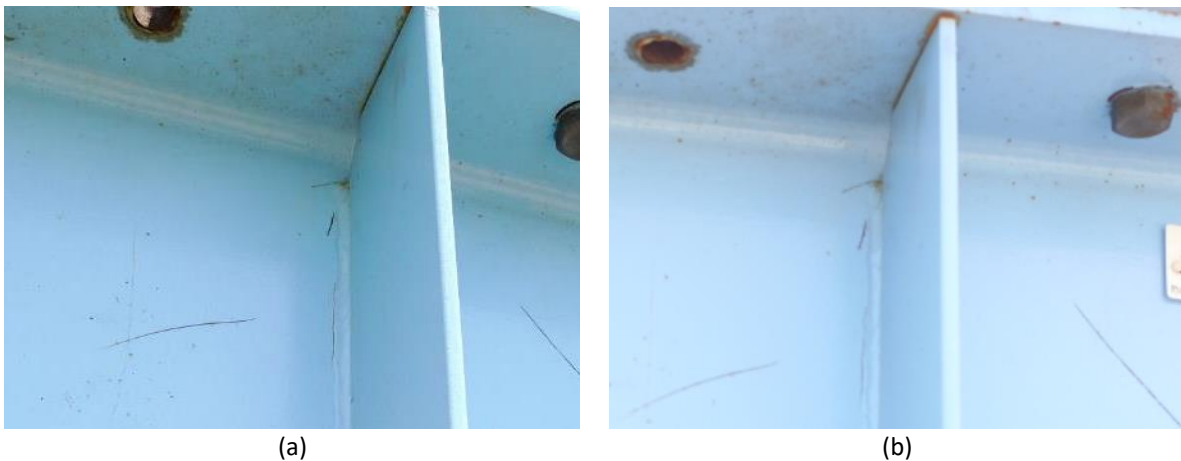
Figure 6.23: (a) 1 fatigue crack reported on top-left in the DJI Mavic images and (b) 2 fatigue cracks reported on top-left in the DJI Inspire images

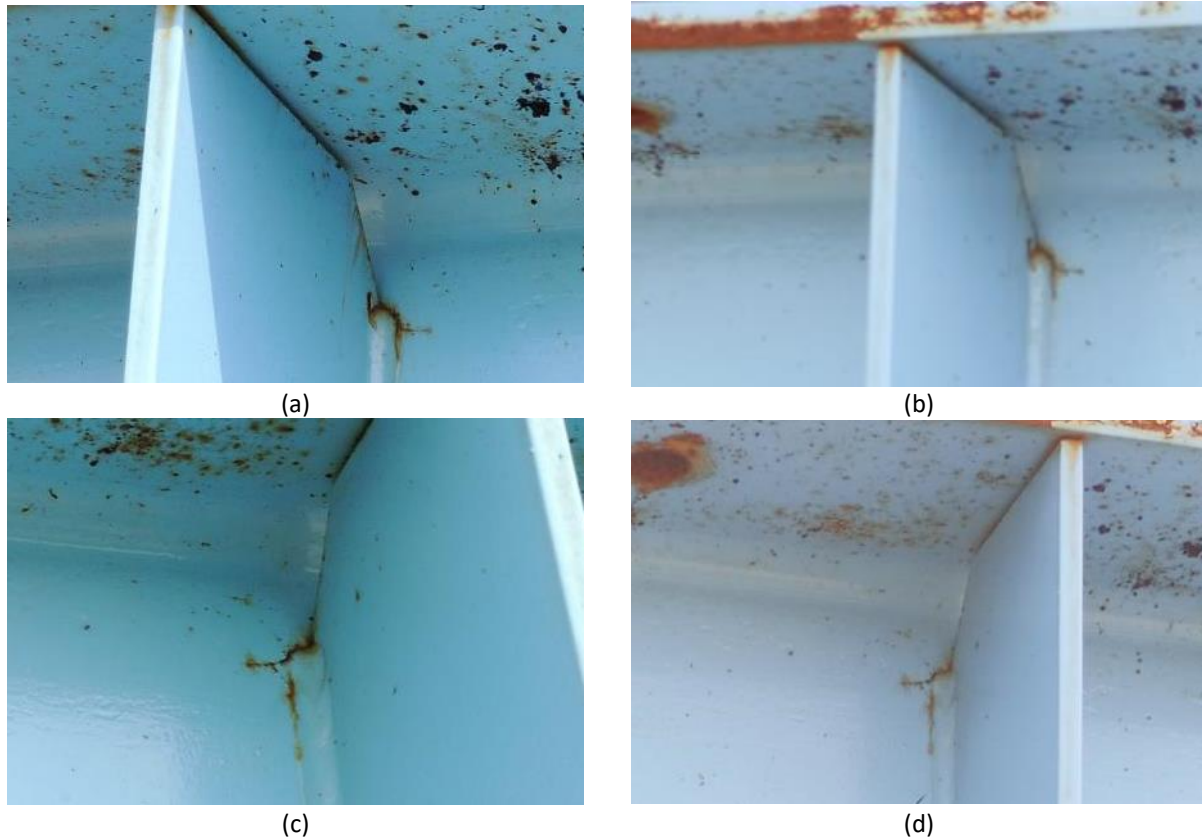
Figure 6.24 Reported fatigue cracks: (a) top-right captured by DJI Mavic, (b) top-right captured by DJI Inspire, (c) top-left captured by DJI Mavic, and (d) top-right captured by DJI Inspire
