Unmanned Aerial Vehicle Augmented Bridge Inspection Feasibility Study

FINAL REPORT
2017

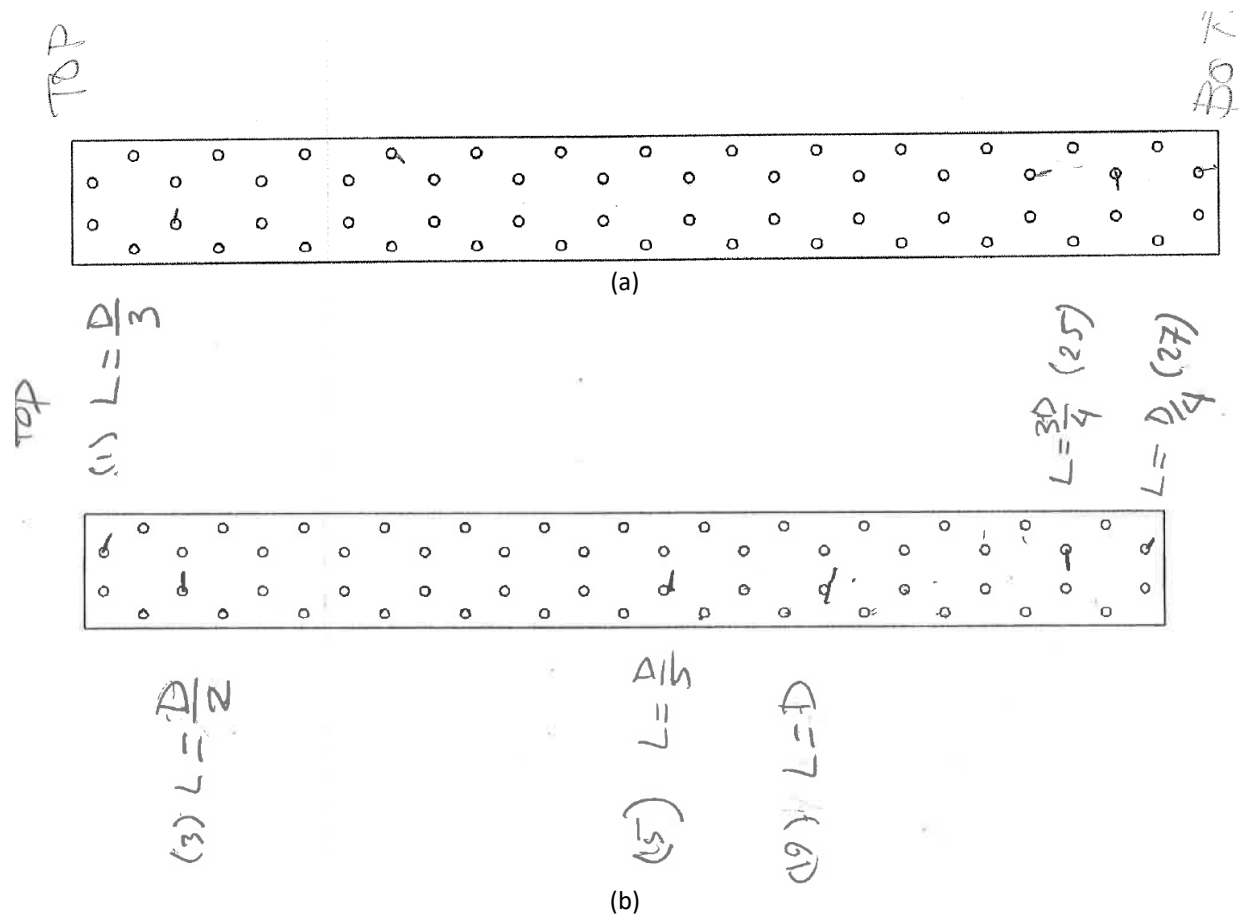
Figure 6.25 A riveted cover plate specimen (a) reported in realtime and (b) reported in postmortem

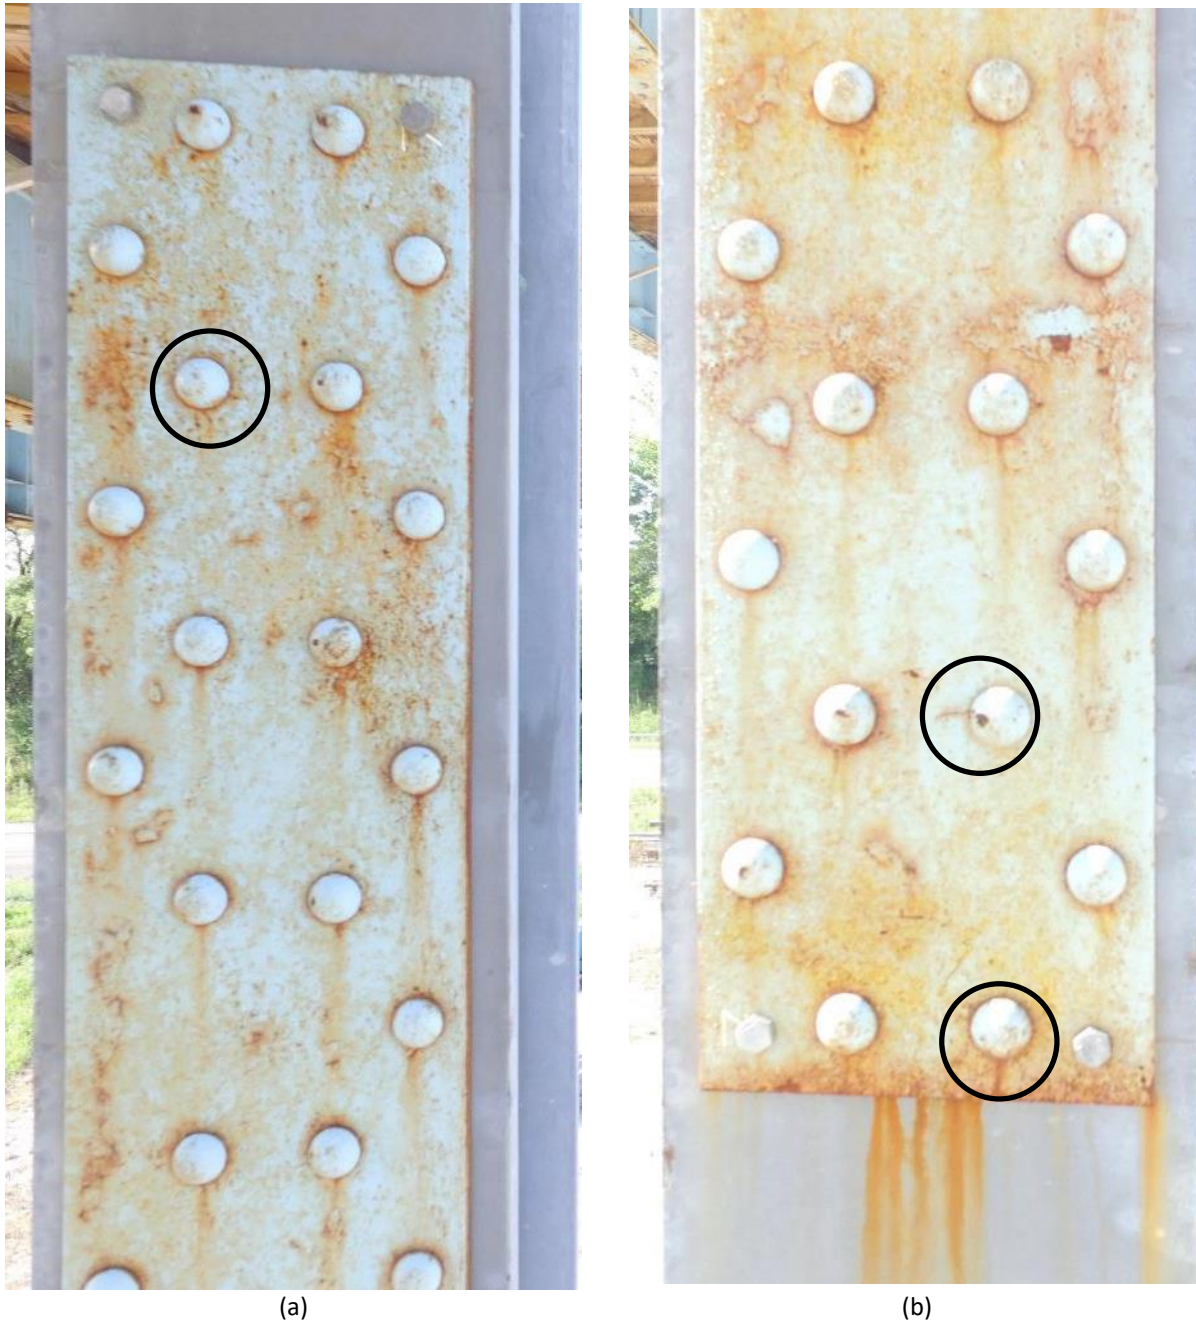
Figure 6.26 Images of the riveted cover plate specimen (a) reported crack on row 3 and (b) reported cracks on row 25 and 27

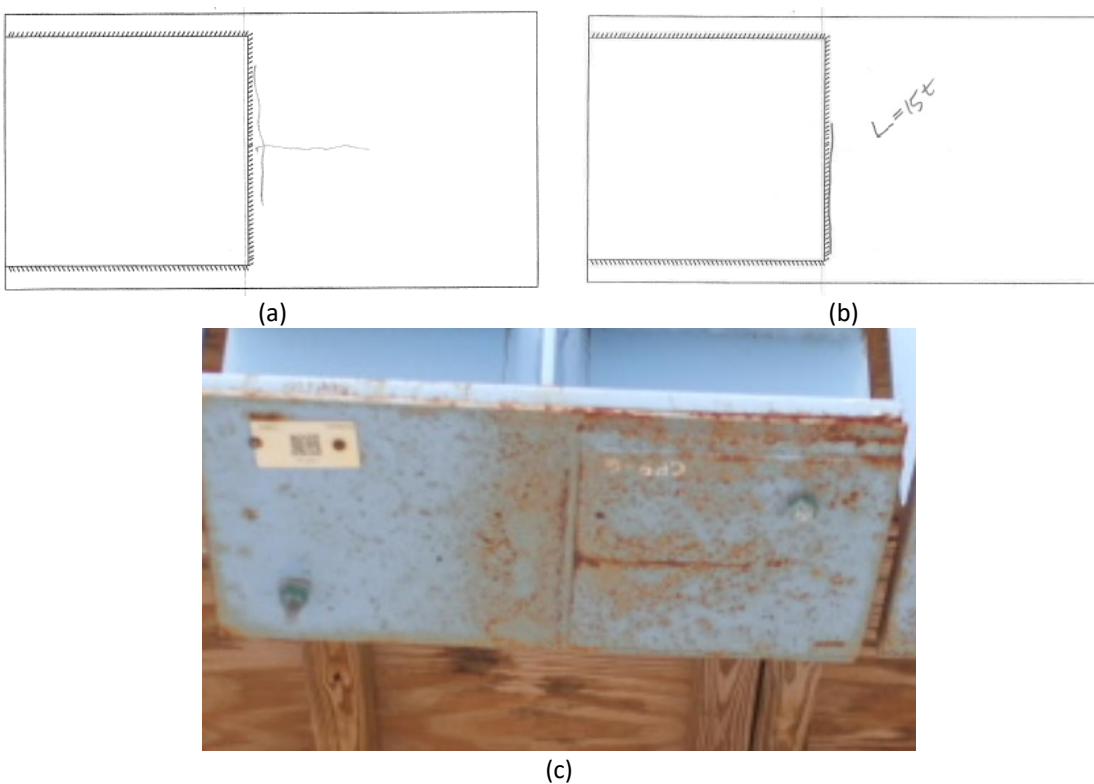
Figure 6.27 A welded cover plate specimen CPP-6 (a) realtime report, (b) postmortem report, and (c) inspection image taken by the DJI Phantom

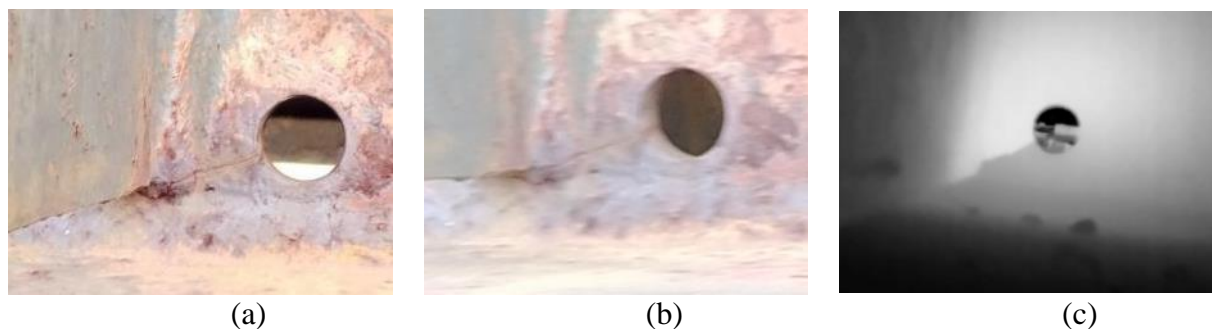
Figure 6.28 Known fatigue crack in the railroad bridge: (a) tablet image, (b) DJI Mavic image, and (c) thermal image

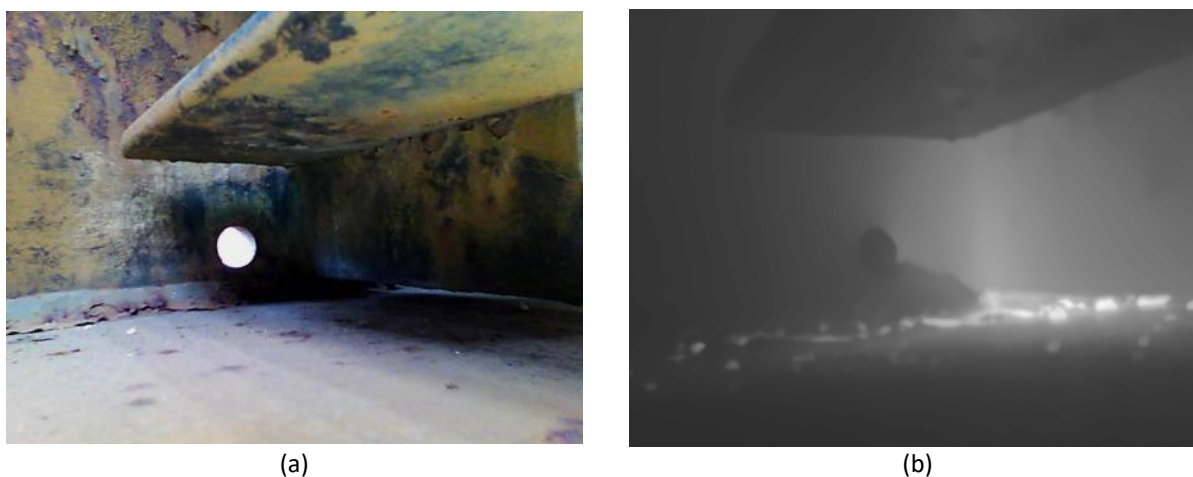
Figure 6.29 (a) A visually undetectable fatigue crack, and (b) fatigue crack detection using active thermography

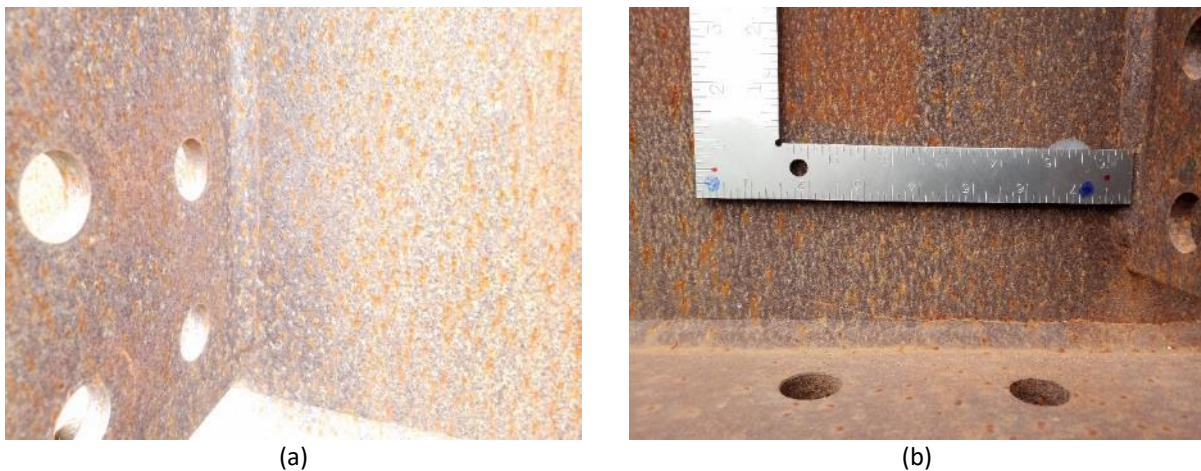
Figure 6.30 Known manufactured fatigue cracks which were (a) small and undetectable visually and (b) large and detectable visually

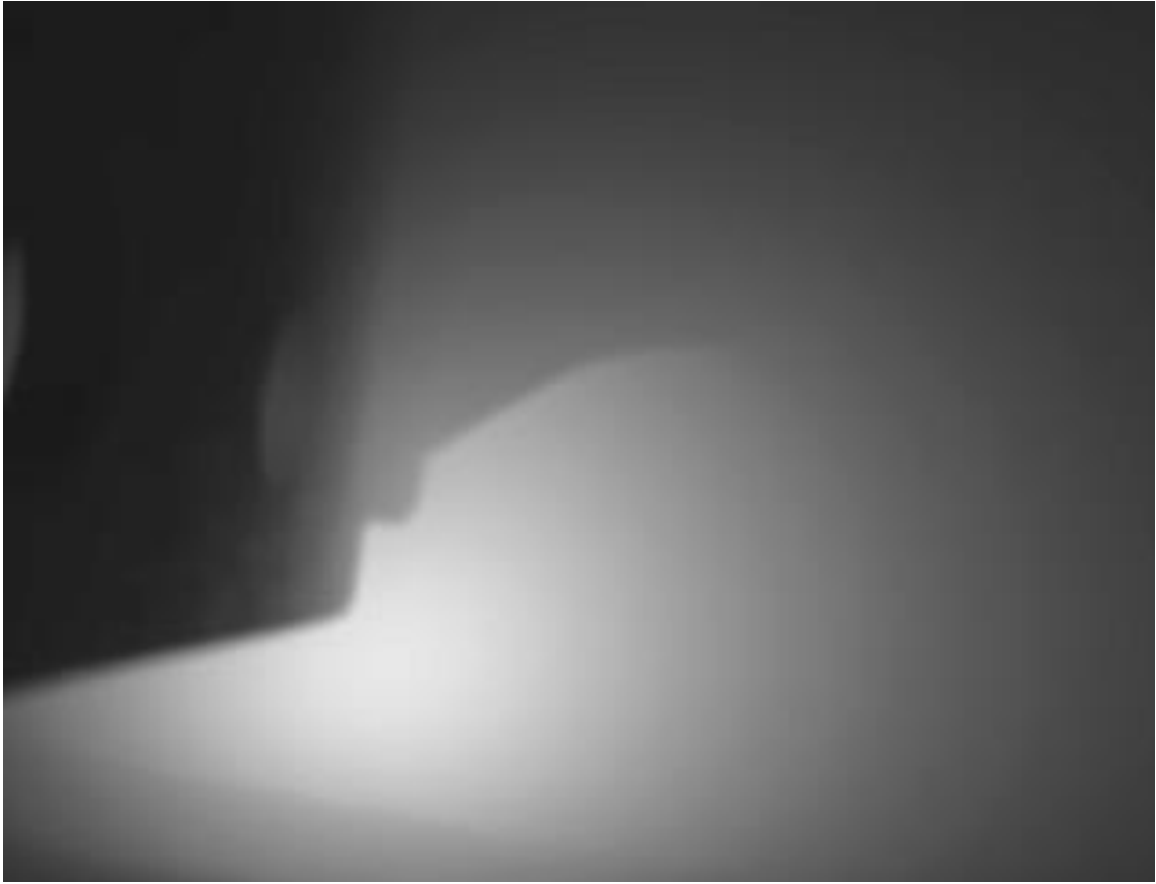
Figure 6.31 Detected fatigue crack in the thermal image of a specimen with a visually undetectable crack

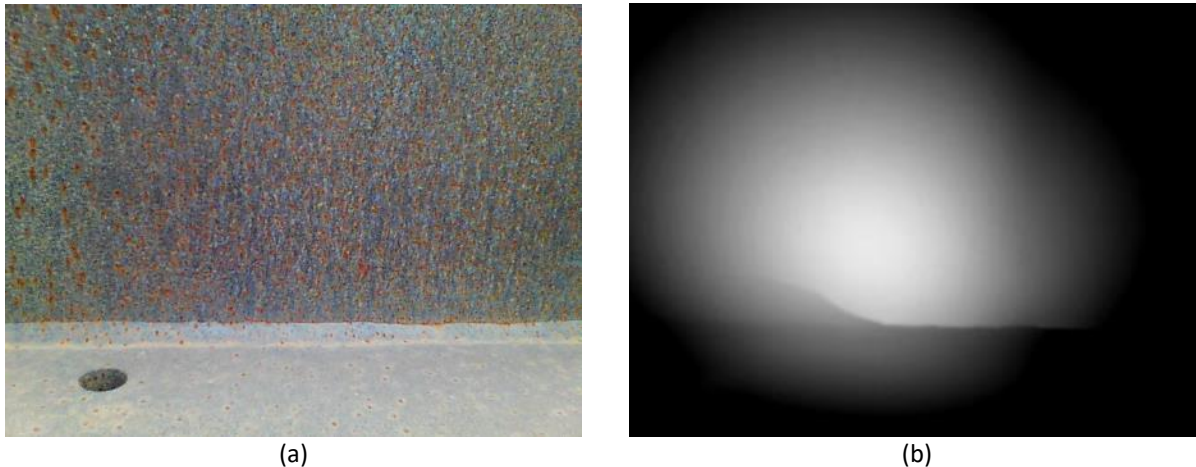
Figure 6.32 Detecting the full length of the fatigue crack using thermography. (a) Visual image, partial detection and (b) thermal image full detection

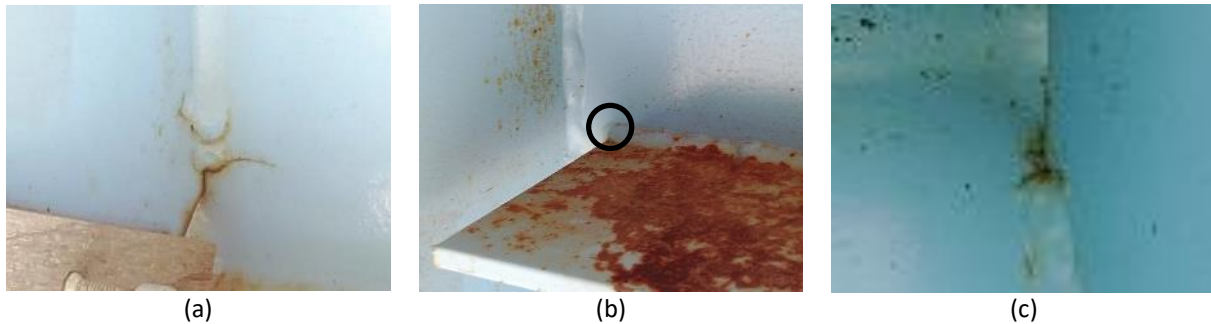
Figure 6.33 Girder UAV inspection (a) a true positive (hit), (b) a false negative (miss), (c) a false positive.

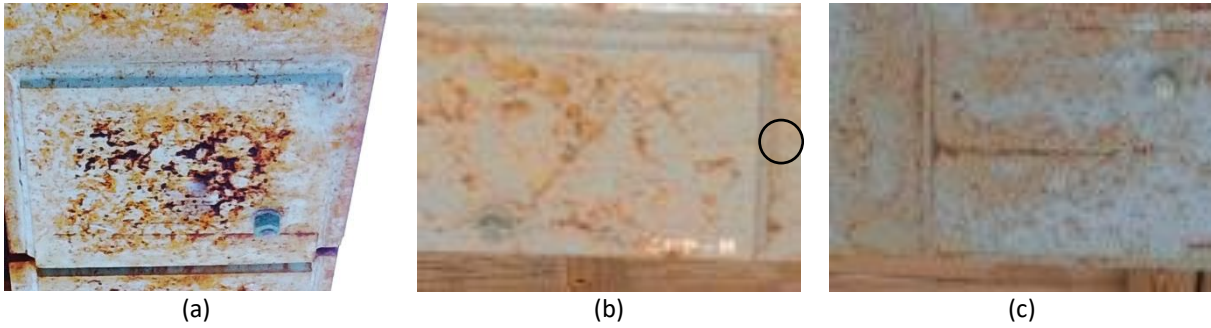
Figure 6.34. Welded plate UAV inspection (a) a true positive (hit), (b) a false negative (miss), (c) a false positive.

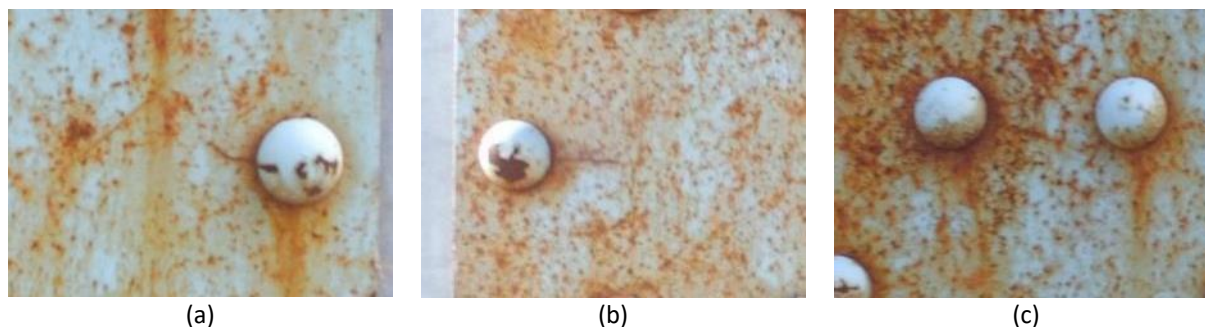
Figure 6.35. Riveted plate UAV inspection (a) a true positive (hit), (b) a false negative (miss), (c) a false positive.

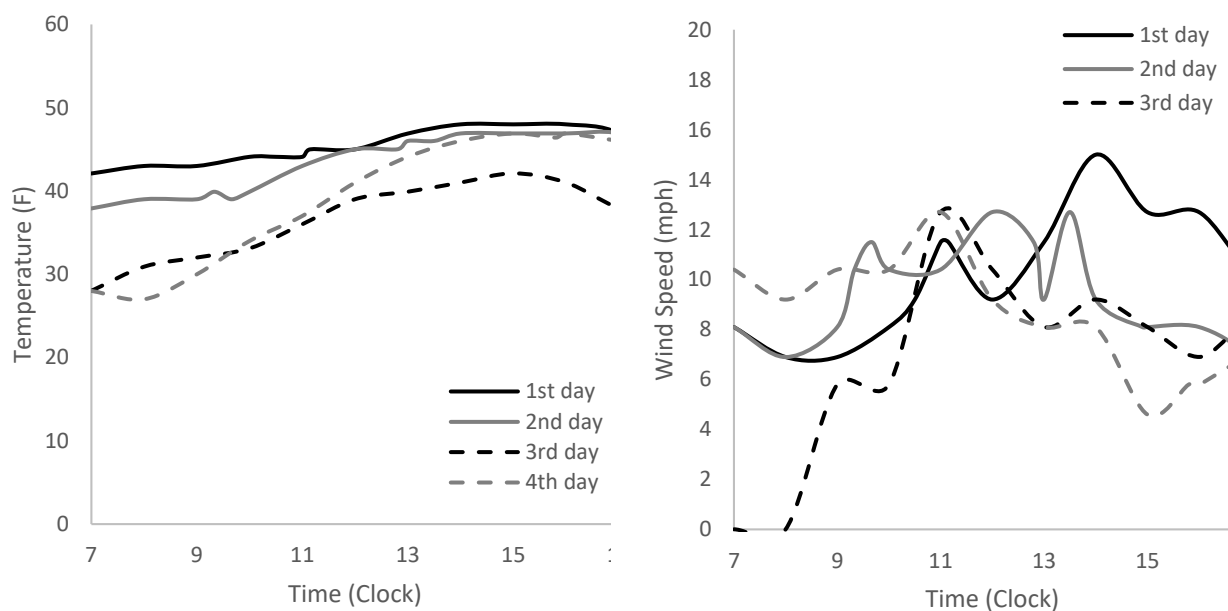
Figure 6.36. Weather information on inspection days, left temperature, right wind speed
