Final Report

Atlanta's Hotel District: ADA Transition Plan

(A Supplement to STRIDE Project #2012-067S)

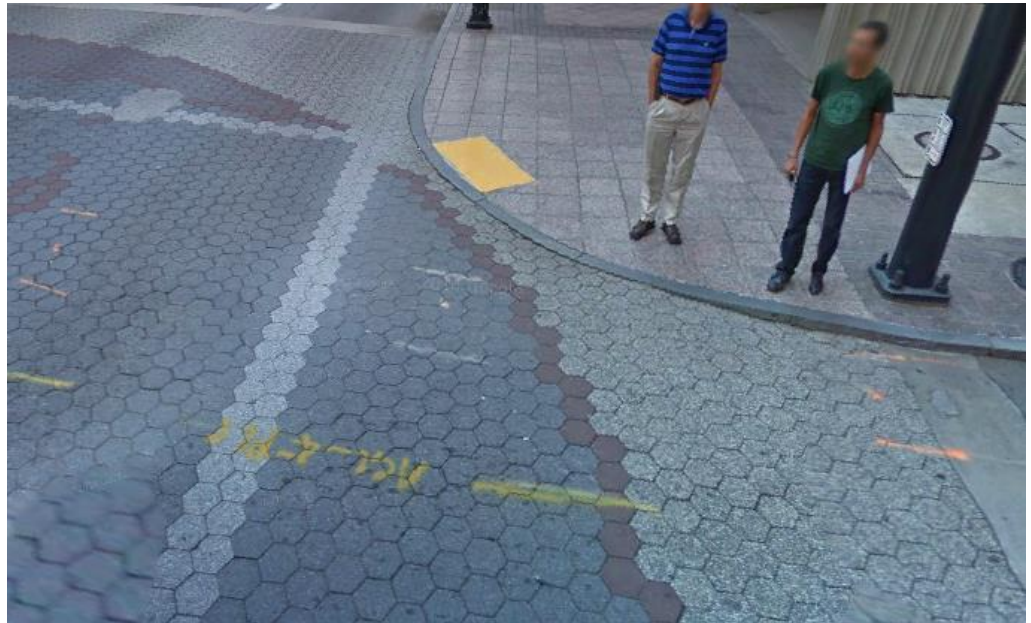
Figure 3: Poorly Delineated Crosswalks at Peachtree Street and Andrew Young International Boulevard

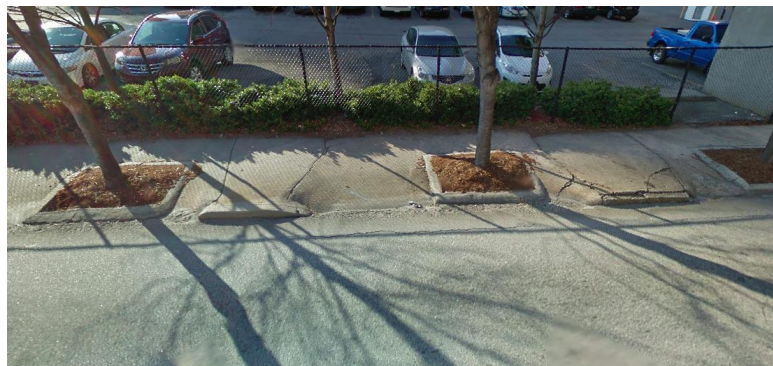
Overall, the team found more issues with the sidewalks than with ramps and crosswalks in this zone. Sidewalk issues are mostly on Courtland Street, John Portman Boulevard, and Andrew Young International Boulevard (documented in Zones 1, 2, and 4 sections). Many of these issues involve the crumbling, disjointed sidewalks of Courtland Street (See Figure 4, below).

Figure 4: Courtland Street NE between Andrew Young International and John Portman Boulevard

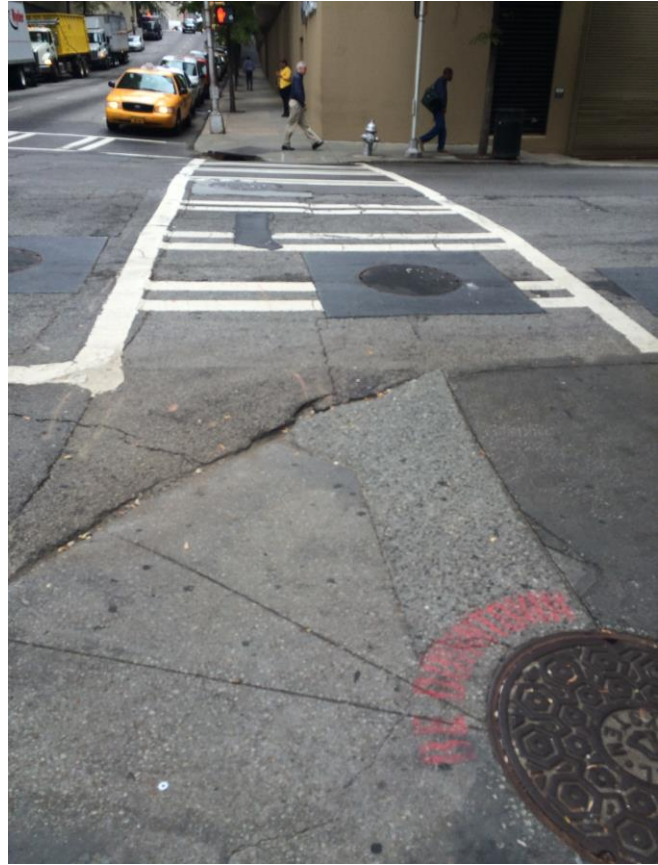
Figure 6: NE Corner of John Portman Boulevard at Peachtree Center Avenue, with Non-compliant Wheelchair Ramp

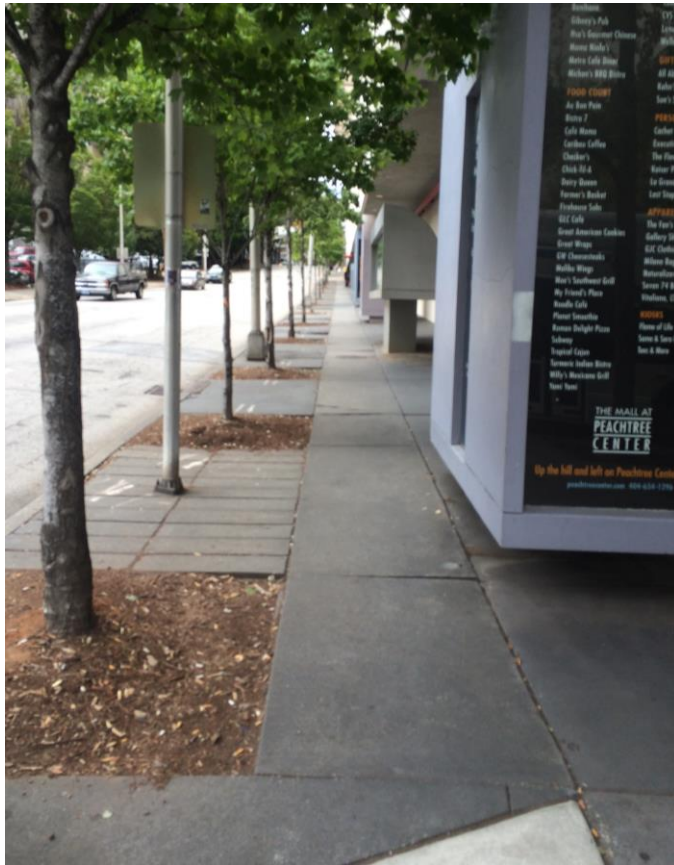
Figure 7: Northern Sidewalk of John Portman Boulevard with Advertising Structures

Many sidewalks in this zone are narrow. There are also design obstructions that cause the sidewalks to feel narrow and uncomfortable. Elements such as wide planting strips without tree grate covers, and advertisement marquees take up space in the pedestrian right-of-way and contribute to both actual and perceived narrowing of the sidewalk. There is a considerable distance between the buildings and the street, leaving room for sidewalk expansion.

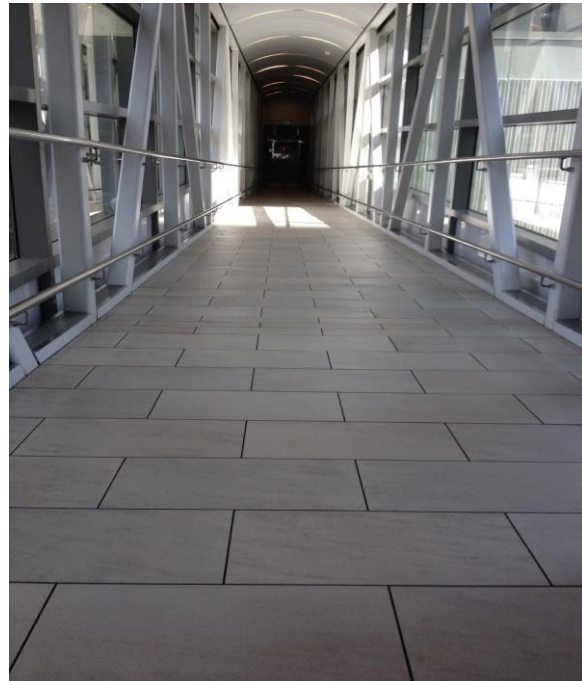
Another accessibility issue in this zone can be found in the sky bridge linking the Hilton to the Atlanta Marriott Marquis (see Figure 8). This route is popular with conventioners, but does not have an automatic door at either access point. While the width of the doors were ADA compliant, guests using wheelchairs or other assistive devices may encounter difficulties operating the manual doors themselves. Automated door openers should be considered at this location given the potential number of users, especially during conventions. The walking surface of the sky bridge was also very smooth, increasing the chances of an individual slipping and falling, especially if the surface is wet. The sky bridge between the Atlanta Marriott Marquis and Hyatt Regency Atlanta has a different type of flooring but also has a moderately-steep slope, measured at 3.7 degrees. While this is also compliant with the ADA running slope requirements, it is still difficult for a person using a wheelchair to move uphill, especially with slow moving pedestrian traffic. Other than the sky bridge issues identified above, accessing the hotels was easy with wide hallways and helpful service staffs to provide direction. Data for this zone and pictorial evidence can be found in Appendices A and B.

Figure 8: Sky Bridge between the Hyatt and Marriott Hotels

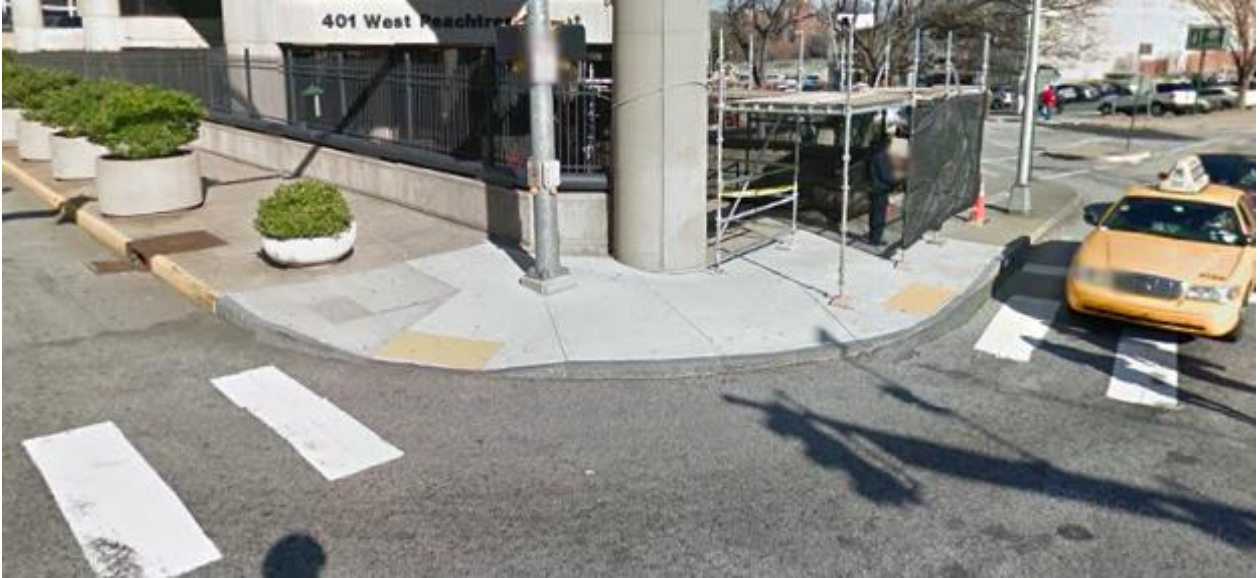
wheelchair ramps at the island or corners of the intersection with Alexander Street. The rest of this sidewalk appears to be compliant. The southern sidewalk on Ivan Allen Junior Boulevard is starting to crack and is too narrow in certain areas to allow for adequate passing room. Widening the Alexander Street sidewalk along this stretch is recommended.

Figure 9: NE Corner of the Intersection of West Peachtree Street and Ivan Allen Junior Boulevard (Parade Route)

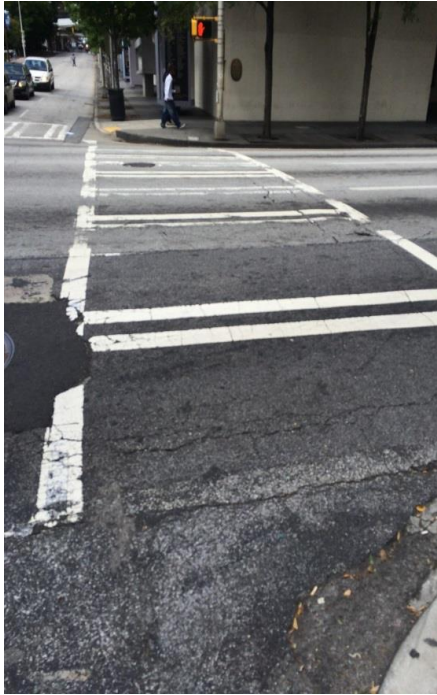
Figure B-1. Northern intersection of John Portman Blvd. and Courtland St. NE, facing west, up John Portman Boulevard towards the Atlanta Marriott Marquis. Only one ramp exists on the other corner (NW corner) and it faces south. An east-facing ramp needs to be installed. The street unevenly meets NE wheelchair ramp, posing issues for users. The crosswalk is faded.

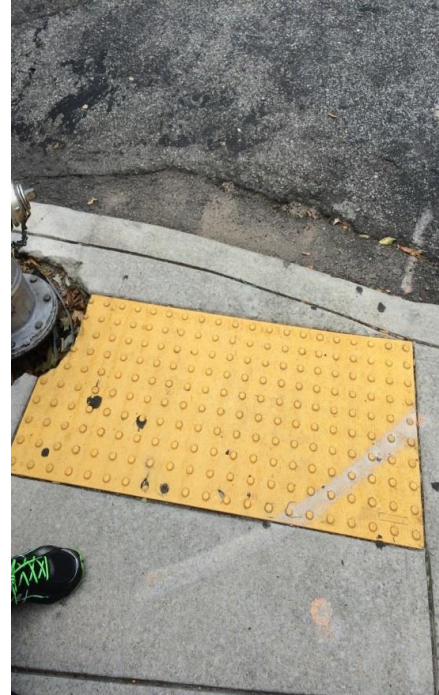
Figure B-2. South-facing wheelchair ramp at the NE corner of intersection John Portman Boulevard and Courtland Street NE (same block as Atlanta Hilton). The uneven connection to ramp from street poses issues for wheelchair users. The ramp is also partially blocked by fire hydrant.

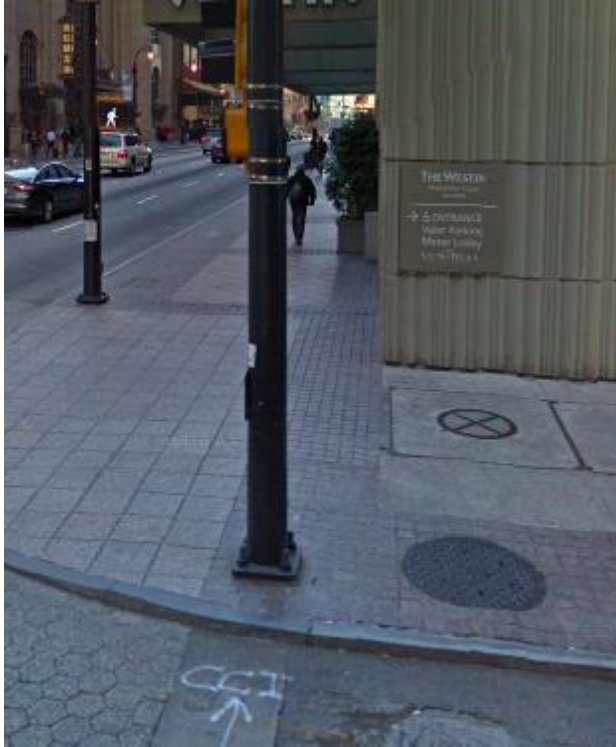
Figure B-3. Westin Peachtree Plaza's wheelchair ramp. The wayfinding sign is visible walking Southbound on Peachtree Street, but is not visible from the east.

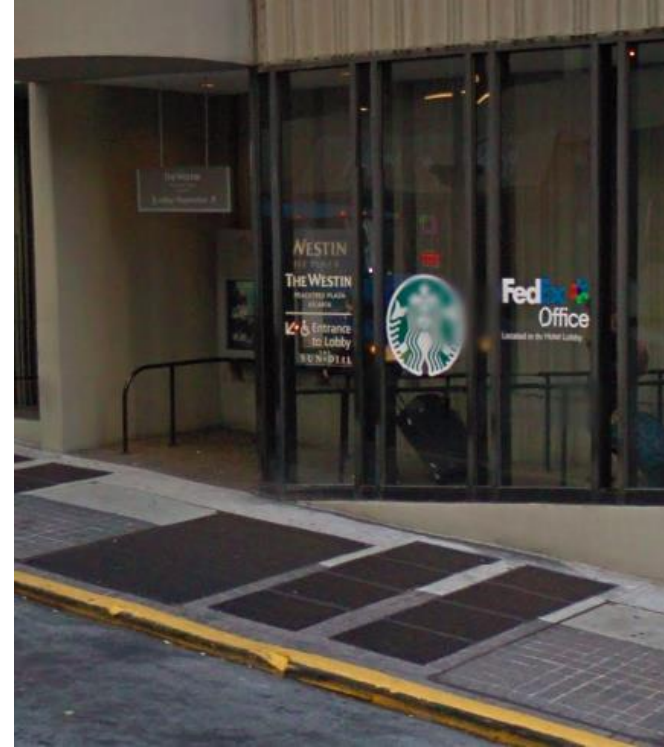
Figure B-4. Westin Peachtree Plaza wheelchair ramp (viewed from Andrew Young International Boulevard). Problematic grating throughout the sidewalk.

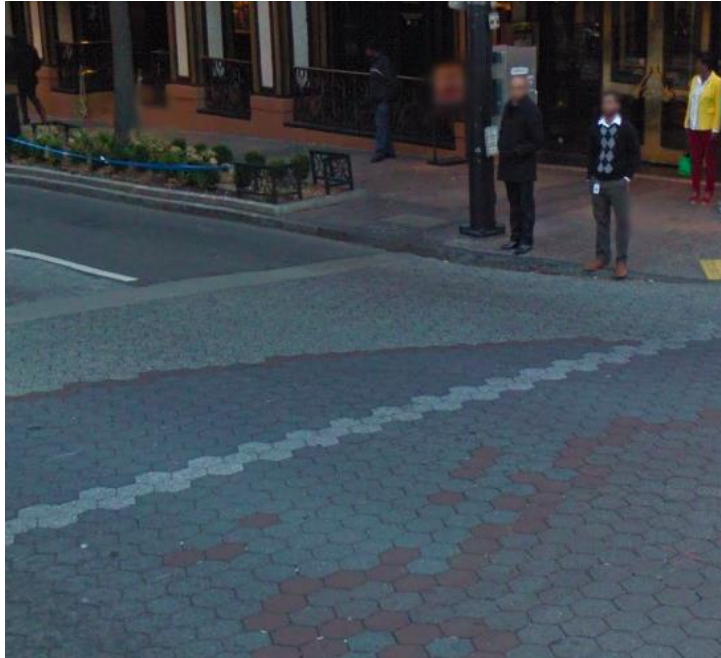
Figure B-5. Andrew Young International Boulevard and Peachtree Street. Another example of poor crosswalk designation. Pavers should be installed to clearly mark horizontal stripes and create perpendicular stripes for the crosswalk area, or the area should be repaved.

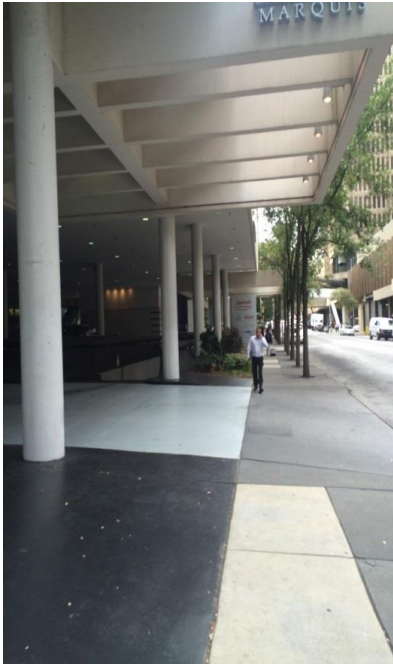
Figure B-7. Sidewalk on Peachtree Center Avenue NE in front of the main vehicular and pedestrian entrance to the Atlanta Marriott Marquis. The sidewalk here is flat and well-maintained, but lacks any form of transition pavers or detectable warning strip to alert the visually impaired pedestrian that they are entering car zones.

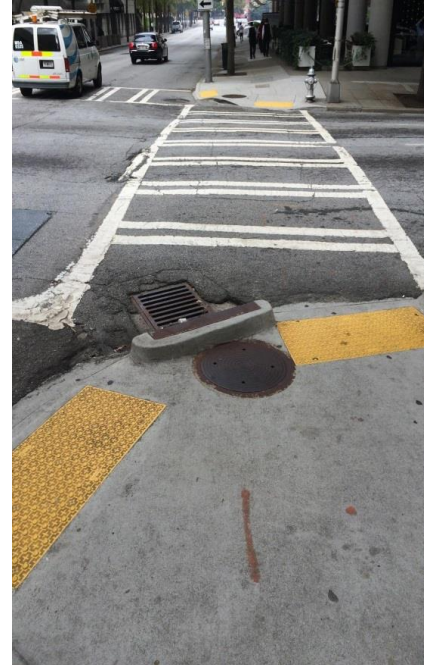
Figure B-8. The SE corner of Baker Street NE and Peachtree Center Avenue looking north on Peachtree Center Avenue. Wheelchair ramps are slightly narrow but feature detectable warning strips and flat grade. The crosswalks meet the wheelchair ramps in a bumpy, uneven way that makes crossing the street in a wheelchair difficult (no flush transition). The asphalt under the crosswalk is also uneven.

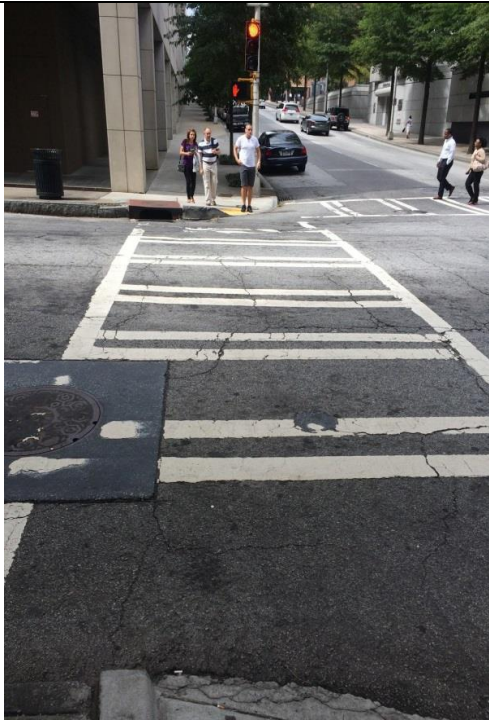
Figure B-9. Looking west toward the Hyatt Regency Atlanta on Baker Street NE from the SE corner of the intersection of Baker Street NE and Peachtree Center Avenue. The SW corner features only one ramp that is not wide to accommodate the needs of users coming from both directions. Crosswalk paint is fading and meets the corner ramps poorly.

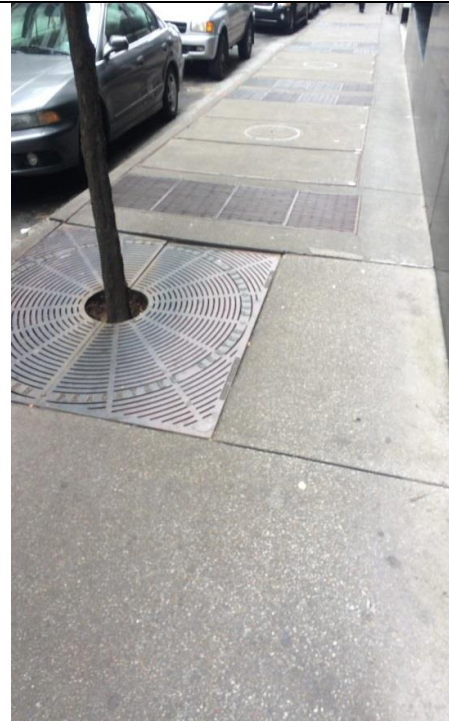
Figure B-10. Baker Street NE, looking eastward on the northern side of the Atlanta Marriott Marquis block, features disjointed sidewalk slabs and tree covers, which are more noticeable in person than in this photograph. Milling and patching would likely suffice in many locations.

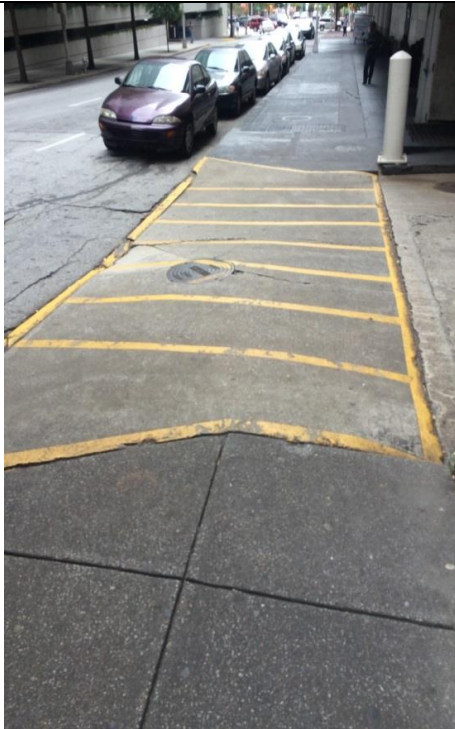
Figure B-11. Vehicle entrance ramp on Baker Street NE looking east towards the Atlanta Hilton. The curbcut is very uneven with many cracks, disjointed slabs, and grade/cross-slope issues. Although the ramp is marked with yellow lines, detectable warning strips are not present to aid visually-impaired pedestrians.

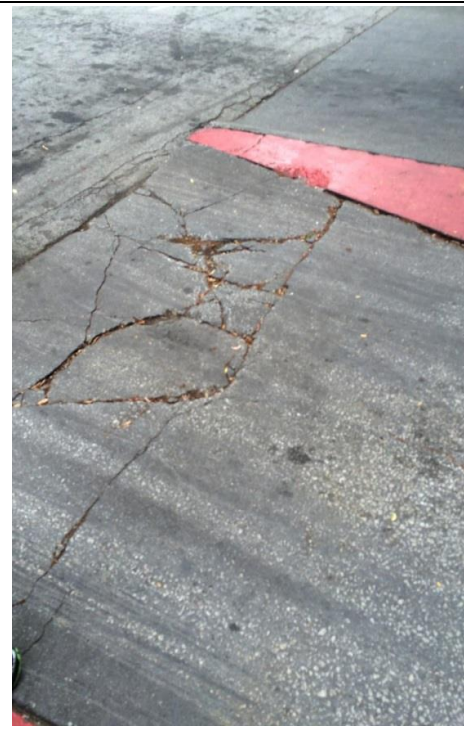
Figure B-12. Another service vehicle entrance curbcut on Baker Street NE on the northern side of the Atlanta Marriott Marquis building. There are two curbcuts and both have steep ramps connecting to the sidewalk, lack detectable warning strips, and are cracked and uneven.

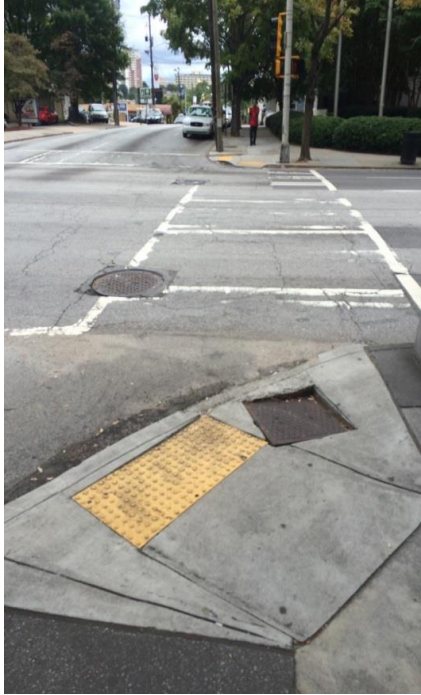
Figure B-13. Wheelchair ramp at the SW corner of Baker Street NE and Courtland Street NE looking east towards the Atlanta Hilton. The ramp partially broken with service box and deterioration visible in bottom left corner of view. Gap between street and beginning of ramp causes issues for wheelchair users. The crosswalks are starting to fade.

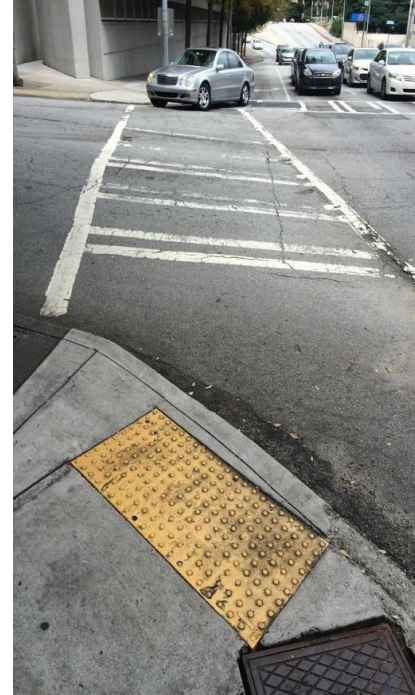
Figure B-14. Wheelchair ramp at the SW corner of Baker Street NE and Courtland Street NE. The ramp is partially broken with service box and deterioration visible in bottom left corner of view. A gap is present between the street and beginning of ramp. Crosswalks are starting to fade and a steep slope is present on street.

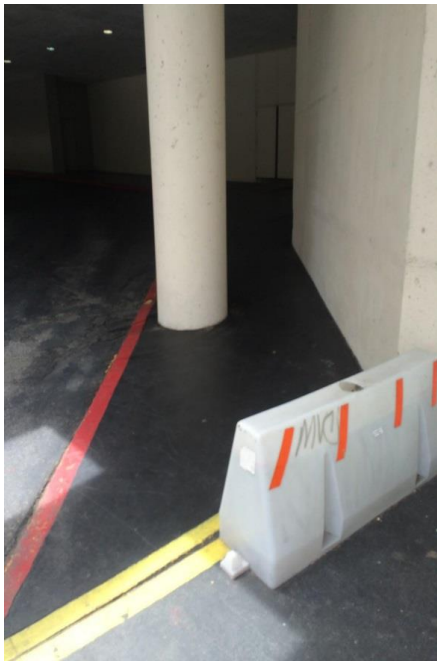
Figure B-15. Sidewalk connecting into car loop and entrance on the eastern side of the building. Although the grade is smooth up into the entrance/waiting area, a large pole obstructs accessibility for those in wheelchairs. The lack of detectable warning strip along red line between vehicular space and pedestrian space could pose problem for individuals with visual impairment.

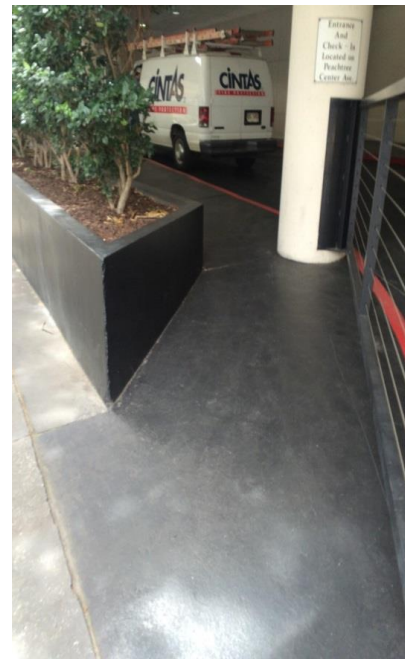
Figure B-16. Sidewalk on the other side of the eastern car bay and entrance features another pedestrian way somewhat blocked by support columns. The only other location to reach the eastern entrance on this street in a wheelchair is down at the intersection of Courtland Street and John Portman Boulevard (quite inconvenient).

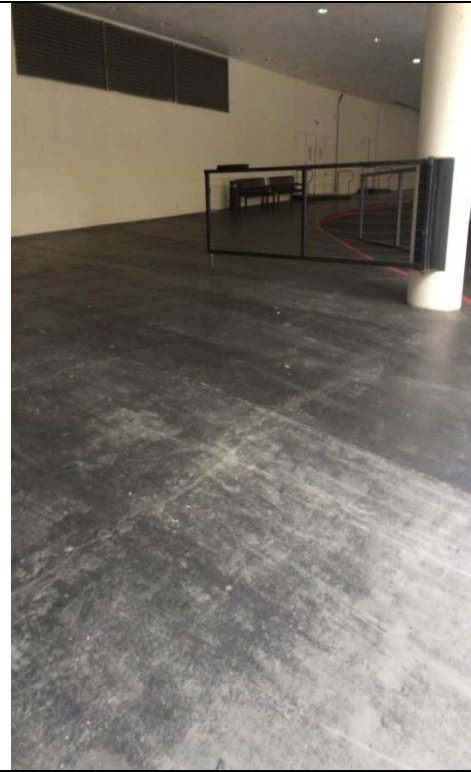
Figure B-18. Smooth slope up from Courtland Street NE on the eastern side of the Atlanta Marriott Marquis building towards the eastern/lower entrance. A vehicle gate provides some obstruction, but ultimately the slope/grade here may be the only obstacle to accessibility.

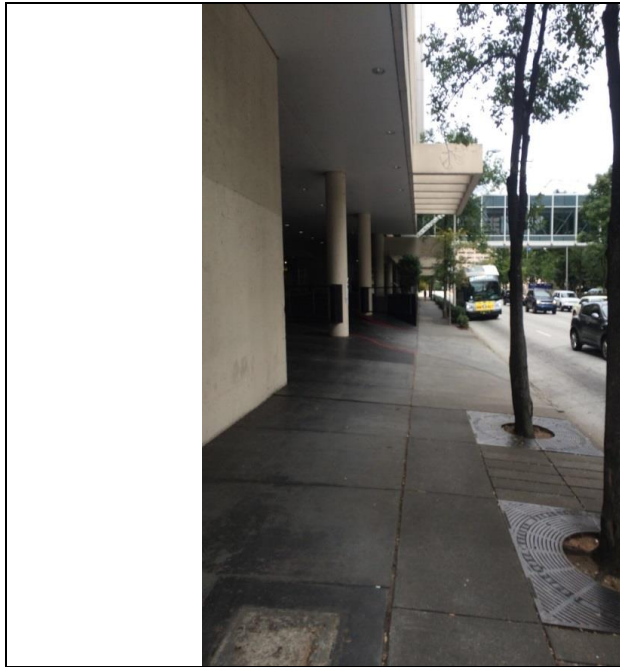
Figure B-19. The sidewalk along the eastern side of the Atlanta Marriott Marquis along Courtland Street NE is in fairly good condition, although some joints from tree root covers and old slabs may need some patchwork.

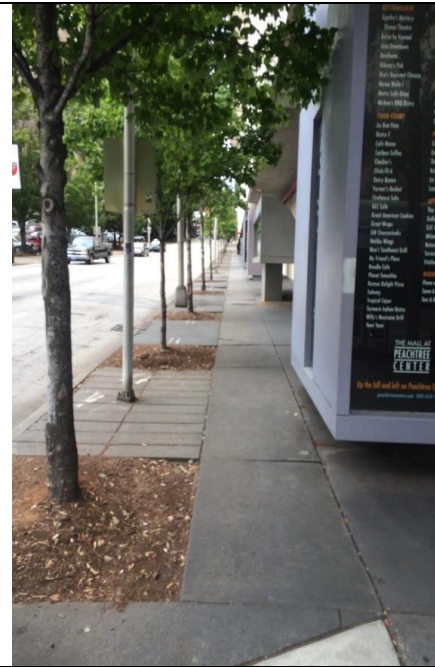
Figure B-20. Sidewalk on the Atlanta Marriott Marquis' south side, looking west on John Portman Boulevard. Trees on this street need grated root zone covers to prevent mulch/debris from entering sidewalk. Slabs all along this sidewalk are disjointed and hazardous for wheelchair users. Outdated advertising boxes for the Mall at Peachtree Center greatly reduce pedestrian space and negatively impact the walking experience.

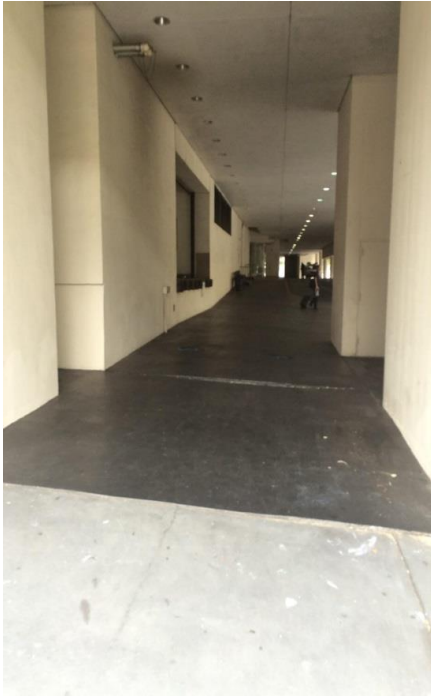
Figure B-21. Side inlet on John Portman Boulevard NE to the Atlanta Marriott Marquis' eastern entrance and car loop. Pavement is smooth, but no detectable warning strip is present to give visually-impaired users notice of the truck loading bay and other mode changes. The cross-slope of the curbcut also appears to be an issue for wheelchair users.

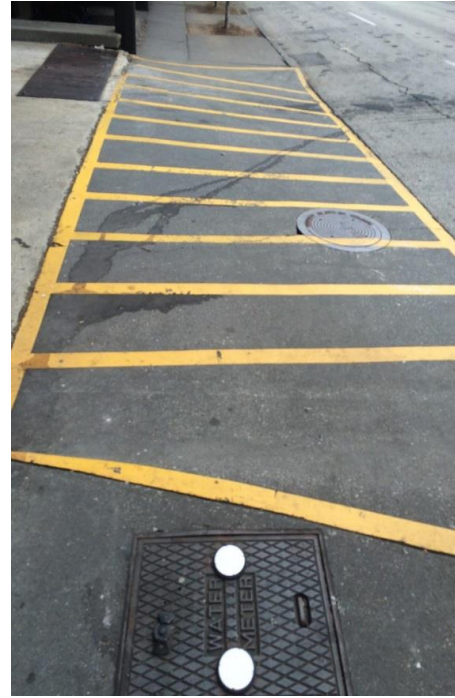
Figure B-22. Vehicle curbcut ramp on John Portman Boulevard NE on southern side of Atlanta Marriott Marquis building. Although the ramp is well marked, the cross-slope is somewhat steep and the transition from sidewalk to vehicle ramp and back are very steep. Also, there are no detectable warning strips in place to alert persons with visual impairments to the change in mode.

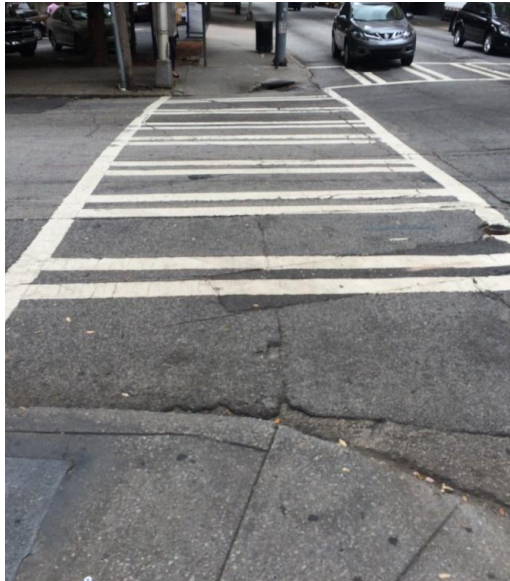
Figure B-25. Wheelchair ramp on the NE corner of John Portman Boulevard NE and Peachtree Center Avenue NE looking south on Peachtree Center Ave. The wheelchair ramp services neither direction of pedestrian traffic and lacks a detectable warning strip. The crosswalk is adequately marked but full of patches, bumps, and potholes. The wheelchair ramps across the street on the SE corner also need to be replaced as they are in the same condition.

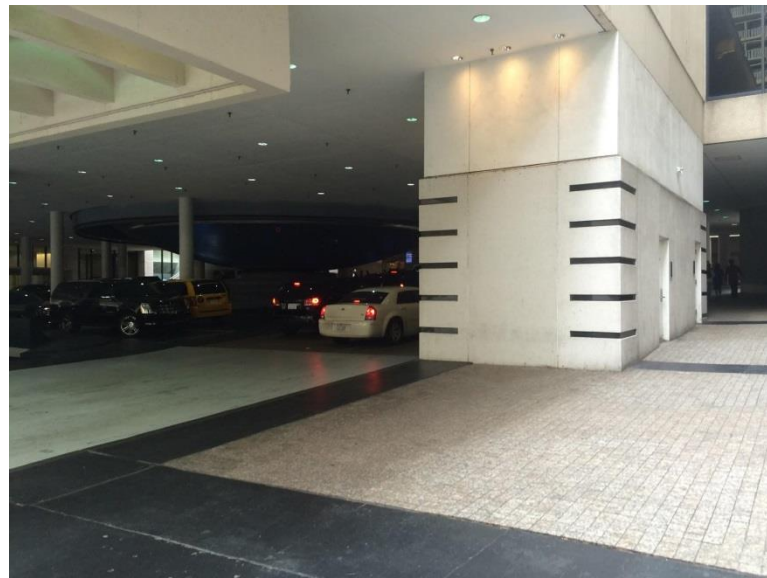
Figure B-26. Sidewalk between Peachtree Center buildings and Atlanta Marriott Marquis entrance on Peachtree Center Avenue NE. The pedestrian route to the entrance is visible on the far right-hand side of photograph. Sidewalks feature attractive pavers and marble tiles but lack detectable warning strips between the car entrance and contiguous sidewalk. There is no clear demarcation between automobile and pedestrian right-of-way.

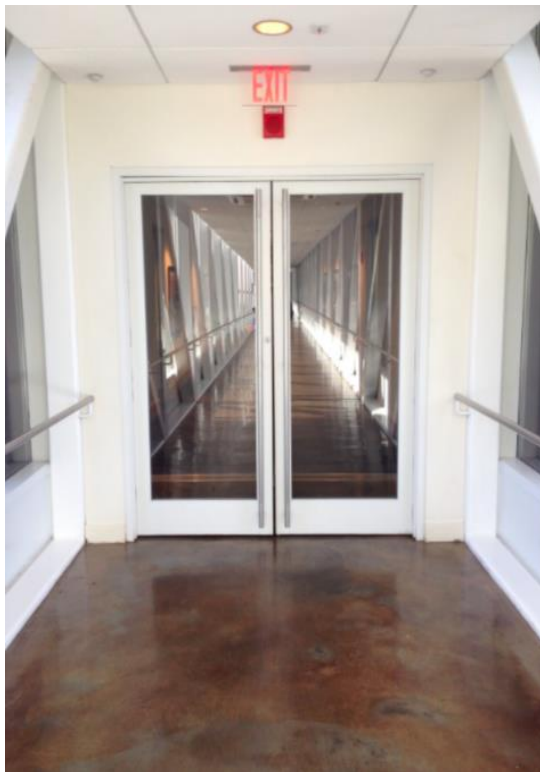
Figure B-27. Sky Bridge Entrance to Atlanta Marriott Marquis from Atlanta Hilton. Heavy doors could not be manually opened by a person with disabilities. Lack of door automatic door operation limits accessibility.

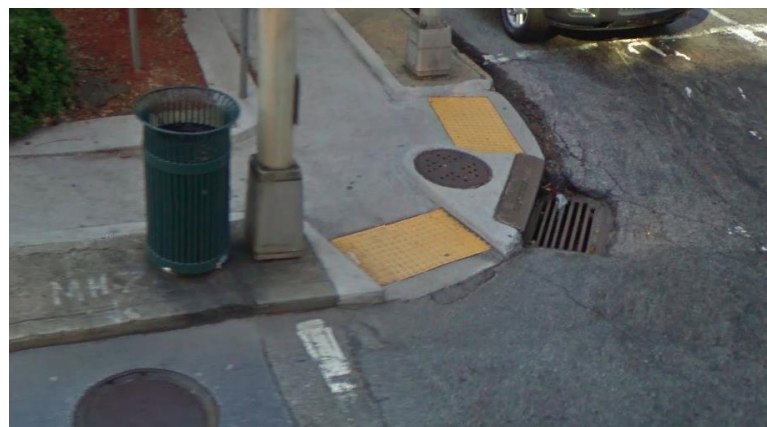
Figure B-28: The SW corner of the intersection of Courtland Street NE and John Portman Boulevard NE. The wheelchair ramps are narrow and are connected via unsmooth transitions into crosswalks that are largely faded.

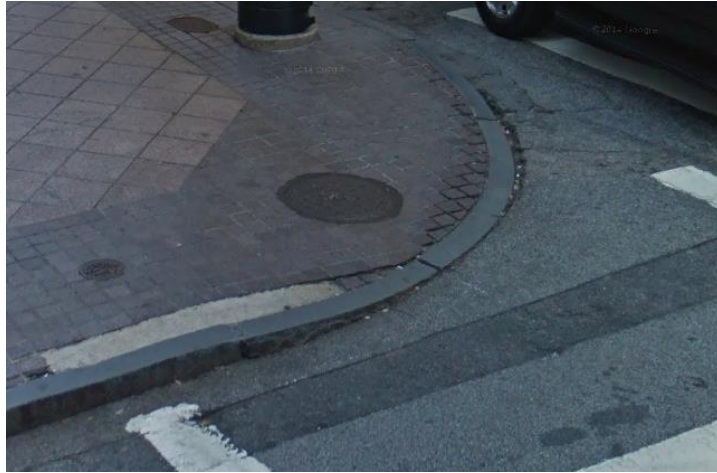
Figure B-29: The SW corner of Peachtree Street and John Portman Boulevard NE features a wheelchair ramp on Peachtree Street that requires improvement. Some pavers are starting to come loose and should be replaced, or removed and replaced with concrete. The patchwork in the bottom left hand corner should is poorly installed and inconsistent. Filler could be applied on the westward side of the corner to fill in the rough transition from crosswalk to corner. A detectable warning strip should be installed.

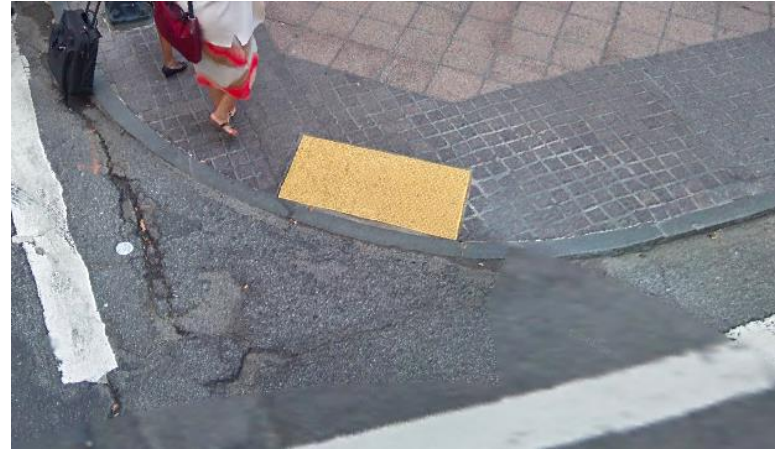
Figure B-30: The SW corner of Peachtree Street and John Portman Boulevard NE. Although the corner and ramp is wide enough to accommodate users coming from either direction, cracks forming on the eastern side of the corner lead to an unsmooth transition for wheelchair users. A bump on the northern side leads to the same problem. Milling and patchwork could fix both problems.

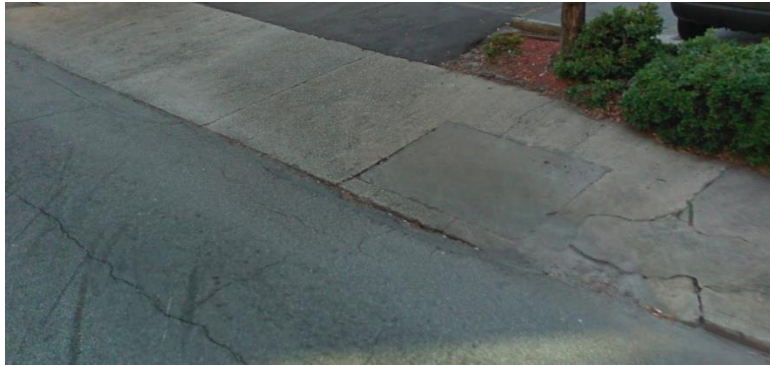
Figure B-31: The western sidewalk on Courtland Street NE (photographed from south-facing perspective) contains broken, narrow sidewalks throughout. There is little to no curb separation from the street. The sidewalk should be replaced to feature a curb and smooth, unbroken slabs, and widened to increase pedestrian space and passing room.

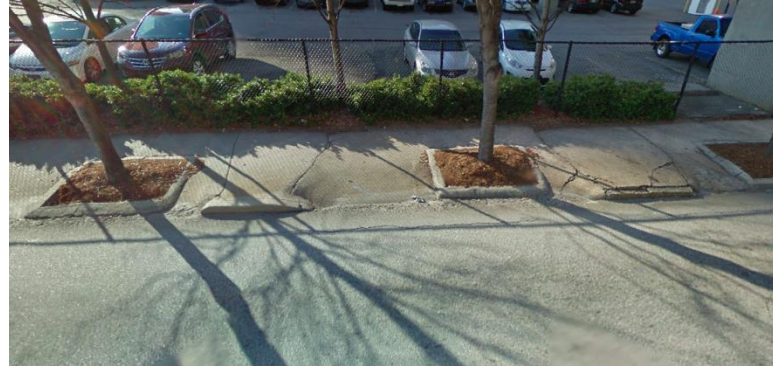
Figure B-32: Additional examples can be seen on Courtland Street NE between the Atlanta Marriott Marquis and Sheraton Atlanta of narrow, broken sidewalks with legacy curbcuts (and non-compliant cross-slopes) that need to be removed. The sidewalk should be replaced to feature a curb and smooth, unbroken slabs, and widened to increase pedestrian space and passing room.

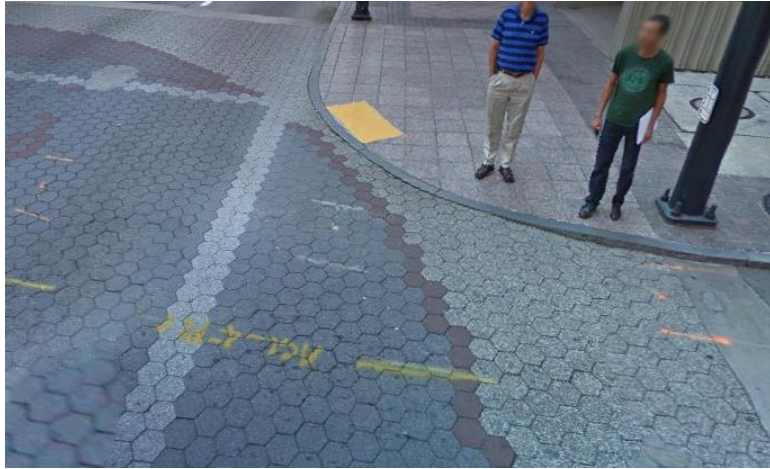
Figure B-33: The crosswalk does not feature formal paint strips, but colored pavers indicate pedestrian right-of-way. Additional, perpendicular pavers could be added to make this clearer, or pavers could be removed. The curb ramp is wide and flat, but should have a flush transition at the intersection.

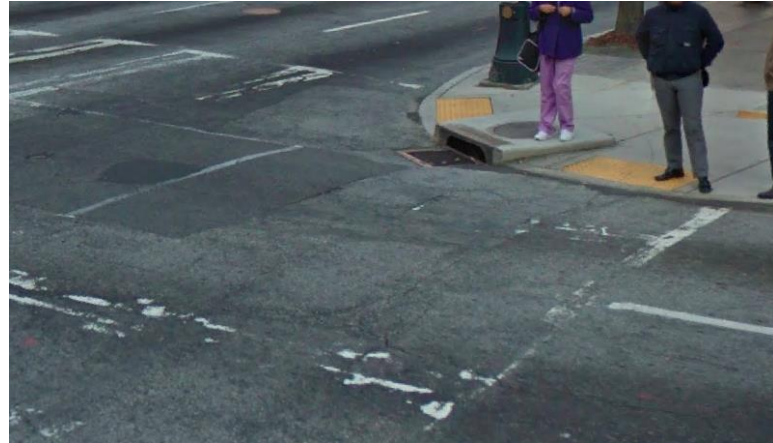
Figure B-34: The SE corner of the intersection of Courtland Street NE and Andrew Young International Boulevard NE. The ramp transitions from street to sidewalk are not flush. Crosswalks have faded dramatically and need to be repainted.

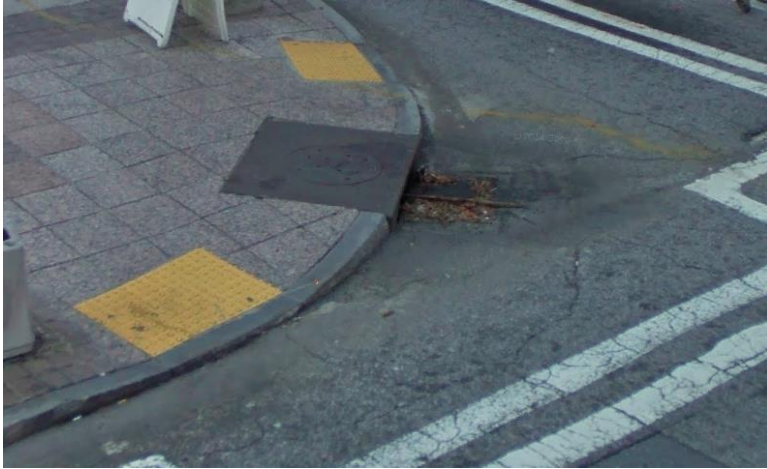
Figure B-35: The SW corner of Andrew Young International Boulevard at Courtland Street NE has quality sidewalk pavers and features warning strips for both directions, but has non-compliant transitions from street to sidewalk. The transition is hazardous for wheelchair users and could accumulate debris.

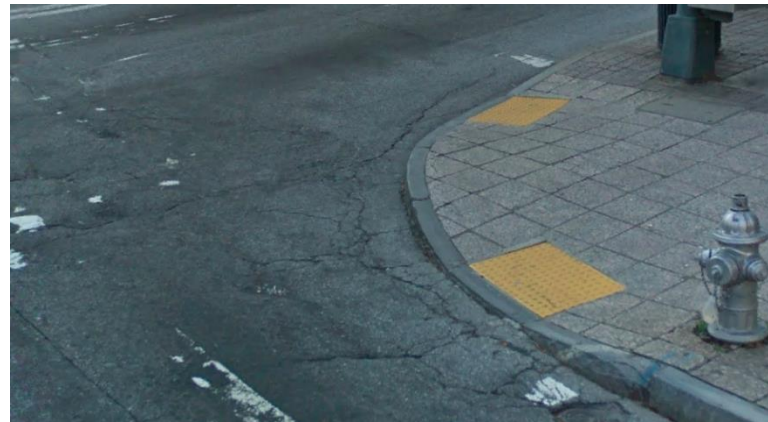
Figure B-36: NW corner of Courtland Street NE at Andrew Young International Boulevard NE. The wheelchair ramps and sidewalks are in good condition, but the transition into the crosswalk needs to be milled, filled, or otherwise smoothed. The crosswalks have all but disappeared and need to be repainted.

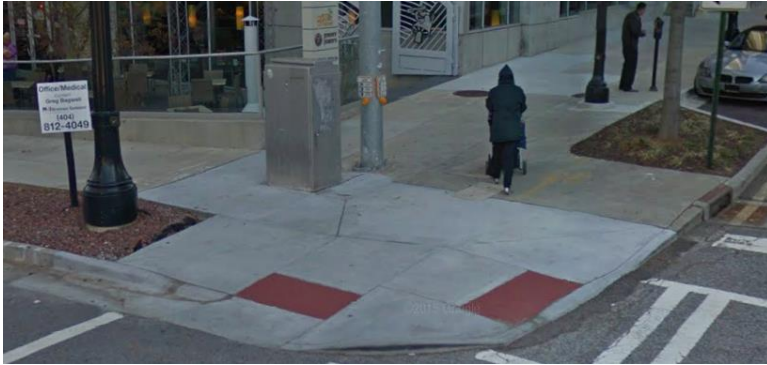
Figure B-37: NE corner of Ivan Allen Junior Boulevard at Spring Street NW. The traffic signal controller cabinet (metal box) may pose as an obstacle for wheelchair users and could be relocated.

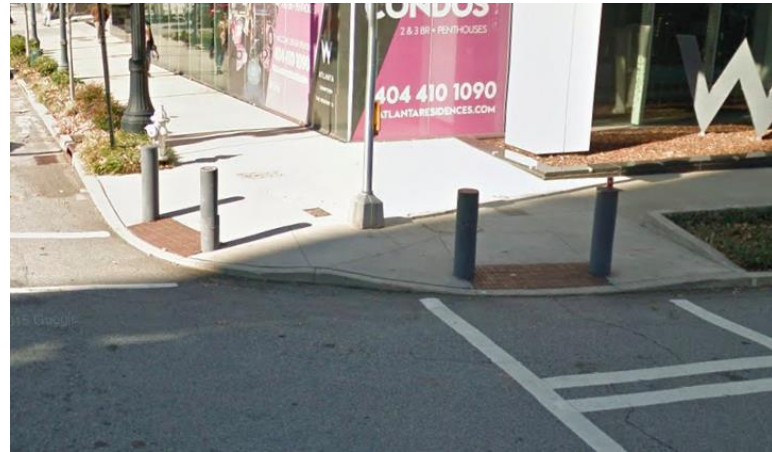
Figure B-38: NW corner of Ivan Allen Junior Boulevard at Spring Street NW. The quality of the ramps and asphalt is good, but the poles on either side of the wheelchair ramps make the pathway narrower for wheelchair users.

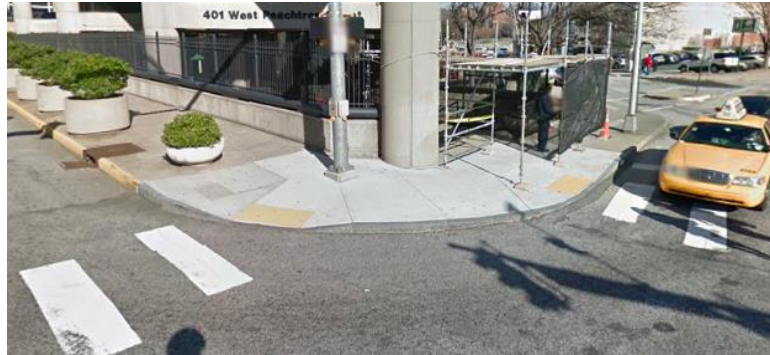
Figure B-39: NE corner of Ivan Allen Junior Boulevard at West Peachtree Street NW. There is no real landing area behind the wheelchair ramps, which poses an issue for wheelchair users. The planter also narrows the sidewalk area. Widening of the sidewalk could remedy this issue.

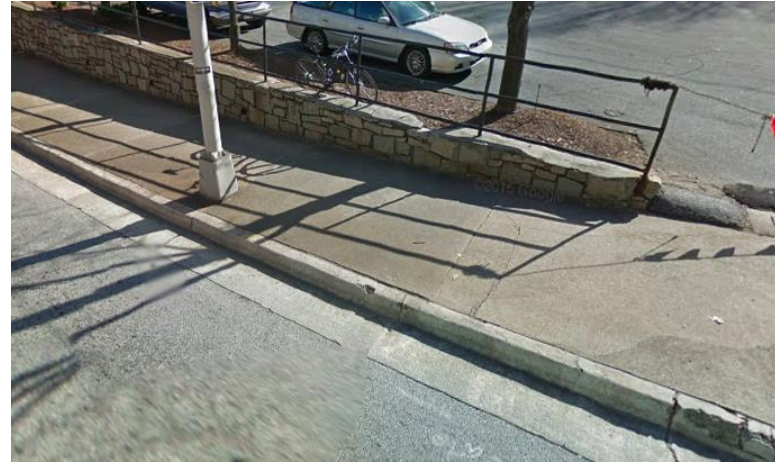
Figure B-40: The southern stretch of Ivan Allen Junior Boulevard between West Peachtree and Peachtree Street Sidewalk is beginning to crack and is fairly narrow.

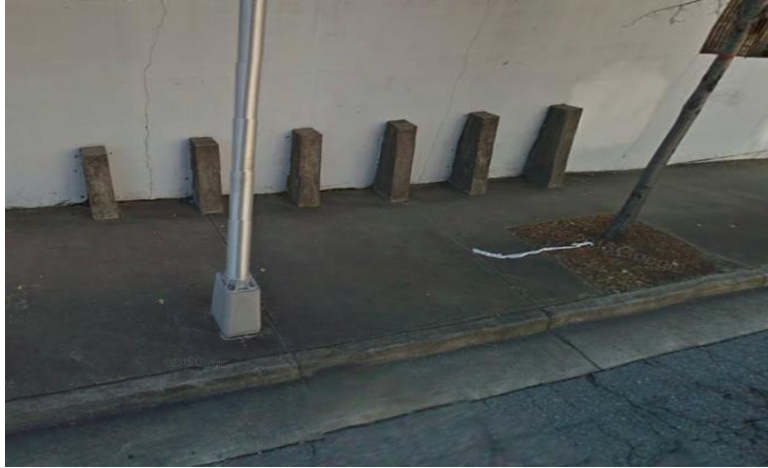
Figure B-41: Southern side of Ivan Allen Junior Boulevard between West Peachtree and Peachtree Streets. Clear example of infrastructure features (tree plantings and random abutments) that narrow sidewalk and passing space. The sidewalk should be widened.

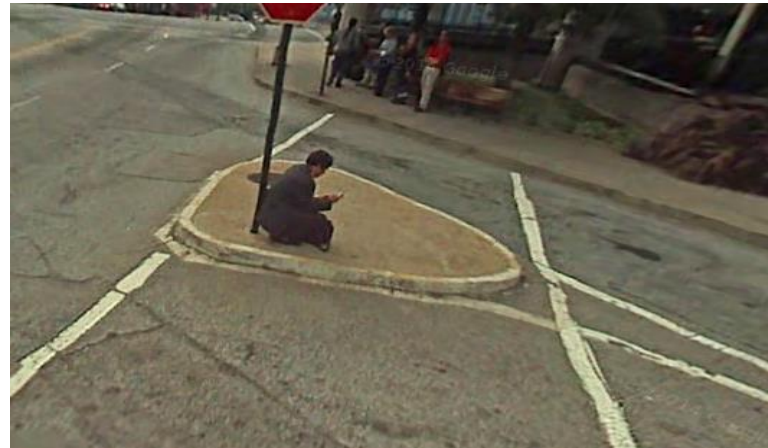
Figure B-42: Intersection of Ivan Allen Boulevard Junior and Alexander Street, looking West. Sidewalk and pedestrian island lack wheelchair ramps. Crosswalks are poorly painted, not very visible, and full of potholes. This image is dated 2007, but the condition is the same in 2015.

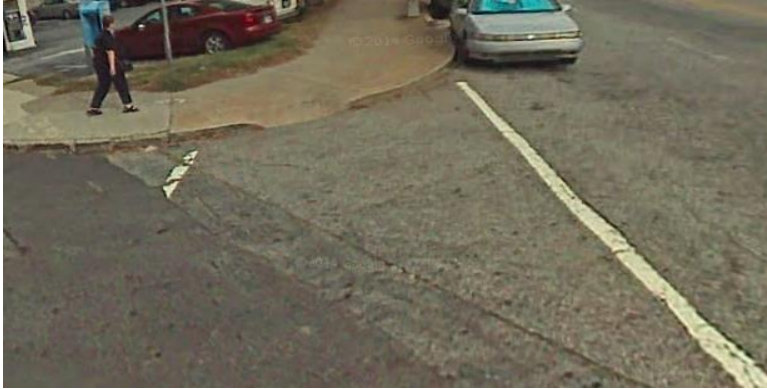
Figure B-43: Intersection of Ivan Allen Boulevard Junior and Alexander Street, looking east. Ramp is present, but severely inadequate. Ramp should be widened, made flush with the crosswalk, and have a detectable warning strip installed. Crosswalk poorly painted and an uneven blend of asphalt paving.

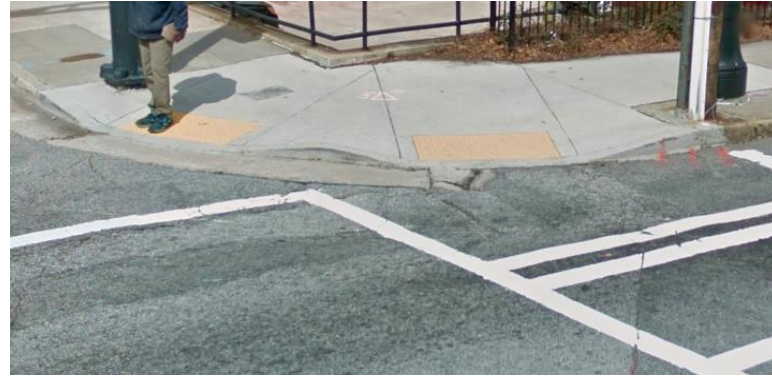
Figure B-44: NW corner of the intersection of Ivan Allen Junior Boulevard and Peachtree Street. Ramps are somewhat misaligned to crosswalks. The landing area is too small, and the concrete in front of the ramp on the right is horribly cracked, leading to an uncomfortable transition for wheelchair users.

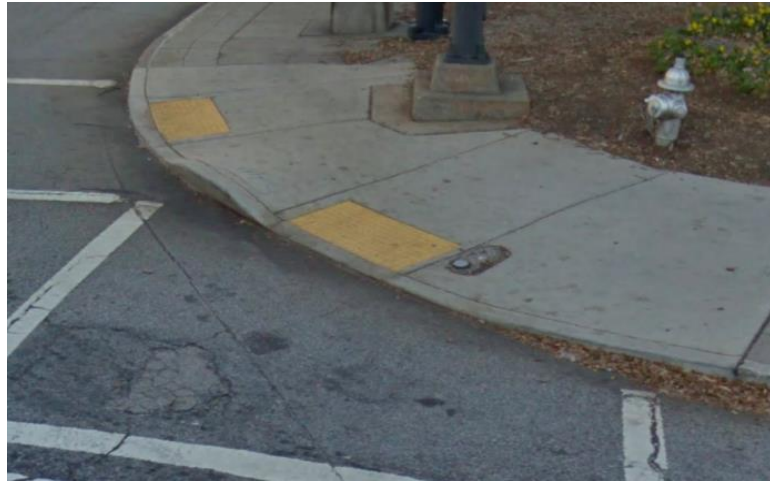
Figure B-45: NE corner of the intersection of Ivan Allen Junior Boulevard and Peachtree Street. Detectable warning strips are too small for the corner, and the ramps are somewhat misaligned to the right-of-way. A utility access portal also cuts into the ramp.

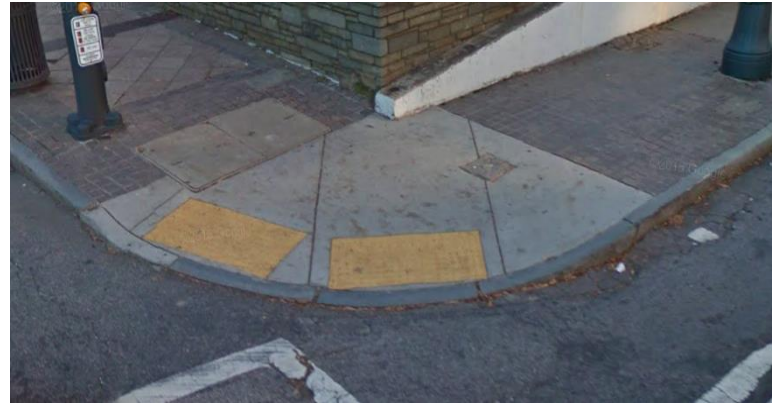
Figure B-46: SW corner of Ivan Allen Junior Boulevard and Peachtree Street. Ramps are poorly oriented to the right-of-way, and the curb is not flush to the crosswalk, leading to a rough transition.

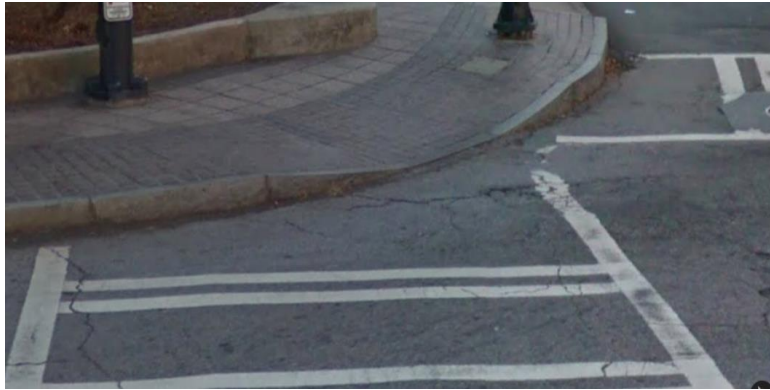
Figure B-47: SE Corner of Ivan Allen Junior Boulevard and Peachtree Street. The ramp is far too small for the orientation of the crosswalks. There is no detectable warning strip present, and the asphalt is cracking and deteriorating.

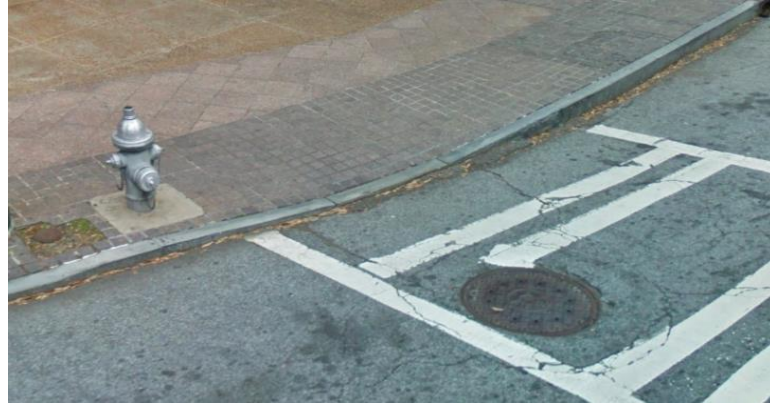
Figure B-48: The eastern sidewalk where Peachtree Street and Peachtree Center Avenue merge is made of pavers/tiles. The ramp lacks a detectable warning strip and is not fully flush to crosswalk.

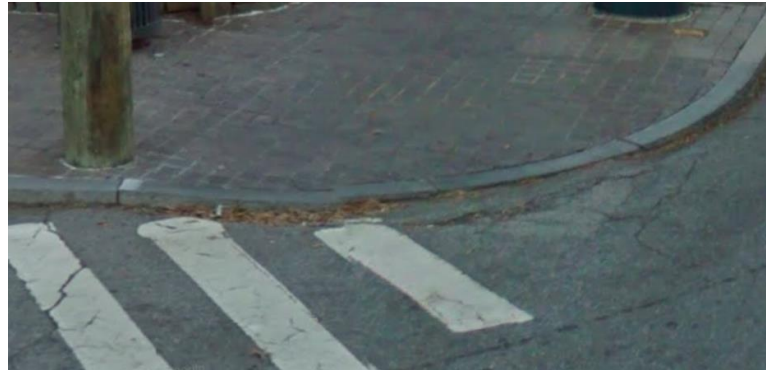
Figure B-50: NW corner of the intersection of West Porter Place and Peachtree Street. The crosswalk is poorly painted. The wheelchair ramp lacks a detectable warning strip and meets the crosswalk very unevenly. The ramp transitions are not flush.
